Stantec Consulting Services Inc.
65 Network Drive, 2nd Floor, Burlington MA 01803-2767

Subject: Town of Belmont
ORDER ON CONSENT Docket No. CWA-AO-R01-FY17-11
Report On Compliance

ILLICIT DISCHARGE DETECTION AND ELIMINATION

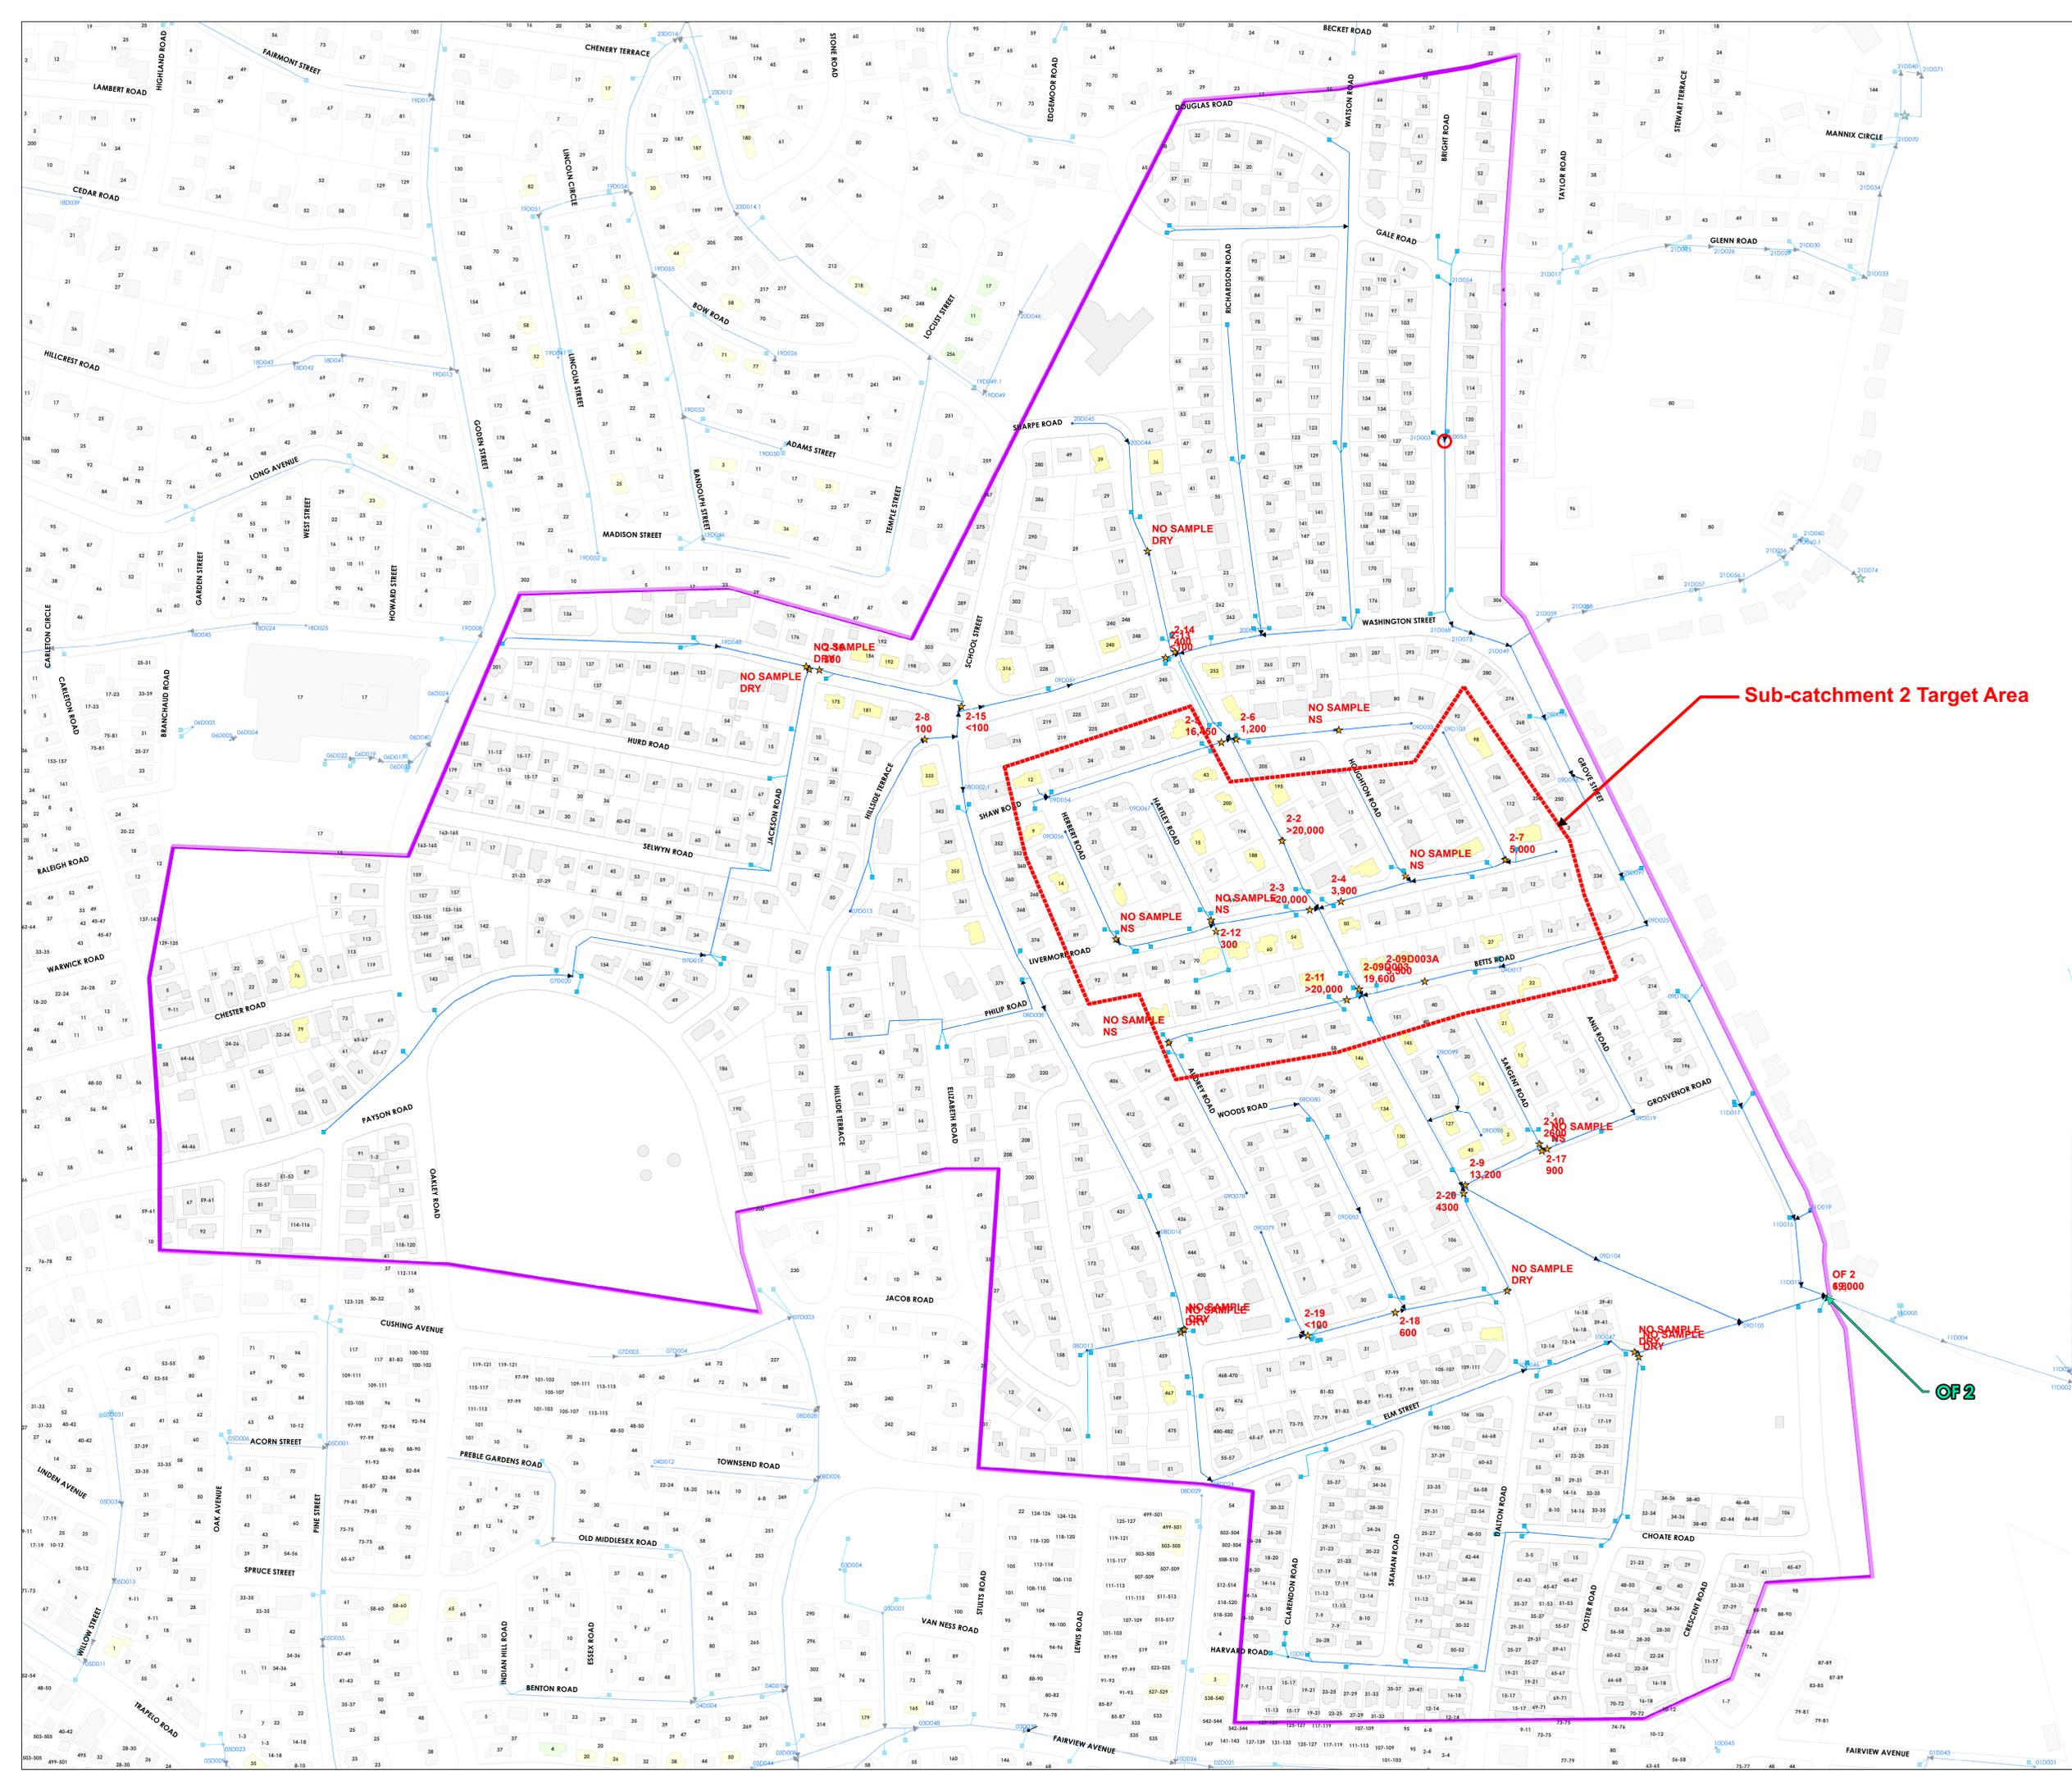
Figure 1
Outfall 2 Subcatchment
Sampling Results
January 2020

Based on sample results conducted on August 12, 2019 and historical sampling results (**Table 1**), 5 areas within Sub-catchment 2 were targeted during these investigations, shown in **Figure 1**. The locations include Shaw Rd West, Betts Rd East, Betts Rd West, Livermore Rd East (Houghton Rd and Shaw Rd) and Livermore Rd West (Herbert Rd and Hartley Rd) and are shown in **Figures 2-6**. Upon Stantec's recommendation, the Town proposes to comprehensively CIPP line all sewer services that have not been previously replaced, in lieu of conducting further dyed water testing, on Shaw Rd, Betts Rd and Livermore Rd. The mainline sewer located above the storm drain has been completely CIPP lined leaving only the service laterals as a source of contamination.

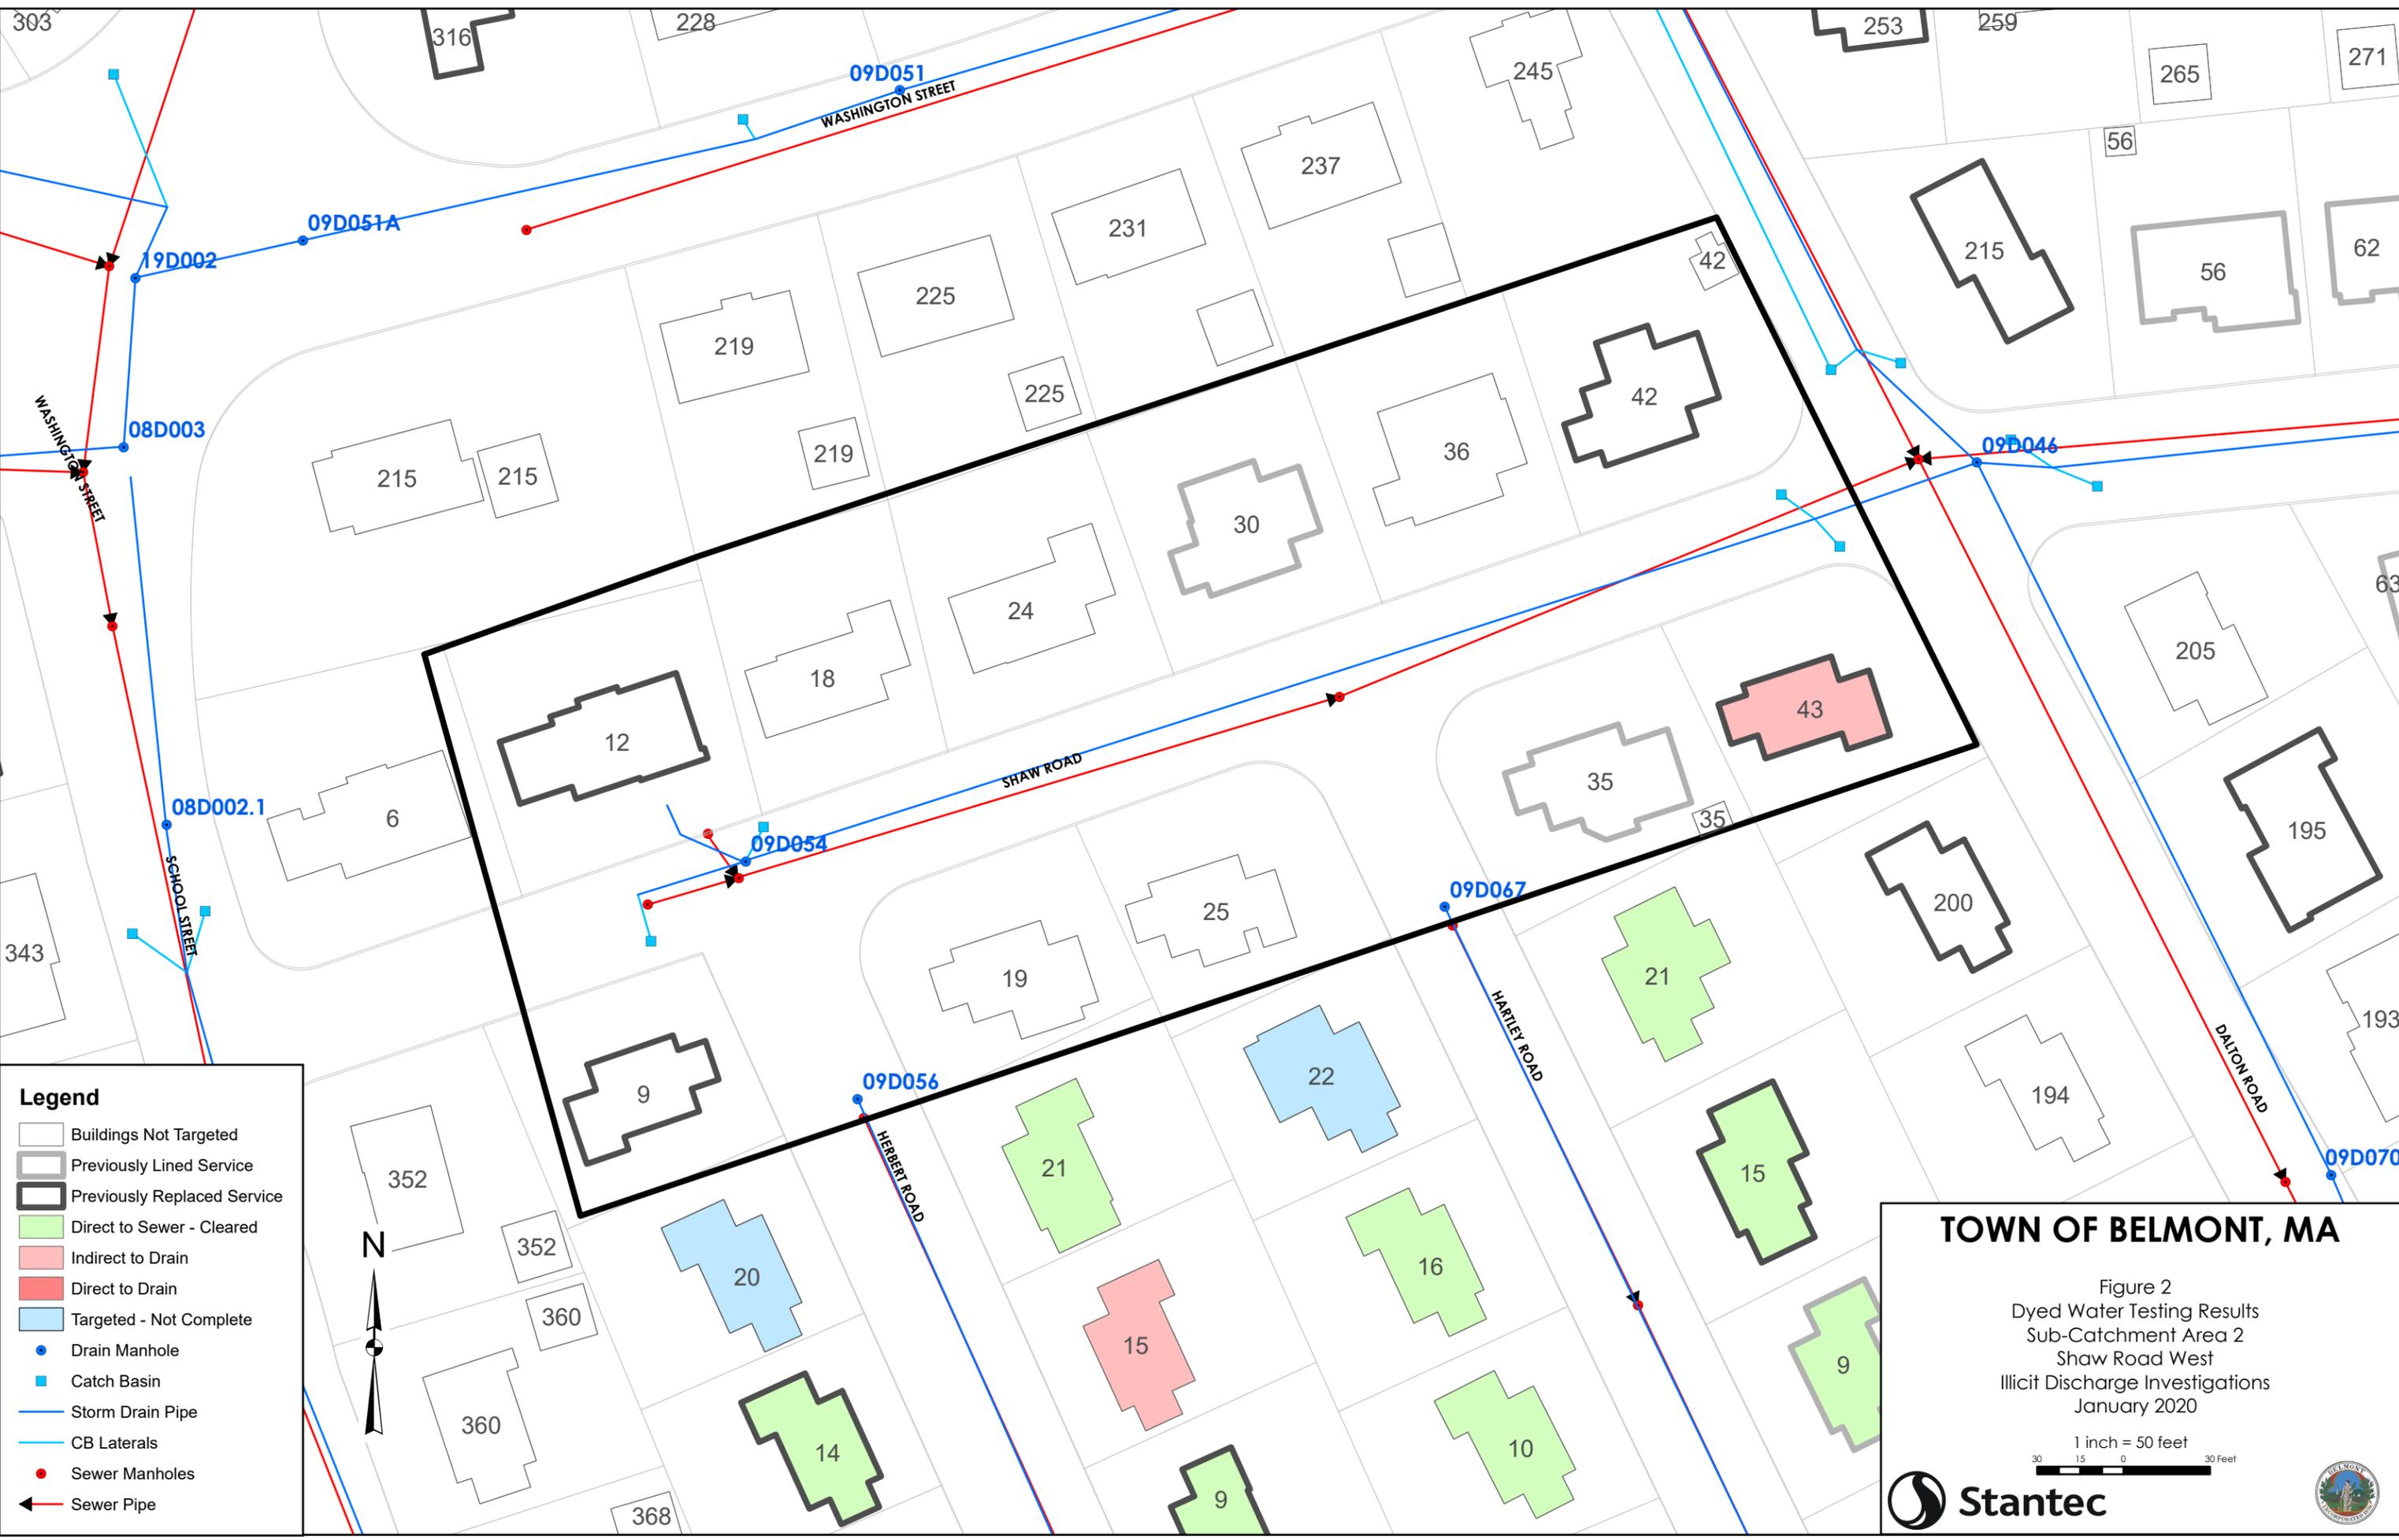
Figure 2
Dyed Water Testing Results
Sub-Catchment Area 2
Shaw Road West
Illicit Discharge Investigations
January 2020

One house at 43 Shaw Rd was dyed water tested prior to deciding to comprehensively CIPP line all sewer service laterals. The sewer lateral at 43 Shaw Rd had been previously replaced, but the dyed water test still showed the lateral to be an indirect contamination source. Six of the 11 building services will be CIPP lined, including 43 Shaw Rd. The remaining 5 buildings have previously been rehabilitated.

All services on Shaw Rd, Livermore Rd and Betts Rd, as described above, along with all identified indirect sources will be CIPP lined in an upcoming Sewer System Rehabilitation project to begin this Spring.

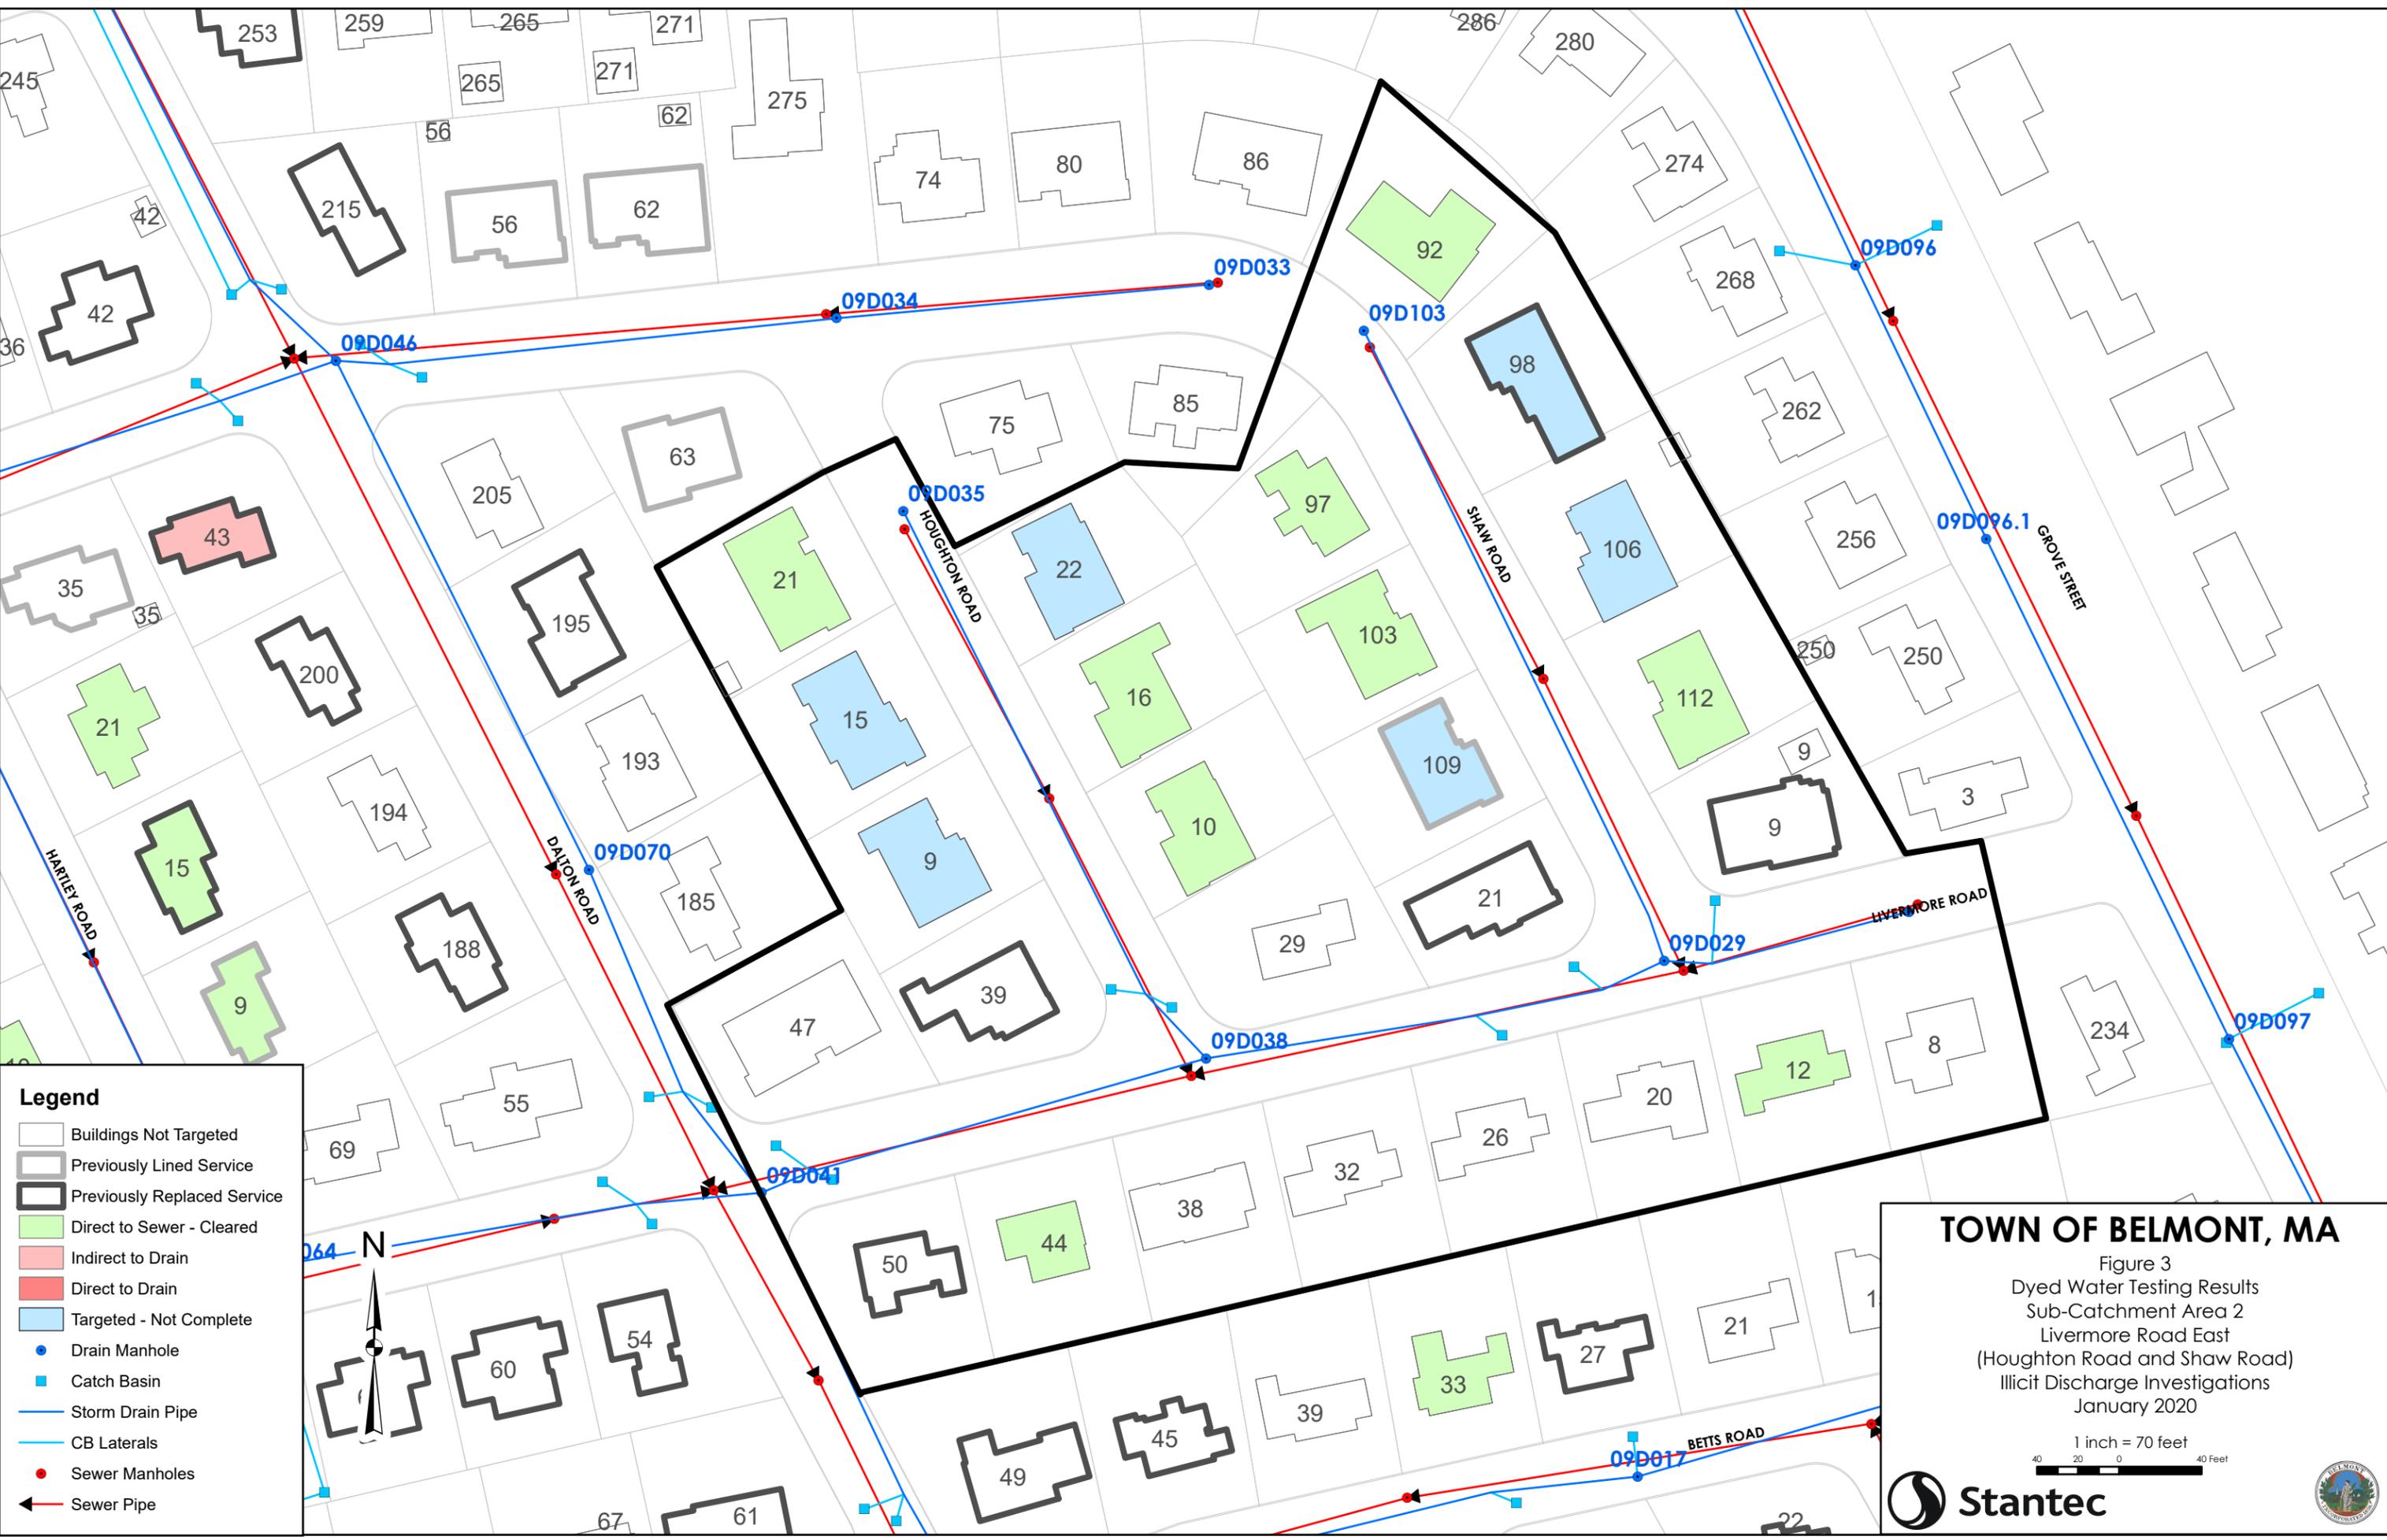
Figure 3
Dyed Water Testing Results
Sub-Catchment Area 2
Livermore Road East
(Houghton Road and Shaw Road)
Illicit Discharge Investigations
January 2020

Two houses were dyed water tested during other ongoing I/I removal investigation work at 12 and 44 Livermore Rd and were cleared as a source of contamination. Similar to Shaw Rd West, Livermore Rd East will have all sewer services completely CIPP lined that have not been previously rehabilitated, which includes 9 services (includes 12 and 44 Livermore Rd as a precaution of becoming a future source). The remaining 4 buildings have been previously been rehabilitated.

Two roadways, a portion of Shaw Rd and Houghton Rd, also discharge to Livermore Rd East and were targeted for dyed water testing. No contamination sources were identified at 7 of the 13 buildings. The remaining 6 buildings were attempted but not entered.

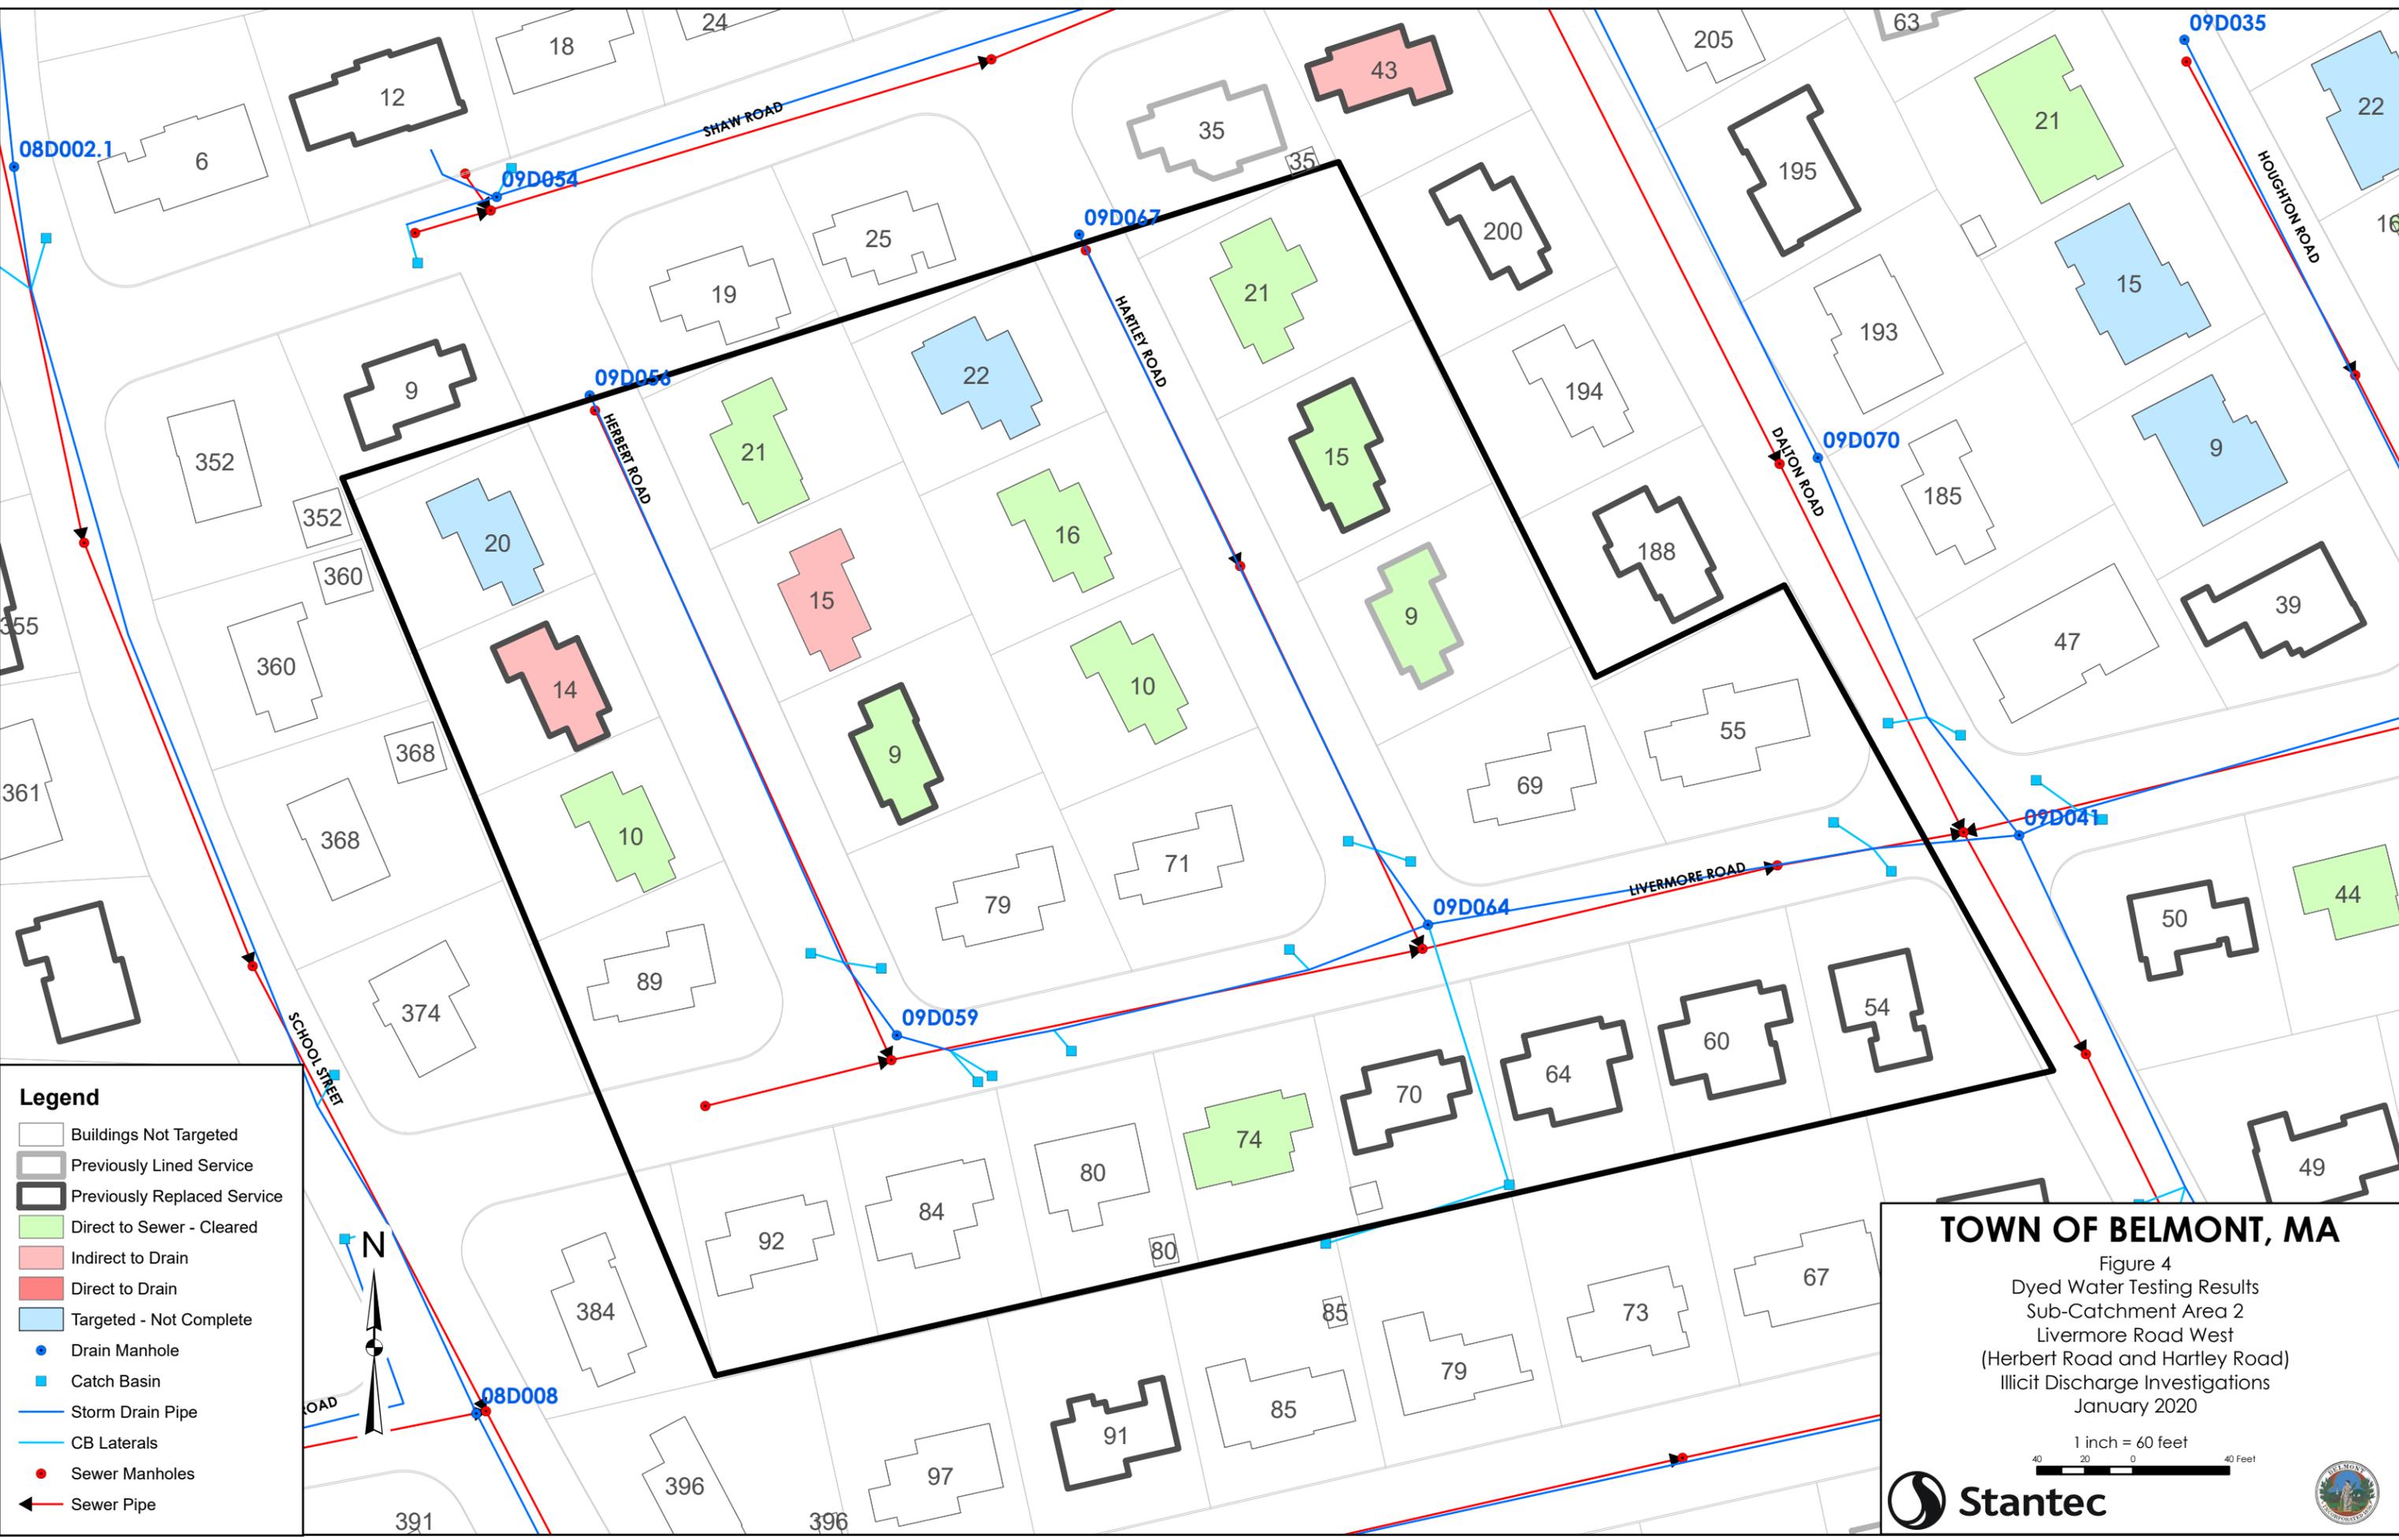
Figure 4
Dyed Water Testing Results
Sub-Catchment Area 2
Livermore Road West
(Herbert Road and Hartley Road)
Illicit Discharge Investigations
January 2020

One house was dyed water tested during other ongoing I/I removal investigation work at 74 Livermore Rd and was cleared as a source of contamination. Similar to Shaw Rd West, Livermore Rd West will have all sewer services completely CIPP lined that have not been previously rehabilitated, which includes 9 services (includes 74 Livermore Rd as a precaution of becoming a future source). The remaining 4 buildings have been previously been rehabilitated.

Two roadways, Herbert Rd and Hartley Rd, also discharge to Livermore Rd West and were targeted for dyed water testing. No contamination sources were identified at 9 of the 12 buildings. Two buildings at 14 and 15 Herbert Rd were identified as indirect connections. The remaining building was attempted but not entered.

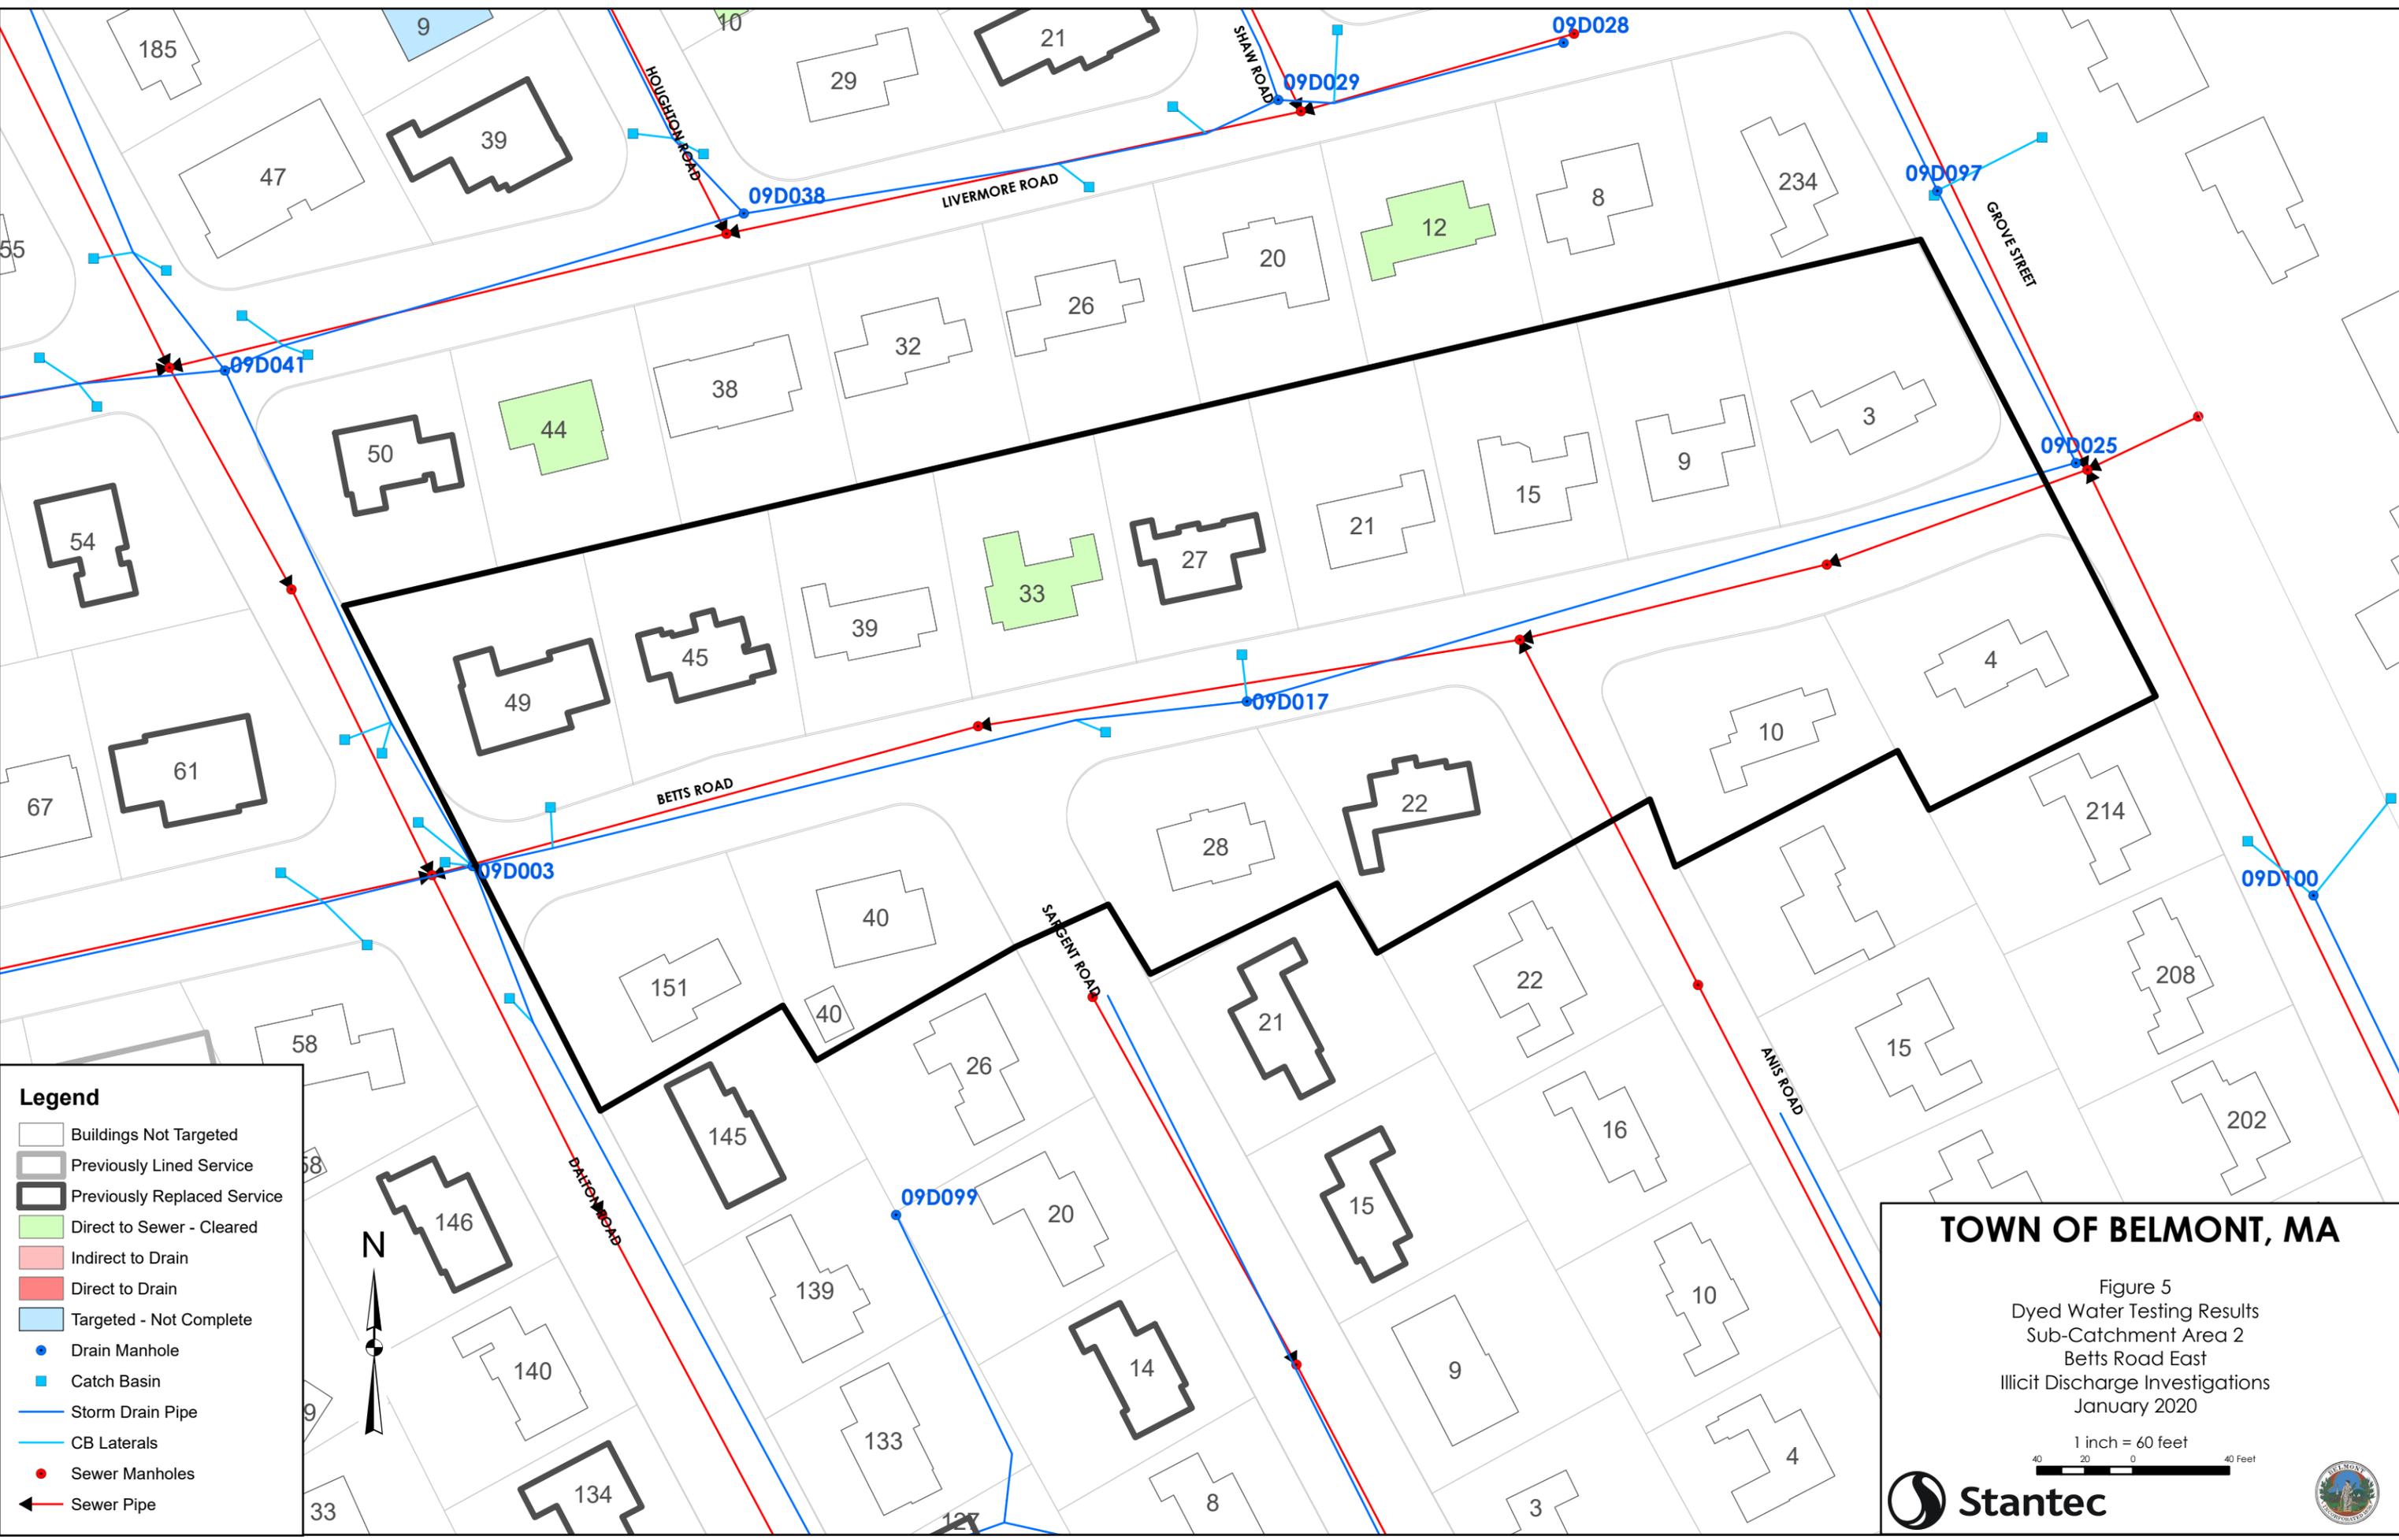
Figure 5
Dyed Water Testing Results
Sub-Catchment Area 2
Betts Road East
Illicit Discharge Investigations
January 2020

One house at 33 Betts Rd was dyed water tested during other ongoing I/I removal investigation work and was cleared as a source of contamination. Similar to Shaw Rd West, Betts Rd will have all sewer services completely CIPP lined that have not been previously rehabilitated, which includes 11 services (includes 33 Betts Rd as a precaution of becoming a future source). The remaining 4 services have been previously been rehabilitated.
