Stantec Consulting Services Inc.
65 Network Drive, 2nd Floor, Burlington MA 01803-2767

Subject: Town of Belmont
ORDER ON CONSENT Docket No. CWA-AO-R01-FY17-11
Report On Compliance

ILLICIT DISCHARGE DETECTION AND ELIMINATION

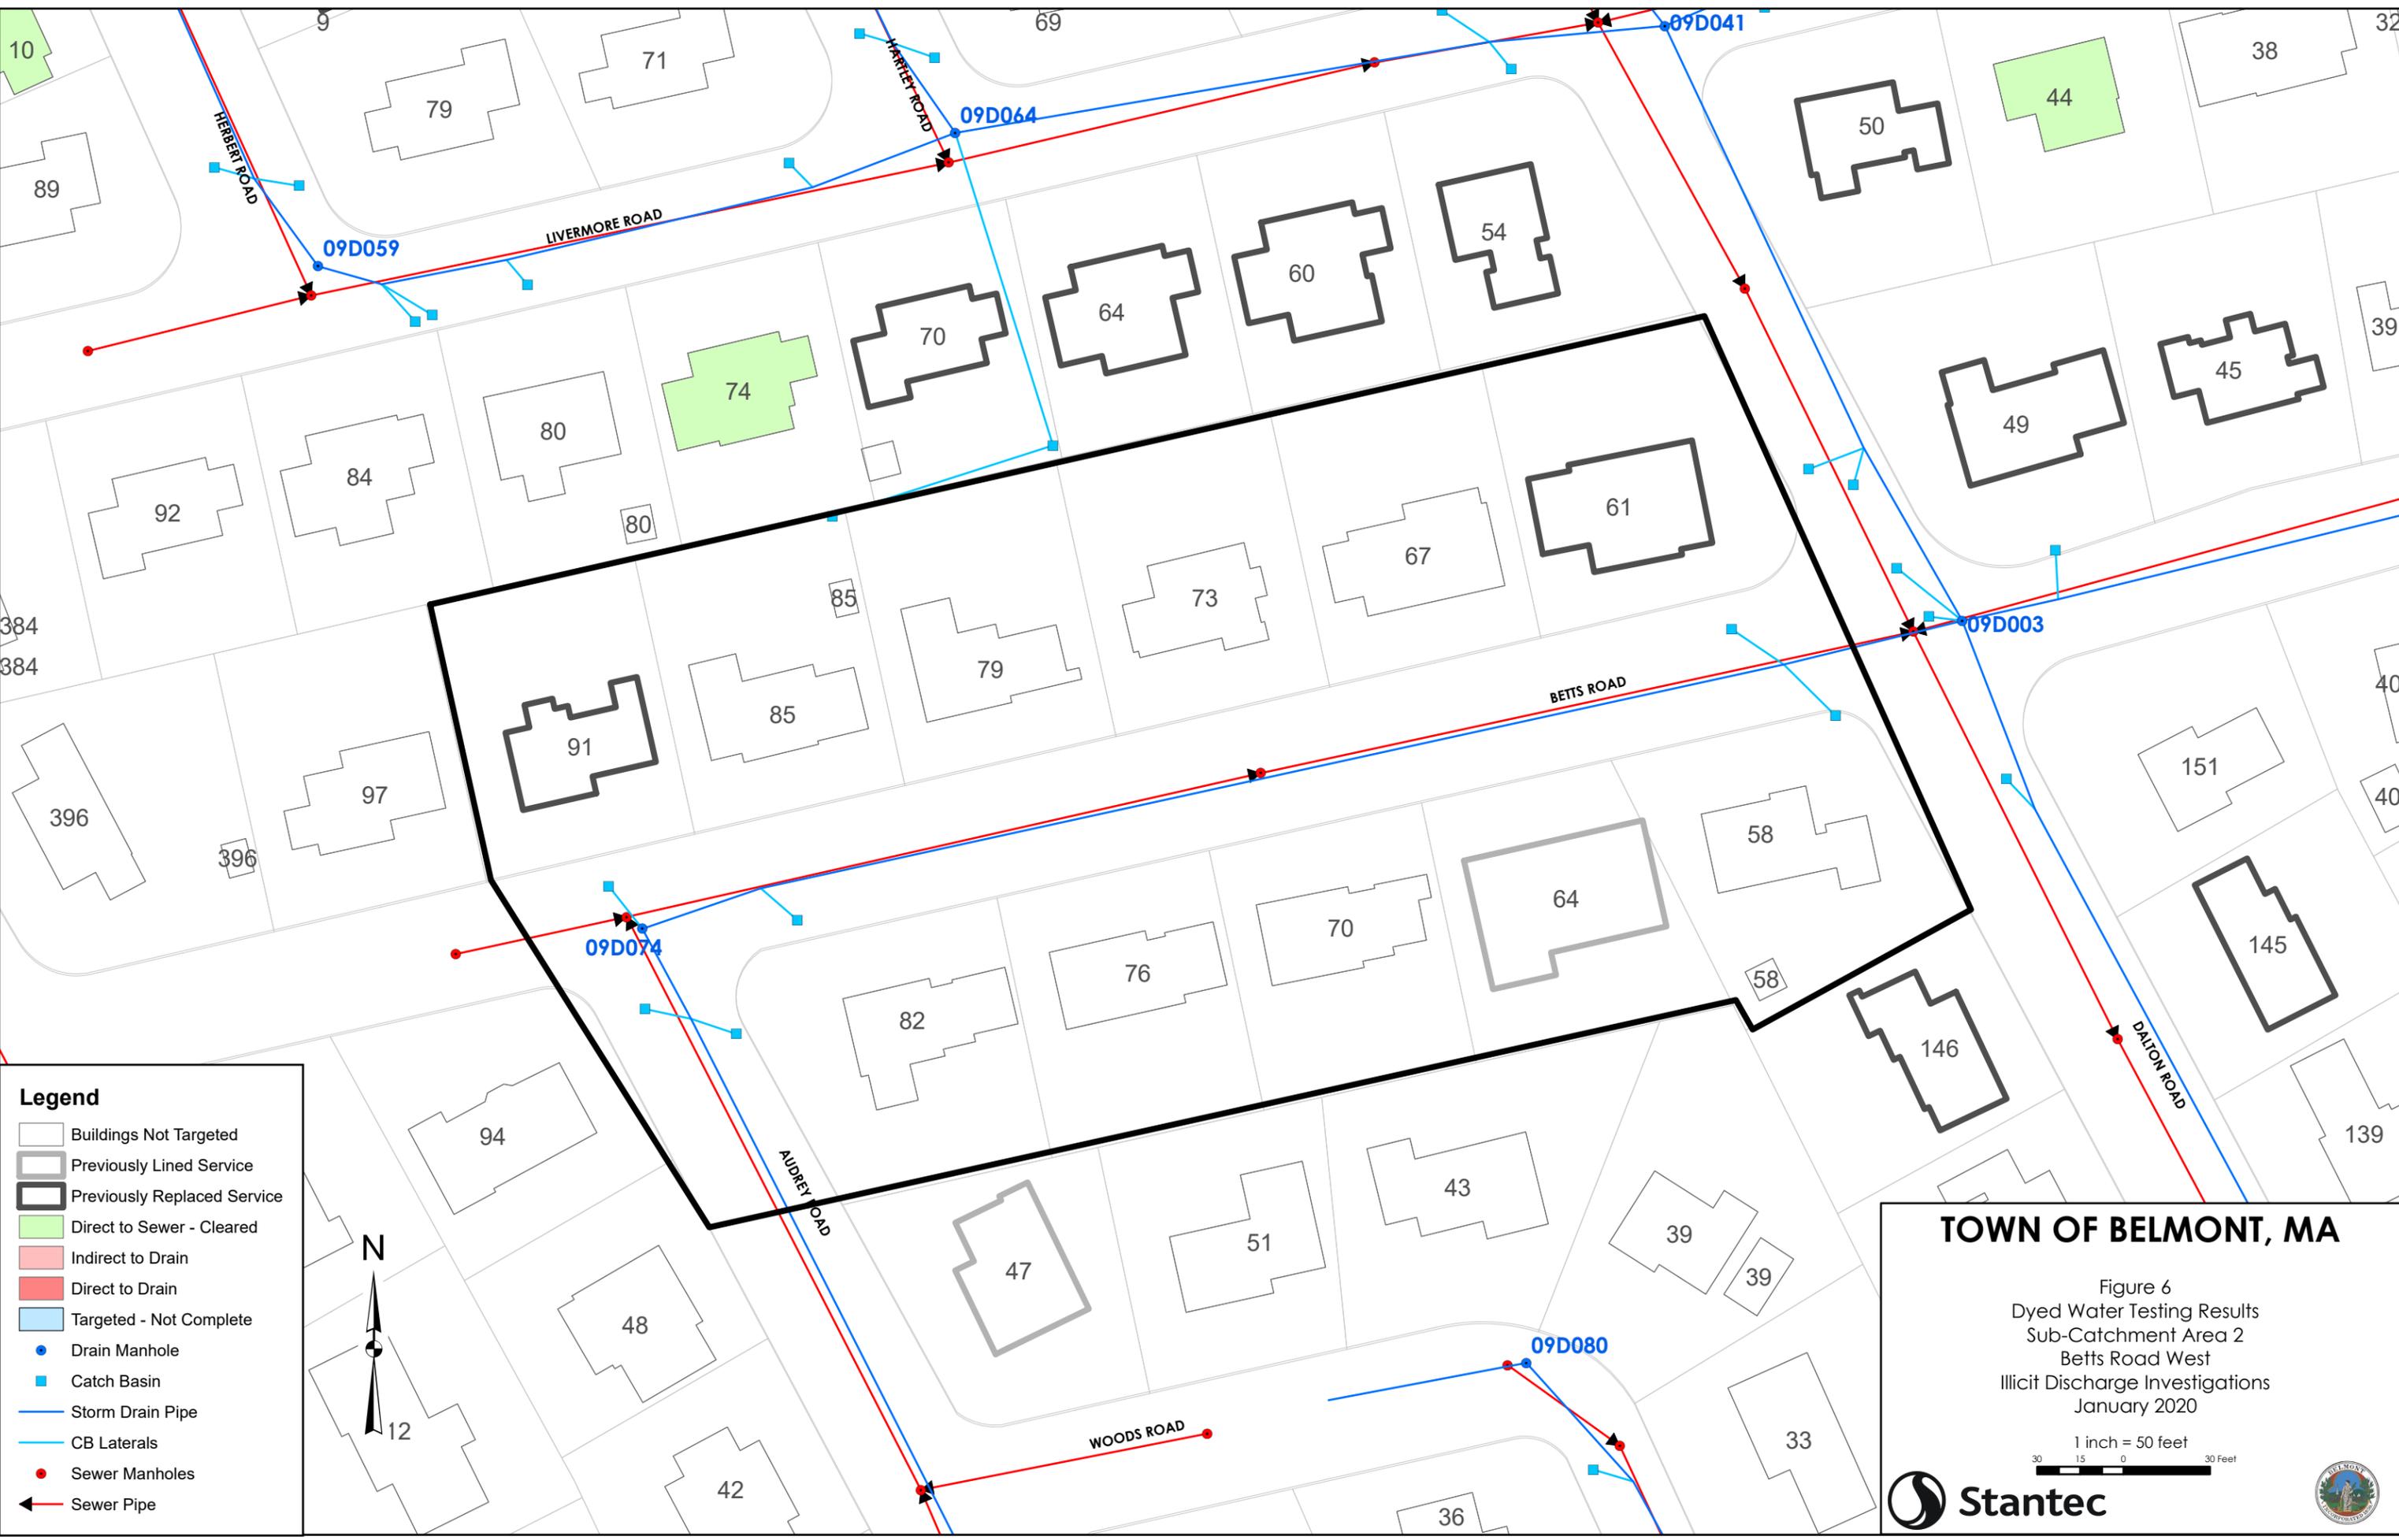
Figure 6
Dyed Water Testing Results
Sub-Catchment Area 2
Betts Road West
Illicit Discharge Investigations
January 2020

Similar to Shaw Rd West, Betts Rd will have all sewer services completely CIPP lined that have not been previously rehabilitated, which includes 8 of the 11 services. The remaining 3 services have been previously rehabilitated.

All services on Shaw Rd, Livermore Rd and Betts Rd, as described above, along with all identified indirect sources will be CIPP lined in an upcoming Sewer System Rehabilitation project to begin this Spring.

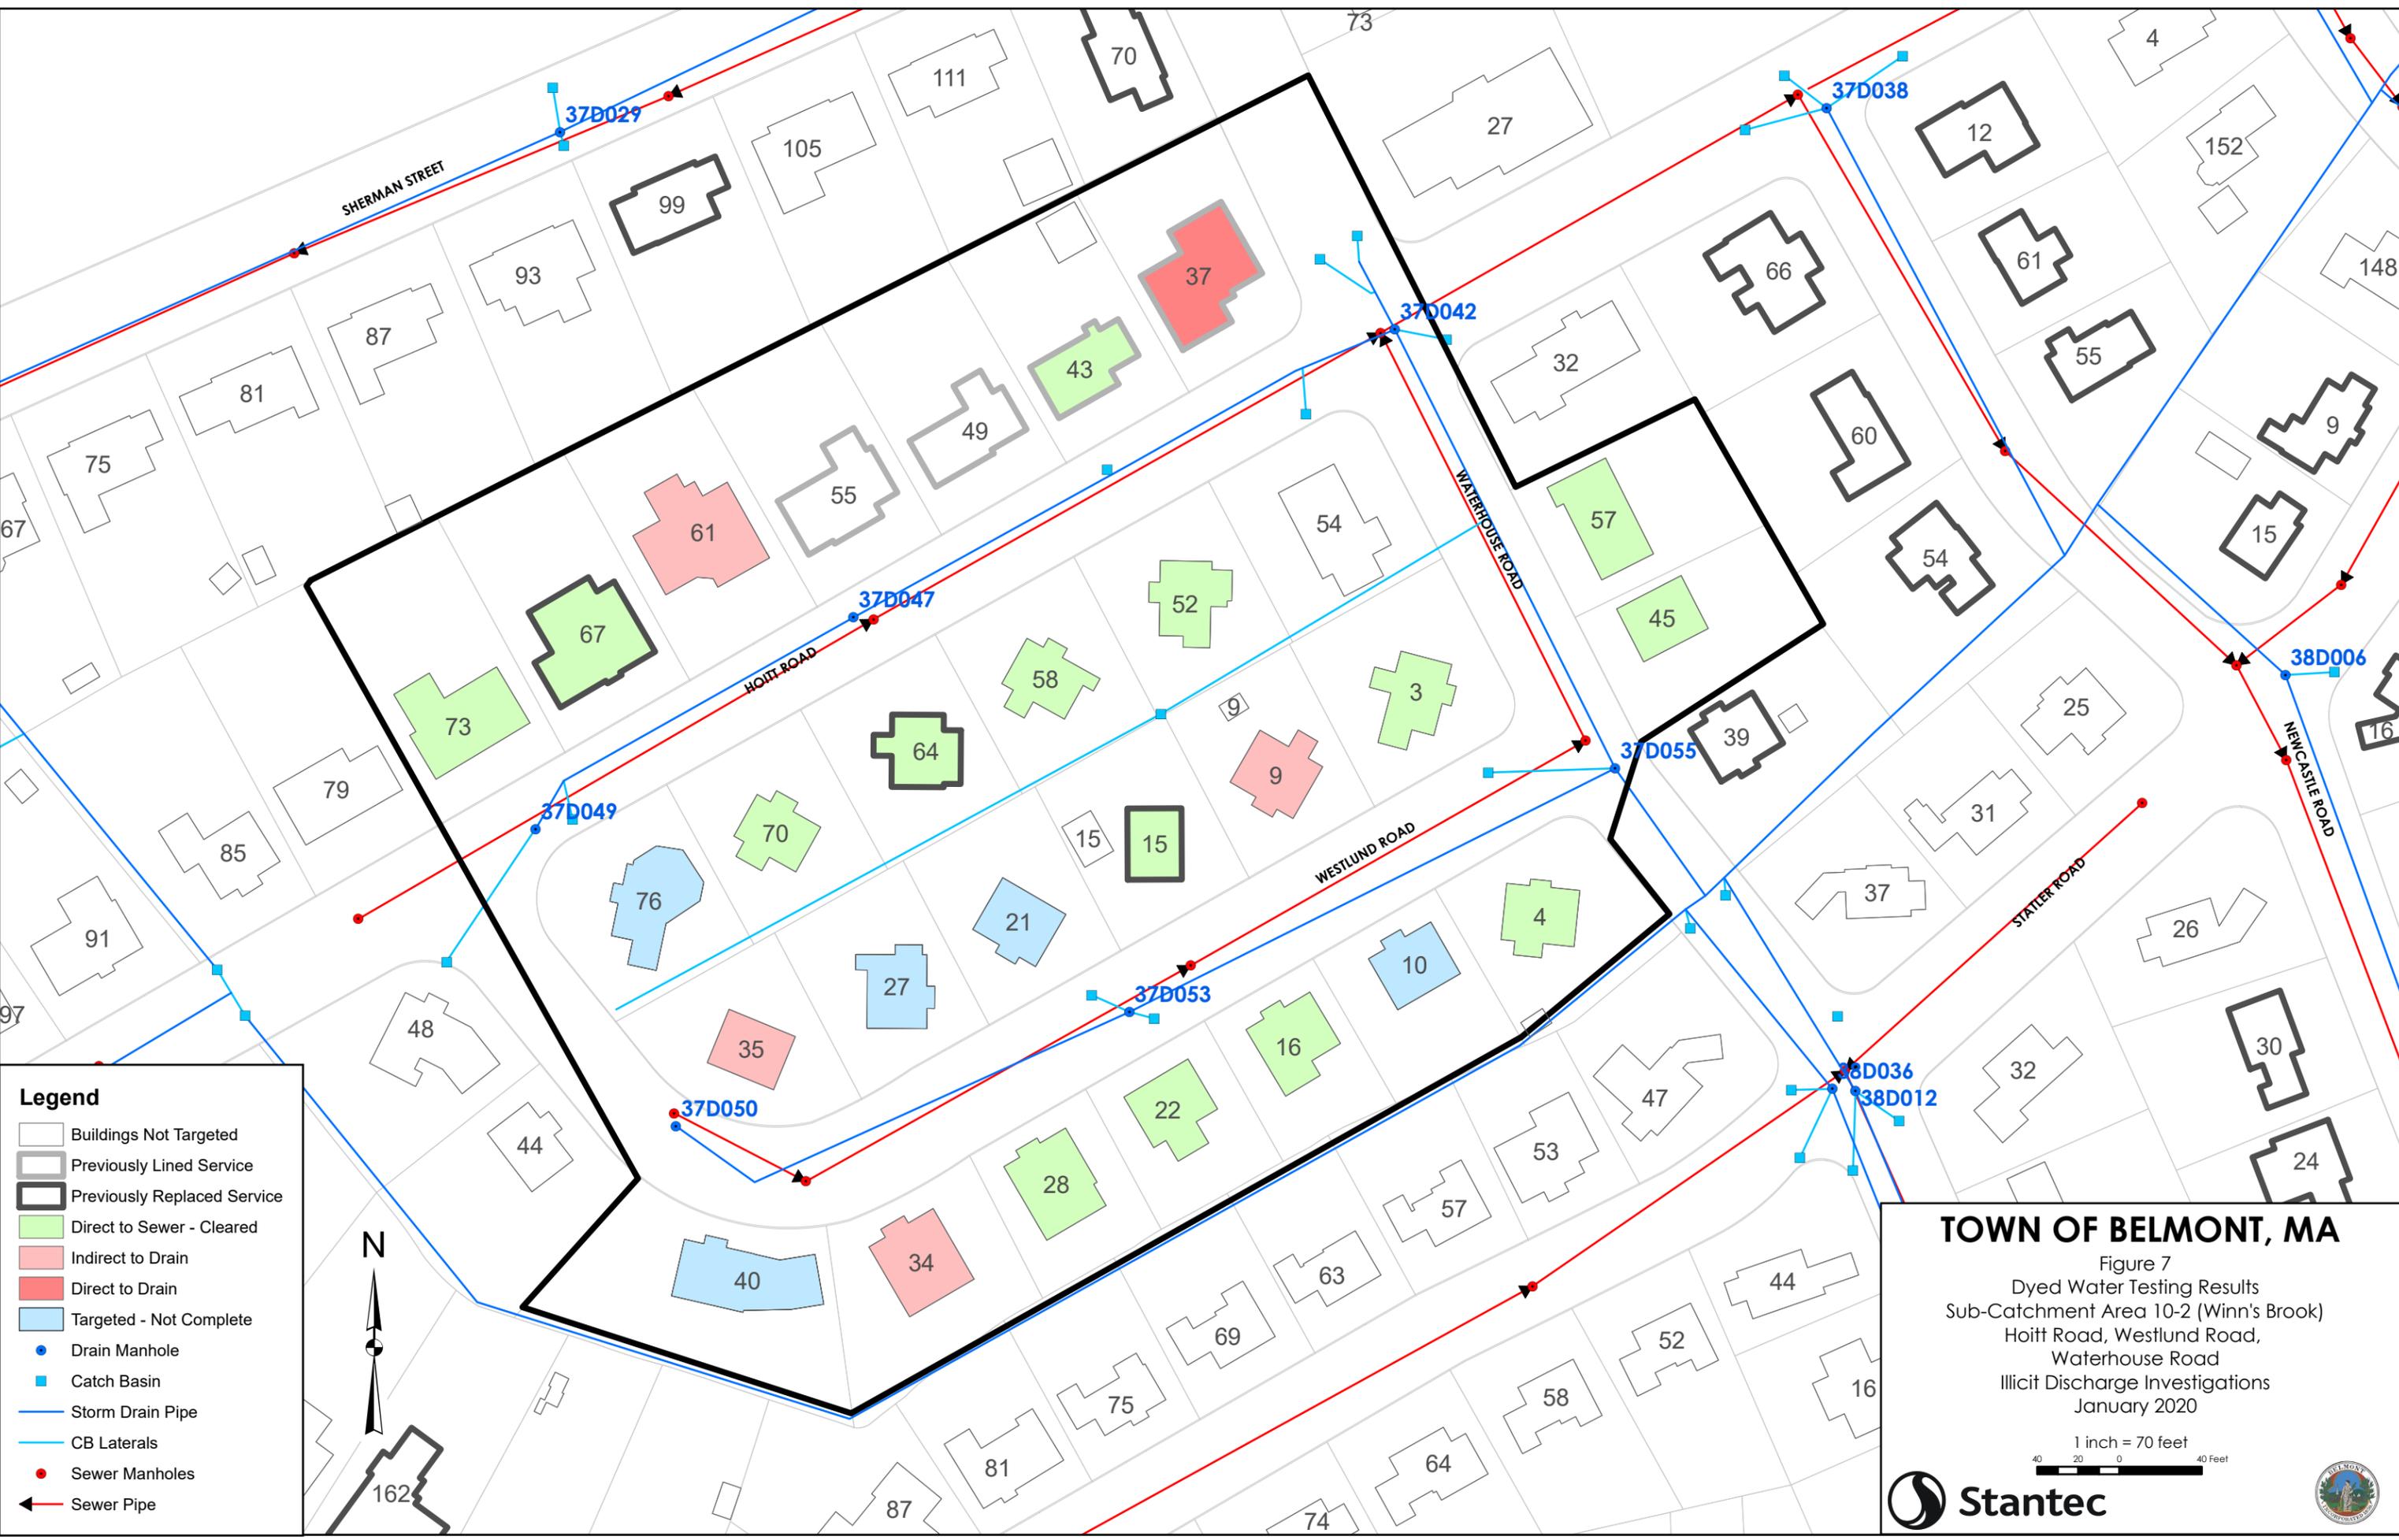
Figure 7
Dyed Water Testing Results
Sub-Catchment Area 10-2 (Winn's Brook)
Hoitt Road, Westlund Road,
Waterhouse Road
Illicit Discharge Investigations
January 2020

Dyed water testing was completed at 20 of the 28 buildings. Of the 8 buildings not completed, 3 were previously cleared and 5 were not entered. Refer to **Figure 7**. A total of 5 sewer services have been identified as a source of contamination. One direct sewer connection to the drain and an indirect source on Hoitt Rd were identified and 3 indirect sources were identified on Westlund Rd.

All indirect sources will be CIPP lined and the direct connection to the drain will be relocated to the sewer in an upcoming Sewer System Rehabilitation project to begin this Spring.
