Subject: Town of Belmont
ORDER ON CONSENT Docket No. CWA-AO-R01-FY17-11
Report On Compliance

In accordance with the above referenced Order On Consent, we are submitting the following Report On Compliance (ROC) dated July 31, 2019, which describes activities conducted from February 1, 2019 through July 31, 2019 associated with the Wellington Brook and Winn's Brook areas in the Town of Belmont. The reporting period was extended through July 31st, for this report, to include critical follow up sampling results where rehabilitation was conducted. These two areas are designated as sub-catchments 8 and 10, respectively. This report also includes activities associated with sub-catchments 9A, 11, 11A, 12, 15 & 15A. Refer to the November 2017 Investigation of the Winn's Brook and Wellington Brook Tributary Areas report and the January 2018 Report On Compliance for complete figures of each sub-catchment area. Approximately 504 gallons per day (GPD) of sewage were removed from the storm drain system within this reporting period.

**BELMONT, MASSACHUSETTS
2019 IDDE INVESTIGATIONS - EPA Compliance Report July 2019**

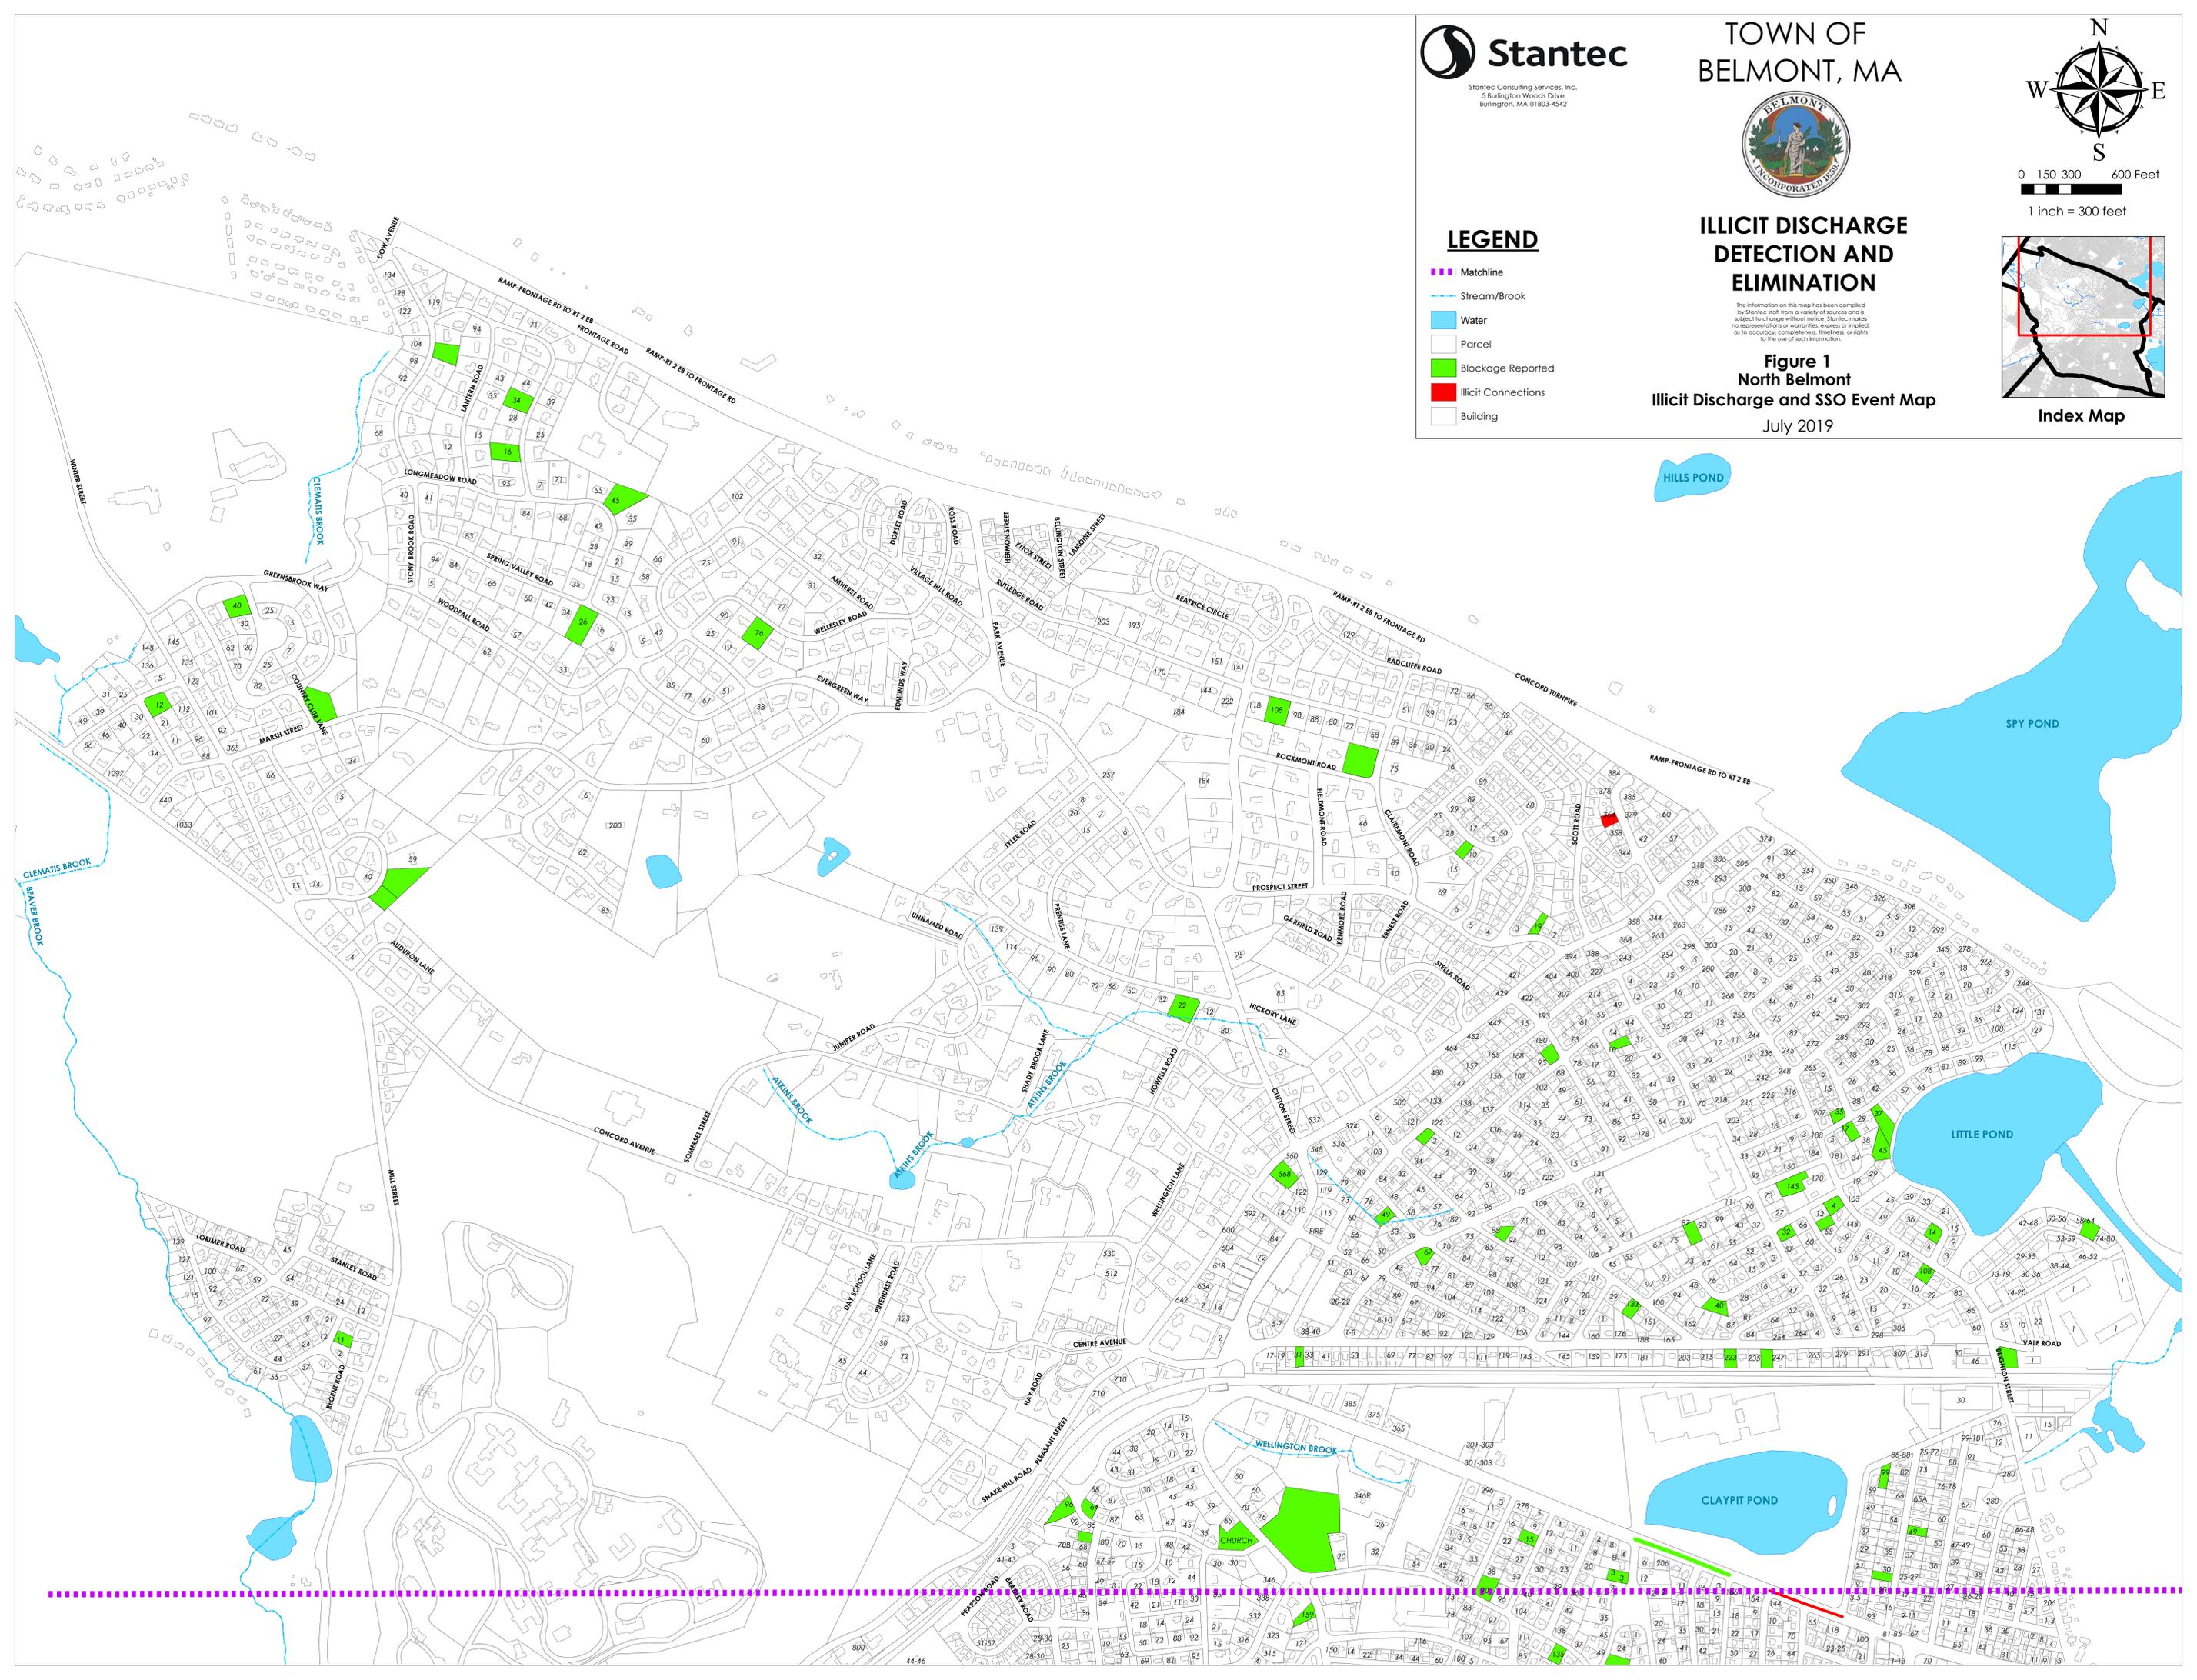
**Figure 1
 North Belmont
 Illicit Discharge and SSO Event Map**
 July 2019

The Illicit Discharge and SSO Event Maps have been updated through July 2019 and are included in this Report (Figures 1 & 2).
