# Plant Healthcare Consultants

## Site Impact Study - Tree Assessment & Appraisal Beatrice Circle, Belmont, MA 02478

July 6, 2020

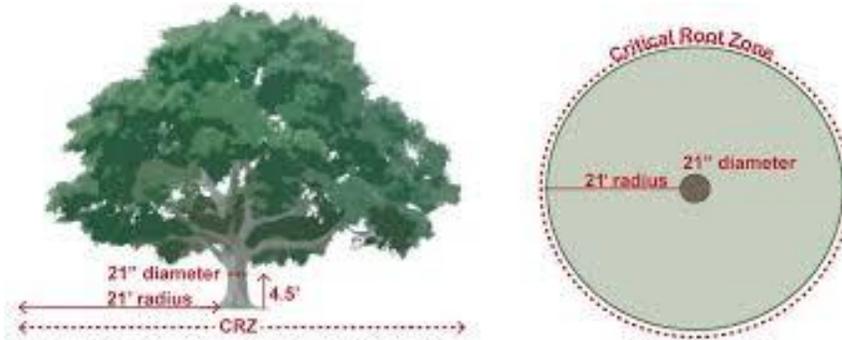
A proper and industry accepted practice for tree preservation around construction sites is to protect the critical root zone (CRZ). The CRZ is the area of soil extending from the tree trunk where roots required for future tree health and survival are located. This area can also be defined as a circle with a minimum radius of 1' for every 1" DBH. This is referred to as the tree protection zone.

Within the tree protection zone, trenching, pavement, soil compaction, mechanical injury, and any change in grade should be avoided. Typically, this area is protected by the installation of a fence or other barricade to prevent impact to the root zone.

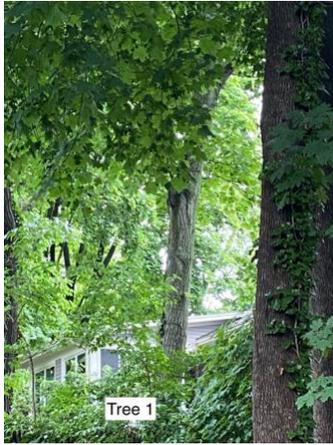
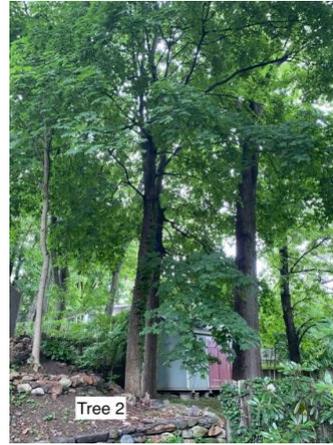
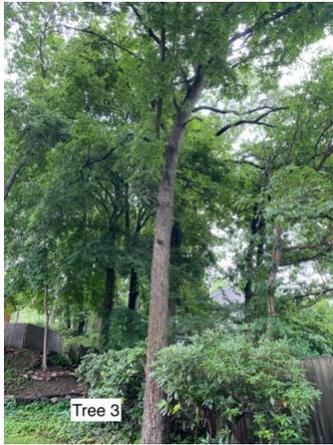
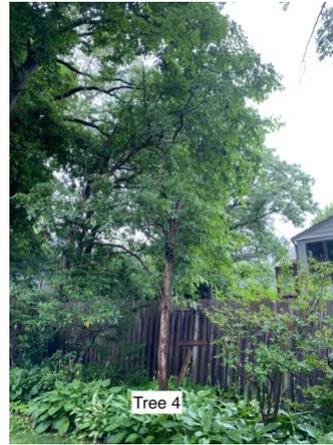
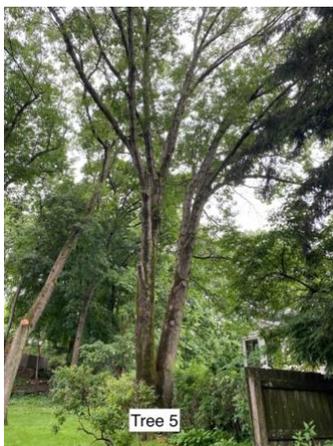
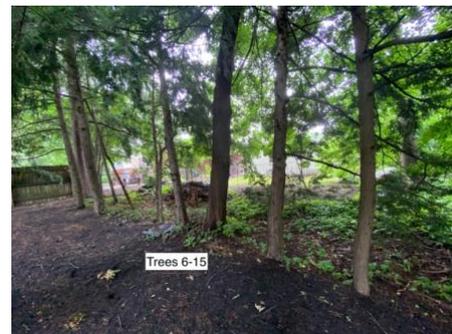
I have identified the following trees with species and diameter at breast height (DBH) (See Tree Map, page 8 & Photographs, page 10):

All of the trees listed above are very close to the property line with CRZ on or over the line. Any construction, excavation or blasting in this this CRZ will have negative effects on these trees.

Based on the proposed construction plans it my professional opinion that the 15 trees I have referenced above are at risk of fatality directly due to the proposed construction project. As such it is reasonable to perform an appraisal for the monetary loss of these trees to the Group.

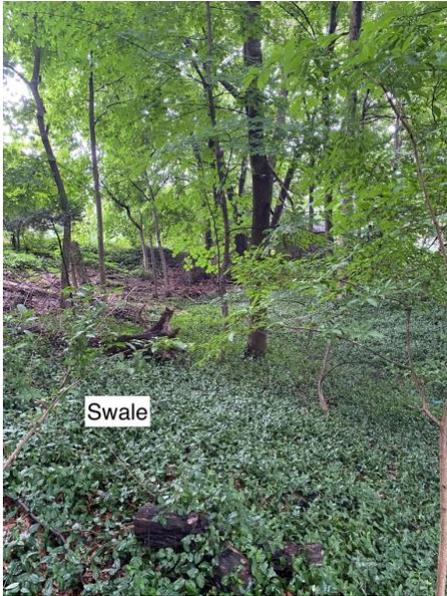
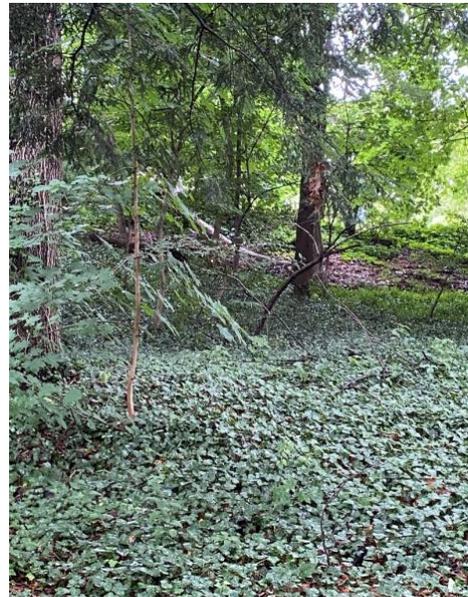
The neighborhood is on a hill with the elevation at 63 Beatrice Circle being approximately 256' and sloping down towards 11 Beatrice Circle with an elevation of approximately 190'. The slope is tiered with plateaus as you move down the hill. There is a slope at the property line between 91 and 105 Beatrice Circle. The elevation change is an approximate 11' drop over a 12' run. The natural contours of this terrain funnel all run-off out to 11 Beatrice circle and further downline (See Terrain Map, page 8 & Photographs, page 11).

Another area of concern is the paving of the parking area of the proposed construction site. The concern here is drainage. This location is already at the top of a grade. Currently water does run-off, down the slope but there is natural percolation into the soil, limiting run-off. Once this area is paved water will travel more rapidly down the slope, into the swales of 105 Beatrice Circle increasing erosion and funneling the water into 11 Beatrice Circle. It is my opinion that this will cause detriment to the trees at the base of the slope, drowning them, as well as flooding 11 Beatrice Circle and other homes downline.
