# TOWN OF BELMONT, MA

Illicit Discharge Investigations  
January 2021

**BELMONT, MA**  
**2020 IDDE INVESTIGATIONS - EPA Compliance Report January 2021**

TABLE 2  
MYSTIC RIVER WATERSHED - CLEAN AND CCTV INSPECTIONS  
SUMMARY OF FINDINGS AND RECOMMENDATIONS

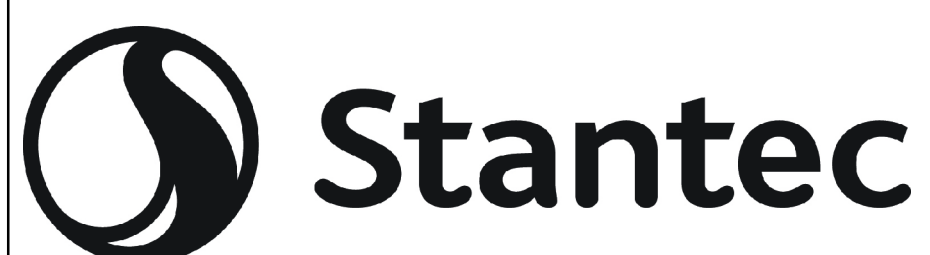
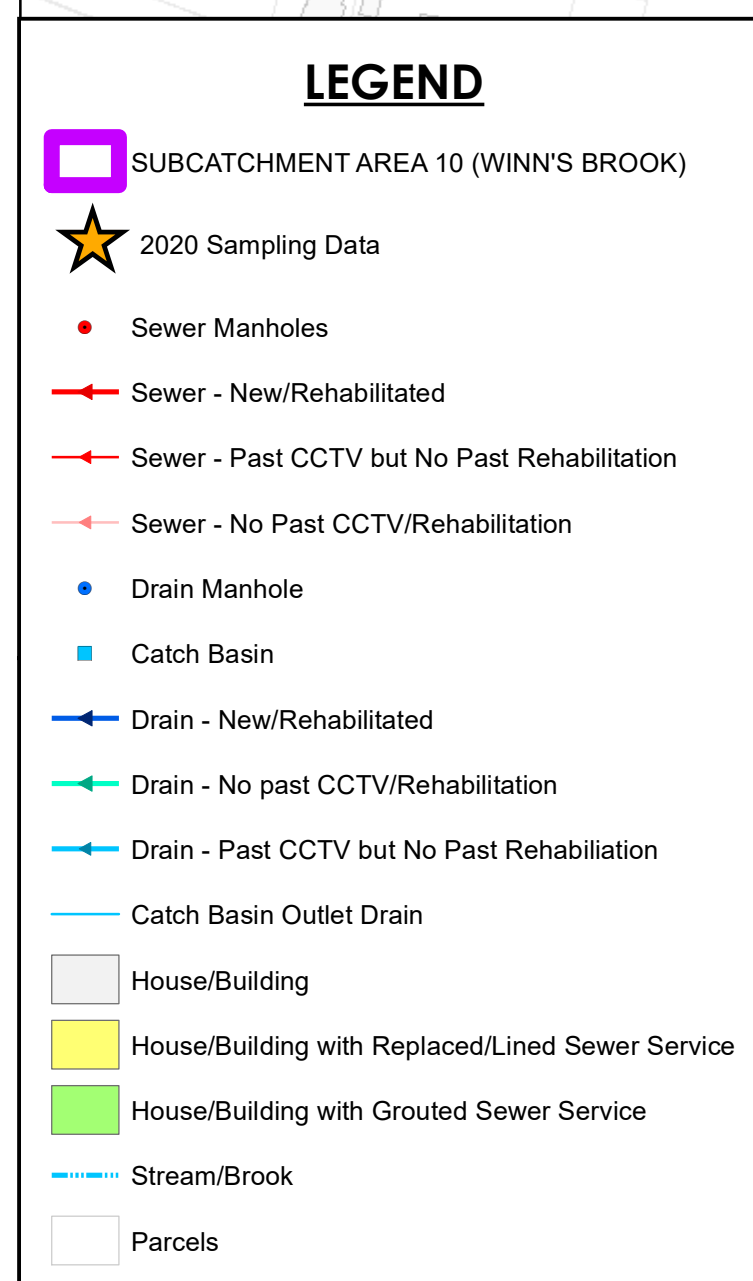
Figure 7  
Upper Tributary Sampling Results  
Subcatchment Area 10-1

OF 10-1  
11/10/20 7,900

10-1-2  
12/16/20 10,600
