**Stantec Consulting Services Inc.**  
65 Network Drive, 2nd Floor, Burlington MA 01803-2767

**Subject: Town of Belmont**  
**ORDER ON CONSENT Docket No. CWA-AO-R01-FY17-11**  
**Report On Compliance**

**Reference: CWA-AO-R01-FY17-11 Report On Compliance**

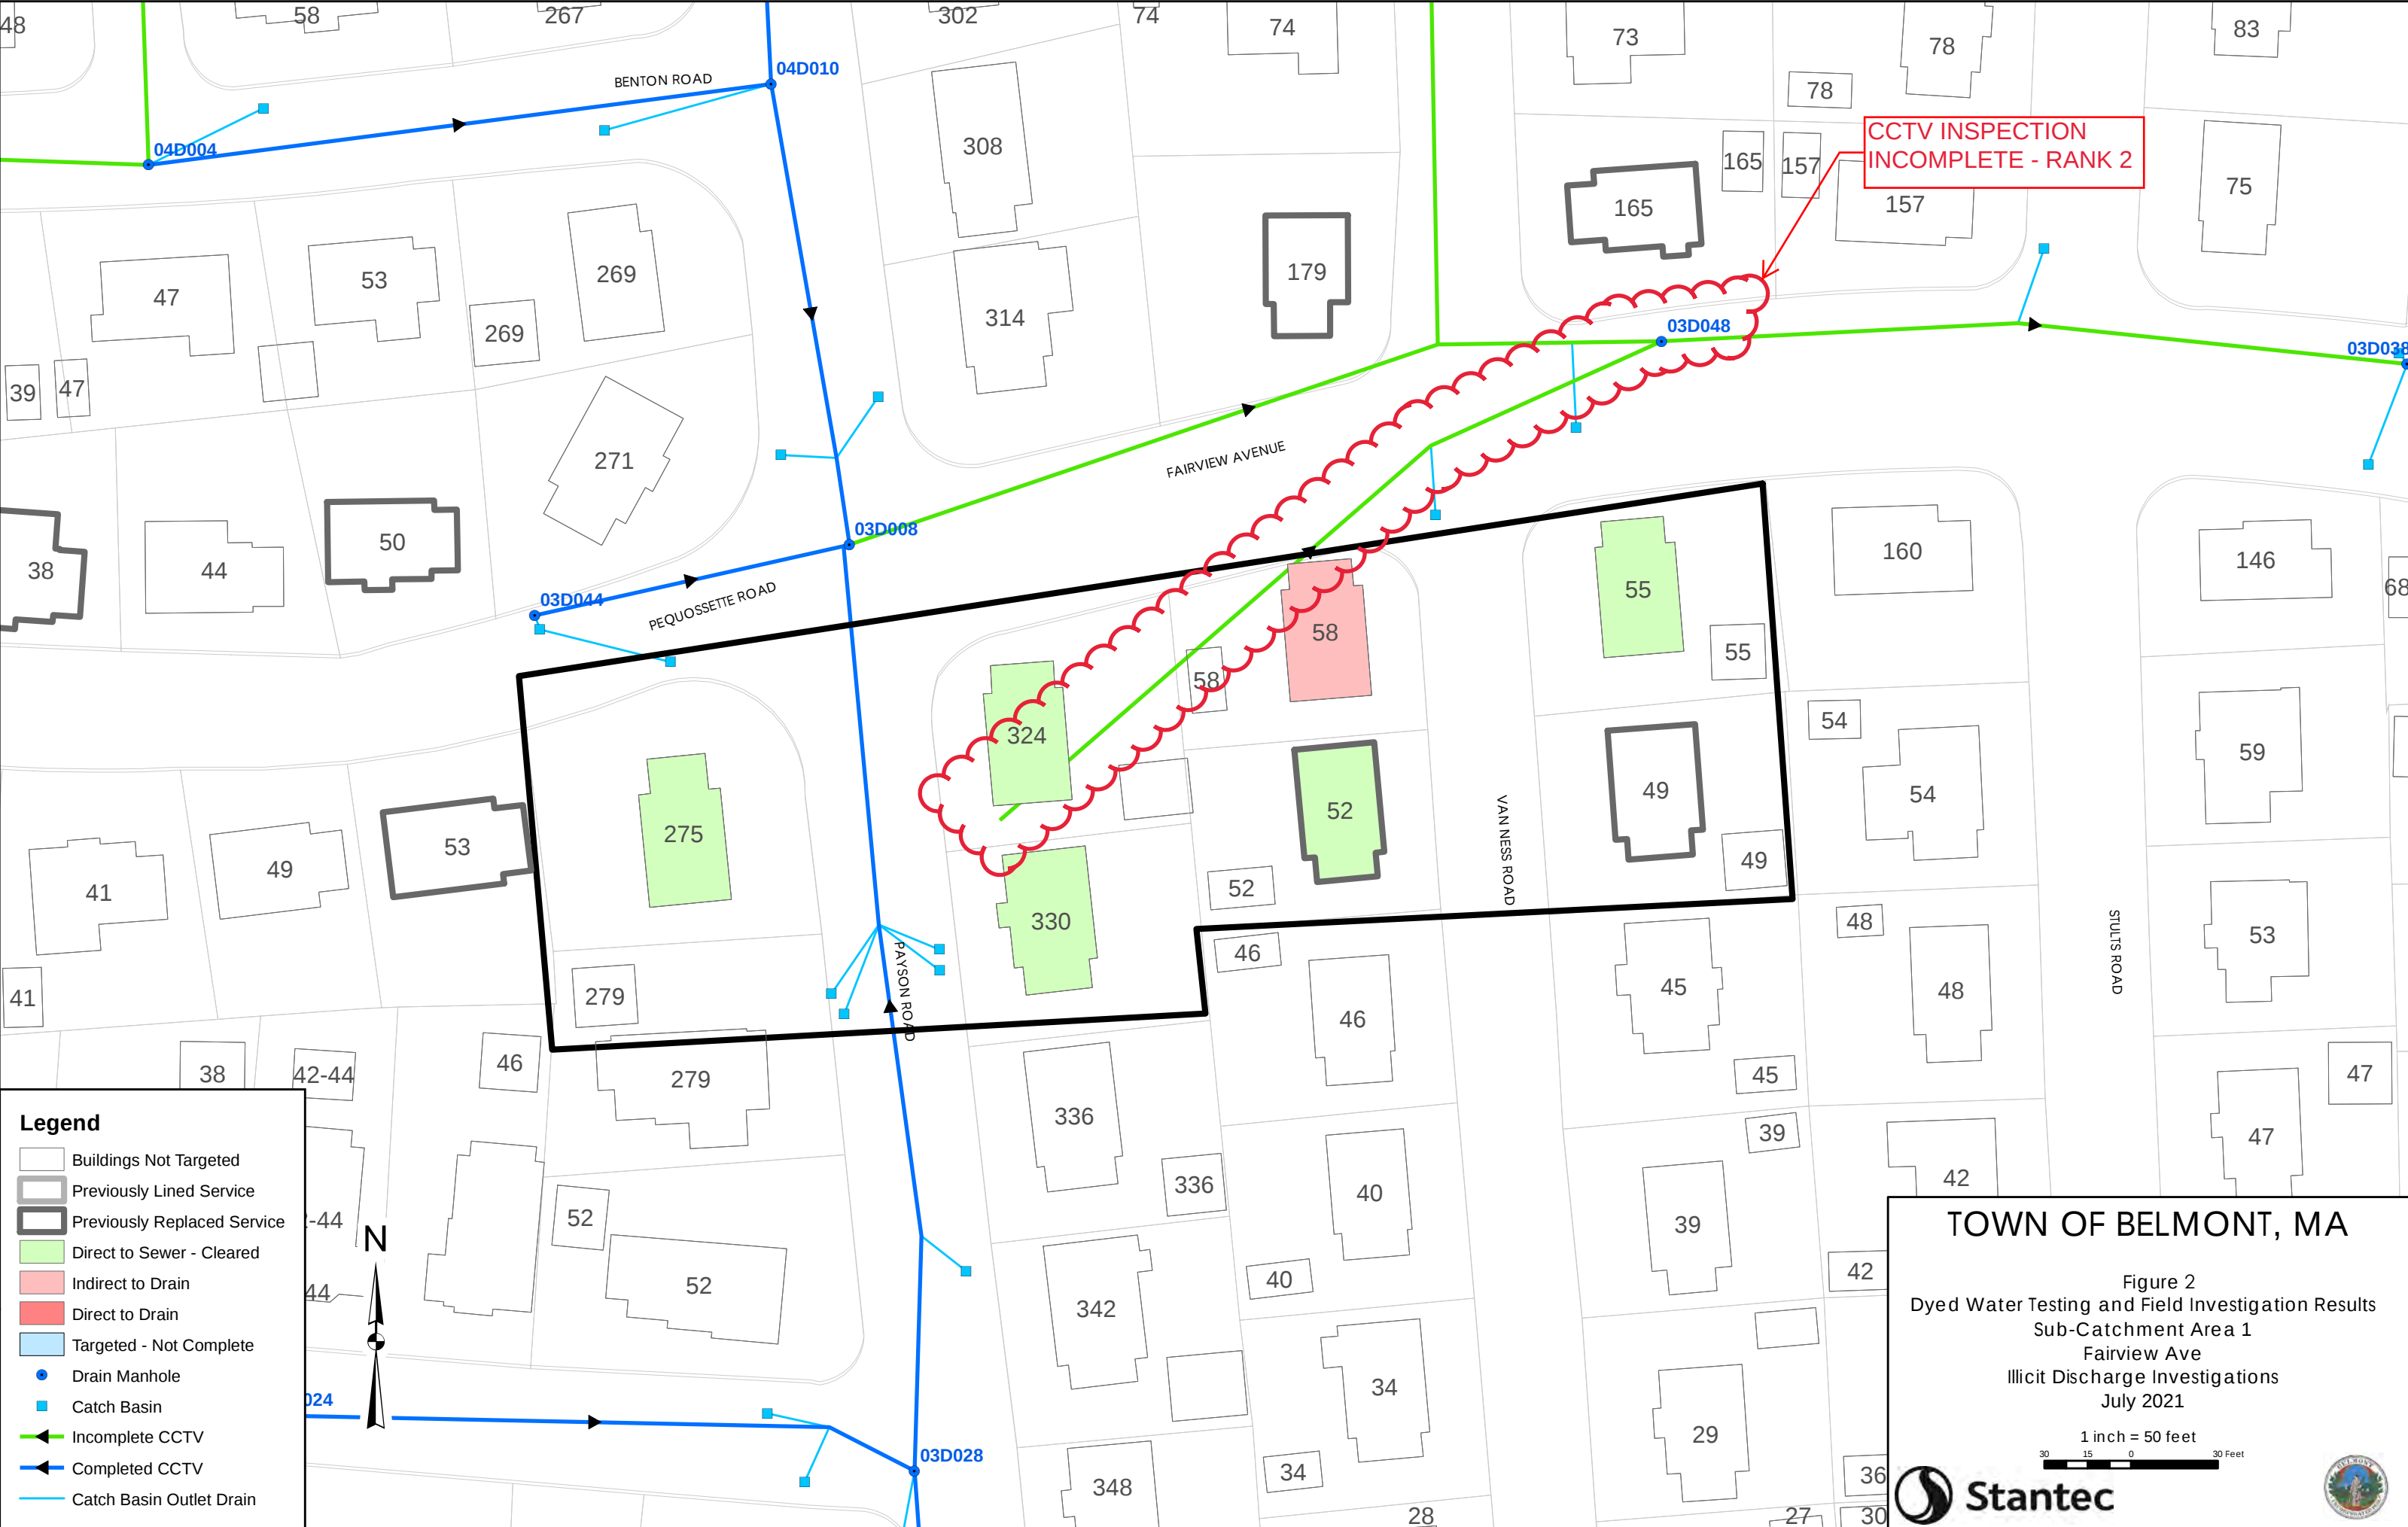
Figure 2  
Dyed Water Testing and Field Investigation Results  
Sub-Catchment Area 1  
Fairview Ave  
Illicit Discharge Investigations  
July 2021

Sub-catchment 1 had been previously cleared as a contamination source. However, follow up sampling, during last reporting period, within the tributary indicated an increased level of *E. Coli* from a 6" pipe from an easement at Fairview Ave and Van Ness Rd. Dyed water testing concluded that 58 Van Ness Road's sewer is illegally connected to drain. CCTV inspections were performed of the drain, however incomplete and so far, ranked as priority 2. Refer to **Figure 2**, and **Table 2**.

The identified illicit connection will be repaired as a change order in the ongoing Sump Pump Removal and Sewer System Rehabilitation Contract.

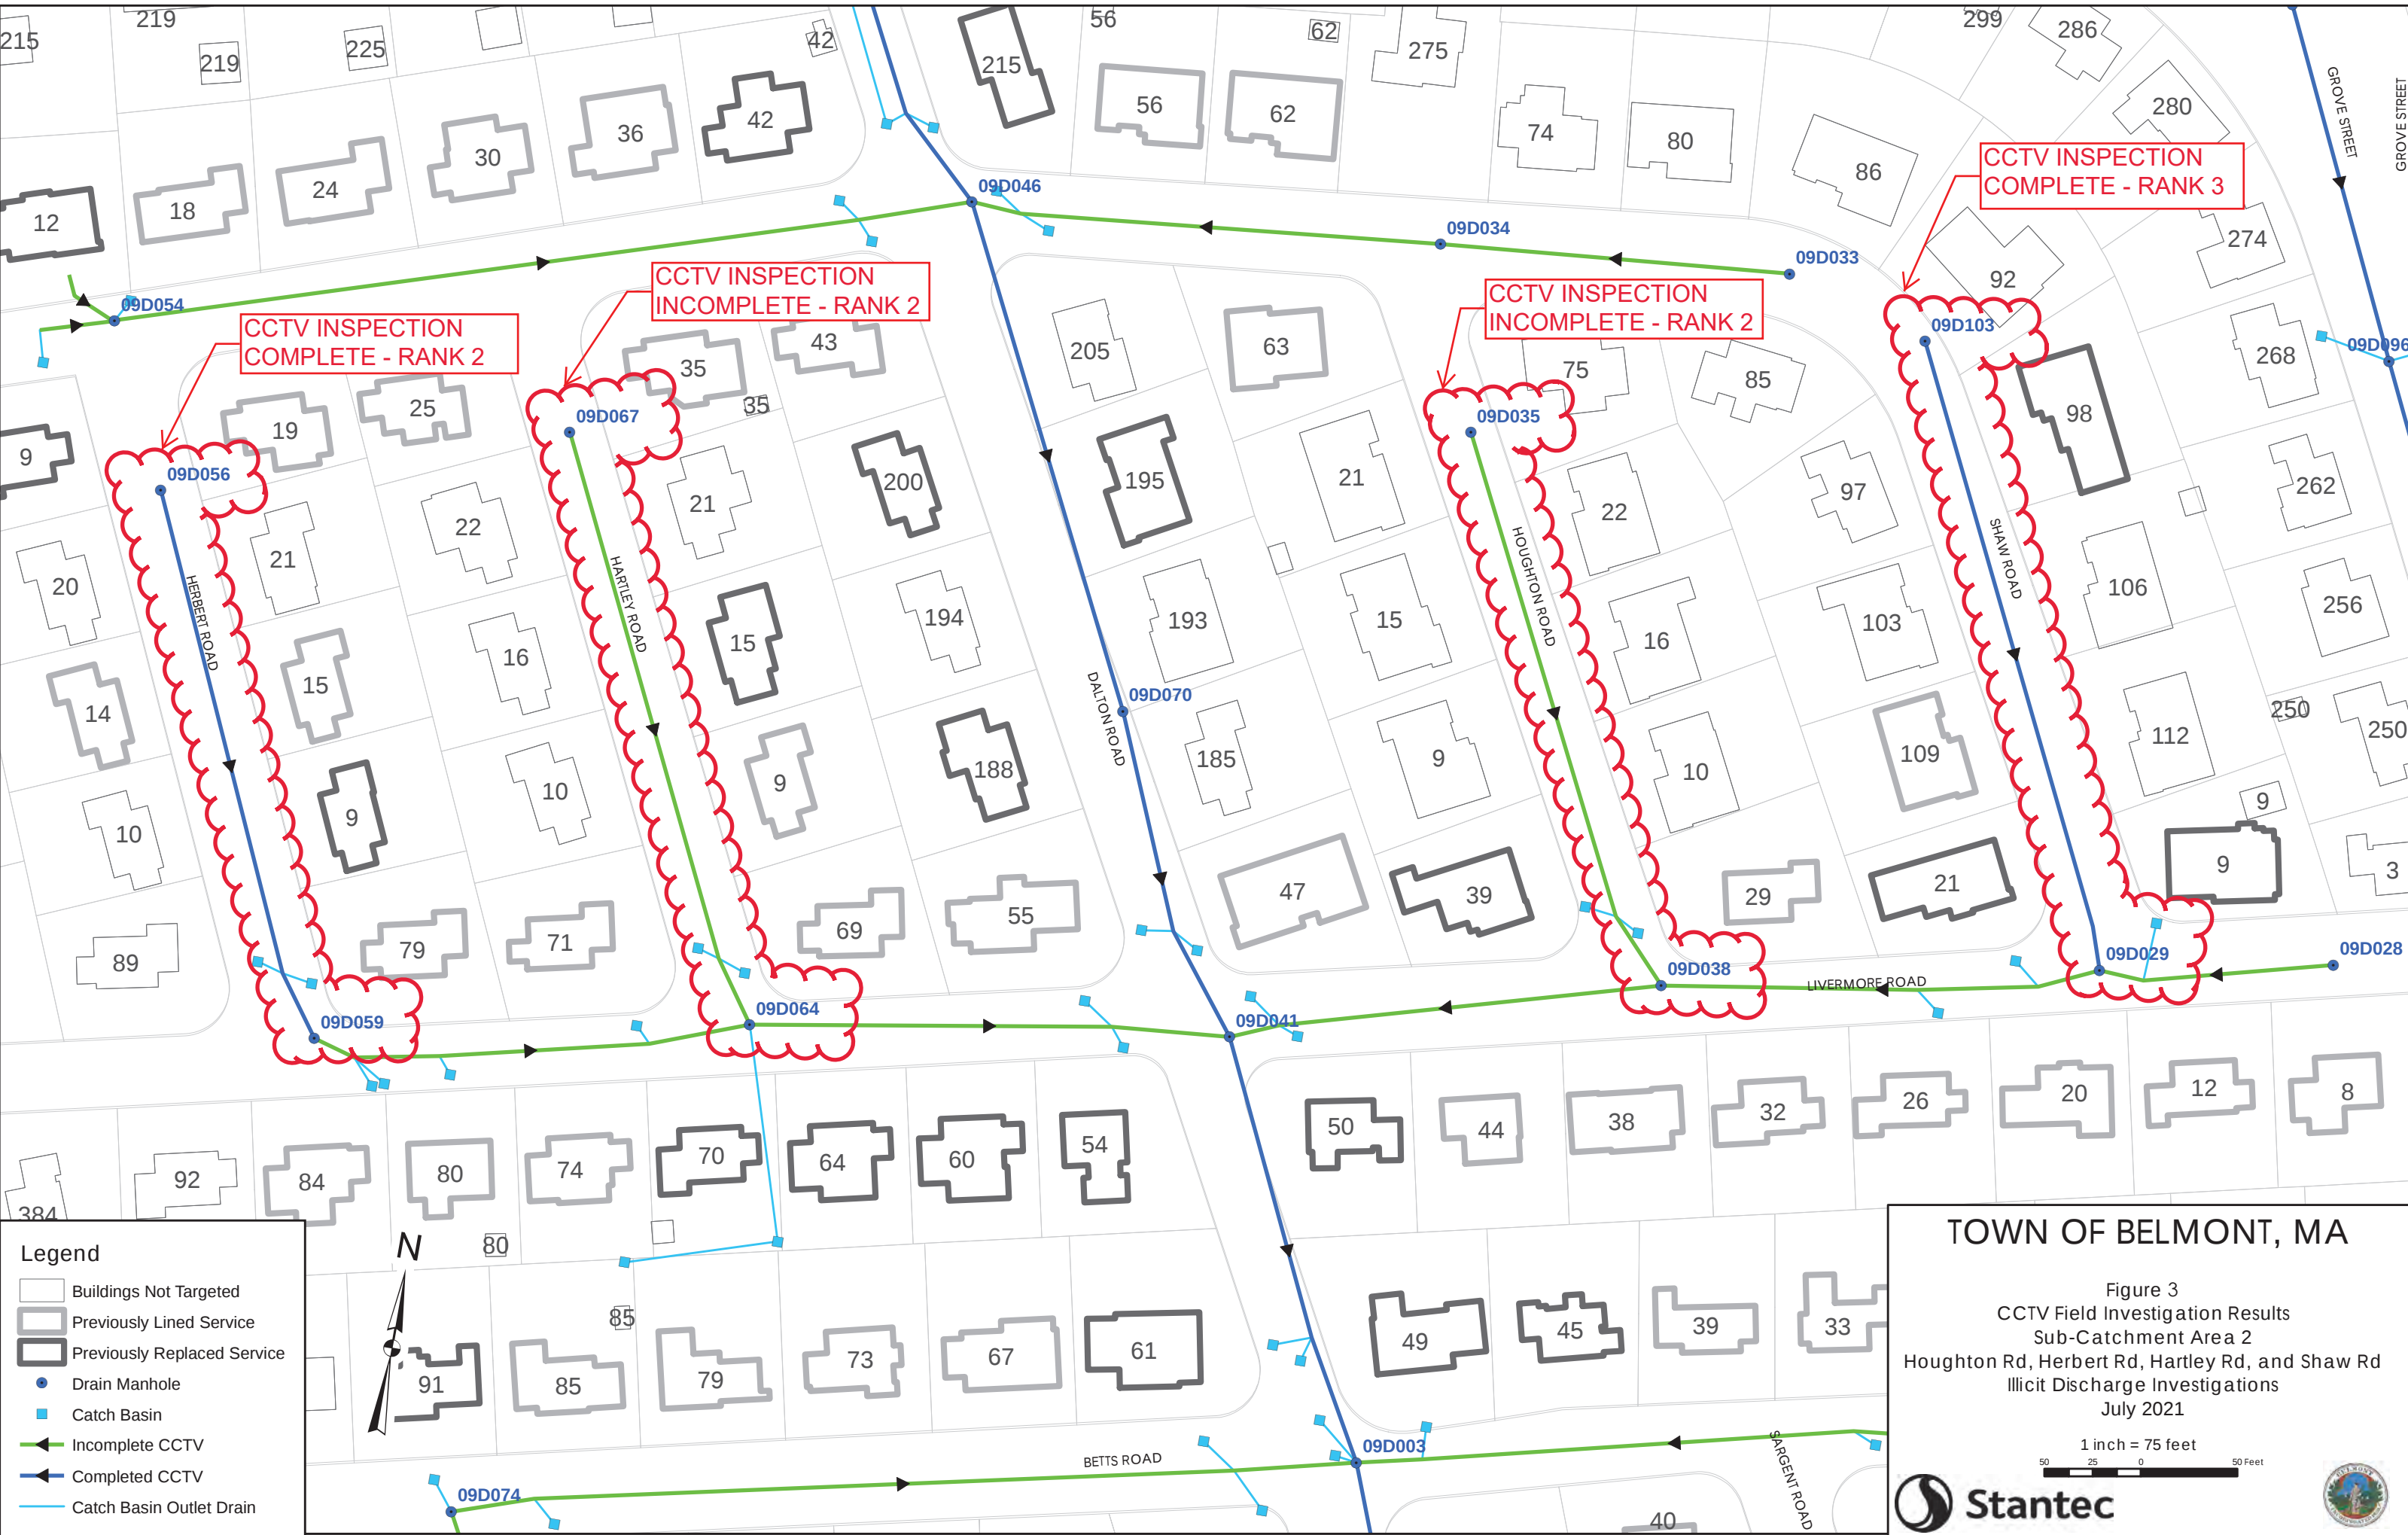
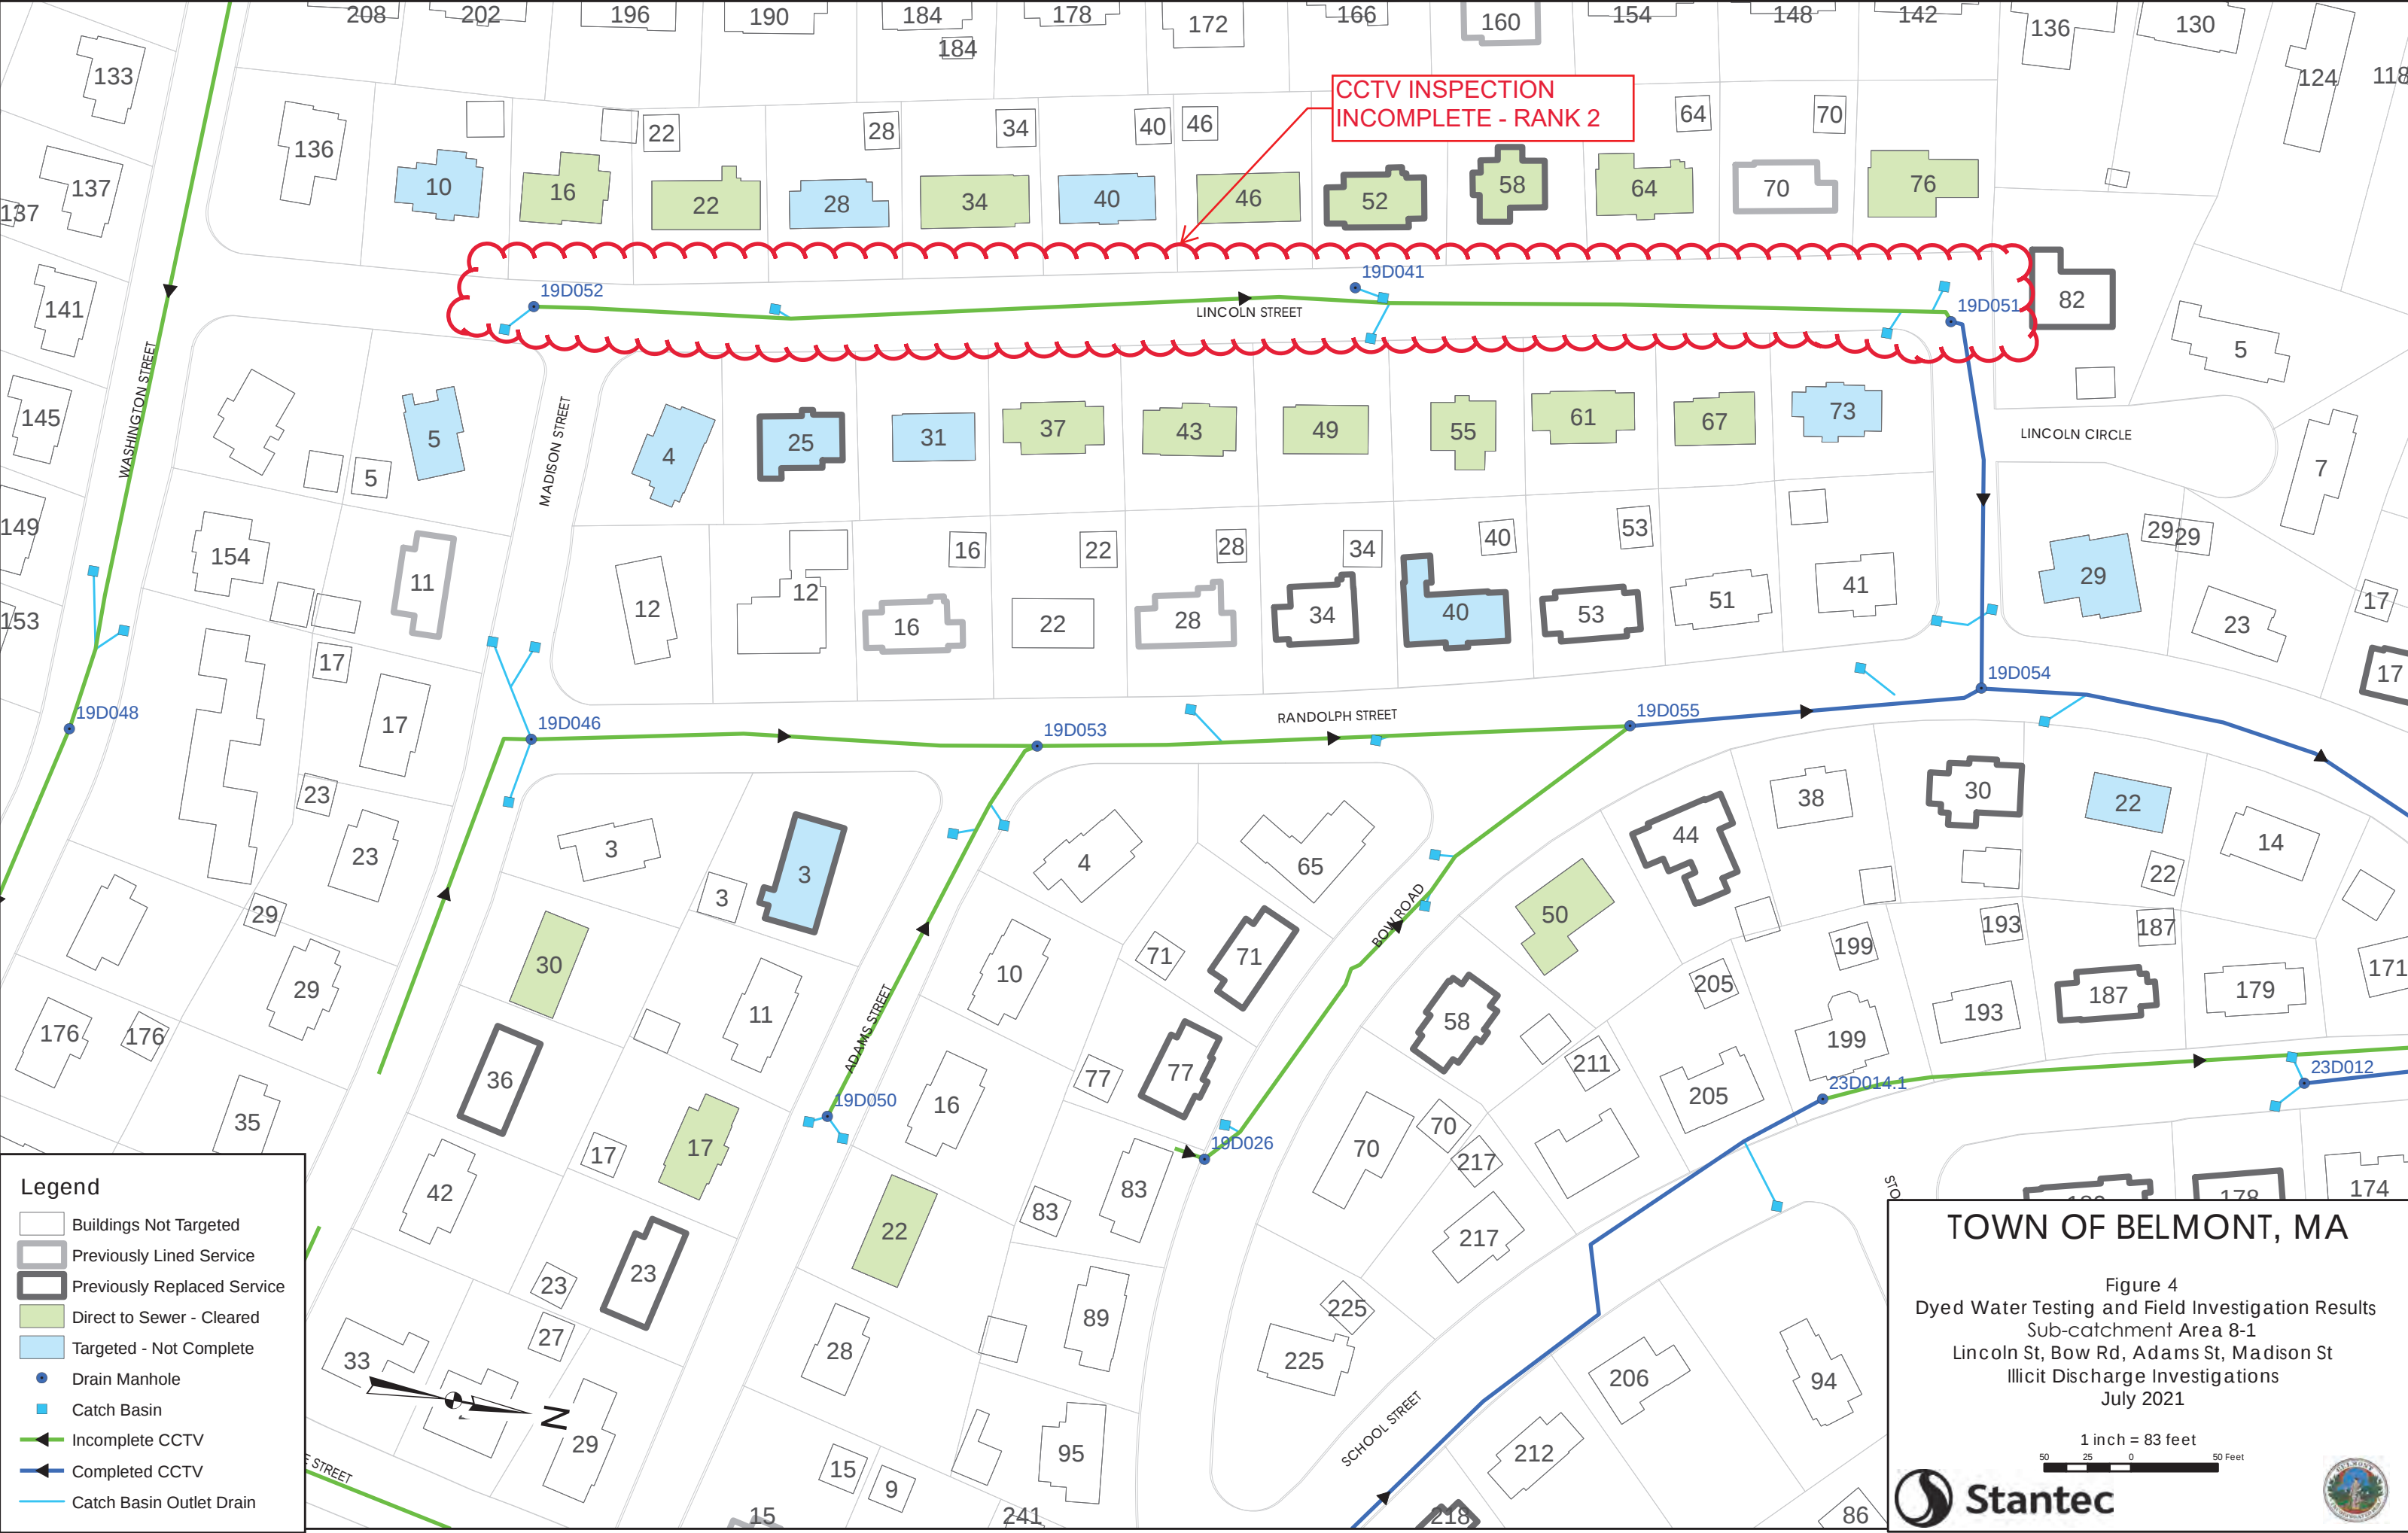
The CCTV inspections on Hartley Rd, Herbert Rd, Houghton Rd, and Shaw Rd were conducted. Defects and recommended rehabilitation are shown in **Table 2** and **Figure 3**.

CCTV INSPECTION  
COMPLETE - RANK 2

CCTV INSPECTION  
INCOMPLETE - RANK 2

CCTV INSPECTION  
COMPLETE - RANK 3
