July 31, 2018

Subject: ORDER ON CONSENT Docket No. CWA-AO-R01-FY17-11
Report On Compliance

This July 2018 Report On Compliance (ROC) describes activities conducted from February 1, 2018 through July 31, 2018. The Wellington Brook and Winn's Brook areas are designated as sub-catchments 8 and 10, respectively. Refer to the November 2017 Investigation of the Winn's Brook and Wellington Brook Tributary Areas report for complete figures of each sub-catchment area. Approximately 630 gallons per day (GPD) of sewage were removed from the storm drain system.

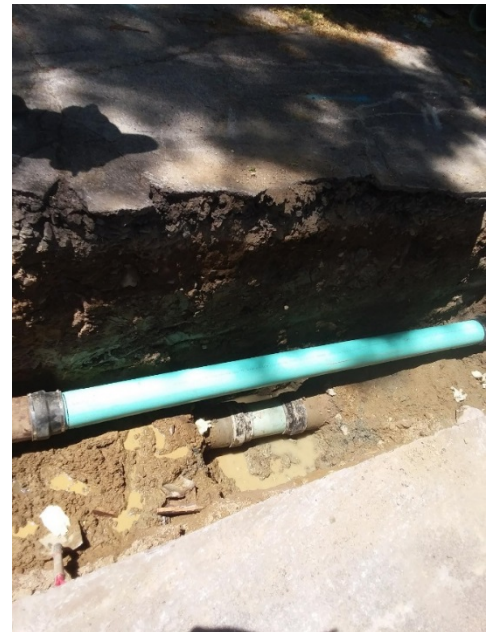
CCTV inspection identified a major collapse in the sanitary sewer on Homer Road. The storm drain in this area is located below the sewer in the same trench. Therefore, sewage exfiltrating from the broken sewer main will migrate directly into the storm drain below.

Stantec prepared construction documents and the sewer was successfully repaired on June 13, 2018 at cost of \$8,500. As shown in the photo, construction revealed a hole in the storm drain below the broken sewer, which was also repair. The record plan for the repair is attached.

There are three houses upstream of the repair. Based on the most recent data from the MWRA, up to 630 GPD (210 gallons per house) of sewage was removed from the storm drain.
