Project Title	School Administration Building Repairs		
Project Locatio	n 644 Pleasant St, Belmont, MA		
Applicant/Cont	act Person Carl Solander, Co-Chair	ir, Belmont Historic District Commission	
Organization_B	elmont Historic District Commission on be	behalf of the Town of Belmont	
Mailing Addres	S Gabriel S. Distler, Town of Belmont Planni	ning Division, 19 Moore Street, 2nd Floor, Belmont, MA 02478	
Telephone 617-	993-2666	E-mail carl_belmonthdc@reversearchitecture.com, gdistler@belmont-	ma.gov
Signature	CLASOS	Date 10/02/2023	
CPA Category (<i>i</i>		page and check all that apply):	
		□ Recreation	
Amount Requ	ested\$160,000		
Total Project (Cost \$160,000

Town of Belmont School Administration Building: Proposed CPA Project September 28, 2023

BELMONT CIVIC COMPLEX
MULTI-BUILDING CONDITIONS ASSESSMENT

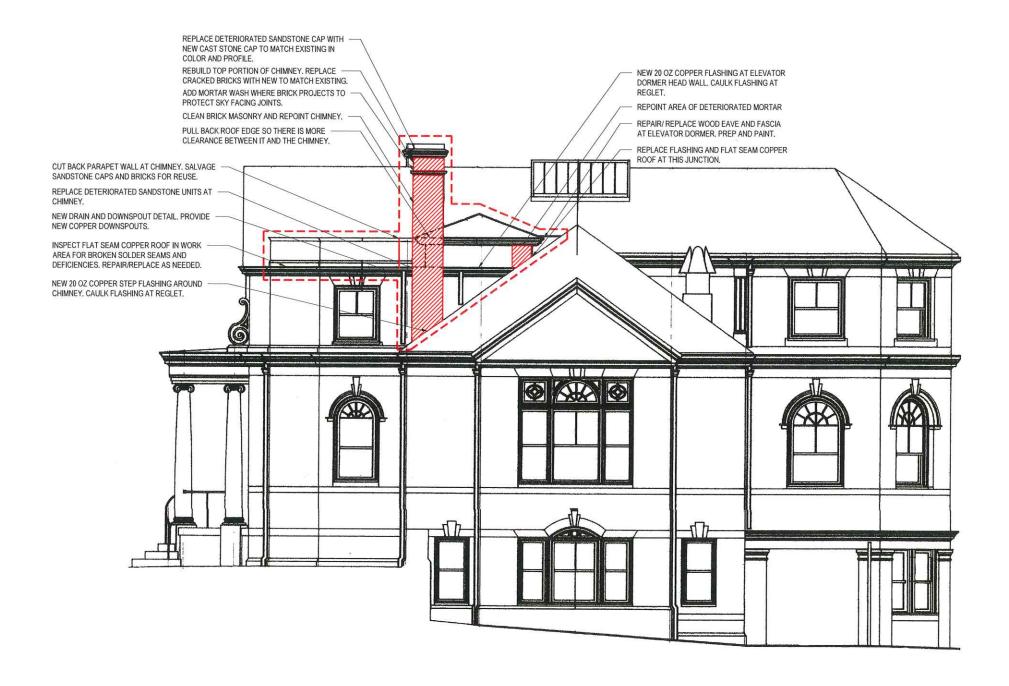
PROPOSED CPA SCOPE - SOUTH ELEVATION

PROPOSED CPA SCOPE: CHIMNEY AND ROOF REPAIR SOUTH ELEVATION OCT. 02 2023

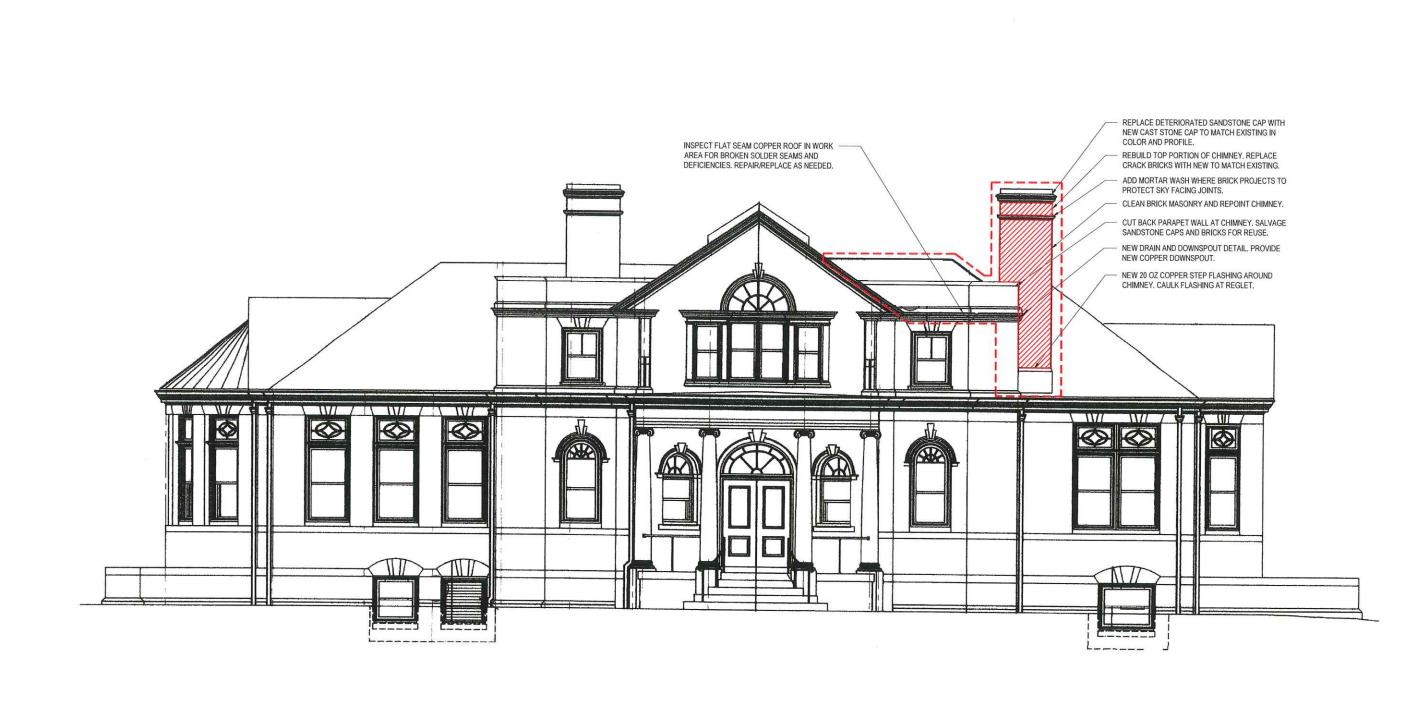
PROPOSED CPA SCOPE - WEST ELEVATION

PROPOSED CPA SCOPE: CHIMNEY AND ROOF REPAIR WEST ELEVATION

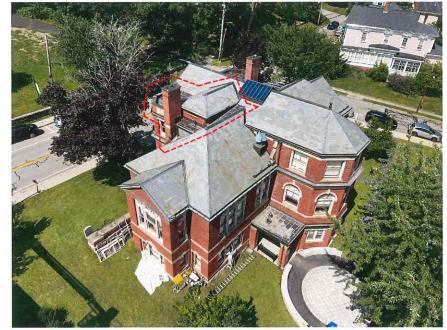
AERIAL VIEW OF SCHOOL ADMINISTRATION BUILDING LOOKING NORTHWEST. PROPOSED CPA SCOPE AREA OUTLINED IN RED.

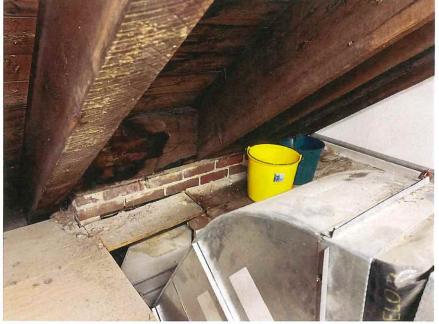
AREA OF INTERIOR WATER DAMAGE AT ATTIC EAST OF ELEVATOR DORMER. EVIDENCE OF STAINING ON ROOF STRUCTURE AND PRESENCE OF ACTIVE LEAK.

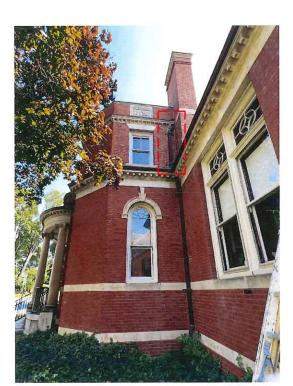
- Eroded mortar joints and efflorescence visible at areas of brick masonry adjacent to the downspout and collector box suggest that there is likely solder joint failure, or the system is undersized for water volume.

SOUTHWEST CORNER OF SCHOOL ADMIN. BUILDING. EFFLORESCENCE AND BRICK DAMAGE VISIBLE AT SECOND LEVEL BY CHIMNEY WALL AND DOWNSPOUT.

- Inspect solder joints in flat seamed copper roofing, gutters and downspouts in the problem area and clean and re-solder cracked or defective joints, replacing some of the copper elements where necessary.

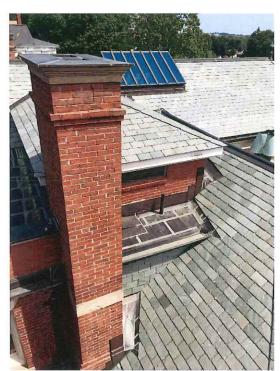
OVERALL VIEW OF DETERIORATED CHIMNEY, FLAT SEAM COPPER, AND INTERSECTING ROOF PLANES.

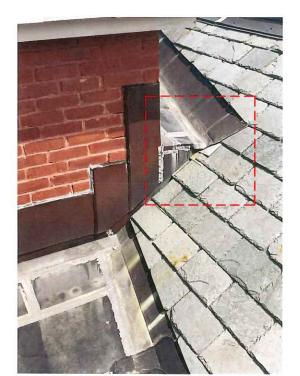
- There are a considerable number of open reglets at flashing terminations that required new sealant.
- There are a number of copper flashing transitions that appear vulnerable to water infiltration by nature of their design and require reconfiguration/replacement.

VIEW OF IMPROPER FLASHING DETAIL AT ROOF INTERSECTION. BROKEN SOLDER SEAMS, MORTAR DETERIORATION, AND CRACKED CAULKING VISIBLE.

- Replace sealants (caulking) in numerous locations at flashing reglets.
- Re-design and refabricate some of the flashing details that are either open to the weather or do not allow positive drainage.

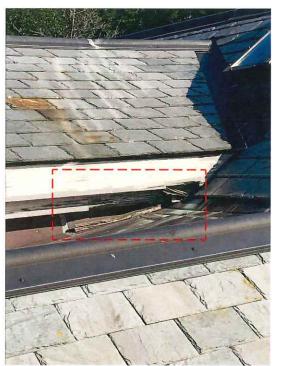
- There is a deteriorated wood fascia and soffit at the override structure that requires repair.

DAMAGED AND DETERIORATED WOOD TRIM AND FASCIA BOARDS REQUIRE REPLACEMENT.

- Modification at the roof edge of the elevator override to provide space at the chimney to direct runoff away from the chimney. While working on the roof edge there, replace deteriorated wood fascia and soffit.

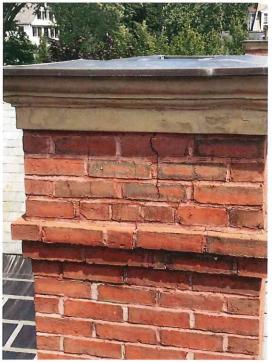
- This same chimney has a number of structural cracks near the top.
- A number of existing copper counterflashings are poorly detailed and rely on sealant joints that are reaching the end of their life expectancy.

VIEW OF CRACKED BRICKS, DETERIORATED MORTAR, AND DAMAGED CAPSTONE AT SOUTH CHIMNEY.

- Rebuild the top portion of the chimney where bricks are cracked and loose. Repoint deteriorated mortar joints at the remainder of that chimney. Provide new copper flashing and add sealant.

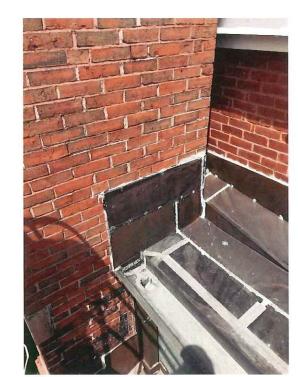
POOR FLASHING DETAIL AT INTERSECTION OF FLAT SEAM COPPER ROOF AND CHIMNEY. CRACKED CAULKING AT REGLET, PUNCTURED COUNTER-FLASHING, AND PRESENCE OF BLACK MASTIC.

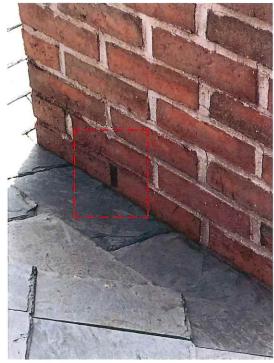
- The elevator override has a hipped slate roof that is pitched directly to an existing brick chimney. With no cricket flashing provided at the chimney, the chimney accepts a good amount of water and snow accumulation, which has led to mortar joint deterioration and open mortar joints.

OPEN MASONRY JOINTS WHERE ELEVATOR DORMER ROOF MEETS NORTH FACE OF CHIMNEY.

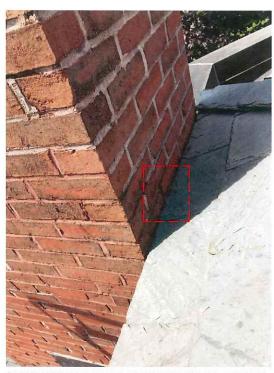
OPEN MASONRY JOINTS WHERE ELEVATOR DORMER ROOF MEETS NORTH FACE OF CHIMNEY.

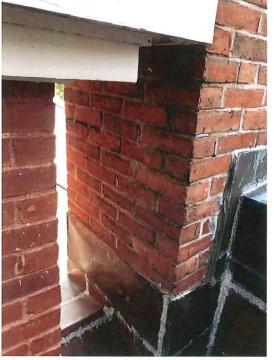
POOR FLASHING DETAIL AT INTERSECTION OF CHIMNEY AND BRICK PARAPET (RIGHT). CRACKED CAULKING AND SEALANT VISIBLE AT REGLET AND BROKEN SOLDER SEAMS THROUGHOUT.

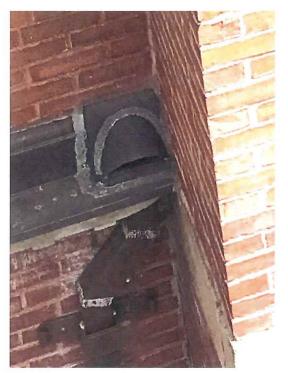
- Brick masonry and mortar deterioration below the through-wall downspout detail at the parapet suggest that this area is vulnerable to water infiltration as a result of this detail and will likely cause significant structural issues at the parapet wall in the future.

THROUGH WALL DRAIN/DOWNSPOUT DETAIL AT PARAPET. COMBINATION OF BROKEN SOLDER SEAMS AND POOR FLASHING CAUSING MASONRY DAMAGE BELOW.

- Cut back brick parapet wall at the chimney to eliminate vulnerable through-wall downspout detail.
