**Community Preservation Committee  
Town of Belmont****CPA Funding – Final Application**

Project Title Town Hall Slate Roof Repairs  
Project Location 455 Concord Ave. Belmont MA 02478  
Applicant/Contact Person David T. Blazon, Director of Facilities  
Organization Belmont Facilities Department  
Mailing Address 19 Moore Street, Belmont MA 02478  
Telephone 617 993 2646 E-mail Dblazon@Belmont-MA.Gov  
Signature [Signature] Date 9/9/2022

## **Belmont Town Hall Roof Assessment Report**

Belmont Town Hall  
455 Concord Avenue  
Belmont, MA  
02478  
Date: 5.25.2021

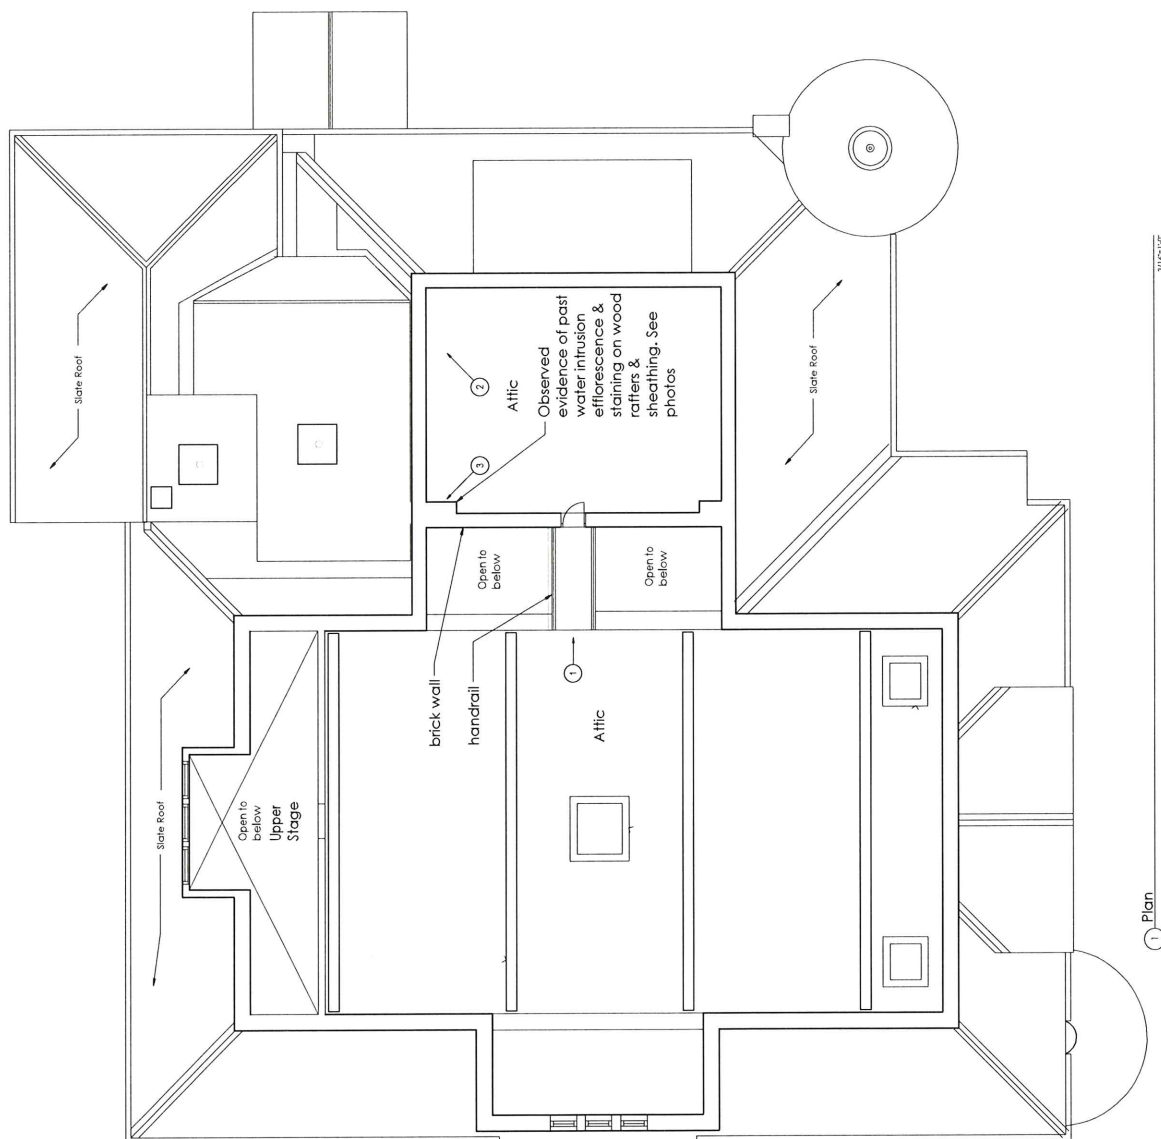
A-102

During site inspection of attic space roof sheathing was verified as 1" thick wood tongue and groove sheathing in good condition and appears to be the original wood sheathing. There were signs of previous water intrusion on the sheathing and structural wood beams as water staining was observed on the wood. Copper roofing nails were observed fastened into the wood sheathing from the exterior. Active water intrusion was not observed. Wood and insulation were dry.

Structural Masonry wall in attic was had noticeable signs of previous water intrusion as some areas were completely white due to efflorescence. Wood beams and wood sheathing directly adjacent to this wall also had signs of water intrusion from the brick and efflorescence had been carried from the masonry to the wood. No active water intrusion was observed. Masonry was dry at the time of observation. Water intrusion from the open masonry chimneys and missing slate may be contributing the masonry wall condition.

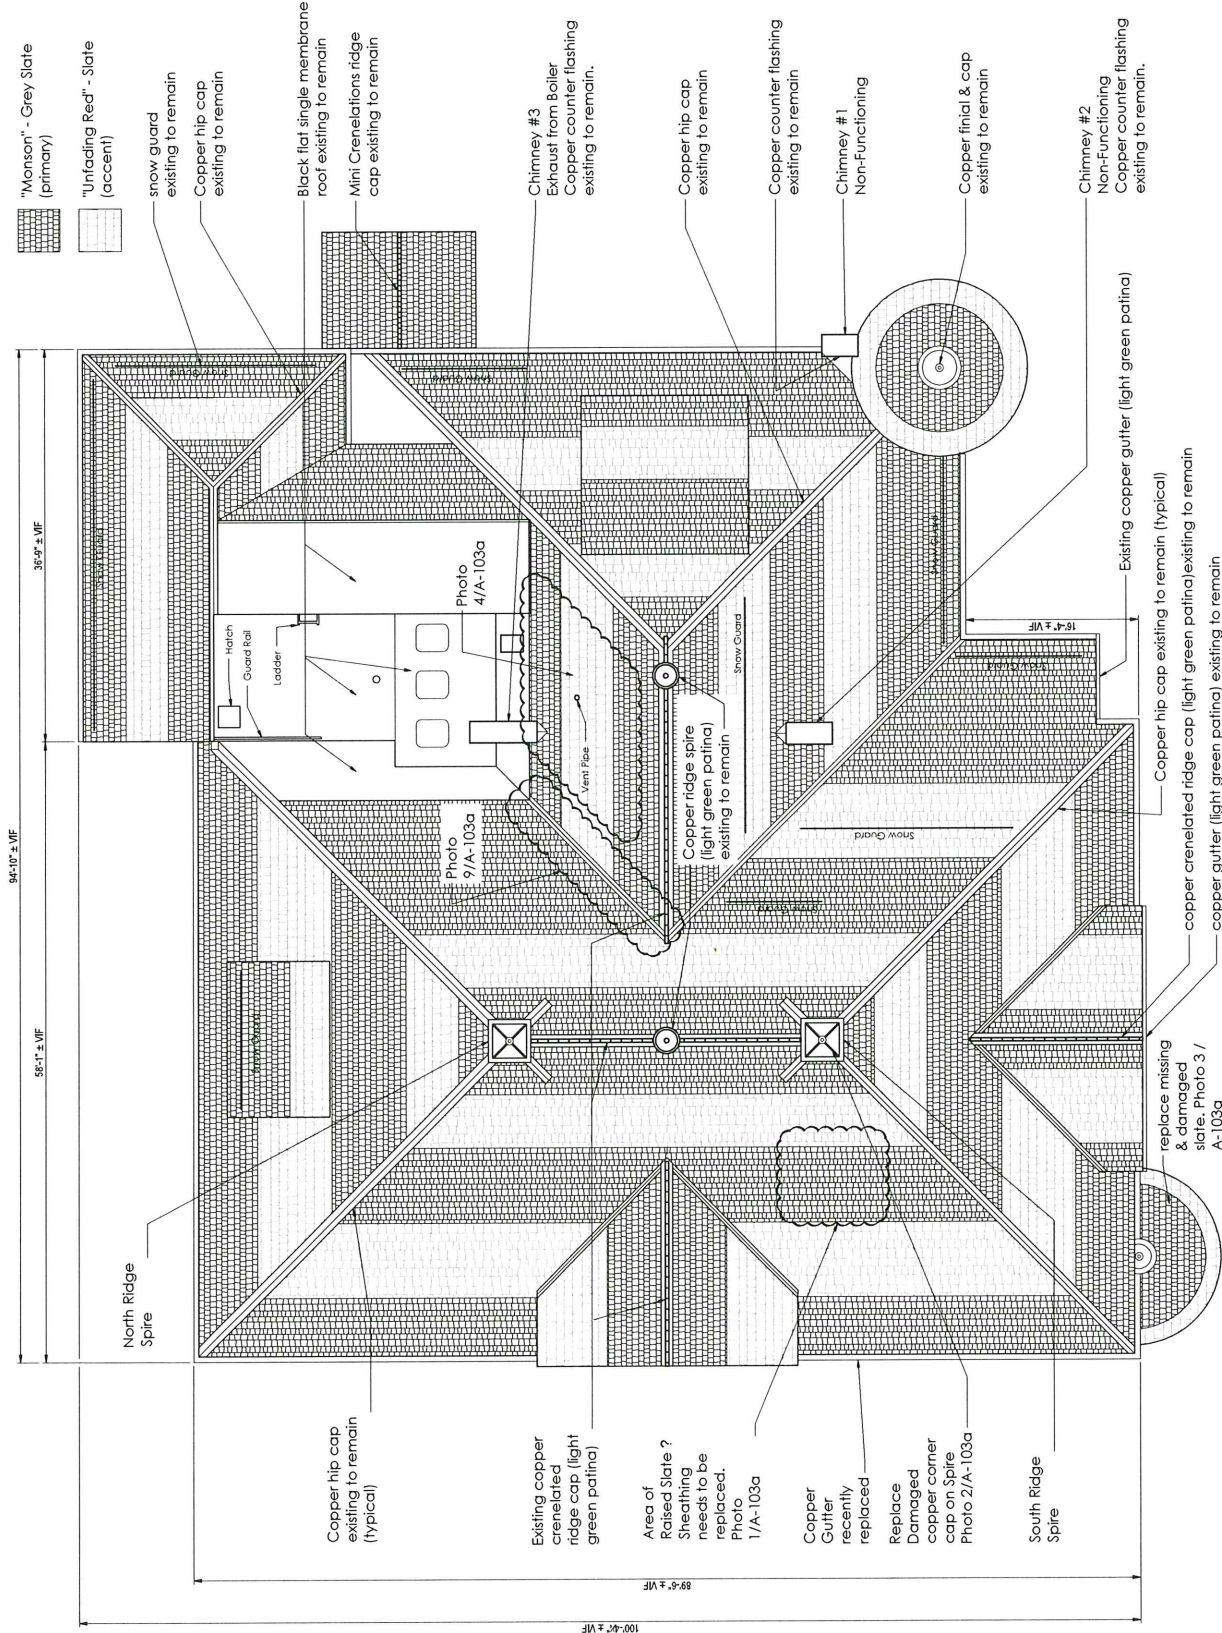
1 Roof Plan

Broken and Missing slate tiles were observed during site inspections.

There are areas of the roof where there are observable raised slate; this condition usually indicates a defect in the sheathing deck. It is recommended to be remediated, as the unsupported slate will eventually break under a live-load. This is typically repaired by removing the existing unsupported slate and "fairing" the wood deck to allow the slate to lie fully supported (usually the culprit is a protruding edge of a sheathing board).

1. Water intrusion testing of the roof should be performed by a 3<sup>rd</sup> party contractor.
2. Missing or broken slate should be replaced and match existing.
3. Slate that does not match the color of the existing slate should be removed and replaced with historic salvaged "Monson" and "Unfading Red".
4. In areas that have visible deflection in the roof & sheathing and areas where slate is lifting up, sheathing should be reinforced to allow the slate to be fully supported.
5. Chimney brick should be repaired as outlined.
6. Chimney caps should be replaced as outlined.
7. Restore roof spire that is missing copper hip.

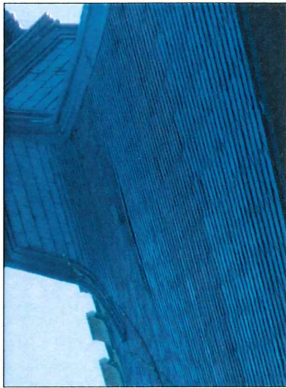
1. Raised Slate Sheathing Damaged
