Beech Street Center

Town of Belmont ADA Transition Plan

October 2020

Institute for Human Centered Design

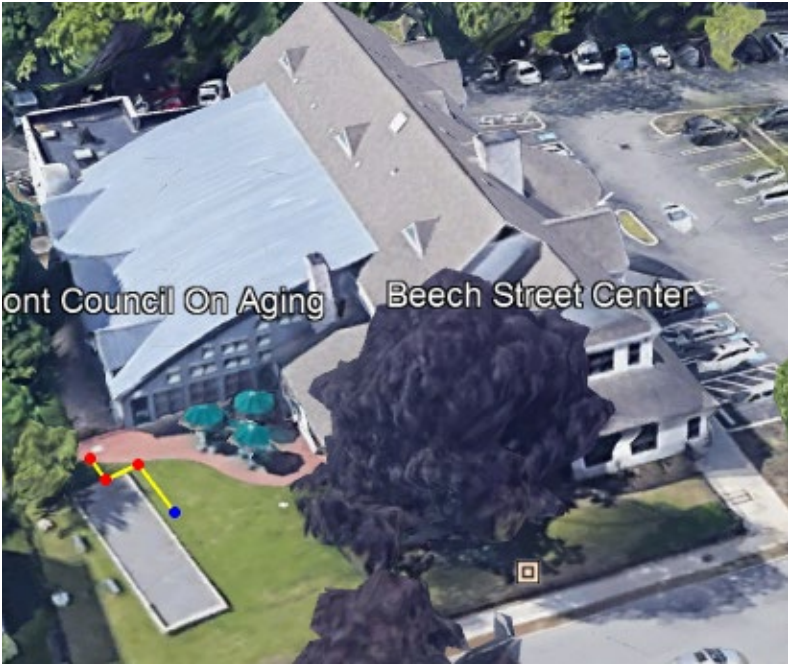
Accessibility issues with exterior access routes include excessive changes in level and an excessive cross slope. There is also lack of an accessible route from the patio to the bocce ball court, to at least one bench in the bocce ball court area, and to the exterior book exchange receptacle on Beech Street.

Figure 1: Suggested location for 48” wide min. accessible concrete path connecting the patio to the bocce ball court and to at least one bench in this area.

No accessible route to one bench in area Accessible route not provided	-	Relocate at least one bench in this area to an accessible route and provide an accessible route from the patio connecting to the bocce ball court and to at least one bench of the north side of the bocce court.) (Cost based on a 4' wide x 30' long concrete path with a max. running slope of 1:20 (5.00%) and a max. cross slope of 1:50 (2.00%) as shown in Figure 1 of the narrative.)	1	1920	\$1920
Toilet & Bathing Rooms

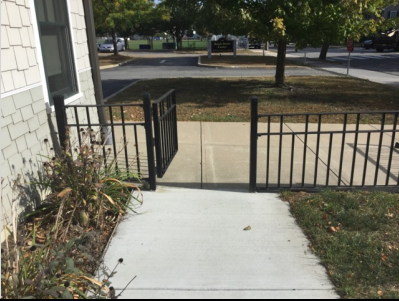
Cross slope > 1:50 (2.00%)	6.0%	Reduce cross slope to be no steeper than 1:50 (2.00%). (Cost for adding concrete to correct pathway cross slope - 10 per square foot.)	1	240	\$240
2	Parking Lot	Ext.		Exterior Access Route	Exterior

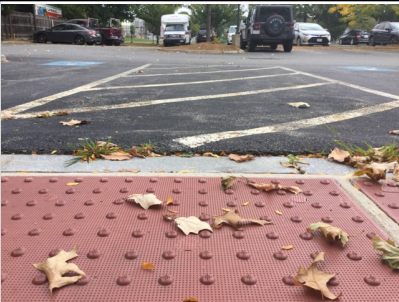
Level changes > 1/4"	1"	Alter change in level to be 1/4" high max. (Cost based on a 4'x4' concrete patch.)	1	256	\$256
3	Multipurpose Room - Egress Near Kitchen	Ext.		Exterior Access Route	Exterior

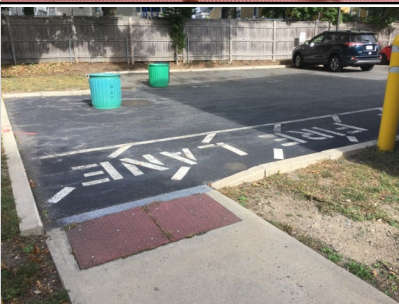
Level changes > 1/4"	1.25"	Alter change in level to be 1/4" high max. (Cost based on a 4'x4' concrete patch.)	1	256	\$256
4	Egress From Stair 2	Ext.		Exterior Access Route	Walkway

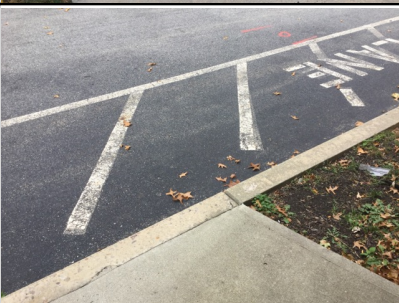
Level changes > 1/4"	1"	Alter change in level to be 1/4" high max. (Cost based on a 4'x4' concrete patch.)	1	256	\$256

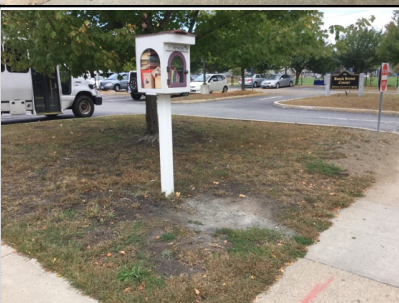
5	Lending Library Book Exchange on Beech Street at Building Entrance	Ext.		Exterior Access Route	Walkway

Accessible route not provided	-	Ensure an accessible route is provided. Provide a 4' wide min. 6' long asphalt path to book exchange. Ensure path has a maximum running slope of 1:20 (5.00%) and a maximum cross slope of 1:50 (2.00%). (Cost for a new concrete route.)	1	384	\$384

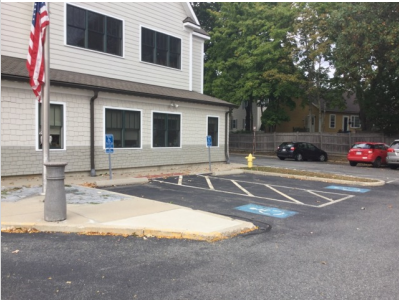
Total # of parking Total # of designated van accessible spaces Total # of designated accessible parking spaces Sign bottom < 60" above finished grade	64 4 2 42.5"	Locate sign with the bottom of the sign 60" above the ground.	2	Labor	\$0
7	Parking Lot	Ext.		Off-Street Parking Lot or Garage	N/A

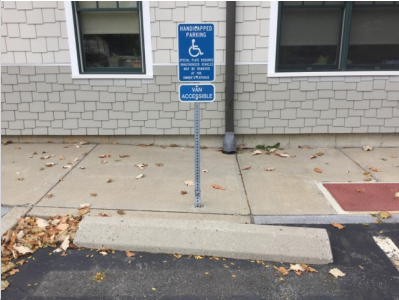
Sign bottom < 60" above finished grade	36"	Locate sign with the bottom of the sign 60" above the ground.	1	Labor	\$0
8	Parking Lot	Ext.		Off-Street Parking Lot or Garage	N/A

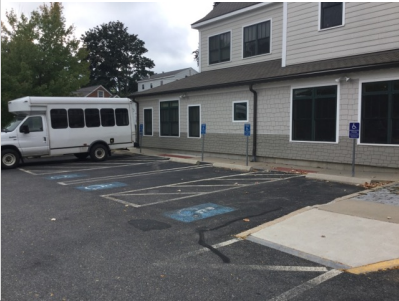
Sign bottom < 60" above finished grade	44"	Locate sign with the bottom of the sign 60" above the ground.	4	Labor	\$0
Access to Goods and Services												
Means of Egress												
9	Multipurpose Room	1	119	Means of Egress	N/A

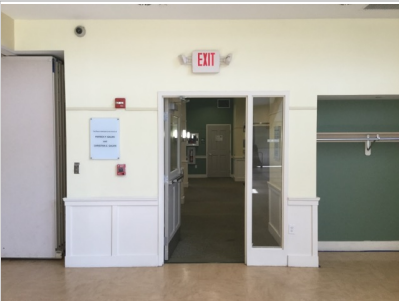
Tactile exit sign not provided	-	Ensure tactile exit signs with raised characters and braille are provided at exit doors. Mount signs between 48"- 60" above the finished floor located on the latch side of the door.	1	232	\$232

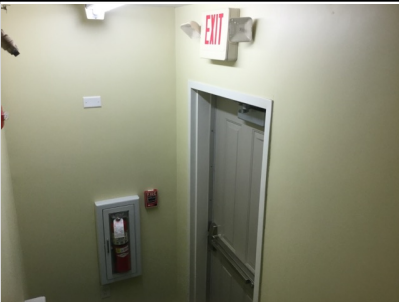
10	Stair 2	2	207	Means of Egress	N/A

Tactile exit sign not provided	-	Ensure tactile exit signs with raised characters and braille are provided at exit doors. Mount signs between 48"- 60" above the finished floor located on the latch side of the door.	1	232	\$232

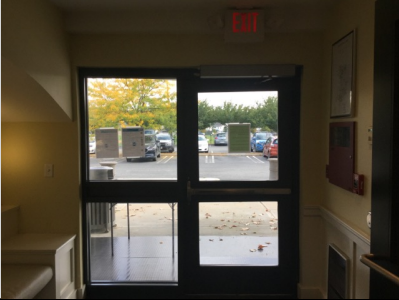
Tactile exit sign not provided Illuminated ISA symbol not provided (MAAB)	- -	Ensure tactile exit signs with raised characters and braille are provided at exit doors. Mount signs between 48"- 60" above the finished floor located on the latch side of the door. Provide an illuminated sign with the International Symbol of Accessibility.	1	432	\$432
12	Multipurpose Room	1	119	Means of Egress	N/A

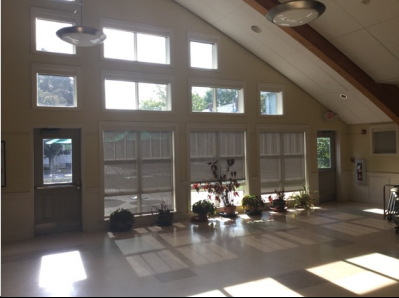
Tactile exit sign not provided Illuminated ISA symbol not provided (MAAB)	- -	Ensure tactile exit signs with raised characters and braille are provided at exit doors. Mount signs between 48"- 60" above the finished floor located on the latch side of the door. Provide an illuminated sign with the International Symbol of Accessibility at the accessible exit with the illuminated exit sign.	1	432	\$432

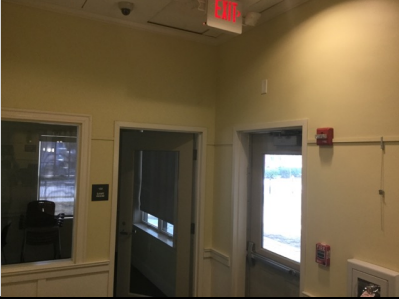
13	Egress Near Game Room	1	122	Means of Egress	N/A

Tactile exit sign not provided Illuminated ISA symbol not provided (MAAB)	- -	Ensure tactile exit signs with raised characters and braille are provided at exit doors. Mount signs between 48"- 60" above the finished floor located on the latch side of the door. Provide an illuminated sign with the International Symbol of Accessibility.	1	432	\$432
Interior Access Route												
14	Counseling Room	1		Interior Access Route	N/A

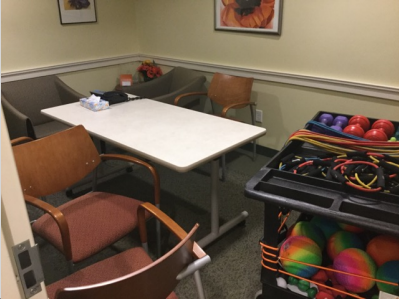
Route < 36" wide	-	Ensure that a clear width of 36" min. is maintained at the accessible route.	1	Labor	\$0
15	Stair 1	1	130	Interior Access Route	N/A

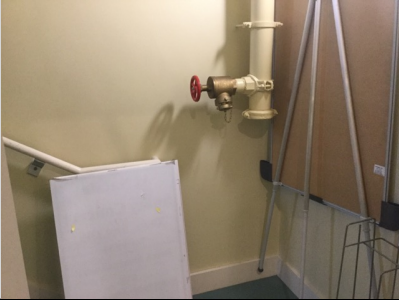
Obstructed by protruding objects	-	Provide a cane-detectable barrier at the water control. Also relocate stored items out of stairway landing.	1	306	\$306

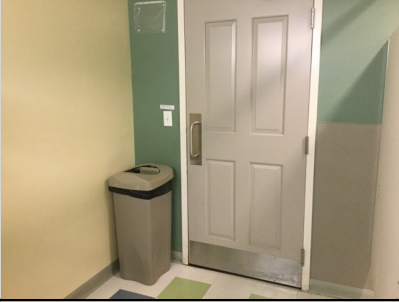
Maneuvering clearance(s) not provided	-	Remove the trash container to provide maneuvering clearance at the door.	1	Labor	\$0
17	Library - Egress to Patio on East Side of Building	1	121	Doors, Doorways, & Gates	Circulation

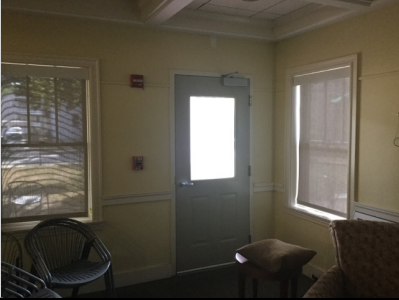
Door requires > 5 lbs. of force to open	18 lbs.	Adjust closers so doors do not require more than 5 pounds of force to open.	1	Labor	\$0
18	Single-User Toilet Room	2	211	Doors, Doorways, & Gates	Toilet Room

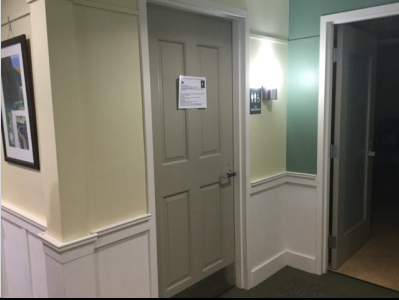
Door requires > 5 lbs. of force to open	18 lbs.	Adjust closers so doors do not require more than 5 pounds of force to open.	1	Labor	\$0
19	Stair 2	2	207	Doors, Doorways, & Gates	Emergency Egress

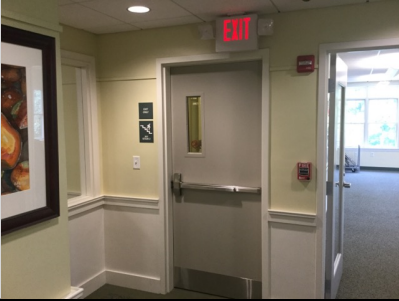
Door requires > 5 lbs. of force to open	20 lbs.	Adjust closers so doors do not require more than 5 pounds of force to open.	1	Labor	\$0

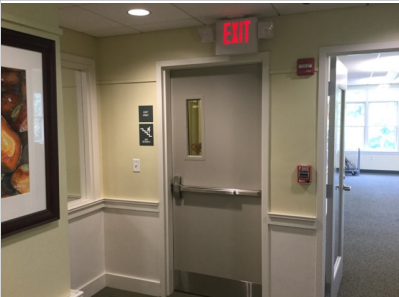
Raised characters < 48" or > 60" above ground	67"	Mount signs so that the baseline of the lowest tactile character is 48" min. above finished floor and the baseline of the highest tactile character is 60" max. above the finished floor.	1	Labor	\$0

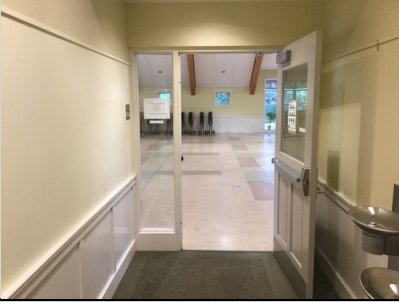
Sign not located on the latch side of the door	-	Locate sign at permanent rooms alongside the door on the latch side.	1	Labor	\$0
Operable Parts												
22	Classroom B	2	206	Operable Parts	Other

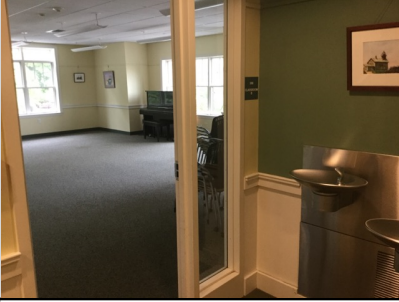
Clear floor space is not provided	-	Clear floor space not provided at sign. Relocate sign closer to latch/mount on glass.	1	Labor	\$0
23	Multipurpose Room	1	119	Operable Parts	Clothes Rod/Hooks

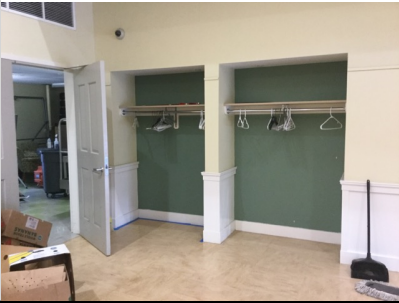
Side reach > 54"	63"	Provide a clothes rod or coat hook no higher than 48" above the finished floor.	1	256	\$256
24	Arts and Crafts Room	1	125	Operable Parts	Clothes Rod/Hooks

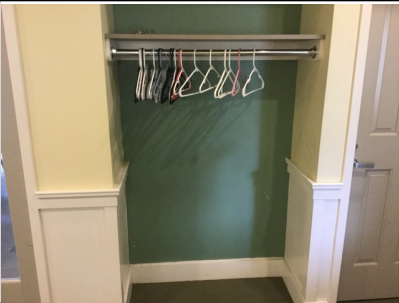
Side reach > 54"	63"	Provide a clothes rod or coat hook no higher than 48" above the finished floor.	1	256	\$256
25	Single-User Toilet Room	2	211	Operable Parts	Other

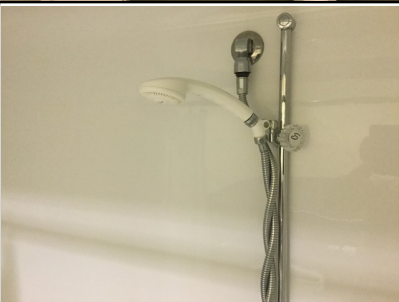
Not operable with a closed fist	-	Provide hardware that can be operable with one hand and not require tight grasping, pinching, or twisting of the wrist.	1	563	\$563

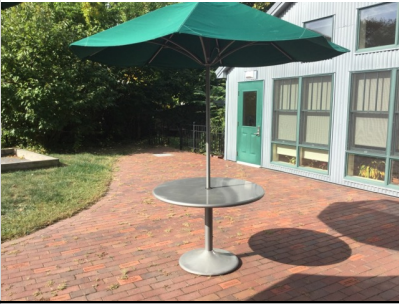
Knee or toe clearance not provided	-	Provide at least 1 dining surface in this area with 30" wide min. and 17" deep min. toe clearance. (This table does have the 27" min. required knee clearance.)	1	1100	\$1100
27	Lounge Area	1	121	Dining or Work Surfaces	Dining Surface

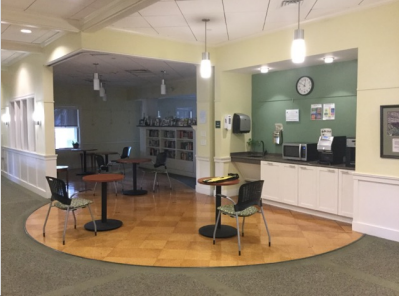
Knee or toe clearance not provided	-	Provide at least 1 dining surface in this area with 30" wide min. and 17" deep min. toe clearance. (This table does have the 27" min. required knee clearance.)	1	1100	\$1100
Assembly Area												
28	Multipurpose Room	1	119	Assembly Area	N/A

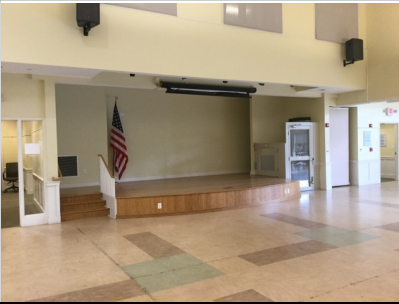
Assistive listening devices not provided	-	If audible communication is integral to the use of the space, provide an assistive listening system.	1	1214	\$1214

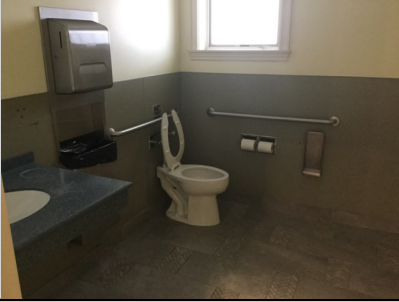
Rear grab bar > 42" long (MAAB)	36'	Provide a rear wall grab bar that is 42" long min. and extends from the toilet 12" min. on one side and 24" min. on the other side (open side).	1	898	\$898
Urinal												
31	Men's Toilet Room	2	205	Urinal	N/A

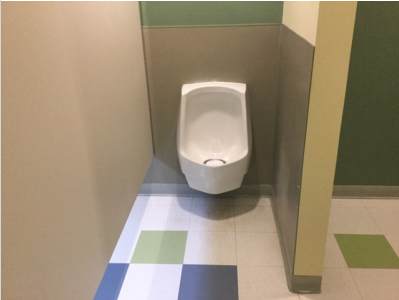
Urinal recessed > 24" has > 36" clear width	33.25"	If urinal is recessed greater than 24" ensure there is a clear width of 36". (Cost to relocate the wall at the urinal where the width is narrower than allowed, or to move the urinal out from the back wall to a location that is recessed no more than 24" is beyond scope of this project.)	1	-	\$0
Additional Access												
Drinking Fountains												
32	Near Multipurpose Room	1	Hallway	Drinking Fountains	High

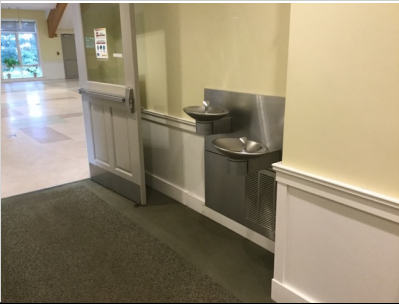
Standing height fountain does not have cane protection	-	Provide a cane-detectable barrier skirt under the high unit.	1	890	\$890

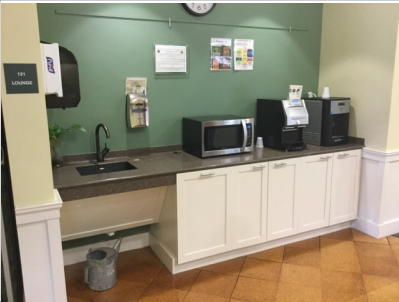
Clear floor space not provided at sink	-	Provide a 30" by 48" clear floor space positioned for a forward approach. (Relocate watering can.)	1	Labor	\$0

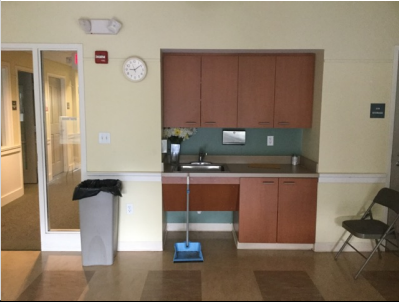
Clear floor space not provided at sink	-	Provide a 30" by 48" clear floor space positioned for a forward approach. (Relocate broom and any other stored items from clear floor space under sink.)	1	Labor	\$0
35	Health Room	2	210	Sink	Other

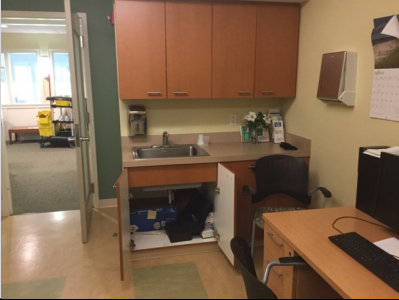
Toe and knee clearances not provided	-	Ensure there is a 27" knee clearance positioned for a forward approach.	1	1686	\$1686
Play and Sport Areas												
Exercise Machines												
36	Fitness	2	209	Exercise Machines	N/A

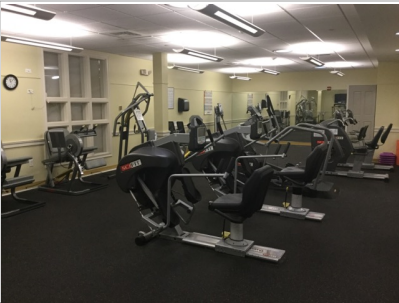
Clear floor space not provided	-	Ensure that one of each type of equipment has a 30" by 48" clear floor space positioned for transfer or for use by an individual seated in a wheelchair. Clear floor space required at exercise machines and equipment shall be permitted to overlap.	1	Labor	\$0

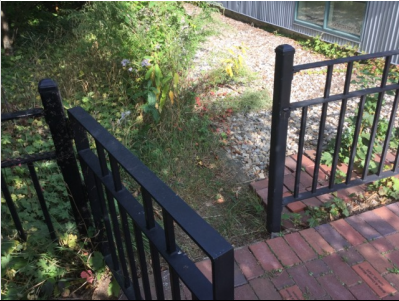
Recommend providing a sign indicating the direction of the accessible route when exiting the multipurpose room.	1	-	\$0
