Main Library

Town of Belmont ADA Transition Plan

February 2021

Institute for Human Centered Design

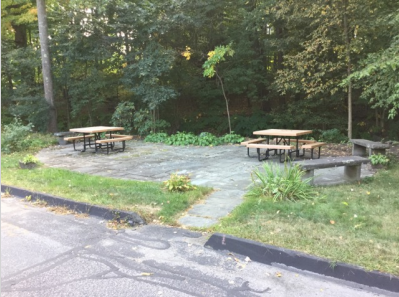
Exterior route < 48" wide	25"	Provide a firm, stable and slip resistant path with a clear width of 48" min. to the picnic tables. Ensure path has a cross slope no steeper than 1:50 (2.00%), and a running slope no steeper than 1:20 (5%).	1	600	\$600
2	Walkway at East Side of Building	Ext.		Exterior Access Route	Walkway

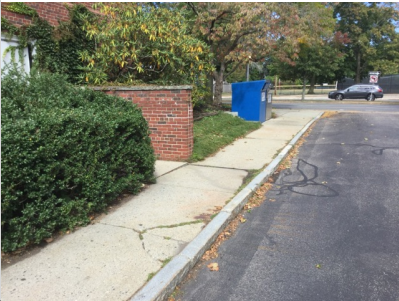
Route not maintained in operable working condition	-	Ensure the accessible route is maintained in operable working condition. (Repair deteriorated cement in walkway.) (Cost based on two 4'x4' concrete patches.)	2	256	\$512
Off-Street Parking Lot or Garage												
3	West Parking Lot	Ext.		Off-Street Parking Lot or Garage	N/A

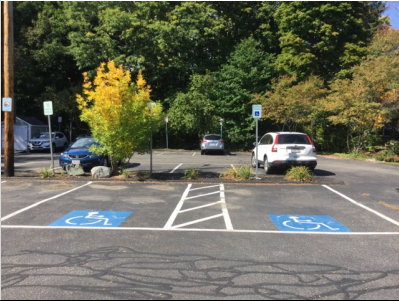
Total # of parking Total # of designated accessible parking spaces Total # of designated van accessible spaces Access aisle < 60" wide at car/van space Access aisle < 96" wide at van space Sign does not have the designation "Van Accessible"	44 3 - 42" 42" -	Provide a van accessible parking space at least 96" wide with a marked access aisle at least 96" wide. Add the designation "Van Accessible" to the sign at the van accessible space. Provide a marked access aisle that is at least 60" wide at the car accessible parking space. (Re-stripe access aisle to 96" wide min.). Add the designation "Van Accessible" to the sign located at the van accessible space.	1	800	\$800

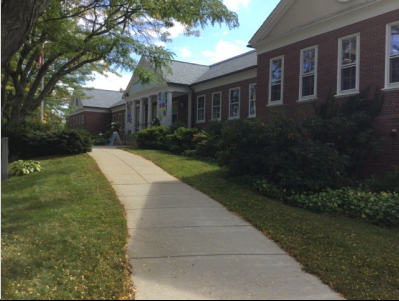
Entrance												
4	West Entrance	Ext.		Entrance	Other

Entrance not on an accessible route Directional sign to accessible entrance not provided	- -	Provide a directional sign indicating the location of the nearest accessible entrance.	1	346	\$346

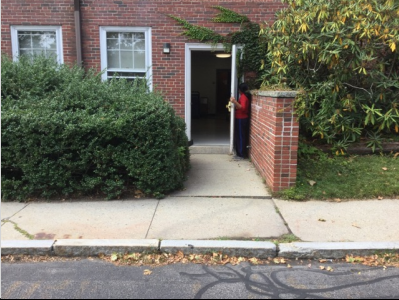
Directional sign to accessible entrance not provided	-	Provide a directional sign indicating the location of the nearest accessible entrance.	1	346	\$346
Access to Goods and Services												
Means of Egress												
6	Main Entrance From North Side of Building	1		Means of Egress	N/A

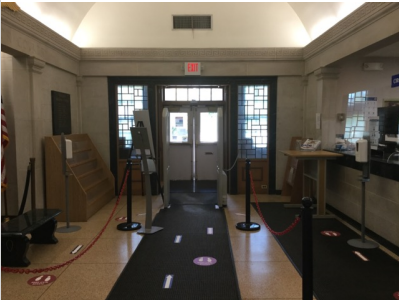
Tactile exit sign not provided	1	Ensure tactile exit signs with raised characters and braille are provided at exit doors. Mount signs between 48"- 60" above the finished floor located on the latch side of the door.	1	232	\$232
7	Assembly Room - Egress to East Parking Lot	G		Means of Egress	N/A

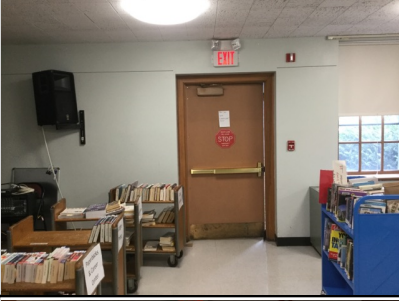
Tactile exit sign not provided	-	Ensure tactile exit signs with raised characters and braille are provided at exit doors. Mount signs between 48"- 60" above the finished floor located on the latch side of the door.	1	232	\$232

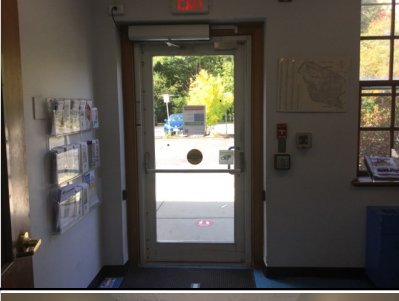
8	West Entrance	1		Means of Egress	N/A

Tactile exit sign not provided Illuminated ISA symbol not provided (MAAB)	- -	Ensure tactile exit signs with raised characters and braille are provided at exit doors. Mount signs between 48"- 60" above the finished floor located on the latch side of the door. Provide an illuminated sign with the International Symbol of Accessibility.	1	432	\$432
9	East Entrance	G		Means of Egress	N/A

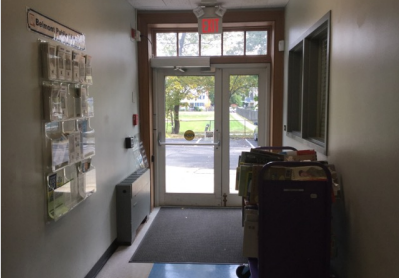
Tactile exit sign not provided Illuminated ISA symbol not provided (MAAB)	- -	Ensure tactile exit signs with raised characters and braille are provided at exit doors. Mount signs between 48"- 60" above the finished floor located on the latch side of the door. Provide an illuminated sign with the International Symbol of Accessibility.	1	432	\$432

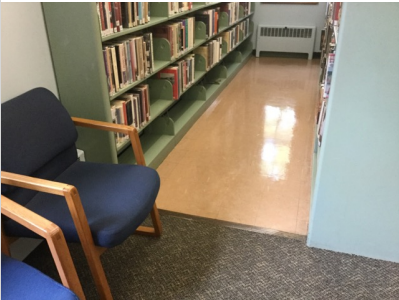
Route < 36" wide	30.5"	Relocate chairs to ensure that a clear width of 36" min. is maintained at the accessible route.	1	Labor	\$0
11	Young Adult Section - East Side of Building	1		Interior Access Route	N/A

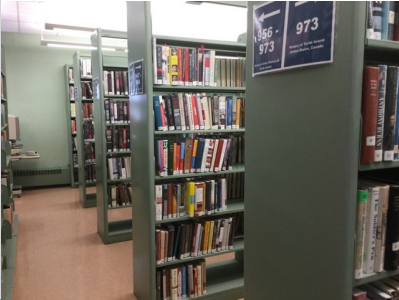
Route < 36" wide	34.25"	Ensure that a clear width of 36" min. is maintained at the accessible route.	1	Labor	\$0
12	Children's Library	G		Interior Access Route	N/A

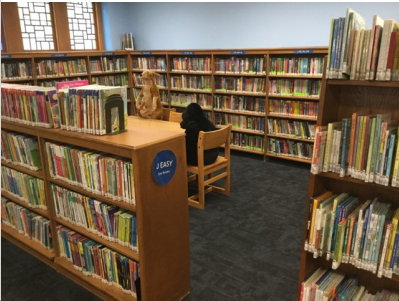
Route < 36" wide	33.5"	Ensure that a clear width of 36" min. is maintained at the accessible route.	1	Labor	\$0
Benches												
13	South of Library - Picnic Area	Ext.		Benches	N/A

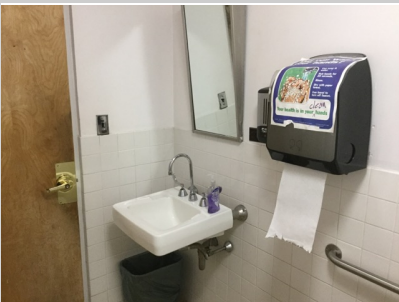
Doors, Doorways, & Gates												
14	Accessible Toilet Room - Ground Level Central Hallway	G		Doors, Doorways, & Gates	Toilet Room

Maneuvering clearance(s) not provided	-	Minimum require 18" pull-side maneuvering clearance not provided. Provide an automatic door opener.	1	3060	\$3060

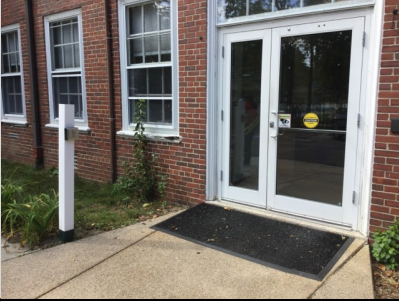
Maneuvering clearance at door > 1:50 (2.00%)	7.5% -	Alter so that the slope in all directions at the doorway landing is no greater than 1:50 (2.00%).	1	200	\$200
16	Clafin Room - Northwest Side of Building	1		Doors, Doorways, & Gates	Circulation

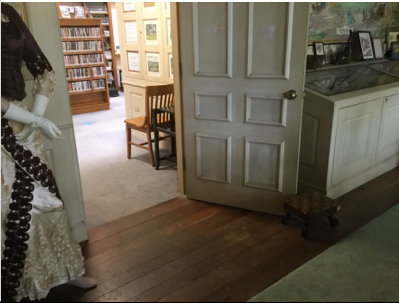
Hardware not operable with a closed fist	-	Provide hardware that can be operable with one hand and not require tight grasping, pinching, or twisting of the wrist.	1	484	\$484
17	Ground Level Central Hallway	G		Doors, Doorways, & Gates	Circulation

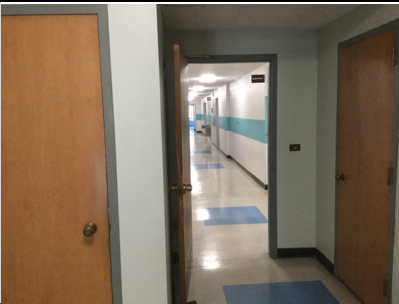
Hardware not operable with a closed fist	-	Provide hardware that can be operable with one hand and not require tight grasping, pinching, or twisting of the wrist.	1	484	\$484
Elevator												
18	Elevator	B		Elevator	Interior

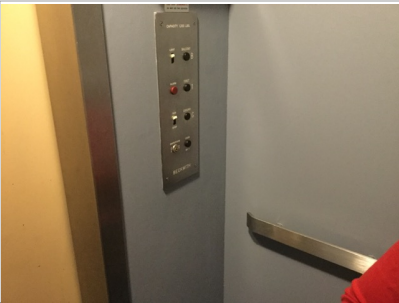
Elevator call buttons > 48"	60"	Lower call buttons to 48" max. above the finished floor.	1	1928	\$1928

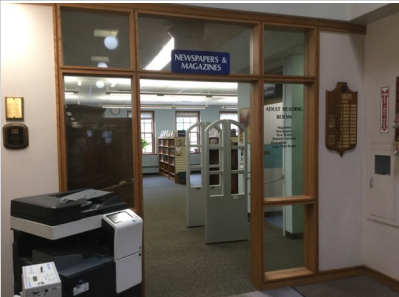
Signage												
19	Newspapers and Magazines - West Side of Building	1		Signage	Designation

Raised characters not provided on sign Braille not provided on sign Sign not located on the latch side of the door	- - -	At permanent rooms where signage is provided, provide text with raised characters duplicated in braille on sign. Mount visual sign so that the baseline of the lowest character is 40" min. above the finished floor. Locate sign at permanent rooms alongside the door on the latch side.	1	232	\$232

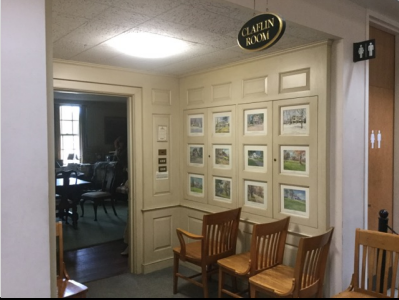
Raised characters not provided on sign Braille not provided on sign Sign not located on the latch side of the door	- - -	At permanent rooms where signage is provided, provide text with raised characters duplicated in braille on sign. Mount visual sign so that the baseline of the lowest character is 40" min. above the finished floor. Locate sign at permanent rooms alongside the door on the latch side.	1	232	\$232
21	Clafin Room - Northwest Side of Building	1		Signage	Designation

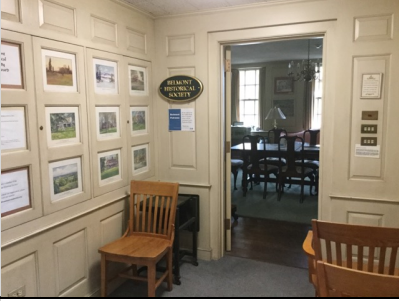
Raised characters not provided on sign Braille not provided on sign Sign not located on the latch side of the door	- - -	Provide text with raised characters duplicated in braille on sign. Provide braille on sign. Locate sign at permanent rooms alongside the door on the latch side.	1	232	\$232

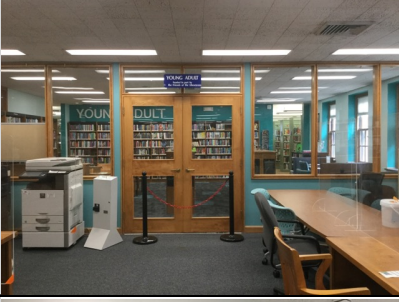
22	Young Adult Section - East Side of Building	1		Signage	Designation

Raised characters not provided on sign Braille not provided on sign Sign not located on the latch side of the door	- - -	At permanent rooms where signage is provided, provide text with raised characters duplicated in braille on sign. Mount visual sign so that the baseline of the lowest character is 40" min. above the finished floor. Locate sign at permanent rooms alongside the door on the latch side.	1	232	\$232
23	Assembly Room	G		Signage	Designation

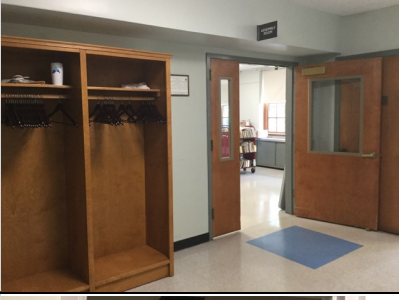
Raised characters not provided on sign Braille not provided on sign Sign not located on the latch side of the door	- - -	At permanent rooms where signage is provided, provide text with raised characters duplicated in braille on sign. Mount visual sign so that the baseline of the lowest character is 40" min. above the finished floor. Locate sign at permanent rooms alongside the door on the latch side.	1	232	\$232

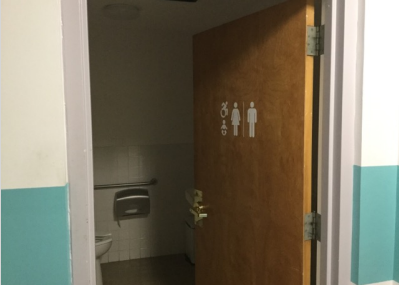
24	Accessible Toilet Room - Ground Level Central Hallway	G		Signage	Designation

Raised characters not provided on sign Braille not provided on sign Sign not located on the latch side of the door	- - -	At permanent rooms where signage is provided, provide text with raised characters duplicated in braille on sign. Mount visual sign so that the baseline of the lowest character is 40" min. above the finished floor. Locate sign at permanent rooms alongside the door on the latch side.	1	232	\$232

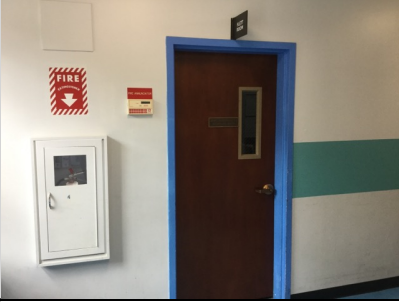
Raised characters not provided on sign Braille not provided on sign Sign not located on the latch side of the door	- - -	At permanent rooms where signage is provided, provide text with raised characters duplicated in braille on sign. Mount visual sign so that the baseline of the lowest character is 40" min. above the finished floor. Locate sign at permanent rooms alongside the door on the latch side.	1	232	\$232
26	Children's Library	G		Signage	Designation

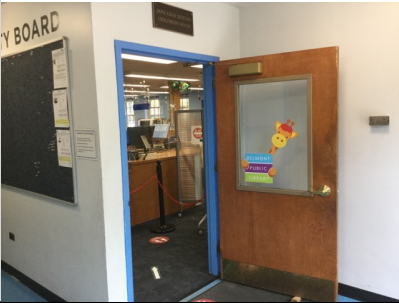
Raised characters not provided on sign Braille not provided on sign Sign not located on the latch side of the door	- - -	At permanent rooms where signage is provided, provide text with raised characters duplicated in braille on sign. Mount visual sign so that the baseline of the lowest character is 40" min. above the finished floor. Locate sign at permanent rooms alongside the door on the latch side.	1	232	\$232

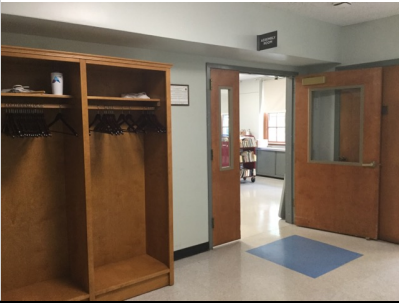
Operable Parts												
27	Assembly Room	G		Operable Parts	Clothes Rod/Hooks

Side reach > 54"	63"	Relocate or provide at least one coat rod between 15" - 48" above the finished floor.	1	256	\$256
Dining or Work Surfaces												
28	Reference Room Computer Terminal - South Side of Building	1		Dining or Work Surfaces	Work Surface

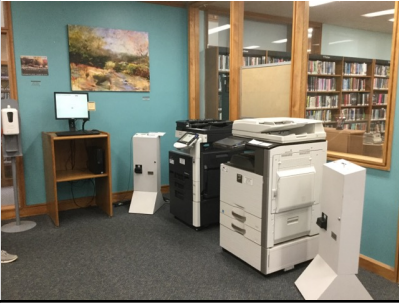
Knee or toe clearance not provided	18"	Provide a comparable terminal on a work surface with 27" min. knee and toe clearance.	1	-	\$0
29	Stacks B04 Near Stair B06	B		Dining or Work Surfaces	Work Surface

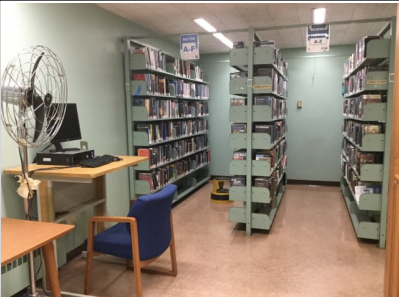
Top of dining/work surface < 28" or > 34"	40"	Provide a comparable computer terminal on an accessible work surface with tops between 28"-34" above the floor and 27" clear height underneath.	1	-	\$0

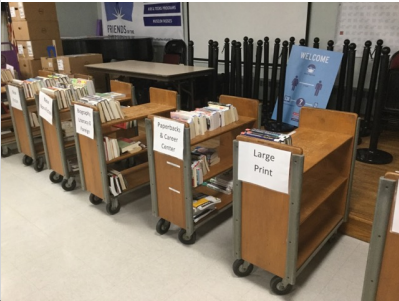
Accessible route to stage not provided	7.5"	Provide an accessible route to the stage. Provide a portable ramp.	1	500	\$500
31	Assembly Room	G		Assembly Area	N/A

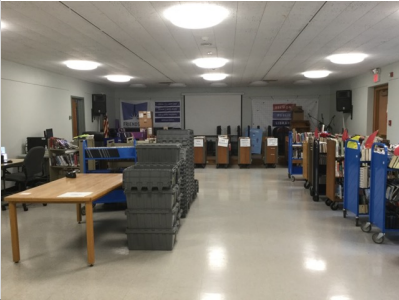
Assistive listening devices not provided	-	If audible communication is integral to the use of the space, provide an assistive listening system.	1	1214	\$1214
Picnic Tables												
32	South of Library - Picnic Area	Ext.		Picnic Tables	N/A

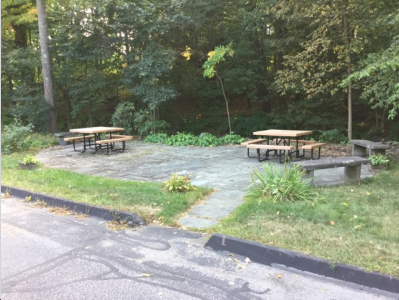
Toe or knee clearance at tables not provided	-	Provide at least 1 picnic table (or ensure that 5% of picnic tables) have toe and knee clearance.	1	1400	\$1400

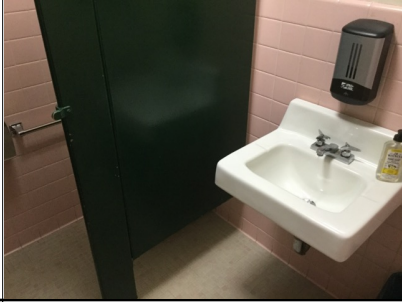
Turning space not provided Sign to accessible toilet not provided	- -	Provide a directional sign on the exterior door indicating the location of the nearest accessible toilet or bathing room.	1	232	\$232
35	Central Hallway of Main Floor	1		Overall Access

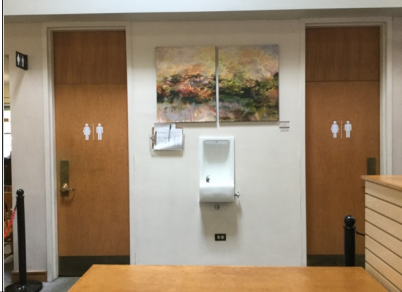
Sign to accessible toilet not provided	-	Provide a directional sign indicating the location of the nearest accessible toilet or bathing room.	1	232	\$232
36	Ground Level Central Hallway - Toilet Rooms	G		Overall Access	Toilet Room

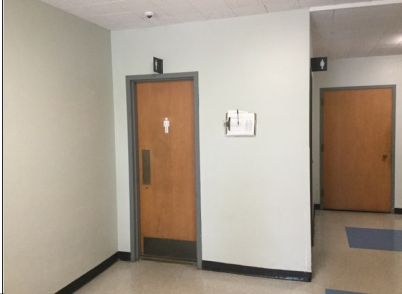
Sign to accessible toilet not provided	-	Provide a directional sign indicating the location of the nearest accessible toilet or bathing room.	1	232	\$232
37	Children's Library	G		Overall Access	Toilet Room

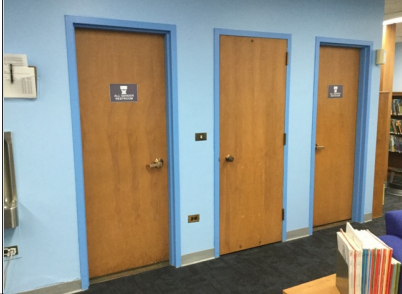
Sign to accessible toilet not provided	-	Provide a directional sign indicating the location of the nearest accessible toilet or bathing room.	1	232	\$232

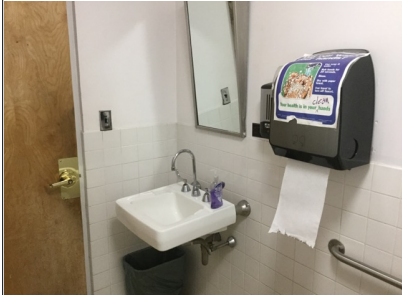
Lavatory												
38	Accessible Toilet Room - Ground Level Central Hallway	G		Lavatory	N/A

Plumbing underneath is exposed	-	Insulate or otherwise configure pipes to prevent contact for at least one lavatory.	1	92	\$92

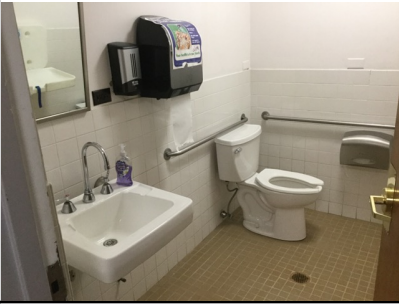
Dispenser acts as a protruding object	-	Relocate paper towel dispenser out of the circulation path or provide a cane-detectible barrier below the dispenser 27" max. above the finished floor.	1	306	\$306
40	Accessible Toilet Room - Ground Level Central Hallway	G		Dispensers	Other

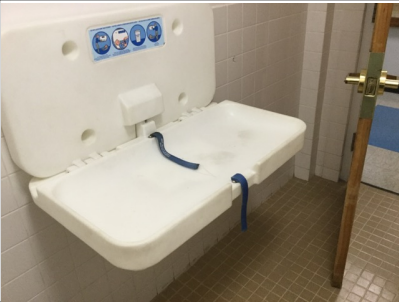
Dispenser acts as a protruding object	30.75"	Changing station not in operable working condition. Repair so table surface can be left in upright position.	1	Labor	\$0
Additional Access												
Drinking Fountains												
41	Near Accessible Toilet Room - Ground Level Central Hallway	G		Drinking Fountains	Low

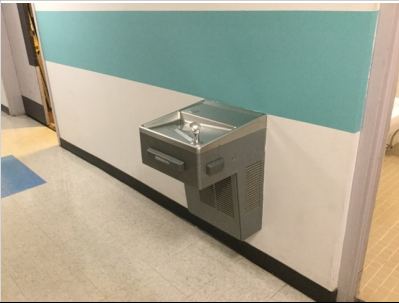
No drinking fountain provided for standing users	-	Provide an additional drinking fountain for standing users or install a Hi-Lo drinking fountain.	1	4028	\$4028

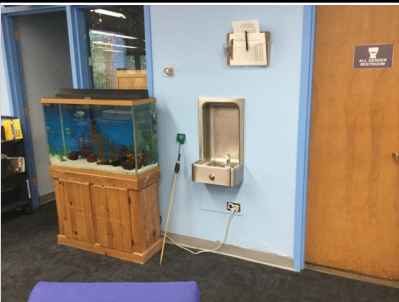
42	Children's Library	G		Drinking Fountains	Low

No drinking fountain provided for standing users	-	Provide an additional drinking fountain for standing users or install a Hi-Lo drinking fountain.	1	4028	\$4028
Best Practice
