Grove Street Park

Town of Belmont
ADA Transition Plan

August 2021

Institute for Human Centered Design

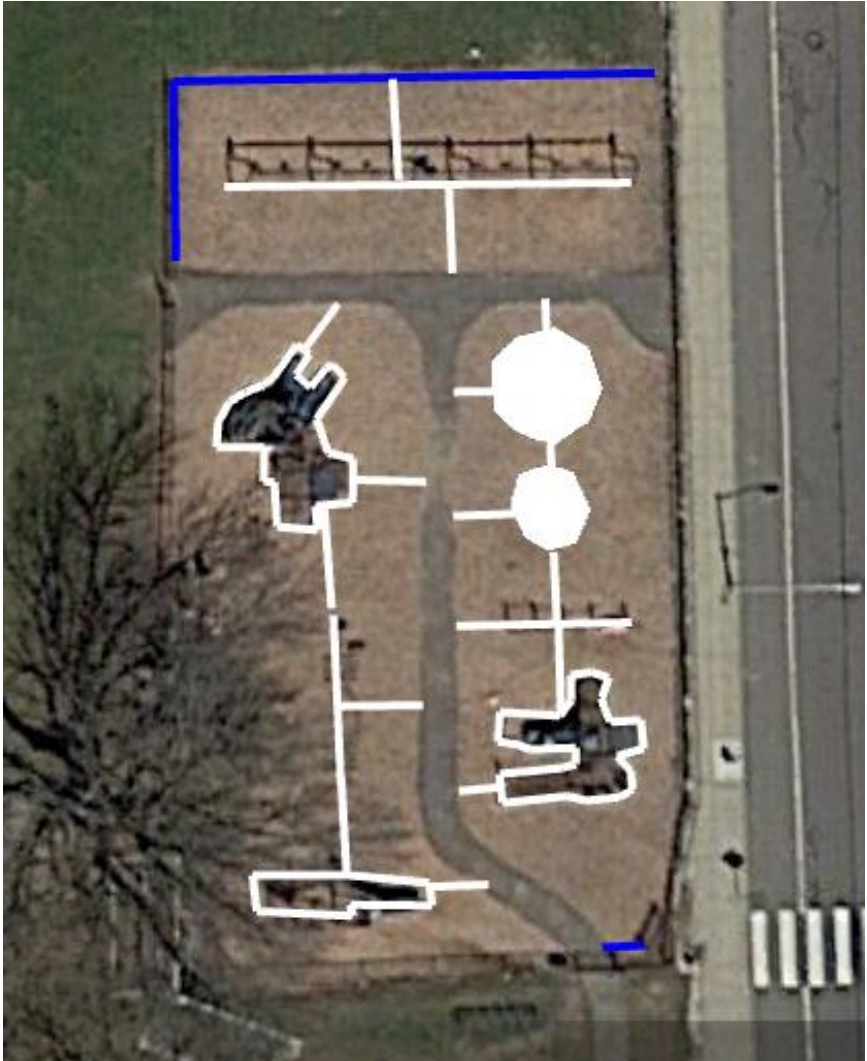
Accessibility issues include a lack of an impact attenuating accessible route to the play components inside the boundary of the playgrounds. In addition, there is no accessible route around the playground. At minimum IHCD recommends providing an accessible route around the north and northwest sides of the playground. Other routes may be too close to the area that is required to be an impact-attenuating surface to be required. See the following image for proposed asphalt routes outlined in blue and proposed poured-in-place rubber routes shown in white:

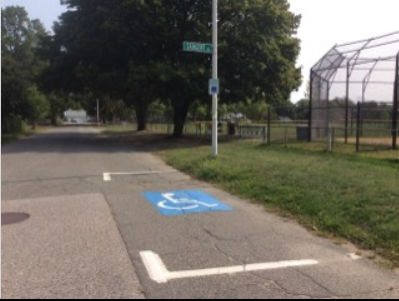
ID	Location	Floor	Room	Element	Type	Photo	Issues	Current Measure	Recommendations	Quantity	Price	Cost Estimation
Approach and Entrance												
Exterior Access Route												
1	Grosvenor Street Parking by Sargent Road and West Baseball Field	Ext.		Exterior Access Route	Exterior

Not provided from all site arrival points	-	Ensure an accessible route is provided from all points of arrival including the accessible parking space on Grosvenor Street. (Cost estimate for 40' long by 4' wide asphalt path to the entrance.)	1	1600	\$1600
2	Route to Batting Cages	Ext.		Exterior Access Route	Walkway

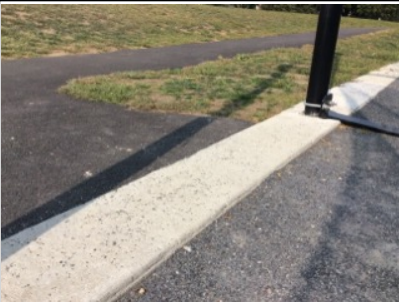
Level changes > 1/4"	1"	Alter change in level to be 1/4" high max.	1	160	\$160
3	Bike Rack by Playground	Ext.		Exterior Access Route	Exterior

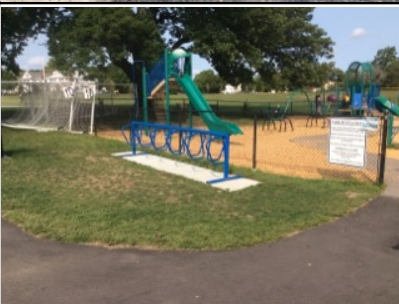
Accessible route not provided	-	Ensure an accessible route is provided to the bike racks. (Cost estimate for 30' long by 4' wide asphalt route.)	1	1200	\$1200

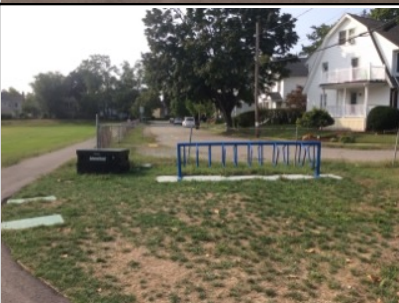
4	Bike Rack by Soccer Fields	Ext.		Exterior Access Route	Walkway

Accessible route not provided	-	Ensure an accessible route is provided to the bike rack. (Cost estimate for 25' long by 4' wide asphalt route.)	1	1000	\$1000
5	Bike Rack by Tennis Courts	Ext.		Exterior Access Route	Walkway

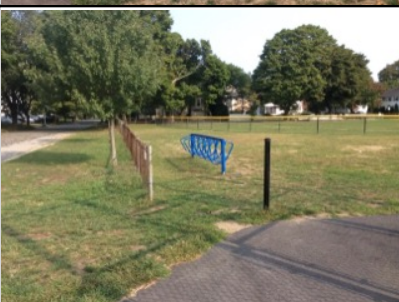
Accessible route not provided	-	Ensure an accessible route is provided to the bike racks. (Cost estimate for 30' long by 4' wide asphalt route.)	1	1200	\$1200

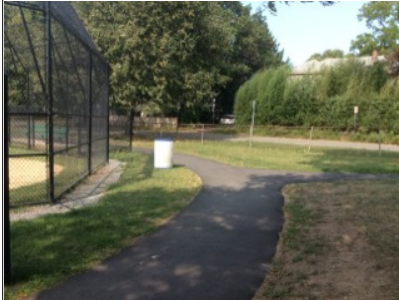
ID	Location	Floor	Room	Element	Type	Photo	Issues	Current Measure	Recommendations	Quantity	Price	Cost Estimation	
11	Walking Path Behind Northeast Baseball Diamond	Ext.		Exterior Access Route	Walkway

Accessible route not provided	-	Relocate trash bin to an accessible route.	1	256	\$256	
Off-Street Parking Lot or Garage													
12	Parking Lot by Tennis Court	Ext.		Off-Street Parking Lot or Garage	Visitor

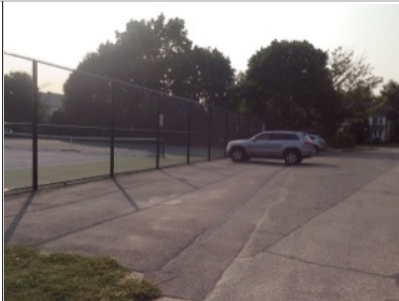
Total # of parking Total # of designated accessible parking spaces	10 0	Provide one van accessible parking space.	1	1850		\$1850
13	Accessible Parking Space on Foster Road	Ext.		Off-Street Parking Lot or Garage	Visitor

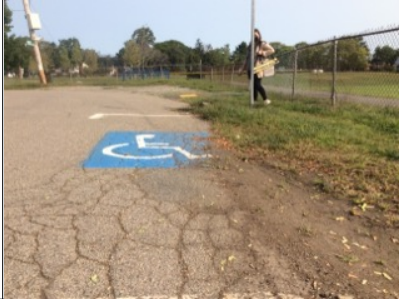
Surface not stable, firm, and slip-resistant	-	Repair surface at accessible parking space.	1	192		
Access to Goods and Services													
Signage													
14	Playground Entrance	Ext.		Signage	Informational

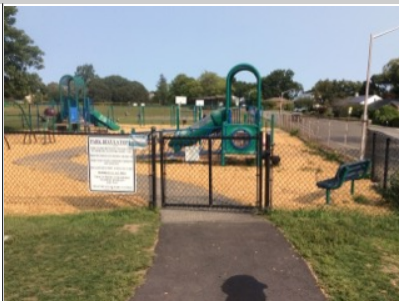
Visual characters < 40" above ground	-	Mount visual sign so that the baseline of the lowest character is 40" min. above the ground.	1	Labor	\$0

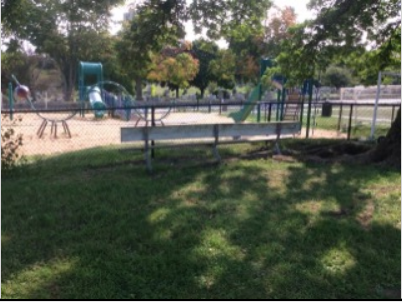
ID	Location	Floor	Room	Element	Type	Photo	Issues	Current Measure	Recommendations	Quantity	Price	Cost Estimation
Exterior Benches												
15	Bench Under Tree by Playground	Ext.		Exterior Benches	N/A

No accessible route to one bench in area	-	Provide an accessible route to this bench. (Cost estimate for 20' long by 4' wide asphalt route.)	1	800	\$800
Additional Access												
Drinking Fountains												
16	Drinking Fountain by Gosvenor Street	Ext.		Drinking Fountains	Low

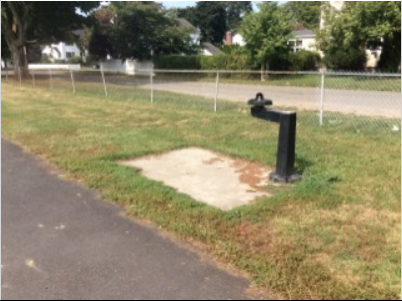
Fountain not on accessible route	-	Ensure an accessible route is provided to the drinking fountain. (Cost estimate for 6' long by 4' wide route.)	1	240	\$240
17	Drinking Fountain by Gosvenor Street	Ext.		Drinking Fountains	Low

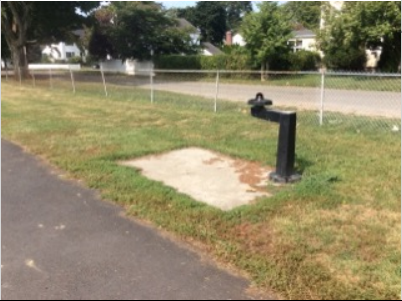
No drinking fountain provided for standing users	-	Provide an additional drinking fountain for standing users.	1	4028	\$4028
Play and Sport Areas												
Play Areas												
18	Playground	Ext.		Play Areas	N/A

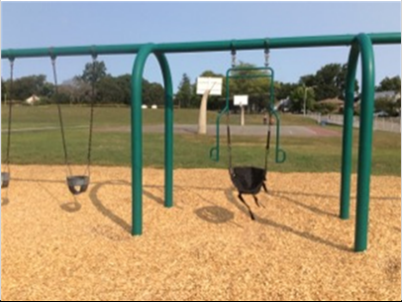
Accessible route not provided around playground	-	Provide an accessible route around the play area on the north and northwest side. (Note: Other routes may be too close to the area that is required to be impact attenuating.) (Cost estimate for 103' long by 4' wide asphalt route.)	1	4120	\$4120

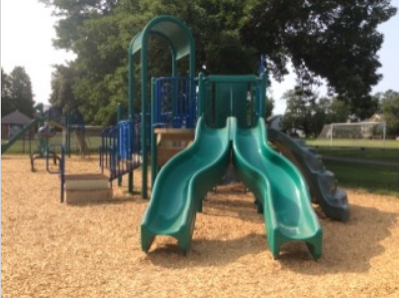
ID	Location	Floor	Room	Element	Type	Photo	Issues	Current Measure	Recommendations	Quantity	Price	Cost Estimation
19	Playground	Ext.		Play Areas	N/A

Accessible route not provided to play components	-	Provide a compliant impact-attenuating surface to and around the play components. (Cost estimate for 2,948 sq. ft. of poured in place rubber surface.)	1	41272	\$41272
20	Playground	Ext.		Play Areas	N/A

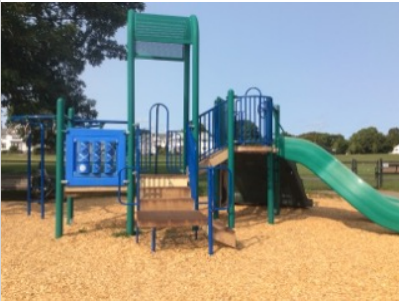
No compliant transfer system	21"	Alteration might be technically infeasible. When replacing surface, attempt to ensure that the transfer platform is 11" to 18" above the ground.	1	-	\$0
Field												
21	Northeast Baseball Diamond, First Base Team Seating Area	Ext.		Field	Baseball

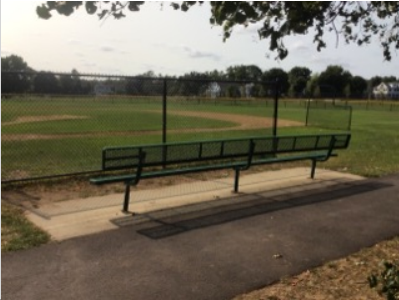
Accessible spaces not provided at team seating Field not connected to an accessible route	28" -	Provide a 36" x 48" clear floor space at team seating. Provide an accessible route to the field from the team seating area. (Cost estimate for 6' long by 4' wide asphalt area.)	1	240	\$240

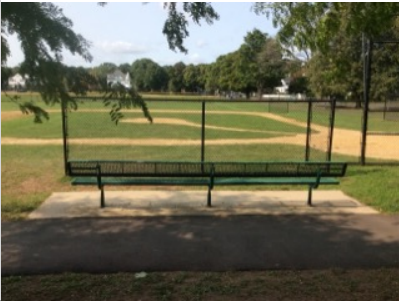
22	Northeast Baseball Diamond, Third Base Team Seating Area	Ext.		Field	Baseball

Accessible spaces not provided at team seating Field not connected to an accessible route	23.5" -	Provide a 36" x 48" clear floor space at team seating. Provide an accessible route to the field from the team seating area. (Cost estimate for 6' long by 4' wide asphalt area.)	1	240	\$240
23	West Baseball Field, Team Seating by First Base	Ext.		Field	Baseball

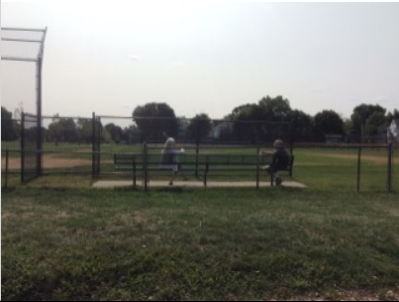
Accessible spaces not provided at team seating Field not connected to an accessible route	23" -	Provide a 36" x 48" clear floor space at team seating. Provide an accessible route to the field from the team seating area and from the entrance walkway to the team seating area. (Cost estimate for 50' long by 4' wide asphalt route.)	1	2000	\$2000

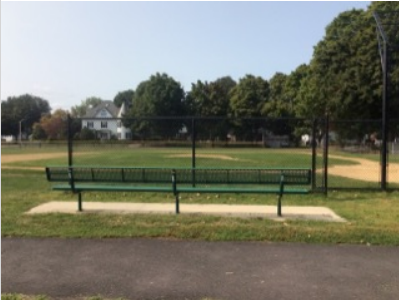
ID	Location	Floor	Room	Element	Type	Photo	Issues	Current Measure	Recommendations	Quantity	Price	Cost Estimation
24	West Baseball Field, Team Seating by Third Base	Ext.		Field	Baseball

Accessible spaces not provided at team seating Field not connected to an accessible route	23" -	Provide a 36" x 48" clear floor space at team seating. Provide an accessible route to the field from team seating. (Cost estimate for 10' by 4' asphalt area.)	1	400	\$400
25	Central Baseball Field by Tennis Courts, First Base Team Seating Area	Ext.		Field	Baseball

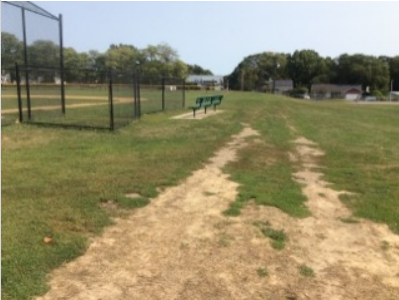
Accessible spaces not provided at team seating No accessible route to all areas of sport activity	24" -	Provide a 36" x 48" clear floor space at team seating. Install an accessible route between all areas of sport activity. (Cost estimate for 75' long 4' wide asphalt area.)	1	3000	\$3000
26	Central Baseball Field by Tennis Courts, Third Base Team Seating Area	Ext.		Field	Baseball

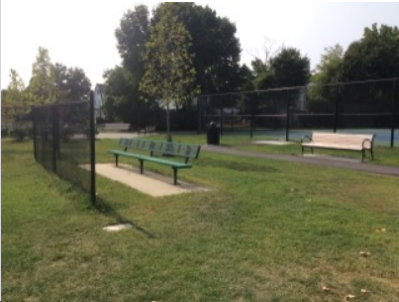
Accessible spaces not provided at team seating No accessible route to all areas of sport activity	- -	Provide a 36" x 48" clear floor space at team seating. Install an accessible route between all areas of sport activity including to the team seating area and from the team seating area to the field. (Cost estimate for 40' long by 4' wide asphalt area.)	1	1600	\$1600

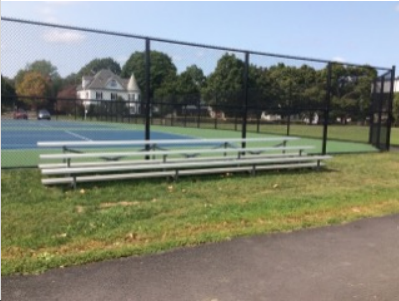
27	Central Baseball Field by Tennis Courts	Ext.		Field	Baseball

Accessible spaces not provided at sidelines seating No accessible route to all areas of sport activity	- -	Provide a 36" x 48" clear floor space at sidelines seating on each side. Install an accessible route to each side of bleacher. (Cost estimate for two 10' long by 4' wide asphalt routes.)	2	400	\$800
28	Northeast Baseball Diamond	Ext.		Field	Baseball

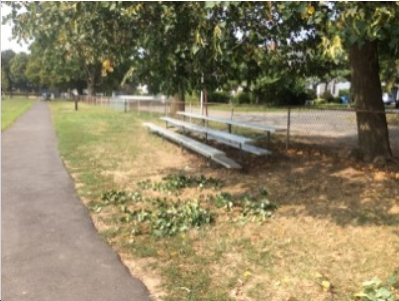
Accessible spaces not provided at sidelines seating No accessible route to all areas of sport activity	- -	Provide a 36" x 48" clear floor space at sidelines seating on each side. Install an accessible route to each side of bleacher. (Cost estimate for two 10' long by 4' wide asphalt routes.)	2	400	\$800

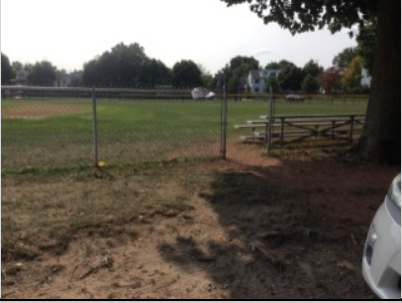
ID	Location	Floor	Room	Element	Type	Photo	Issues	Current Measure	Recommendations	Quantity	Price	Cost Estimation
29	West Baseball Field Spectator Seating	Ext.		Field	Baseball

Accessible spaces not provided at sidelines seating No accessible route to all areas of sport activity	- -	Provide a 36" x 48" clear floor space at sidelines seating. Install an accessible route between the accessible street parking space, the entrance by the bleachers and the bleachers, (Cost estimate for 70' long 4' wide asphalt area.)	1	2800	\$2800
Court												
30	Basketball Court	Ext.		Court	Basketball

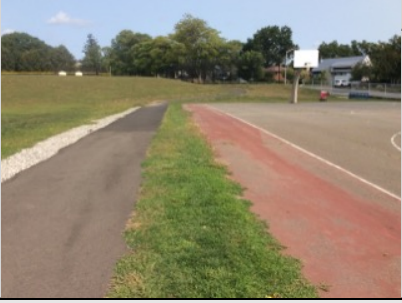
Court is not connected to an accessible route	-	Provide an accessible route to the court. (Cost estimate for 6' long by 4' wide asphalt route.)	1	240	\$240
Best Practice												
31	Tennis Courts	Ext.			-

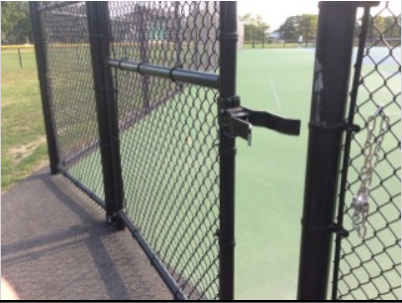
-	Recommend providing a 10" high solid surface (kickplate) on the push side of all gates.	1	-	\$0

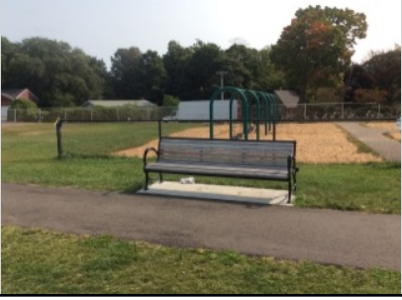
32	Walking Path by Playground Swings	Ext.			-

-	Recommend providing clear floor space alongside one bench in each area of the park so that a person using a wheelchair or wheeled mobility device can sit shoulder to shoulder with a person seated on the bench.	1	-	\$0
