Town Hall

Town of Belmont ADA Transition Plan

March 2021

Institute for Human Centered Design

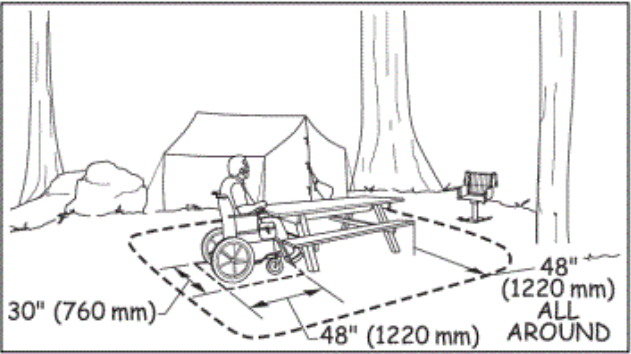
- Recommend providing contrasting strips on stair treads.
- Recommend providing a sign with raised characters and braille at permanent rooms where no sign is provided.
- Recommend providing handrail extensions that extend 12" past the bottom stair at exterior stairs at the northwest exits.
- Recommend providing a second handrail at the stair to the stage.
- Recommend providing handrails at exterior stair from the dressing room level.
- Recommend providing a 48" wide stable, firm and slip resistant walking surface around accessible picnic tables. See the following image:

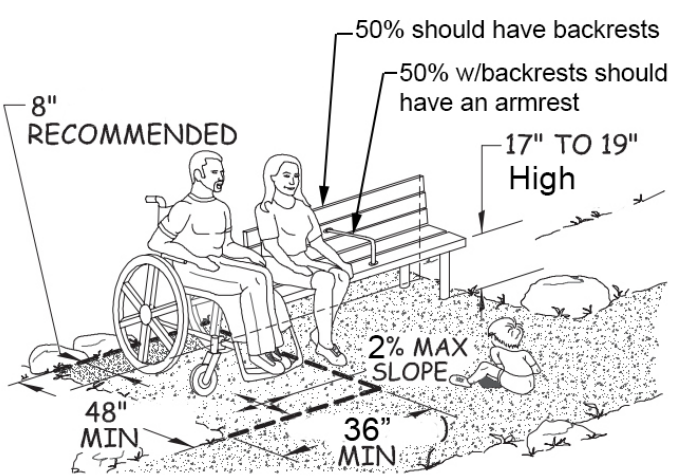
- Recommend providing clear floor space alongside at least one bench in each area where benches are provided so that a wheelchair user can sit shoulder to shoulder with a person seated at the bench. See the following image:

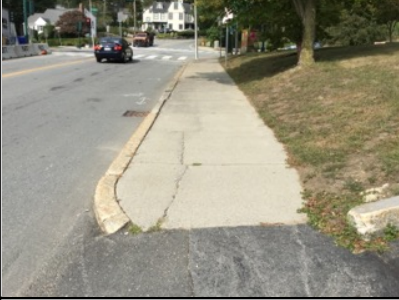
ID	Location	Floor	Room	Element	Type	Photo	Issues	Current Measure	Recommendations	Quantity	Price	Cost Estimation
Approach and Entrance												
Exterior Access Route												
1	Concord Avenue	Ext.		Exterior Access Route	Sidewalk

Cross slope > 1:50 (2.00%) Does not prevent accumulation of water	3.1% -	Reduce cross slope to be no steeper than 1:50 (2.00%). Repair surface. (Cost estimate for 10' long by 4' wide area.)	1	400	\$400
2	Moore Street Sidewalk	Ext.		Exterior Access Route	Sidewalk

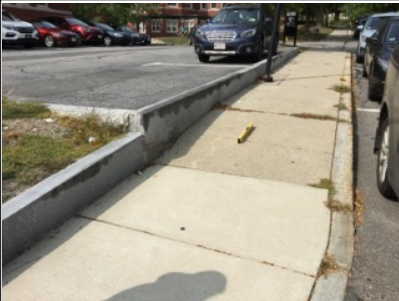
Running slope > 1:20 (5%)	11.4%	Reduce running slope to be no steeper than 1:20 (5%). (Cost estimate for 20' long by 4' wide area.)	1	800	\$800
3	Route to Bench	Ext.		Exterior Access Route	Walkway

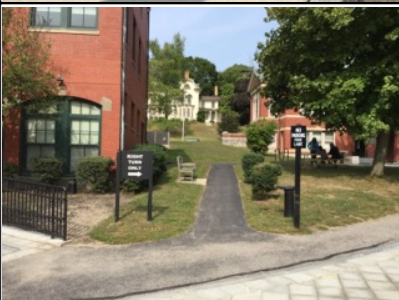
Running slope > 1:20 (5%)	10.9%	Reduce running slope to be no steeper than 1:20 (5%). (Cost estimate for 30' long asphalt route.)	1	1200	\$1200
4	Bike Rack	Ext.		Exterior Access Route	Walkway

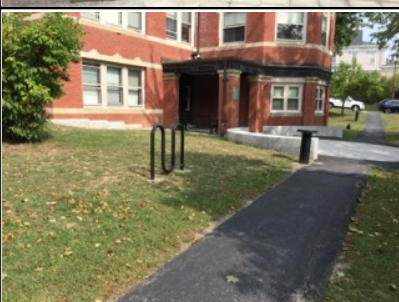
Accessible route not provided	-	Ensure an accessible route is provided to the bike rack. (Cost estimate for a 6' long, 4' wide asphalt route.)	1	240	\$240

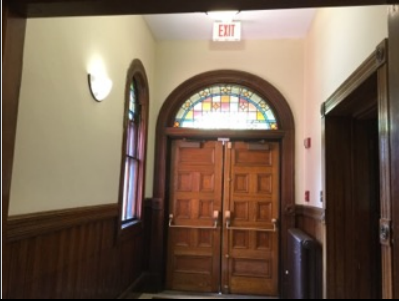
Emergency Exit												
5	Southwest Exit	1		Emergency Exit	N/A

Tactile sign not provided at exit	-	Provide tactile exit signs with raised characters and braille at exit doors. Mount signs between 48"- 60" above the finished floor located on the latch side of the door.	1	232	\$232

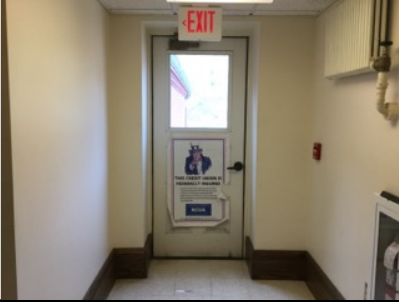
ID	Location	Floor	Room	Element	Type	Photo	Issues	Current Measure	Recommendations	Quantity	Price	Cost Estimation
6	Route to Exterior Egress Stair	2R		Emergency Exit	N/A

Tactile sign not provided at exit	-	Provide tactile exit signs with raised characters and braille at exit doors. Mount signs between 48"- 60" above the finished floor located on the latch side of the door.	1	232	\$232
7	Egress From Dressing Room Level	B		Emergency Exit	N/A

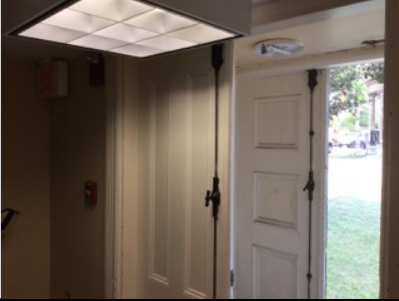
Tactile sign not provided at exit	-	Provide tactile exit signs with raised characters and braille at exit doors. Mount signs between 48"- 60" above the finished floor located on the latch side of the door.	1	232	\$232
8	Main Entrance (Egress)	G		Emergency Exit	N/A

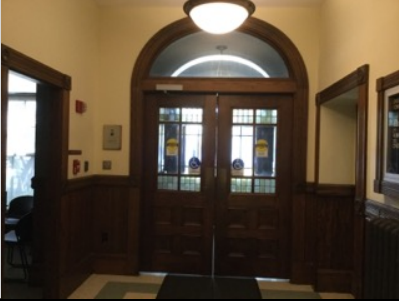
Tactile sign not provided at exit	- -	Provide tactile exit signs with raised characters and braille at exit doors. Mount signs between 48"- 60" above the finished floor located on the latch side of the door.	1	232	\$232

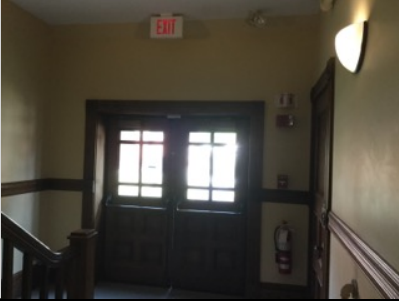
9	Stair 1	G		Emergency Exit	N/A

Tactile sign not provided at exit Directional sign to accessible emergency exit not provided	- -	Provide tactile exit signs with raised characters and braille at exit doors. Mount signs between 48"- 60" above the finished floor located on the latch side of the door. Provide a directional sign indicating the location of the nearest accessible emergency exit.	1	464	\$464
10	Southwest Exit	G		Emergency Exit	N/A

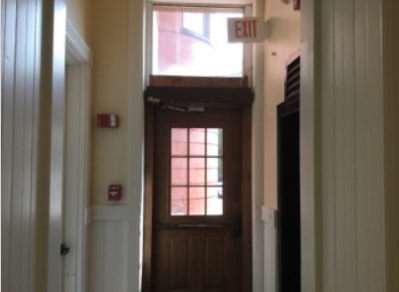
Tactile sign not provided at exit Directional sign to accessible emergency exit not provided Door requires > 15 lbs. of force to open	- 4" 19 lbs	Provide tactile exit signs with raised characters and braille at exit doors. Mount signs between 48"- 60" above the finished floor located on the latch side of the door. Provide a directional sign indicating the location of the nearest accessible emergency exit. Adjust closers of exterior doors so doors do not require more than 15 pounds of force.	1	464 Labor	\$464

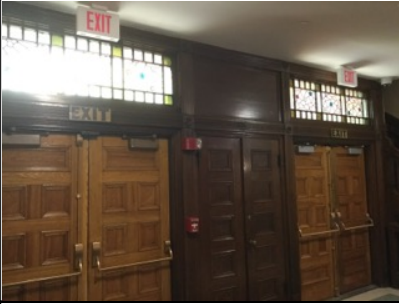
ID	Location	Floor	Room	Element	Type	Photo	Issues	Current Measure	Recommendations	Quantity	Price	Cost Estimation
11	Northwest Exits	1		Emergency Exit	N/A

Tactile sign not provided at exit Door requires > 15 lbs. of force to open	- 18 lbs	Provide tactile exit signs with raised characters and braille at exit doors. Mount signs between 48"- 60" above the finished floor located on the latch side of the door. Adjust closers of exterior doors so doors do not require more than 15 pounds of force.	2	232 Labor	\$464
12	Main Entrance (Egress)	G		Emergency Exit	N/A

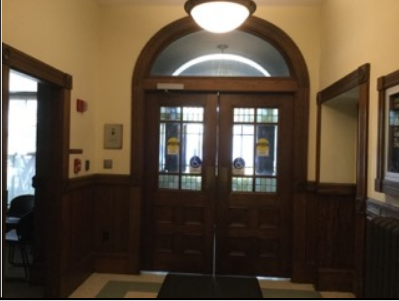
Illuminated Int. Symbol of Acc. not provided (MAAB)	-	If an illuminated exit sign is provided, provide an illuminated sign with the International Symbol of Accessibility at this exit.	1	-	\$0
Access to Goods and Services												
Means of Egress												
13	Auditorium Exits	1		Means of Egress	N/A

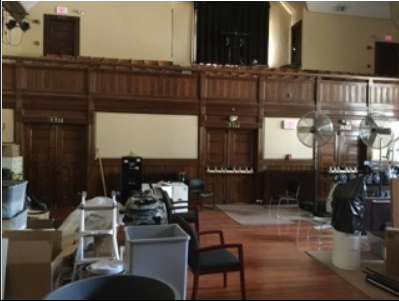
Tactile exit sign not provided	-	Ensure tactile exit signs with raised characters and braille are provided at exit doors. Mount signs between 48"- 60" above the finished floor located on the latch side of the door.	3	232	\$696

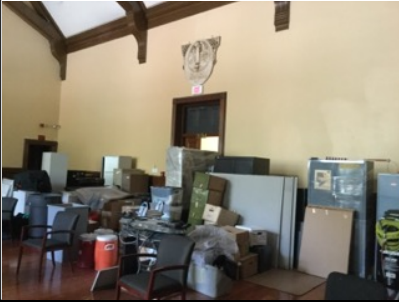
14	Auditorium	1		Means of Egress	N/A

Tactile exit sign not provided	-	Ensure tactile exit signs with raised characters and braille are provided at exit doors. Mount signs between 48"- 60" above the finished floor located on the latch side of the door.	1	232	\$232
15	Auditorium Exit Leading to Elevator Next to Town Administrator	1		Means of Egress	N/A

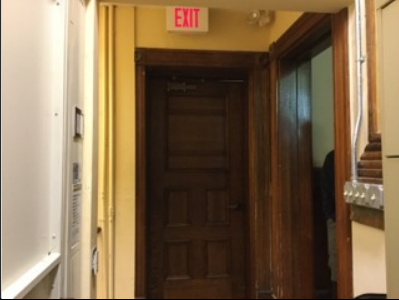
Tactile exit sign not provided	-	Ensure tactile exit signs with raised characters and braille are provided at exit doors. Mount signs between 48"- 60" above the finished floor located on the latch side of the door.	1	232	\$232

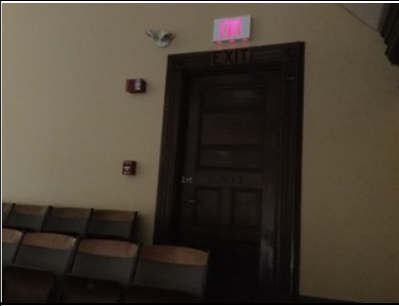
ID	Location	Floor	Room	Element	Type	Photo	Issues	Current Measure	Recommendations	Quantity	Price	Cost Estimation
16	Balcony Exits	2		Means of Egress	N/A

Tactile exit sign not provided	-	Ensure tactile exit signs with raised characters and braille are provided at exit doors. Mount signs between 48"- 60" above the finished floor located on the latch side of the door.	2	232	\$464
17	Stair Egress by Human Resources	2F		Means of Egress	N/A

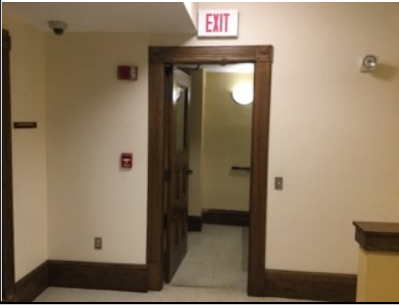
Tactile exit sign not provided	-	Ensure tactile exit signs with raised characters and braille are provided at exit doors. Mount signs between 48"- 60" above the finished floor located on the latch side of the door.	1	232	\$232
Interior Access Route												
18	Defibrillator by Elevator	1		Interior Access Route	N/A

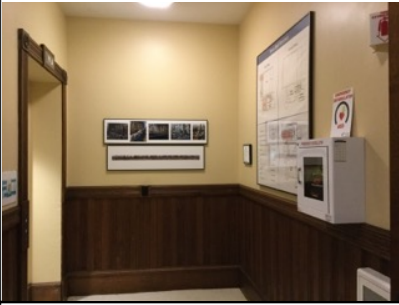
Obstructed by protruding objects	7"	Relocate defibrillator.	1	Labor	\$0
19	Stairs to Dressing Rooms	B		Interior Access Route	N/A

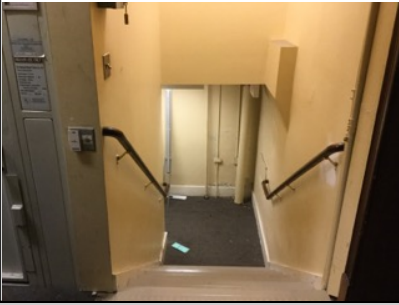
Accessible route not provided	-	Provide an accessible route between the stage and dressing rooms. (Cost estimate for a 2-stop Limited Use Limited Access Application [LULA] elevator.)	1	90000	\$90000

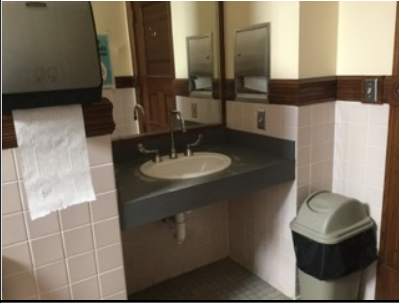
Doors, Doorways, & Gates												
20	Women's Toilet Room on Southwest	1		Doors, Doorways, & Gates	Toilet Room

Maneuvering clearance(s) not provided	-	Relocate trash bin.	1	Labor	\$0

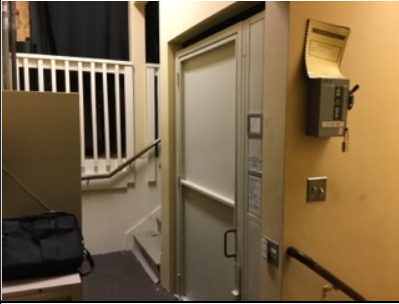
ID	Location	Floor	Room	Element	Type	Photo	Issues	Current Measure	Recommendations	Quantity	Price	Cost Estimation
21	Platform Lift to Stage	1		Doors, Doorways, & Gates	Other

Maneuvering clearance(s) not provided	-	Relocate stored items so that there is maneuvering clearance at the door to the lift.	1	Labor	\$0
22	Women's Toilet Room	G		Doors, Doorways, & Gates	Toilet Room

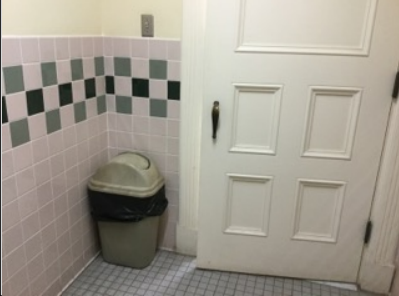
Maneuvering clearance(s) not provided	-	Relocate trash bin.	1	Labor	\$0
23	Door by Stage	1		Doors, Doorways, & Gates	Circulation

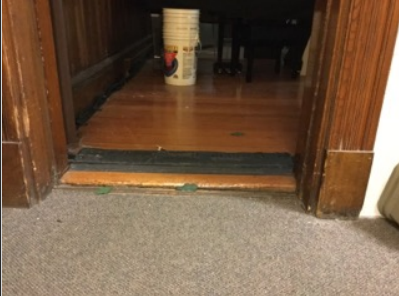
Threshold > 1/2" high	1.5"	Alter the threshold to be 1/2" high max.	1	150	\$150
24	Auditorium Door to Corridor	1		Doors, Doorways, & Gates	Circulation

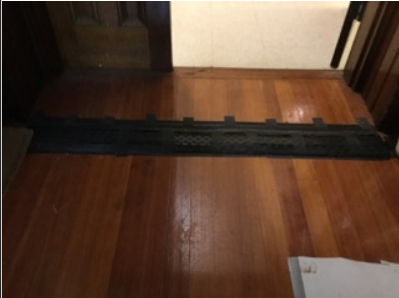
Threshold > 1/2" high	1.5"	Alter the threshold to be 1/2" high max.	1	150	\$150
25	Women's Toilet Room on Southwest	1		Doors, Doorways, & Gates	Toilet Room

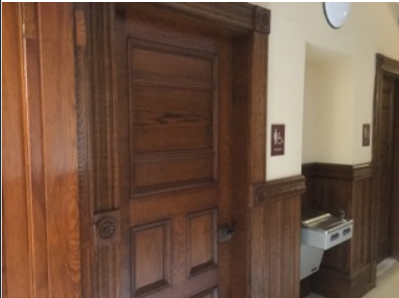
Door requires > 5 lbs. of force to open	9 lbs	Adjust closers so doors do not require more than 5 pounds of force to open.	1	Labor	\$0

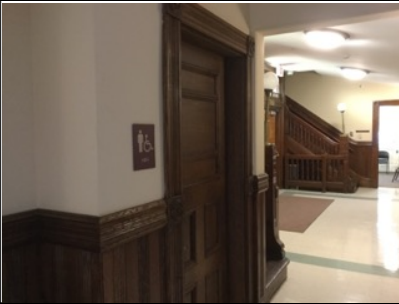
ID	Location	Floor	Room	Element	Type	Photo	Issues	Current Measure	Recommendations	Quantity	Price	Cost Estimation
26	Men's Toilet Room on West	1		Doors, Doorways, & Gates	Toilet Room

Door requires > 5 lbs. of force to open	14 lbs	Adjust closers so doors do not require more than 5 pounds of force to open.	1	Labor	\$0
27	Corridor Door to Toilet Rooms	G		Doors, Doorways, & Gates	Circulation

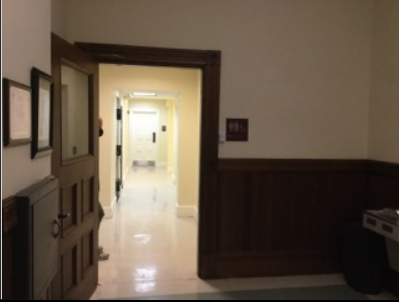
Door requires > 5 lbs. of force to open	8 lbs	Adjust closers so doors do not require more than 5 pounds of force to open.	1	Labor	\$0
28	Women's Toilet Room	G		Doors, Doorways, & Gates	Toilet Room

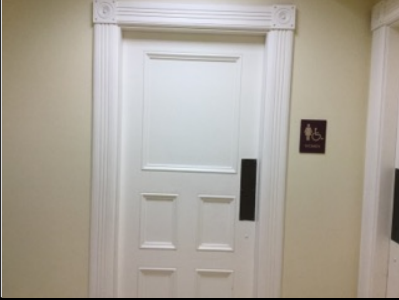
Door requires > 5 lbs. of force to open	8 lbs	Adjust closers so doors do not require more than 5 pounds of force to open.	1	Labor	\$0
29	Men's Toilet Room	G		Doors, Doorways, & Gates	Toilet Room

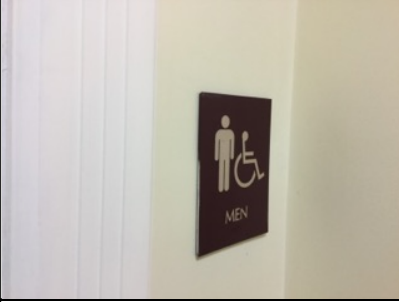
Door requires > 5 lbs. of force to open	10 lbs	Adjust closers so doors do not require more than 5 pounds of force to open.	1	Labor	\$0

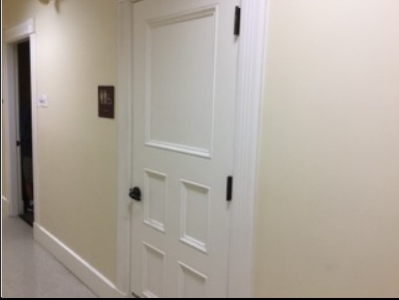
30	Single-User Toilet Room	G		Doors, Doorways, & Gates	Toilet Room

Door requires > 5 lbs. of force to open	10 lbs	Adjust closers so doors do not require more than 5 pounds of force to open.	1	Labor	\$0

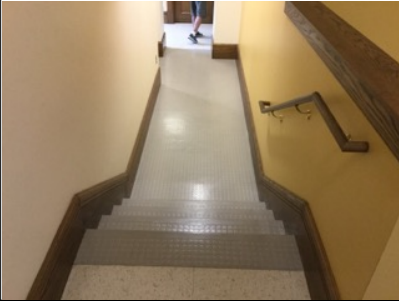
ID	Location	Floor	Room	Element	Type	Photo	Issues	Current Measure	Recommendations	Quantity	Price	Cost Estimation
Stairways												
31	Stair to Floor 2R	2R		Stairways	Egress

Handrail not provided on both sides	-	Provide a handrail on each side.	1	1320	\$1320
32	Staircase From Ground Floor to First Floor	G		Stairways	Egress

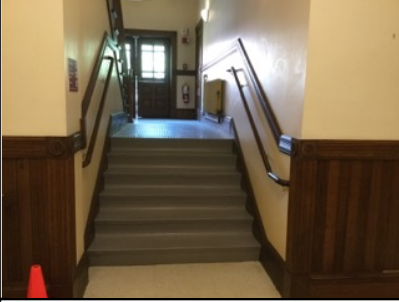
Handrails do not extend 12" from stairs	1	Bottom: Ensure handrails extend to one tread depth beyond the last riser (on the left handrail).	1	332	\$332
33	Stair 1	1		Stairways	Egress

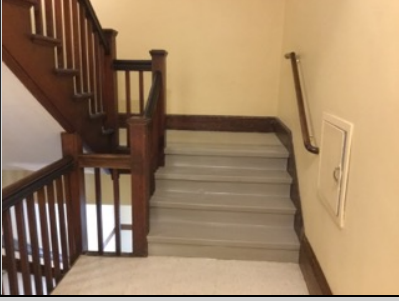
Handrails not continuous where required	-	Provide a continuous handrail on the interior side of stair.	1	1320	\$1320
Signage												
34	Credit Union Office	2R		Signage	Designation

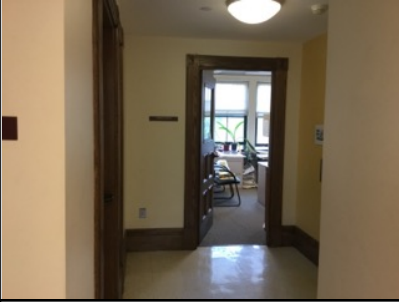
Sign not located on the latch side of the door	-	Locate sign at permanent rooms alongside the door on the latch side.	1	Labor	\$0
35	Men's Toilet Room	G		Signage	Designation

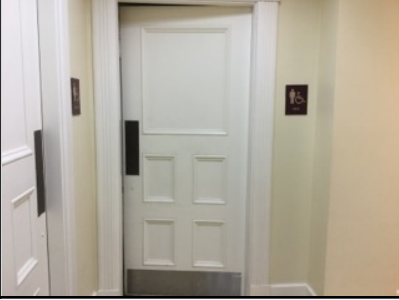
Sign not located on the latch side of the door	-	Locate sign at permanent rooms alongside the door on the latch side.	1	Labor	\$0

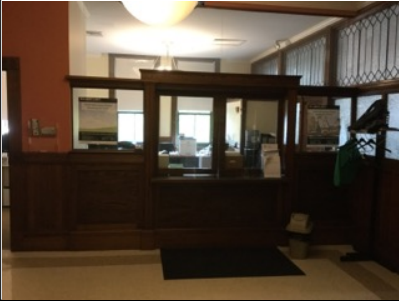
ID	Location	Floor	Room	Element	Type	Photo	Issues	Current Measure	Recommendations	Quantity	Price	Cost Estimation
Service Counter												
36	Town Administrator's	1		Service Counter	N/A

Surface not stable, firm, and slip-resistant	-	Secure the mat.	1	Labor	\$0
Operable Parts												
37	Select Board Meeting Room	1		Operable Parts	Clothes Rod/Hooks

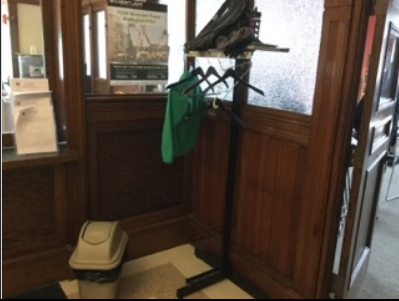
Reach < 15" or > 48"(forward/side approach)	61"	Provide a clothes rack that is located no higher than 48" above the finished floor.	1	100	\$100
Dining or Work Surfaces												
38	Select Board Meeting Room	1		Dining or Work Surfaces	Work Surface

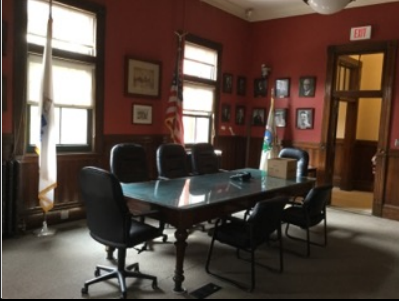
Knee or toe clearance not provided	24"	Provide at least 1 work surface with 27" min. knee and toe clearance.	1	1100	\$1100
39	Human Resources Director	2F		Dining or Work Surfaces	Work Surface

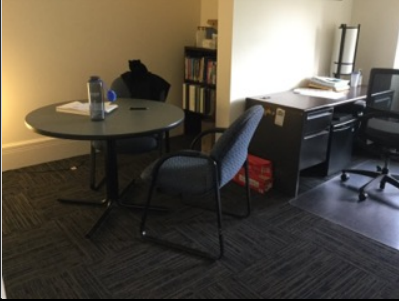
Knee or toe clearance not provided	-	Provide at least 1 work surface with toe clearance.	1	700	\$700

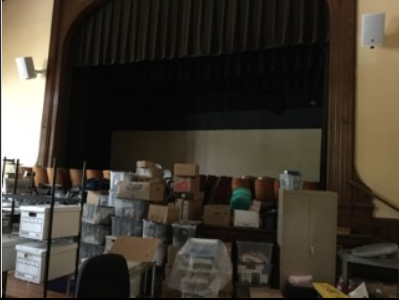
Assembly Area												
40	Auditorium	1		Assembly Area	N/A

Assistive listening devices not provided	-	If audible communication is integral to the use of the space, provide an assistive listening system and signage notifying visitors of the assistive listening system. (Cost estimate for capacity of 250 people.)	1	3941	\$3941

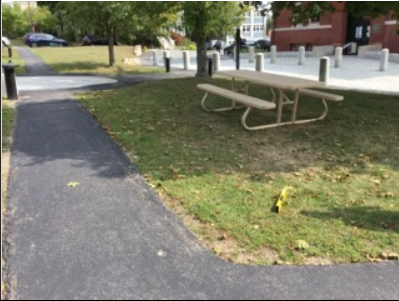
ID	Location	Floor	Room	Element	Type	Photo	Issues	Current Measure	Recommendations	Quantity	Price	Cost Estimation
Picnic Tables												
41	Shaded Picnic Area	Ext.		Picnic Tables	N/A

Picnic table not on an accessible route	-	Ensure that the dining surface is connected to an accessible route. (Cost estimate for a 10' long by 4' wide asphalt route to the picnic table.)	1	400	\$400
42	Sunny Picnic Area on Concord Avenue	Ext.		Picnic Tables	N/A

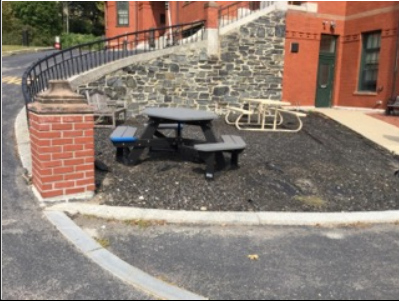
Picnic table not on an accessible route	-	Ensure that the dining surface is connected to an accessible route. (Cost estimate for a 15' long by 4' wide asphalt route to the picnic table.)	1	600	\$600
Exterior Benches												
43	Sunny Picnic Area on Concord Avenue	Ext.		Exterior Benches	N/A

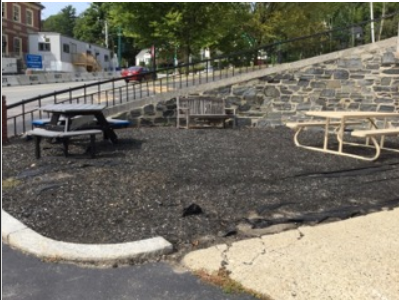
No accessible route to one bench in area	-	Provide an accessible route to the bench. (Cost estimate for a 20' long by 4' wide asphalt route.) Alternatively relocate the bench.	1	800	\$800

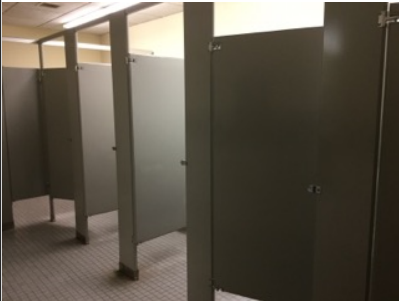
Toilet & Bathing Rooms												
Overall Access												
44	Women's Toilet Room	G		Overall Access	Toilet Room

6 fixtures, but no ambulatory compartment provided	-	Provide one ambulatory accessible compartment.	1	3012	\$3012

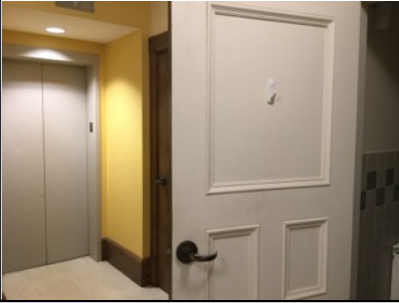
ID	Location	Floor	Room	Element	Type	Photo	Issues	Current Measure	Recommendations	Quantity	Price	Cost Estimation
Single-User Toilet												
45	Single-User Toilet Room	2F		Single-User Toilet	N/A

Hook located > 48" high	65.5"	Locate hook no higher than 48" above the finished floor.	1	150	\$150
Toilet Compartment												
46	Women's Toilet Room	G		Toilet Compartment	Accessible Compartment

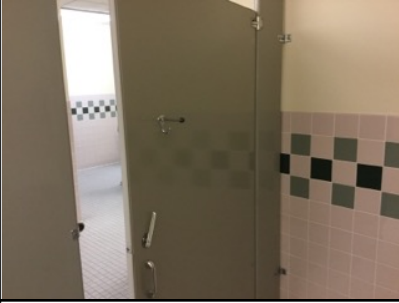
Door has malfunctioning self-closing hinge	-	Repair hinge.	1	Labor	\$0
47	Men's Toilet Room	G		Toilet Compartment	Accessible Compartment

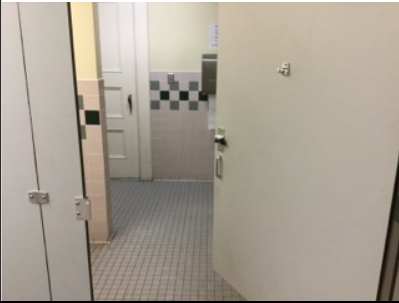
Coat hook > 48"	55.25"	Lower coat hook so that it is no higher than 48".	1	150	\$150
Dispensers												
48	Single-User Toilet Room	2F		Dispensers	Paper Towel Dispenser

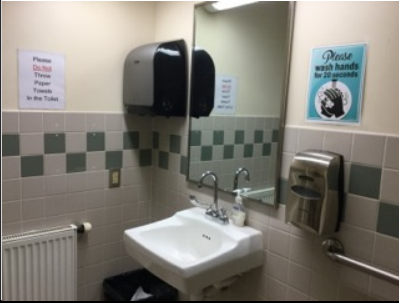
Controls > 42" high Not operable with a closed fist	55.5 -	Relocate so the operable part is 42" max. above the finished floor. Provide a dispenser that can be operable with one hand and not require tight grasping, pinching, or twisting of the wrist.	1	1353	\$1353

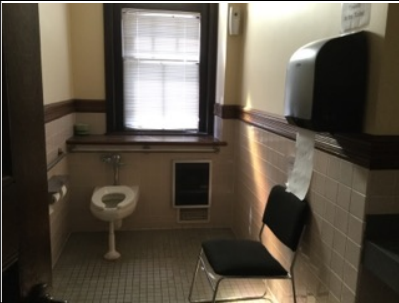
49	Women's Toilet Room on Southwest	1		Dispensers	Paper Towel Dispenser

Dispenser acts as a protruding object	-	Relocate paper towel dispenser out of the circulation path.	1	256	\$256

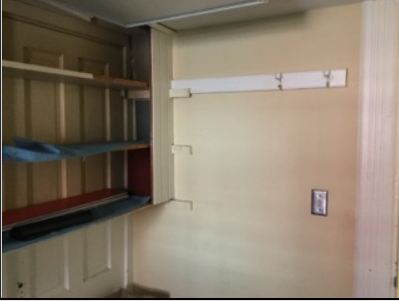
ID	Location	Floor	Room	Element	Type	Photo	Issues	Current Measure	Recommendations	Quantity	Price	Cost Estimation
Changing Rooms												
50	Dressing Room 3	B		Changing Rooms	N/A

Bench not provided Hook > 48" high	- 68"	Provide a 48" long 24" wide accessible bench with clear floor space alongside it within the room. Locate hook no higher than 48" above the finished floor.	1	350	\$350
Additional Access												
Drinking Fountains												
51	Corridor by Town Clerk	G		Drinking Fountains	Low

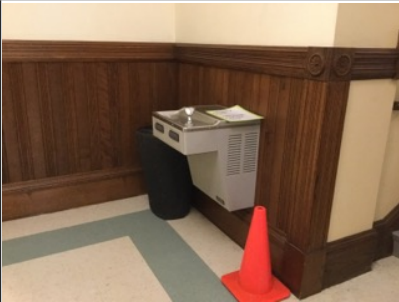
Inadequate water flow No drinking fountain provided for standing users	- -	Repair drinking fountain to provide adequate water flow. Provide an additional drinking fountain for standing users.	1	Labor 4028	\$4028
52	Corridor by West Side Toilet Rooms	1		Drinking Fountains	Low

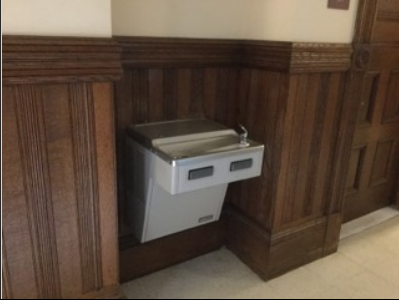
No drinking fountain provided for standing users	-	Provide an additional drinking fountain for standing users.	1	4028	\$4028

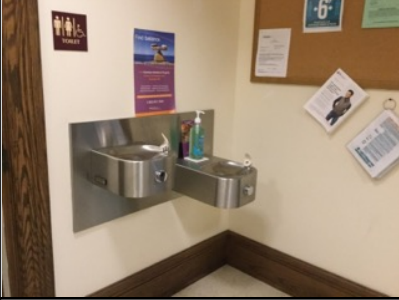
53	Outside Human Resources	2F		Drinking Fountains	Hi-Lo

Standing height fountain does not have cane protection	33"	Provide a cane-detectable barrier skirt under the high unit.	1	890	\$890
Best Practice

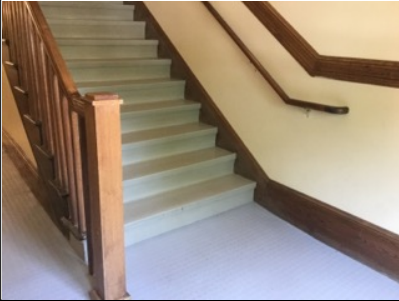
ID	Location	Floor	Room	Element	Type	Photo	Issues	Current Measure	Recommendations	Quantity	Price	Cost Estimation
54	Stair 1	1

Recommend providing contrasting strips on stair treads.	1	-	\$0
55	Select Board Meeting Room	1

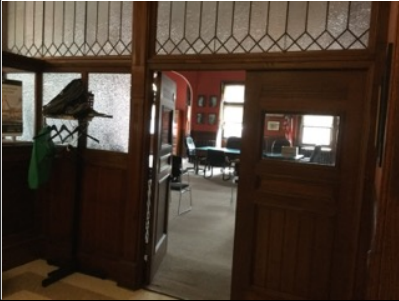
Recommend providing a sign at permanent rooms where no sign is provided.	1	-	\$0
56	Northwest Exits	1

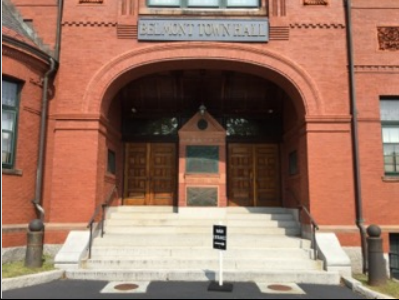
Recommend providing handrail extensions that extend 12" past the bottom stair at exterior stairs.	1	-	\$0
57	Stair to Stage	1

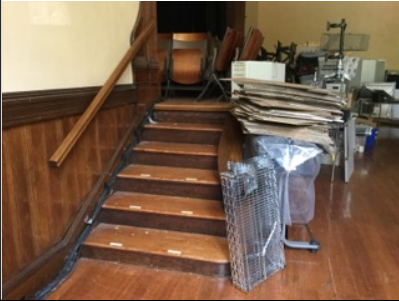
Recommend providing a second handrail.	1	-	\$0
58	Stairs to Dressing Rooms	B

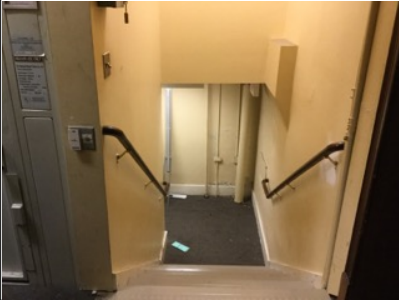
Recommend providing contrast strips on the stair treads to improve visibility of the stairs.	1	-	\$0

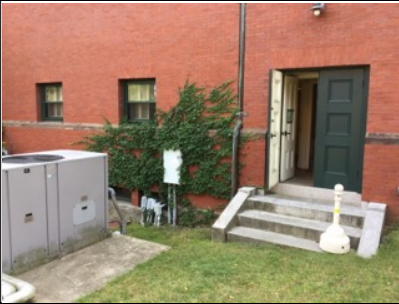
ID	Location	Floor	Room	Element	Type	Photo	Issues	Current Measure	Recommendations	Quantity	Price	Cost Estimation
59	Egress From Dressing Room Level	B

Recommend providing handrails at exterior stair.	1	-	\$0
60	Shaded Picnic Area	Ext.

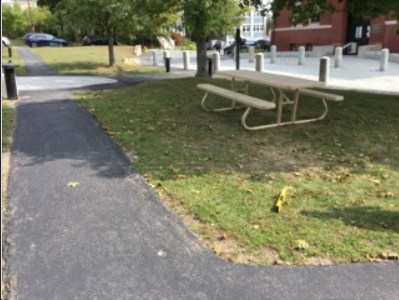
-	Recommend providing a 48" wide stable, firm and slip resistant walking surface around picnic tables.	1	-	\$0
61	Exterior Bench	Ext.

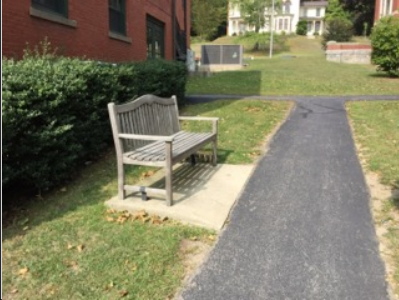
Recommend providing clear floor space alongside bench so that a wheelchair user can sit shoulder to shoulder with a person seated at the bench.	1	-	\$0
62	Main Entrance (East Side)	G

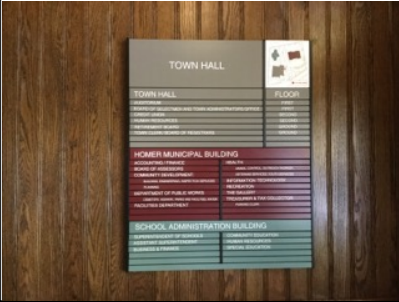
Recommend providing increased contrast at the directory sign.	1	-	\$0
63	Directory by Elevator	G

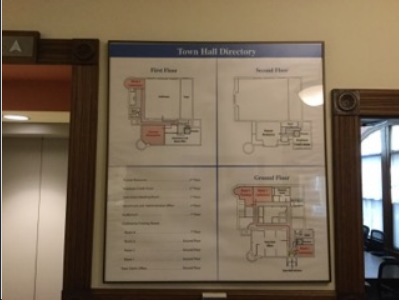
This is a good example of wayfinding signage.	1	-	\$0

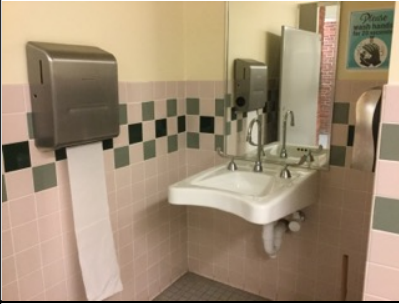
ID	Location	Floor	Room	Element	Type	Photo	Issues	Current Measure	Recommendations	Quantity	Price	Cost Estimation
64	Women's Toilet Room	G

Good example of an accessible lavatory in an accessible toilet compartments. Lavatories in the open area are compliant as well.	1	-	\$0
65	Corridor	G

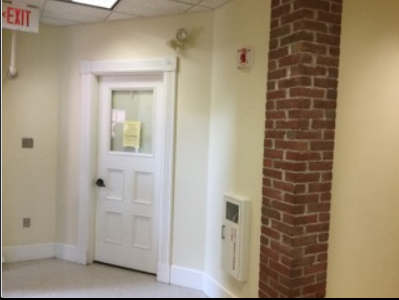
Good example of a recessed fire extinguisher.	1	-	\$0
