# Underwood Park

## Town of Belmont ADA Transition Plan

August 2021

Institute for Human Centered Design

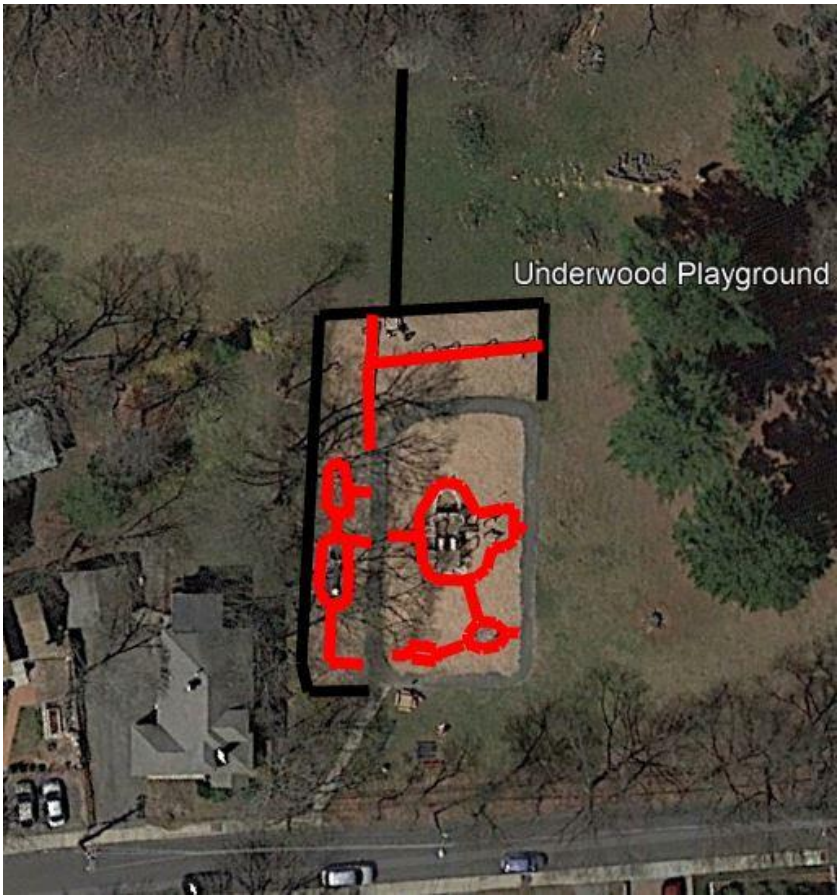
Accessibility issues include lack of an accessible route around the playgrounds with the swings and slides. There is also a lack of an impact attenuating accessible route to the play components inside the boundary of the playgrounds. See the following diagram depicting accessible routes around the playgrounds (in black) and to the play components in the playgrounds (in red). The route to the tetherball court is also shown:

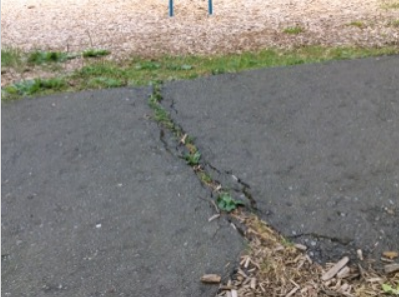
ID	Location	Floor	Room	Element	Type	Photo	Issues	Current Measure	Recommendations	Quantity	Price	Cost Estimation
Approach and Entrance												
Exterior Access Route												
1	Walkway by South Playground	Ext.		Exterior Access Route	Walkway

Route not maintained in operable working condition	-	Ensure the accessible route is maintained in operable working condition.	1	160	\$160
2	Sidewalk by Cottage Street Entrance	Ext.		Exterior Access Route	Sidewalk

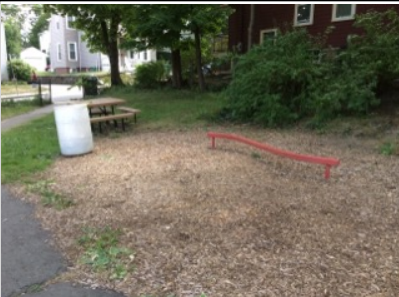
Route not maintained in operable working condition	-	Ensure the sidewalk is maintained in operable working condition.	1	Labor	\$0
3	South Playground Trash Bin	Ext.		Exterior Access Route	Walkway

Accessible route not provided	-	Locate trash bin on an accessible route.	1	Labor	\$0
4	Bike Rack Along Walkway to Cottage Street Entrance	Ext.		Exterior Access Route	Walkway

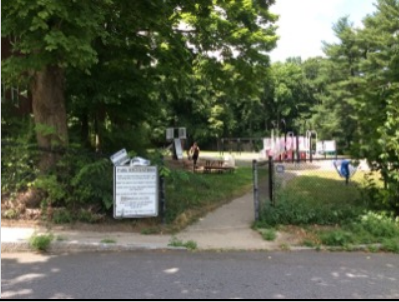
ID	Location	Floor	Room	Element	Type	Photo	Issues	Current Measure	Recommendations	Quantity	Price	Cost Estimation
Signage												
5	Park Entrance Signage	Ext.		Signage	Informational

Visual characters < 40" above ground	-	Mount visual sign so that the baseline of the lowest character is 40" min. above the finished floor.	1	Labor	\$0
Picnic Tables												
6	Main Playground Picnic Table	Ext.		Picnic Tables	N/A

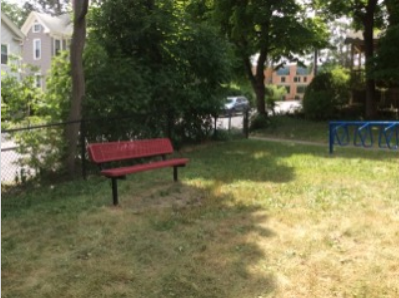
Toe or knee clearance at tables not provided Picnic table not on an accessible route	- -	Provide at least 1 dining surface that has toe and knee clearance. Locate the dining surface on an accessible route.	1	1400	\$1400
Exterior Benches												
7	Bench by Entrance and Bike Rack	Ext.		Exterior Benches	N/A

No accessible route to one bench in area	-	Provide an accessible route to at least one bench in the park. (Cost estimate for a 15' long 4' wide asphalt route to the bench.)	1	600	\$600

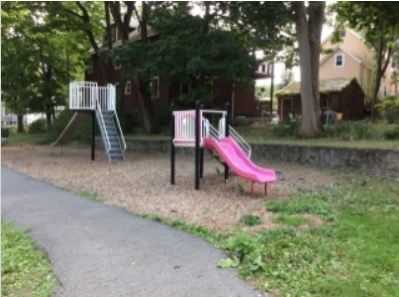
Play and Sport Areas												
Play Areas												
8	South Playground	Ext.		Play Areas	N/A

Accessible route not provided around playground	- -	Provide an accessible route around the play area with the slides and the play area with the swings. (Cost estimate for 256' long 4' wide asphalt route.)	1	10240	\$10240

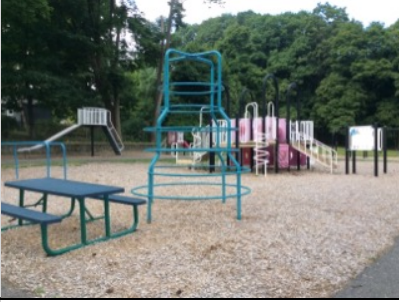
ID	Location	Floor	Room	Element	Type	Photo	Issues	Current Measure	Recommendations	Quantity	Price	Cost Estimation
9	Main Playground	Ext.		Play Areas	N/A

Accessible route not provided to play components	-	Provide a compliant impact-attenuating surface to and around the play components. (Cost estimate for 1300 sq. ft. of poured in place rubber surface.)	1	18200	\$18200
10	Bucket Swings	Ext.		Play Areas	N/A

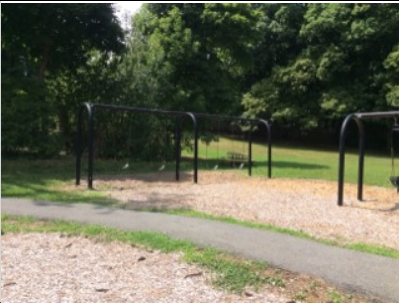
Accessible route not provided to play components	- -	Provide a compliant impact-attenuating surface to and around the play components. (Cost estimate for 456 sq. ft. of poured in place rubber surface.)	1	6384	\$6384
11	Standard Swings	Ext.		Play Areas	N/A

Accessible route not provided to play components	- -	Provide a compliant impact-attenuating surface to and around the play components. (Cost estimate for 174 sq. ft. of poured in place rubber surface.)	1	2436	\$2436
12	South Playground, Slide for Young Children	Ext.		Play Areas	N/A

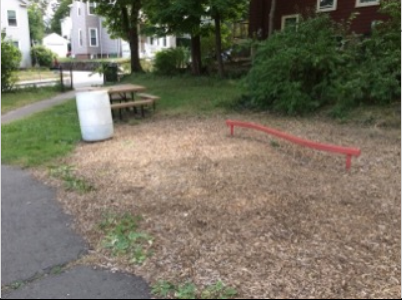
ID	Location	Floor	Room	Element	Type	Photo	Issues	Current Measure	Recommendations	Quantity	Price	Cost Estimation
14	South Playground, Balance Beam	Ext.		Play Areas	N/A

Accessible route not provided to play components	-	Provide a compliant impact-attenuating surface to and around the play components. (Cost estimate for 168 sq. ft. of poured in place rubber surface.)	1	2354	\$2354
Court												
15	Tetherball Court	Ext.		Court

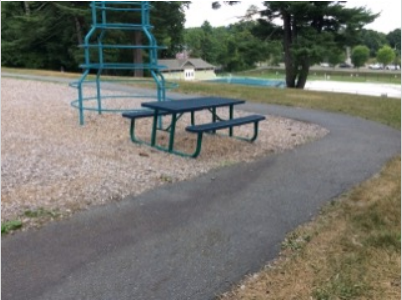
Court is not connected to an accessible route	-	Provide an accessible route to the court. (Cost estimate for 84 ft long 4' wide stone dust route.)	1	2688	\$2688
Best Practice												
16	Main Playground Picnic Table	Ext.

-	Recommend providing a 48" wide min. stable, firm and slip resistant surface under and around an accessible picnic table once it is placed in the picnic area and connected to an accessible route.	1	-	\$0
17	Bench by Entrance and Bike Rack	Ext.
