Underwood Pool and Bathhouse

Town of Belmont ADA Transition Plan

October 2020

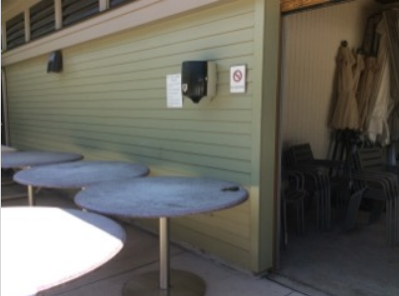
Obstructed by protruding objects Reach < 15" or > 48"(forward/side approach)	9" 54"	Relocate paper towel dispenser out of the circulation path and locate so that controls are between 15"- 48" above the finished floor.	1	256	\$256
2	Sidewalk by Main Entrance to Pool	Ext.		Exterior Access Route	Sidewalk

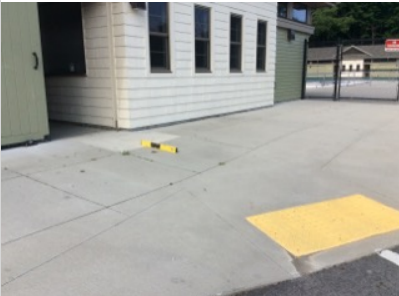
Cross slope > 1:50 (2.00%)	6.2%	Reduce cross slope to be no steeper than 1:50 (2.00%). (Cost to demolish and rebuild 10' long concrete sidewalk.)	1	1250	\$1250
3	Sidewalk by Parking Lot on Cottage Street	Ext.		Exterior Access Route	Sidewalk

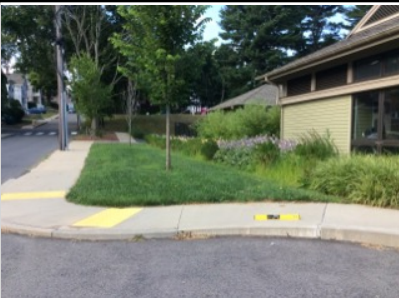
Running slope > 1:20 (5%)	7.9%	Reduce running slope to be no steeper than 1:20 (5%). (Cost to demolish and rebuild 10' long concrete sidewalk.)	1	1250	\$1250

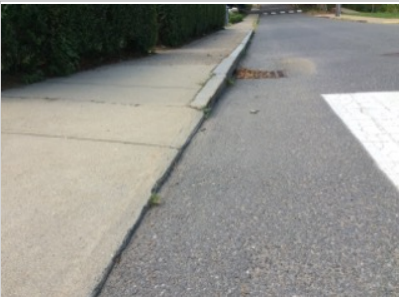
Curb Ramp												
4	Crosswalk Across Cottage Street From the Pool	Ext.		Curb Ramp	N/A

Transition from curb ramp to street not flush	1"	Ensure transition from curb ramp to street is flush or free of changes in level.	1	170	\$170
5	Sidewalk	Ext.		Curb Ramp	N/A

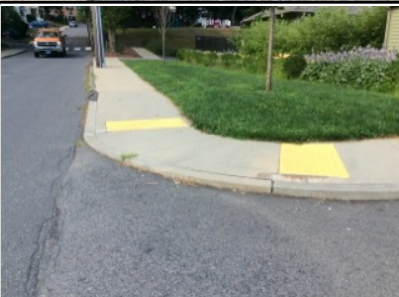
Transition from curb ramp to street not flush	1.5"	Ensure transition from curb ramp to street is flush or free of changes in level.	1	170	\$170

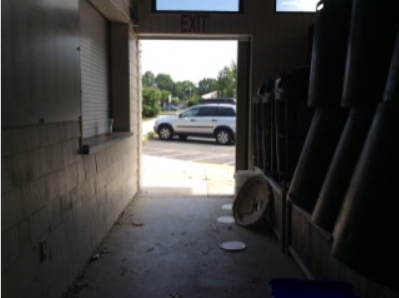
ID	Location	Floor	Room	Element	Type	Photo	Issues	Current Measure	Recommendations	Quantity	Price	Cost Estimation
Emergency Exit												
6	Main Entrance to Pool (Egress Doorway)	1		Emergency Exit	N/A

Tactile sign not provided at exit Illuminated Int. Symbol of Acc. not provided (MAAB)	- -	Provide tactile exit signs with raised characters and braille at exit doors. Mount signs between 48"- 60" above the finished floor located on the latch side of the door. Provide an illuminated sign with the International Symbol of Accessibility.	1	1116	\$1116
7	Men's and Women's Bathhouses Egress to Front	1		Emergency Exit	N/A

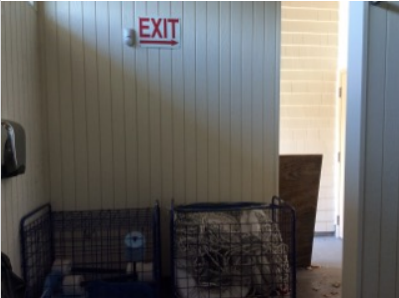
Tactile sign not provided at exit Illuminated Int. Symbol of Acc. not provided (MAAB)	- -	Provide tactile exit signs with raised characters and braille at exit doors. Mount signs between 48"- 60" above the finished floor located on the latch side of the door. Provide an illuminated sign with the International Symbol of Accessibility.	2	1116	\$2232

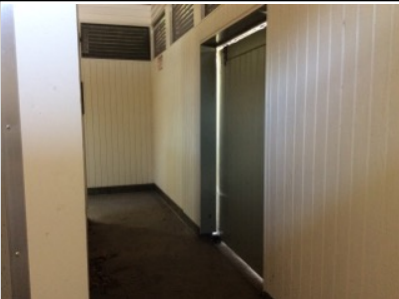
8	Men's and Women's Bathhouses Egress to Side (By Compartments)	1		Emergency Exit	N/A

Tactile sign not provided at exit Illuminated Int. Symbol of Acc. not provided (MAAB)	- -	Provide tactile exit signs with raised characters and braille at exit doors. Mount signs between 48"- 60" above the finished floor located on the latch side of the door. Provide an illuminated sign with the International Symbol of Accessibility.	2	1116	\$2232
9	Egress to Pool Deck	Ext.		Emergency Exit	N/A

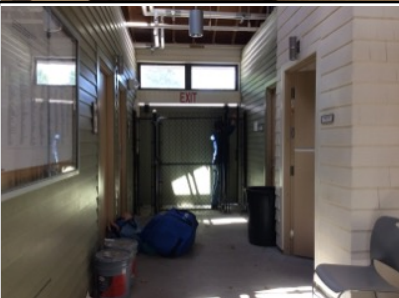
Tactile sign not provided at exit Illuminated Int. Symbol of Acc. not provided (MAAB)	- -	Provide tactile exit signs with raised characters and braille at exit doors. Mount signs between 48"- 60" above the finished floor located on the latch side of the door. Provide an illuminated sign with the International Symbol of Accessibility.	1	1116	\$1116
Access to Goods and Services												
Interior Access Route

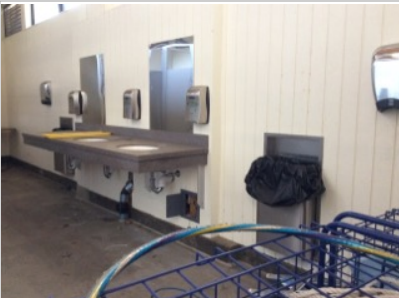
10	Men's Bathhouse Toilet Room	1		Interior Access Route	N/A

Obstructed by protruding objects	24"	Provide a cane-detectable barrier at each side of the lavatories.	2	306	\$612

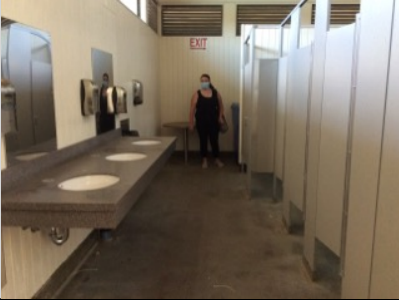
ID	Location	Floor	Room	Element	Type	Photo	Issues	Current Measure	Recommendations	Quantity	Price	Cost Estimation
11	Women's Bathhouse Toilet Room	1		Interior Access Route	N/A

Obstructed by protruding objects	24"	Provide a cane-detectable barrier at each side of the lavatories.	2	306	\$612
Doors, Doorways, & Gates												
12	Pool Entrance Gate	Ext.		Doors, Doorways, & Gates	Circulation

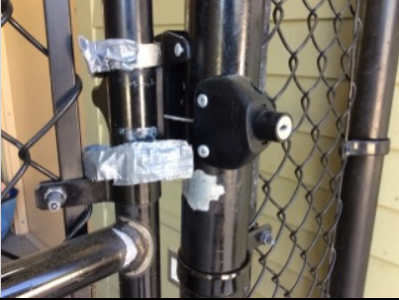
Hardware not operable with a closed fist	-	Provide ADA compliant gate hardware that can be operable with one hand and not require tight grasping, pinching, or twisting of the wrist.	1	484	\$484
13	Pool Entrance Gate	Ext.		Doors, Doorways, & Gates	Circulation

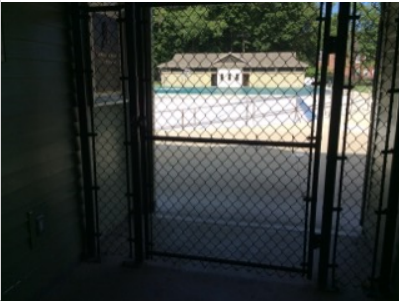
10" solid surface not provided	-	Swinging door and gate surfaces within 10 inches of the finished floor or ground measured vertically shall have a smooth surface on the push side extending the full width of the door or gate.	1	316	\$316
Signage

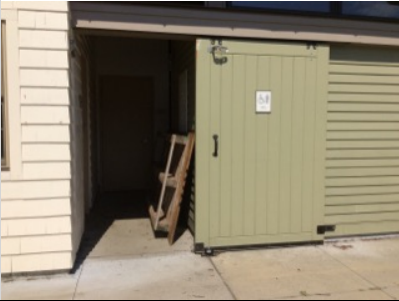
14	Men's Bathhouse	Ext.		Signage	Designation

Sign not located on the latch side of the door	-	Locate sign at permanent rooms alongside the door on the latch side.	1	Labor	\$0
15	Women's Bathhouse	Ext.		Signage	Designation

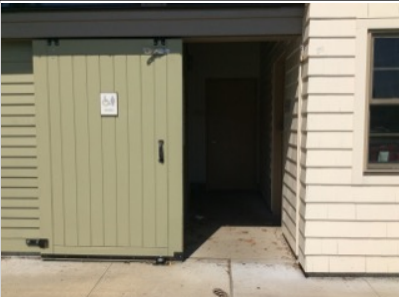
Sign not located on the latch side of the door	-	Locate sign at permanent rooms alongside the door on the latch side.	1	Labor	\$0

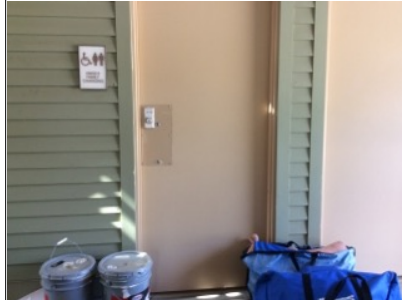
ID	Location	Floor	Room	Element	Type	Photo	Issues	Current Measure	Recommendations	Quantity	Price	Cost Estimation	
16	Accessible Single-User Family Changing Rooms by the Main Entrance	1		Signage	Designation

Sign is not compliant	-	Due to the inadequate size of clear floor space at the transfer showers and the lack of a compliant bench, the four changing rooms by the entrance are not compliant. IHCD recommends making one single-user toilet room fully compliant and providing designation signage at the other three that does not have the International Symbol of Accessibility (ISA). (Cost for 3 signs.)	3	232	\$696	
Service Counter													
17	First Aid Room	1		Service Counter	N/A

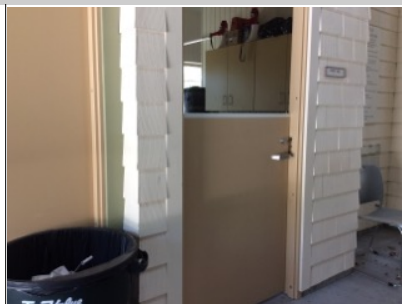
Counter > 36" high	49"	Provide a call button adjacent to the latch side of the door within the appropriate reach ranges indicating assistance is available by ringing the bell, with the International Symbol of Accessibility.	1	400		\$400

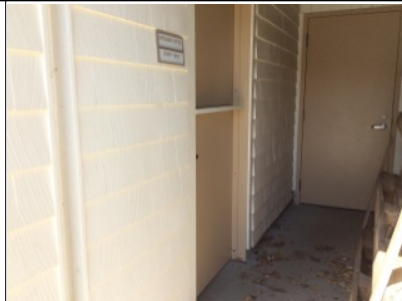
18	Lifeguard Office on Men's Bathhouse Side	1		Service Counter	N/A

Counter > 36" high	49"	Provide a call button adjacent to the latch side of the door within the appropriate reach ranges indicating assistance is available by ringing the bell, with the International Symbol of Accessibility.	1	400		
19	Lifeguard Office on Women's Bathhouse Side	1		Service Counter	N/A

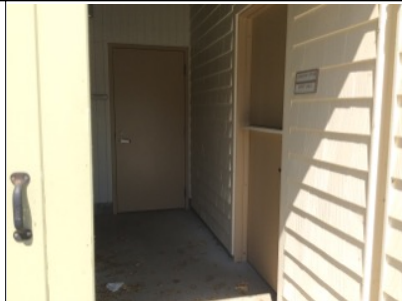
Counter > 36" high	49"	Provide a call button adjacent to the latch side of the door within the appropriate reach ranges indicating assistance is available by ringing the bell, with the International Symbol of Accessibility.	1	400		\$400
Locker Room													
20	Accessible Single-User Family Changing Room 1 Near the Main Entrance	1		Locker Room

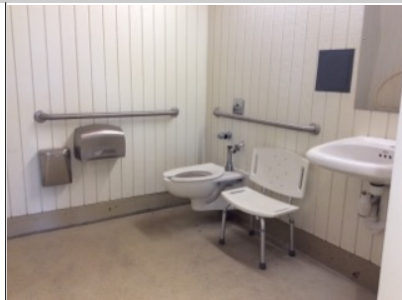
Bench < 48" long	-	Renovate one of the single-user shower/changing rooms by the entrance to provide a fixed bench that is 48" long for changing. Benches must be strong enough to withstand a vertical or horizontal force of 250 pounds applied at any point on the seat, fastener, mounting device, or supporting structure. A 30" wide clear floor space is required alongside the bench.	1	200	\$200

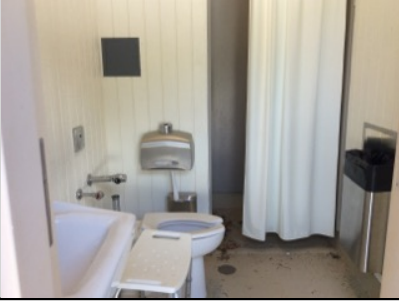
ID	Location	Floor	Room	Element	Type	Photo	Issues	Current Measure	Recommendations	Quantity	Price	Cost Estimation
Overall Access												
21	Single-User Family Changing and Shower Room with Direct Access to the Pool Deck	1		Overall Access	Bathing Room

Accessible plumbing fixtures or stalls not provided Sign to accessible toilet not provided	- -	Toilet room clear floor space at the toilet does not comply with 521 CMR, toilet lacks room for grab bar on the side wall and the transfer shower lacks required clear floor space. Provide a directional sign indicating the location of the nearest accessible bathing room and provide a designation sign at the toilet room that does not contain the International Symbol of Accessibility (ISA).	2	232	\$464
Lavatory												
22	Men's Bathhouse Toilet Room	1		Lavatory	N/A

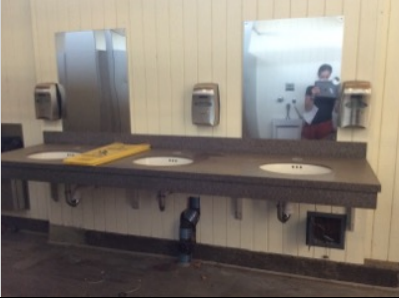
Plumbing underneath is exposed	-	Insulate or otherwise configure pipes to prevent contact for at least one lavatory.	1	92	\$92

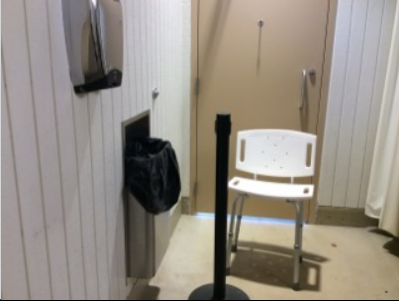
Single-User Toilet												
23	Accessible Single-User Family Changing Room 1 Near the Main Entrance	1		Single-User Toilet	N/A

Hook located > 48" high	60"	Locate hook no higher than 48" above the finished floor.	1	150	\$150
Toilet Compartment												
24	Men's Bathhouse Toilet Room	1		Toilet Compartment	Accessible Compartment

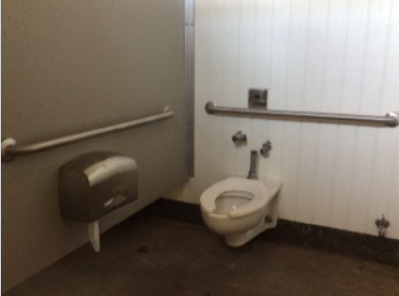
Coat hook > 48"	54"	Lower coat hook so that it is no higher than 48".	1	150	\$150

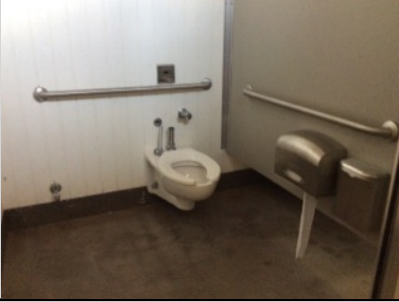
ID	Location	Floor	Room	Element	Type	Photo	Issues	Current Measure	Recommendations	Quantity	Price	Cost Estimation
25	Women's Bathhouse Toilet Room	1		Toilet Compartment	Accessible Compartment

Coat hook > 48"	53"	Lower coat hook so that it is no higher than 48".	1	150	\$150
Urinal												
26	Men's Bathhouse Toilet Room	1		Urinal	N/A

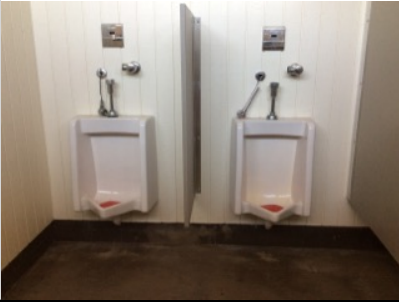
Flush control too high or not properly located	52"	Mount flush control at 44" max. above the finished floor at one urinal.	1	500	\$500
Dispensers												
27	Accessible Single-User Family Changing Room 1 Near the Main Entrance	1		Dispensers	Hand Dryer

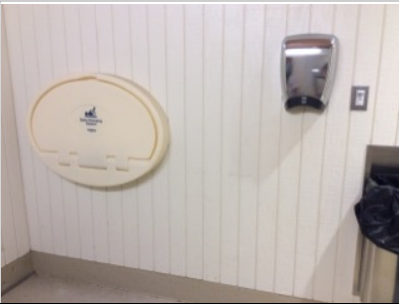
Controls > 42" high	47"	Relocate hand dryer so the operable part is 42" max. above the finished floor.	1	256	\$256
Shower Compartment												
28	Accessible Single-User Family Changing Room 1 Near the Main Entrance	1		Shower Compartment	Transfer Type

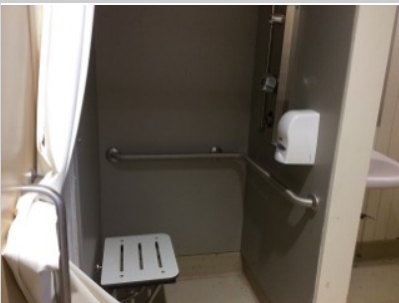
Clear space at transfer shower > 48" x 36" Grab bars mounted in wrong location Seat is not padded (MAAB)	- - -	Renovate one of the single-user shower/changing rooms by the entrance to provide a 48" x 36" clear floor space for a transfer shower. Ensure grab bars are not provided over the seat. Provide a padded shower seat.	1	6072	\$6072

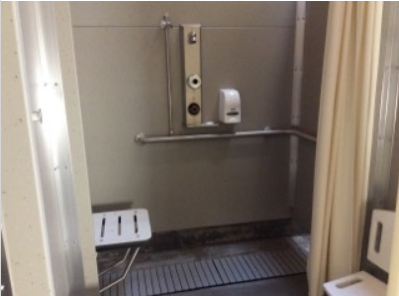
29	Men's Bathhouse and Women's Bathhouse Accessible Shower	1		Shower Compartment

Seat is not padded (MAAB) Side edge of seat > 1-1/2" from the adjacent wall	- -	Provide a padded shower seat. Locate the side edge of the seat so that it is 1-1/2" max. from the adjacent wall.	2	600	\$1200

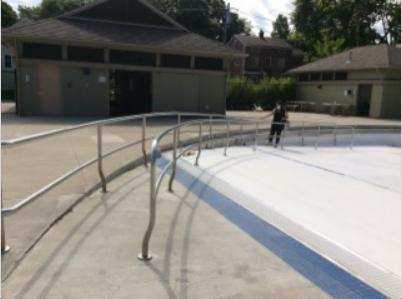
ID	Location	Floor	Room	Element	Type	Photo	Issues	Current Measure	Recommendations	Quantity	Price	Cost Estimation
Play and Sport Areas												
Swimming Pool												
30	Family Pool With Zero Depth Sloped Entry	Ext.		Swimming Pool	Sloped Entry

The circular ramp that provides an accessible entrance into this pool has a cross slope that is steeper than allowed.

Cross slope > 1:50 (2.00%)	6%	Reduce cross slope to be no steeper than 1:50 (2.00%). (Cost beyond project scope.)	1	Cost beyond project scope	\$0
Overall Review												
31	Lap Swimming and Diving Pool	Ext.

*** Note:** Cost does not include the cost to renovate the ramp into the zero-depth entry pool as this will require further research.

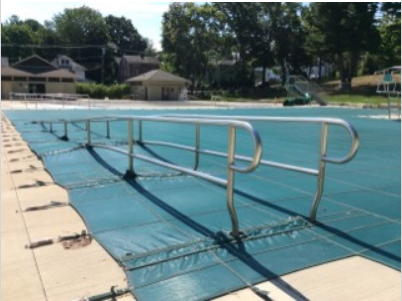
Note: Pool entry unable to be fully surveyed.	1	-	\$0
Best Practice												
32	Accessible Single-User Family Changing Room 1 Near the Main Entrance	1

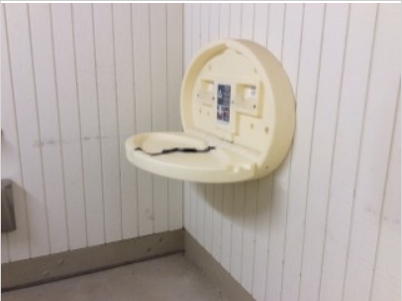
The baby changing tables are mounted at an accessible height.	1	-	\$0
33	Parking Lot	Ext.

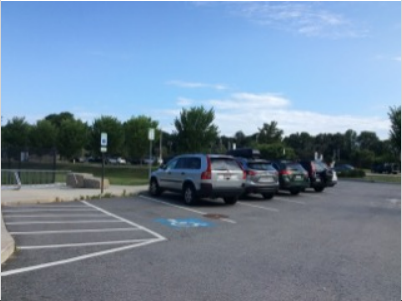
Parking lot has a compliant van accessible parking space.	1	-	\$0
