# Winn Brook Park

## Town of Belmont ADA Transition Plan

August 2021

Institute for Human Centered Design

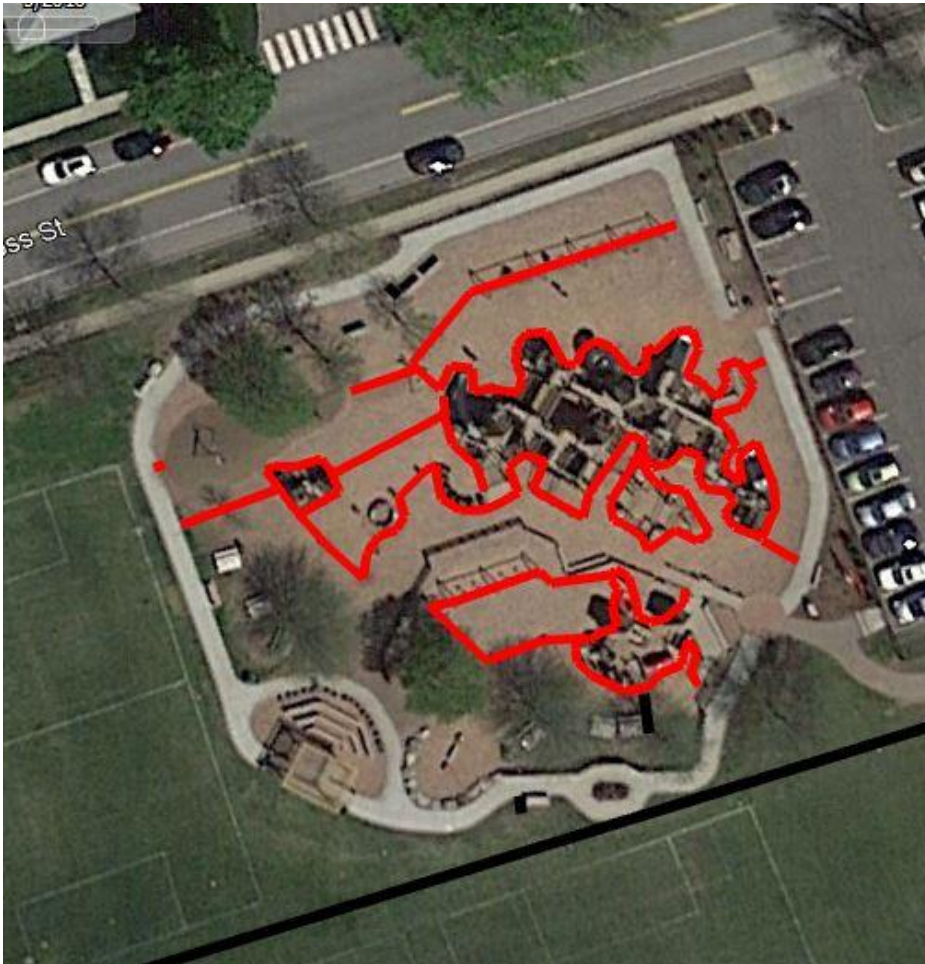
Accessibility issues include a lack of an impact attenuating accessible route to the play components inside the boundary of the playgrounds. In addition, play areas are not maintained in operable working condition due to wood chips that have infilled part of the accessible walkway. See the following diagram

illustrating accessible routes to and around the play components within the playgrounds (in red).

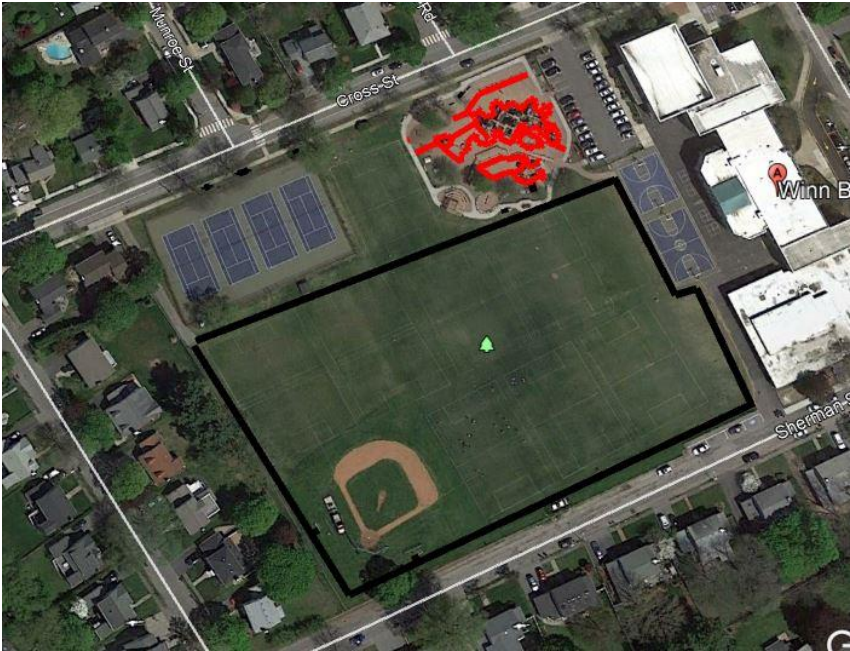
There is no accessible route connecting all areas of sport activity, including the baseball field, soccer fields, tennis courts and basketball courts. In addition, there is no accessible route to the team seating areas and there is a lack of clear floor space alongside the team benches in the baseball field. See the following diagram that illustrates a proposed route connecting all areas of sport activity in black:

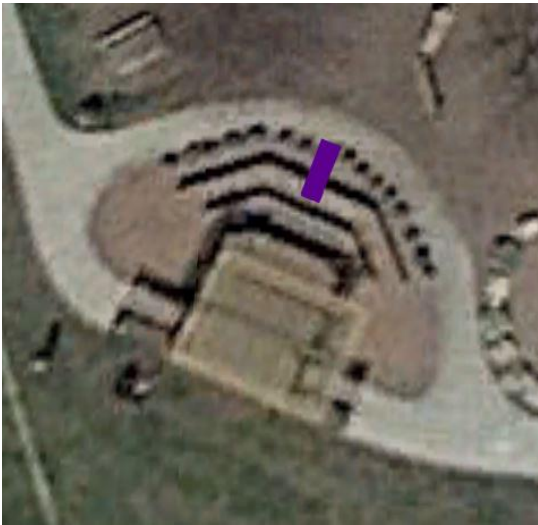
- Lack of a directional sign at the inaccessible entrance to the playground.
- Lack of maneuvering clearance with a slope of 1:50 (2%) max. at the Cross Street entrance to the park.
- Lack of an accessible route to one bench in each area.
- Lack of a wheelchair space in the seating area in front of the stage. See following diagram showing the recommended location of the wheelchair space in purple:

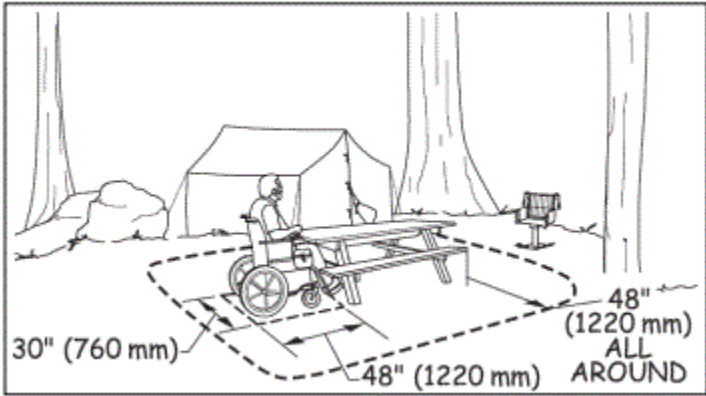
- Recommend providing benches at tennis courts.
- As the rise to the stage is less than 6", handrails are not required, but for greater access consider providing circular handrails located between 34" - 38" high and between 18" - 20" high with 12" extensions at the top and bottom of the ramp run.
- Recommend providing a 48" wide min. stable, firm and slip resistant surface under and around accessible picnic tables. See the following diagram:

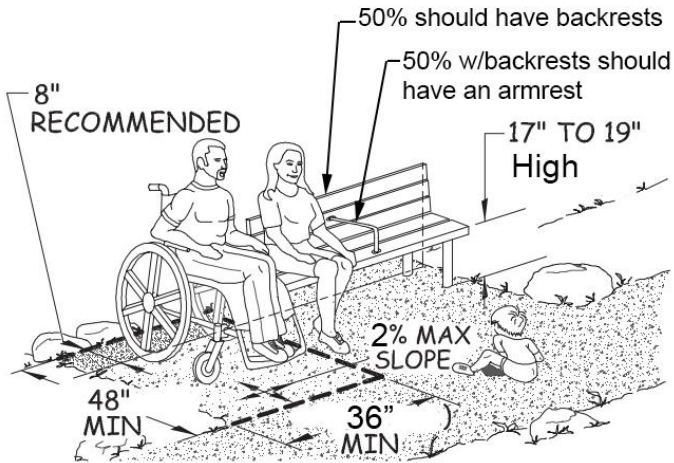
- Recommend providing clear floor space of 36" wide minimum by 48" deep alongside one bench so that a wheelchair user can sit alongside someone sitting on the bench. See the following diagram:

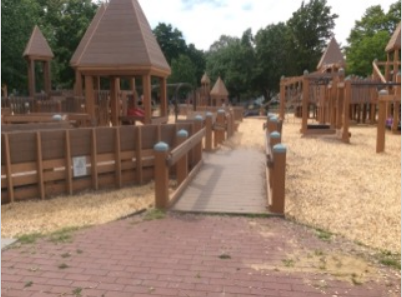
ID	Location	Floor	Room	Element	Type	Photo	Issues	Current Measure	Recommendations	Quantity	Price	Cost Estimation
Approach and Entrance												
Exterior Access Route												
1	Tot Lot	Ext.		Exterior Access Route	Walkway

Level changes > 1/4"	1.25"	Alter change in level at the base of the ramp to be 1/4" high max.	1	256	\$256
2	Playground Walkway	Ext.		Exterior Access Route	Walkway

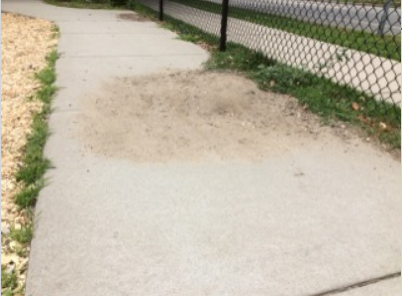
Route not maintained in operable working condition	-	Ensure the accessible route is maintained in operable working condition and kept clear of sand.	1	Labor	\$0
3	Playground Walkway	Ext.		Exterior Access Route	Walkway

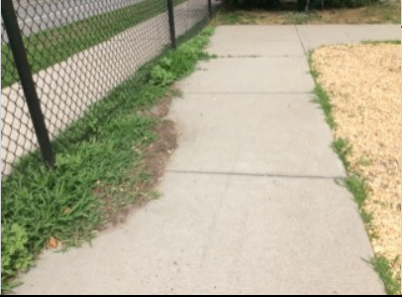
Route not maintained in operable working condition	-	Ensure the accessible route is maintained in operable working condition and kept clear.	1	Labor	\$0
4	Playground Entrance	Ext.		Exterior Access Route	Walkway

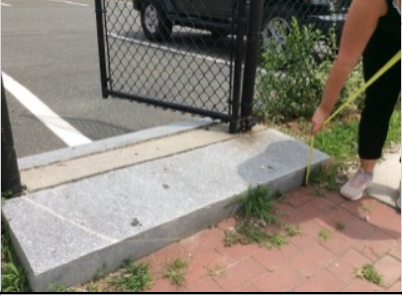
Accessible route not provided	4.5"	Provide an accessible route. (Cost estimate for a 6' long sloped concrete path with a level landing.)	1	384	\$384

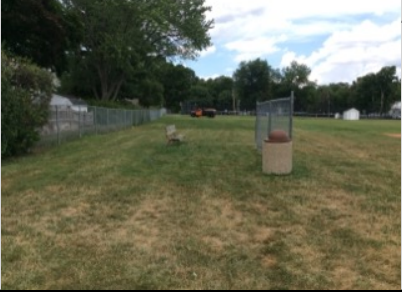
5	Baseball Diamond Trash Bin	Ext.		Exterior Access Route	Exterior

Accessible route not provided	-	Relocate the trash bin on the new accessible route.	1	Labor	\$0

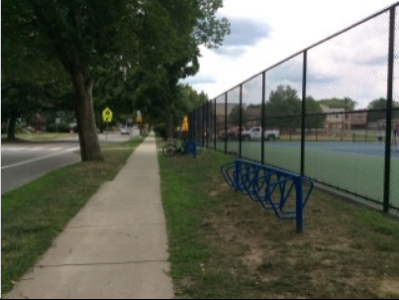
ID	Location	Floor	Room	Element	Type	Photo	Issues	Current Measure	Recommendations	Quantity	Price	Cost Estimation
6	Cross Street Sidewalk	Ext.		Exterior Access Route	Exterior

Accessible route not provided	-	Provide an accessible route to each bike rack. (Cost estimate based on 46 square ft. of stone dust.)	1	368	\$368
7	Playground Walkway Trash Bin	Ext.		Exterior Access Route	Exterior	 	Accessible route not provided	-	Relocate the trash bin to the edge of the path.	1	Labor	\$0
8	Playground Walkway Facing Basketball Court	Ext.		Exterior Access Route	Exterior

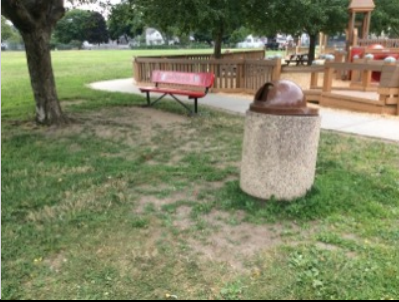
Accessible route not provided	-	Ensure an accessible route is provided to the trash bin. (Cost estimate for a 6' long 4' wide concrete route.)	1	384	\$384
Curb Ramp												
9	Parking Lot to Basketball Court	Ext.		Curb Ramp	N/A

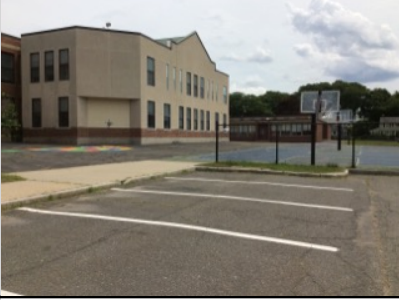
Curb ramp not provided	6"	Provide a curb ramp at intersection. (Cost estimate for a concrete curb ramp.)	1	2800	\$2800

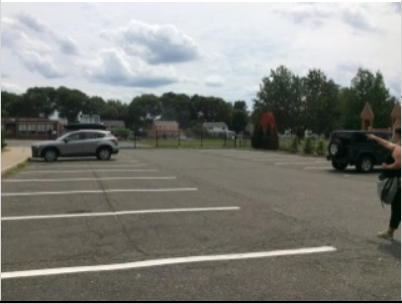
ID	Location	Floor	Room	Element	Type	Photo	Issues	Current Measure	Recommendations	Quantity	Price	Cost Estimation
Off-Street Parking Lot or Garage												
11	Parking Lot	Ext.		Off-Street Parking Lot or Garage	Visitor

Total # of parking Total # of designated accessible parking spaces Total # of designated van accessible spaces	28 0 0	Provide one car accessible parking space and one van accessible parking space.	2	800	\$1600
Entrance												
12	Stepped Playground Entrance	Ext.		Entrance	Secondary Entrance

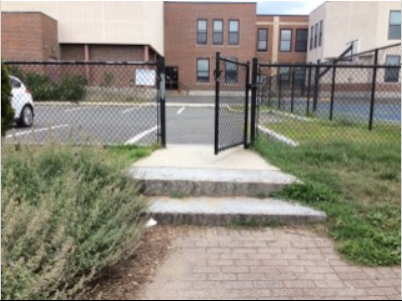
Entrance not on an accessible route Directional sign to accessible entrance not provided	- -	Provide a directional sign indicating the location of the nearest accessible entrance at the exterior of the gate. .	1	346	\$346
13	Cross Street Park Entrance	Ext.		Entrance	Secondary Entrance

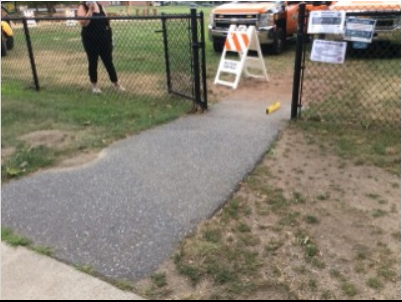
Maneuvering clearance at door > 1:50 (2.00%)	9.1%	Alter so that the slope in all directions is no greater than 1:50 (2.00%) at the gate.	1	360	\$360

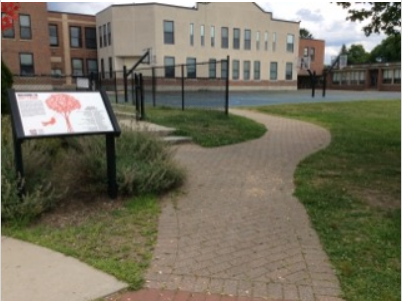
Access to Goods and Services												
Signage												
14	Playground Entrance	Ext.		Signage	Informational

Signage not located on an accessible route	-	Provide an accessible route to the sign. (Cost estimate for a 6' long, 4' wide concrete route.)	1	384	\$384

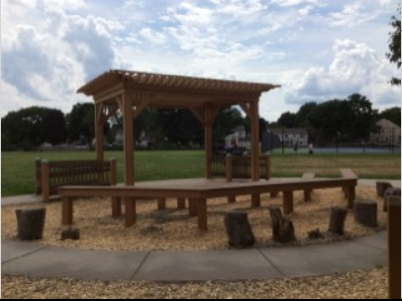
ID	Location	Floor	Room	Element	Type	Photo	Issues	Current Measure	Recommendations	Quantity	Price	Cost Estimation
Assembly Area												
15	Stage	Ext.		Assembly Area	N/A

Minimum # wheelchair spaces not provided Wheelchair spaces not on accessible route	- -	Provide one wheelchair accessible space with an accessible route to it. (Recommended location would be in the center of the back row.)	1	300	\$300
Picnic Tables												
16	Playground Walkway on the Northeast Side	Ext.		Picnic Tables	N/A

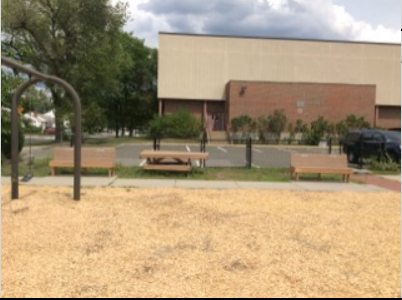
Toe or knee clearance at tables not provided Picnic table not on an accessible route	24" -	Provide at least 1 picnic table in this area has toe and knee clearance. Ensure that the picnic table is located on an accessible route.	1	1400	\$1400
17	Playground Walkway - Picnic Tables	Ext.		Picnic Tables	N/A

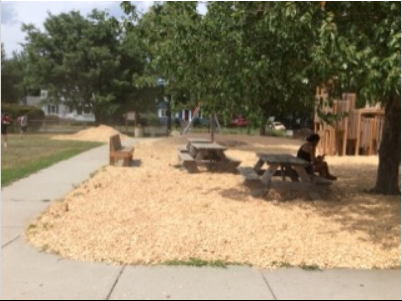
Picnic table not on an accessible route	-	Ensure that the accessible picnic table is connected to an accessible route. (Cost estimate for a 6' long, 4' wide concrete route.)	1	384	\$384

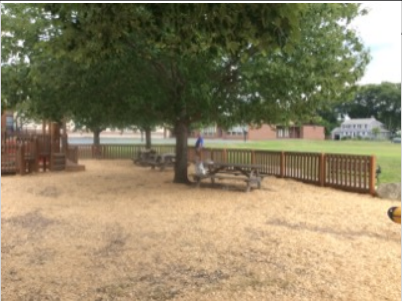
18	Tot Lot Picnic Area	Ext.		Picnic Tables	N/A

Picnic table not on an accessible route	-	Provide an accessible route to the accessible picnic table. (Cost estimate for a 10' long, 4' wide stone dust route.)	1	320	\$320
Exterior Benches												
19	Cross Street Sidewalk	Ext.		Exterior Benches	N/A

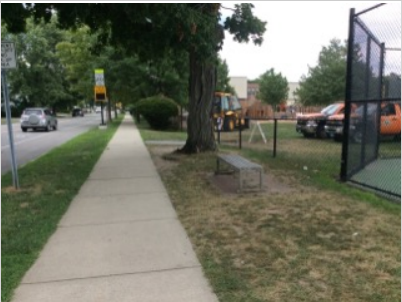
No accessible route to one bench in area	-	Provide an accessible route to the bench. (Cost estimate for 4' wide, 5' long stone dust route.)	1	160	\$160

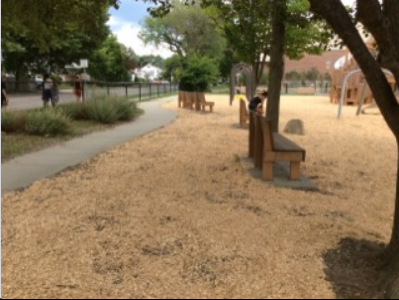
ID	Location	Floor	Room	Element	Type	Photo	Issues	Current Measure	Recommendations	Quantity	Price	Cost Estimation
20	Playground Walkway on the Northwest Side	Ext.		Exterior Benches	N/A

No accessible route to one bench in area	-	Provide an accessible route to one bench in this area. (Cost estimate for a 4' wide, 4' long asphalt route.)	1	160	\$160
21	Playground Walkway South Side - Bench Facing Field	Ext.		Exterior Benches	N/A

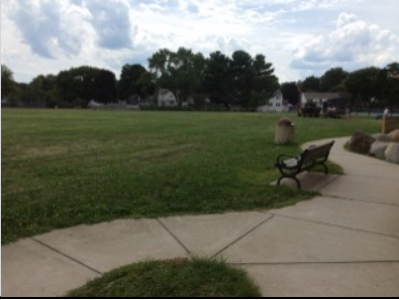
No accessible route to one bench in area	-	Provide an accessible route to one bench in this area. (Cost estimate for a 4' wide, 4' long stone dust route.)	1	128	\$128
22	Playground Walkway, Bench Facing Basketball Court	Ext.		Exterior Benches	N/A

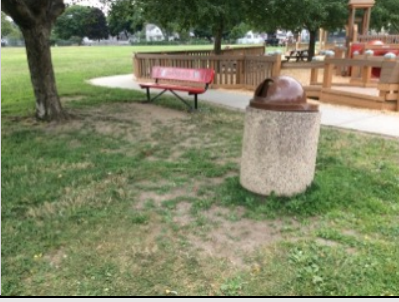
No accessible route to one bench in area	-	Provide an accessible route to the bench in this area. (Cost estimate for a 4' wide, 4' long stone dust route.)	1	128	\$128
Play and Sport Areas												
Play Areas

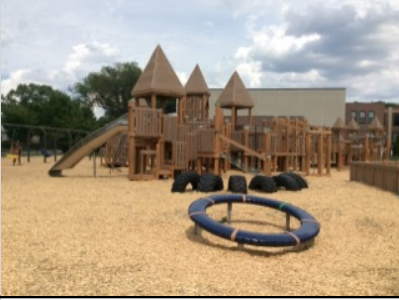
23	Playground	Ext.		Play Areas

Accessible route not provided to play components	-	Provide a compliant impact-attenuating surface to and around the play components. (Cost estimate for 4,070 sq. ft. of poured in place rubber surface.)	1	56980	\$56980
24	Tot Lot	Ext.		Play Areas	N/A

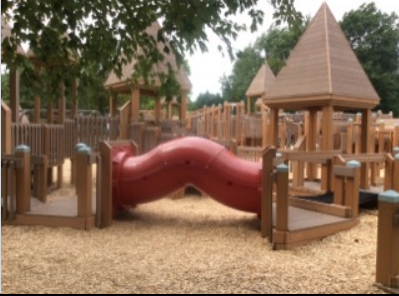
Accessible route not provided to play components	-	Provide a compliant impact-attenuating surface to and around the play components. Ensure that one bench in this playground is located on an accessible route. (Cost estimate for 1,284 sq. ft. of poured in place rubber surface.)	1	17976	\$17976

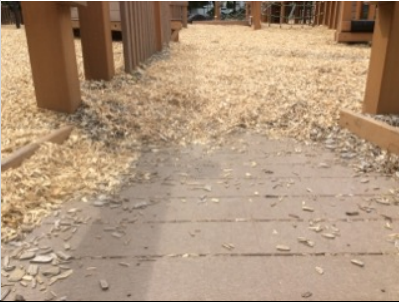
ID	Location	Floor	Room	Element	Type	Photo	Issues	Current Measure	Recommendations	Quantity	Price	Cost Estimation
25	Tot Lot Ramp	Ext.		Play Areas	N/A

Play areas not maintained in operable working condition	-	Ensure play area is maintained in operable working condition.	1	Labor	\$0
Field												
26	Baseball Diamond	Ext.		Field	Baseball

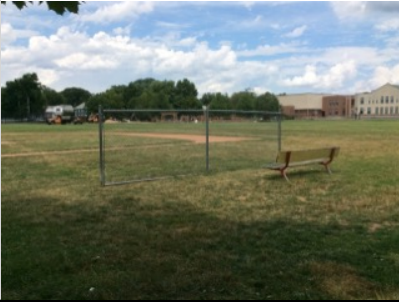
Accessible spaces not provided at team seating	-	Provide a 36" x 48" clear floor space at both team seating areas and a route to each team seating bench from the new accessible route around the park. (Cost estimate for 4' wide, 16' long stone dust routes.)	1	512	\$512
27	Soccer and Baseball Fields	Ext.		Field

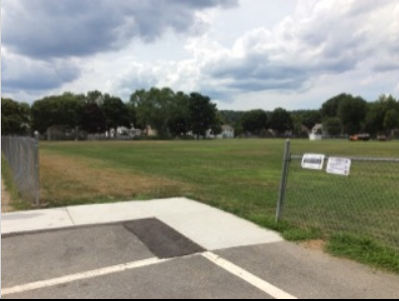
No accessible route to all areas of sport activity	-	Install an accessible route connecting all areas of sport activity, including routes between the soccer fields, baseball field, tennis courts and basketball court. (Cost estimate for 4' wide 1,515' long stone dust route.)	1	48480	\$48480

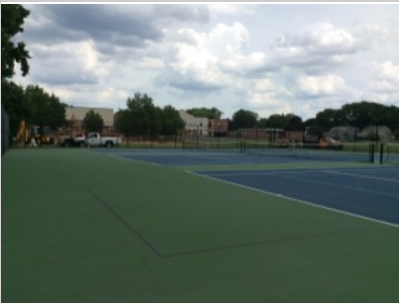
Best Practice												
28	Tennis Courts	Ext.

-	Recommend providing benches at tennis courts.	1	-	\$0
29	Stage	Ext.

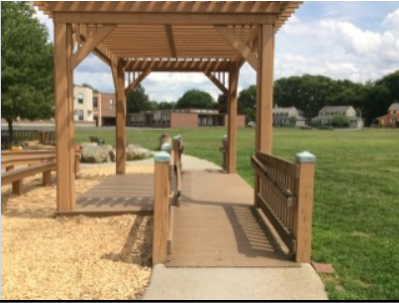
-	As the rise to the stage is less than 6", handrails are not required, but for greater access consider providing circular handrails located between 34"-38" high and between 18"- 20" high with 12" extensions at the top and bottom of the ramp run.	1	-	\$0

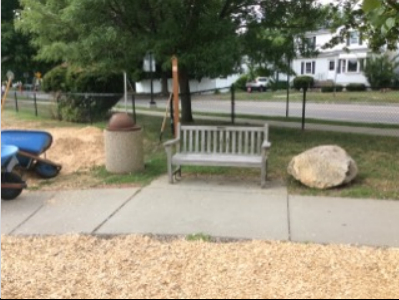
ID	Location	Floor	Room	Element	Type	Photo	Issues	Current Measure	Recommendations	Quantity	Price	Cost Estimation
30	Playground Walkway Bench	Ext.

-	Recommend providing clear floor space of 36" wide minimum by 48" deep alongside one bench so that a wheelchair user can sit alongside someone sitting on the bench.	1	-	\$0
31	Playground Walkway - Picnic Tables	Ext.

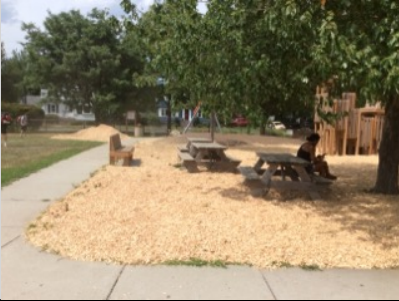
-	Recommend providing a 48" wide min. stable, firm and slip resistant surface under and around accessible picnic tables.	1	-	\$0
32	Tot Lot Ramp	Ext.

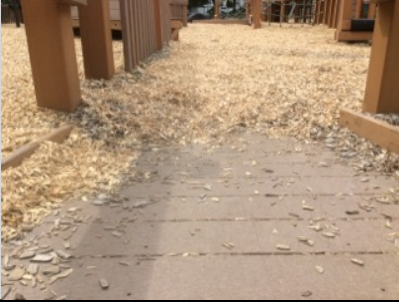
-	IHCD strongly recommends exploring the possibility of an alternative surface to engineered wood fiber (EWF). When used in combination with other surfaces required for accessible routes to play components in Massachusetts, it will present a challenge to prevent level changes at the transition points between EWF and other surfaces, and to keep the accessible routes clear of EWF.	1	-	\$0
