The Trustees of Reservations

Conservation Restriction (CR) Monitoring Report

Town of Belmont - CR# 233 & 237.02

Belmont, MA

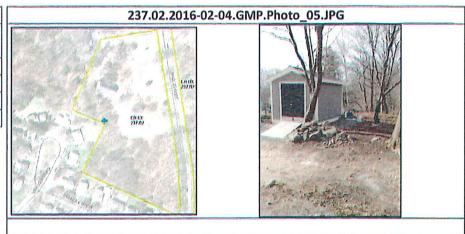
*Explain:	CR 237.02: Near-encroachment: construction of shed on abutter land directly along stone wall on boundary of parcel west of Mill Street. (237.02_02.04.2016_photo 3 -5)

Attributes				
Photopoint	Shed built on Rock wall boundary			
Latitude	N 42° 23' 55.95"			
Longitude	W 71° 11' 44.25"			
Photo Direction	274° W			
Model	odel iPad2.7
