## **Appendix A**

### **Trail Analysis Existing Conditions Photographs**

**McLean Open Space Land**  
**Comprehensive Trail System Plan**

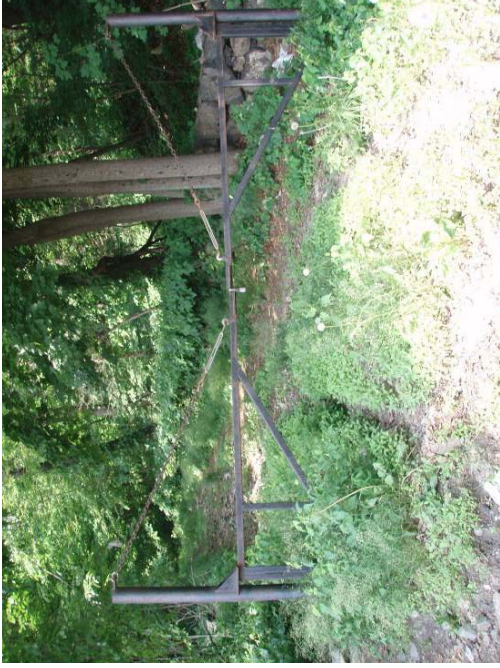
Figure 1a: Locked vehicular gate at Trail 1's northern trailhead at Pleasant Street (Trailhead II). Most of Trail 1 is wide enough to allow vehicle access.

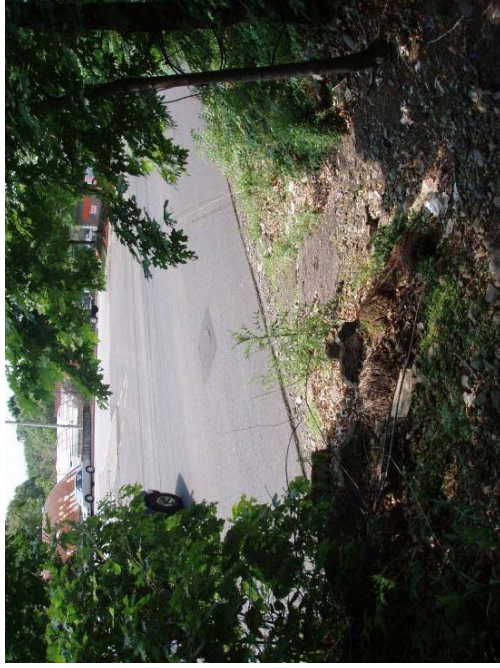
Figure 1c: Dangerous intersection and poor sightlines due to dense vegetation and road alignment at the bottom of Trail 1's southern trailhead at Pleasant Street (Trailhead I).

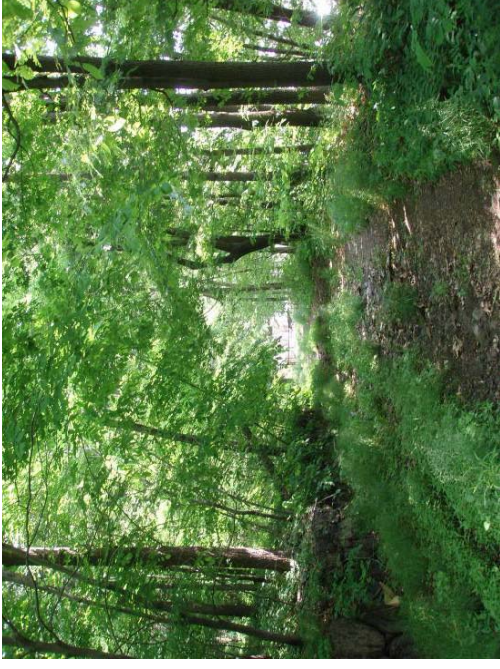
Figure 1b: Rocky trail surface and significant erosion immediately above Trail 1's northern trailhead at Pleasant Street (Trailhead II).

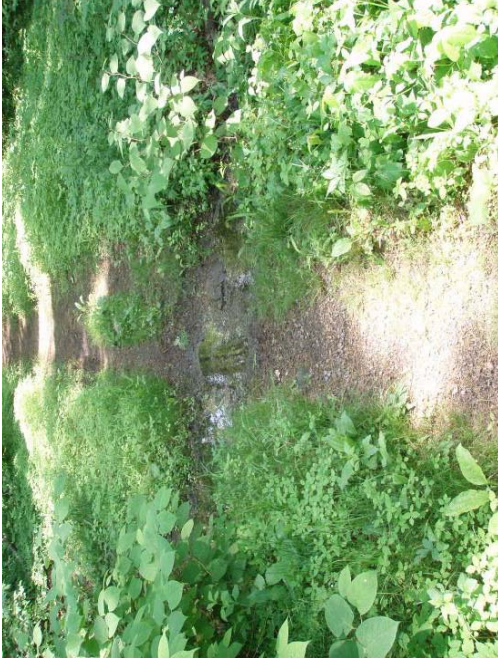
Figure 1i: Stream crossing perpendicular to the trail creating muddy conditions in Spring. The small pipe culvert underneath trail may be partially blocked, thus allowing for water flow over the trail surface..

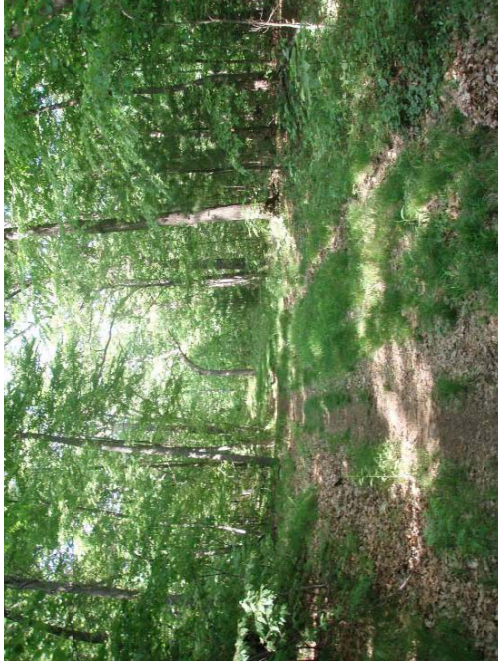
Figure 1j: Some minor trail erosion due to steep grade. Note compacted, vehicular tracks.

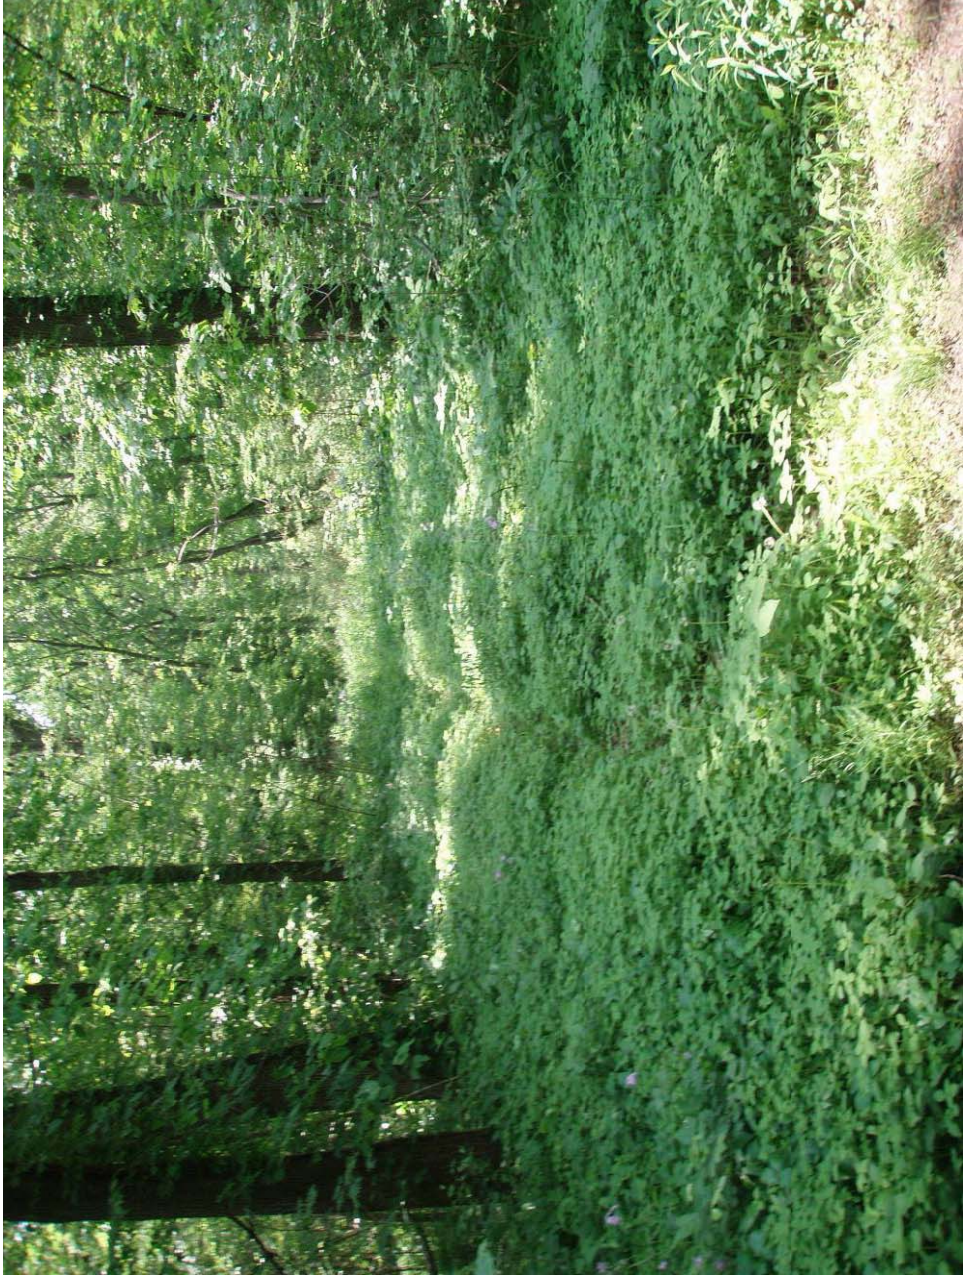
Figure 2a: Overgrown vegetation and lack of regular use is effectively closing this trail. Trail leads to a currently unused part of the McLean Hospital campus (Trailhead IV). Vegetation growing within the trail includes jewelweed, poison ivy, and various grasses along with some woody seedlings. Vehicle access in current condition will be difficult.

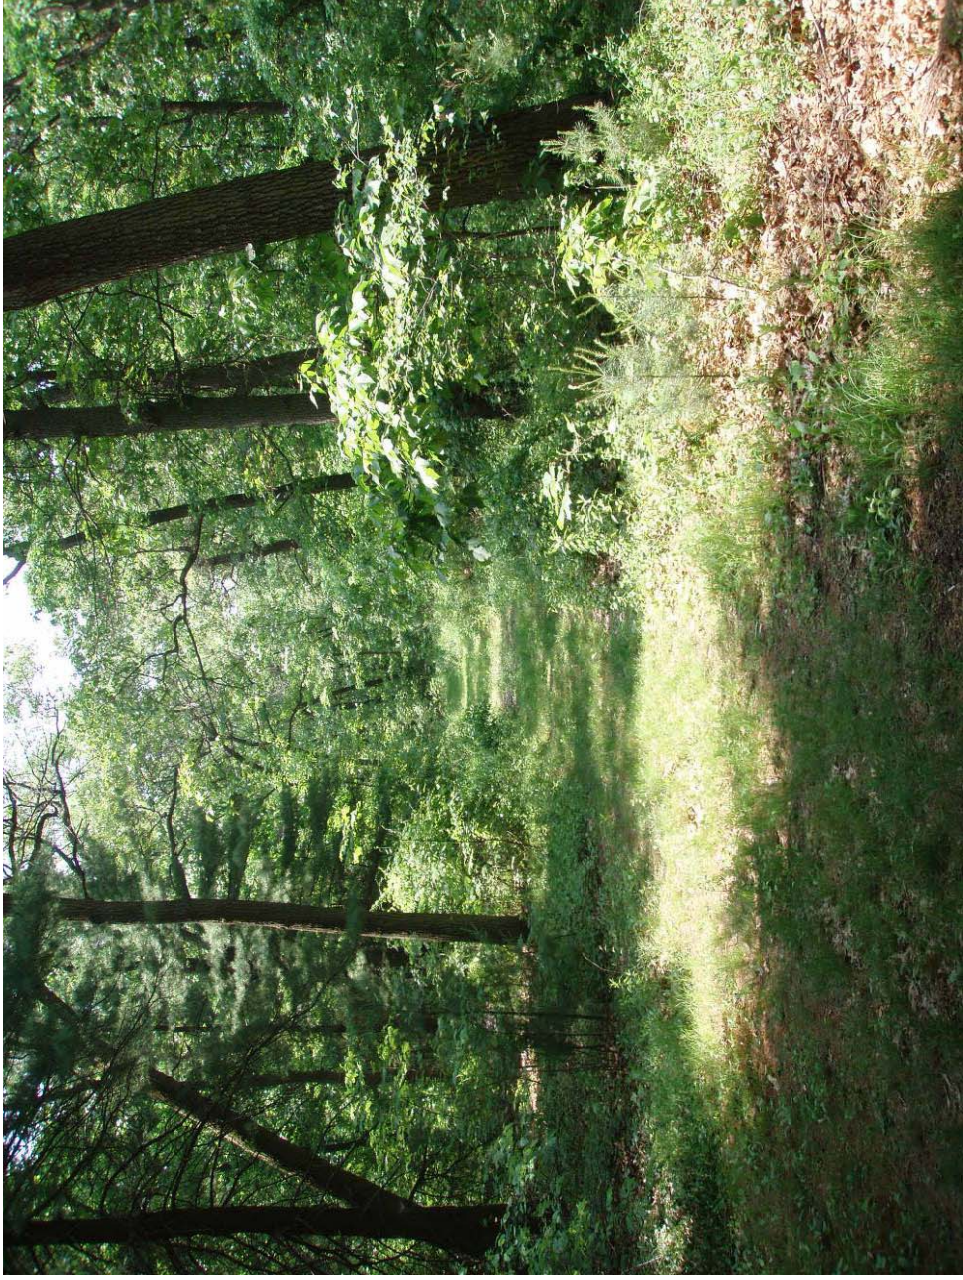
Figure 3b: Trail 3 as seen from Trail 1. Trail 3 is primarily grass-covered tread within the Open Space but the tread changes to a gravel surface within the steeper trail sections in the 100-foot Buffer Zone. Trail 3 connects to a used area within the main McLean Hospital Campus (Trailhead V). Trail is wide enough for vehicle access.

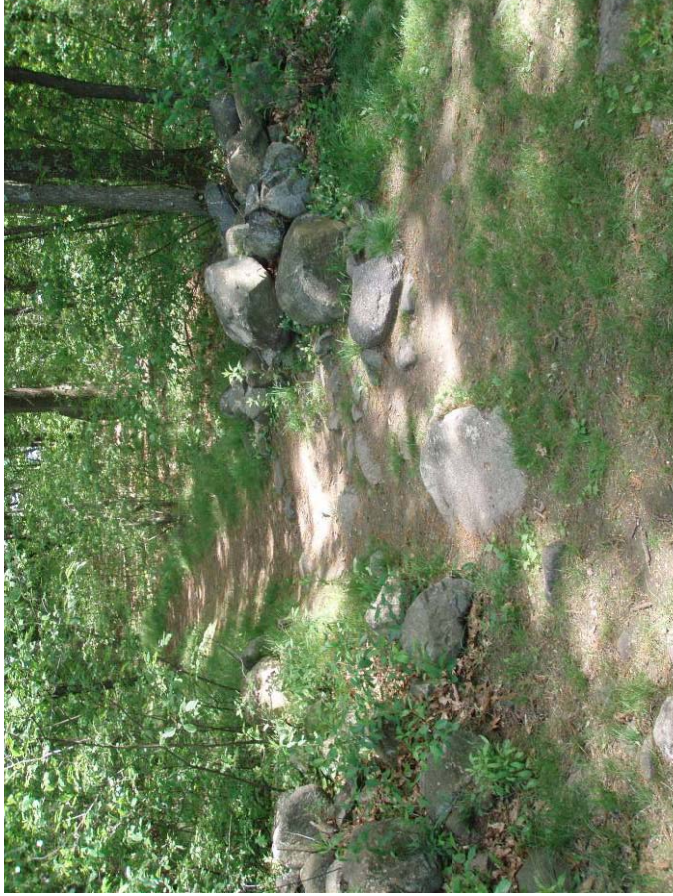
Figure 5a: North entrance to Trail 5 at the intersection of Trails 6 and 7. Trail goes through opening in stone field wall. Tread of trail is typically narrower (2' to 3') along the northern stretch of Trail 5.

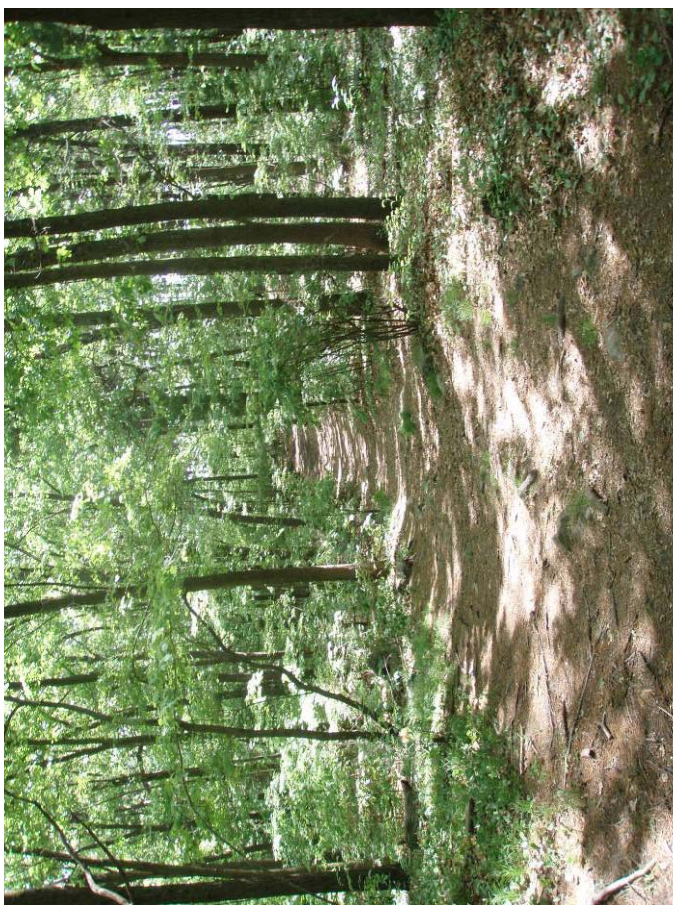
Figure 5b: Wider trail tread and corridor (8' – 12') along the southern stretch of Trail 5. Trail clearance is wide enough for vehicular access.

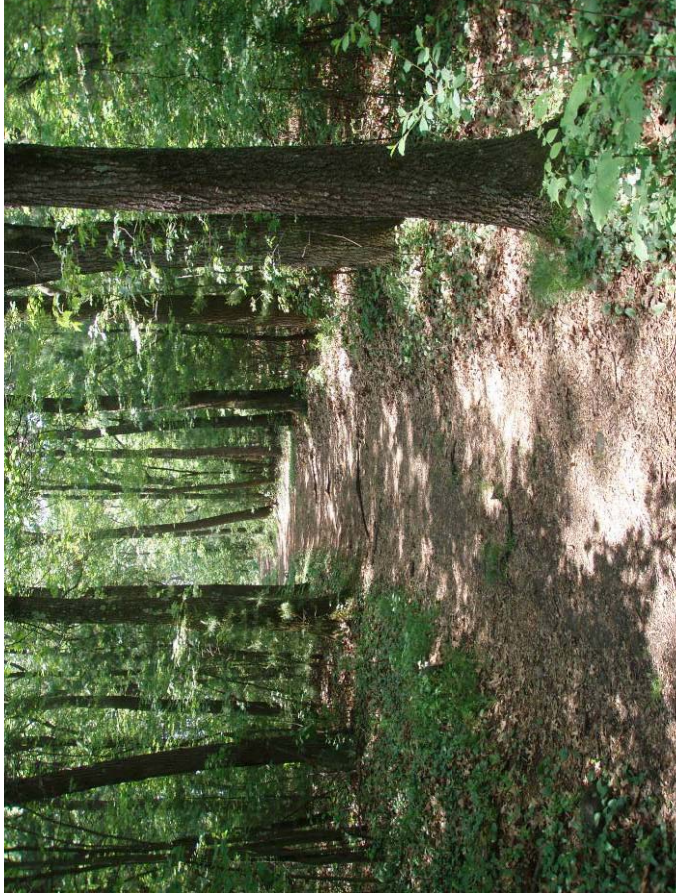
Figure 6a: Trail 6 has a fairly consistent wide tread and trail clearance and is wide enough for vehicular access..

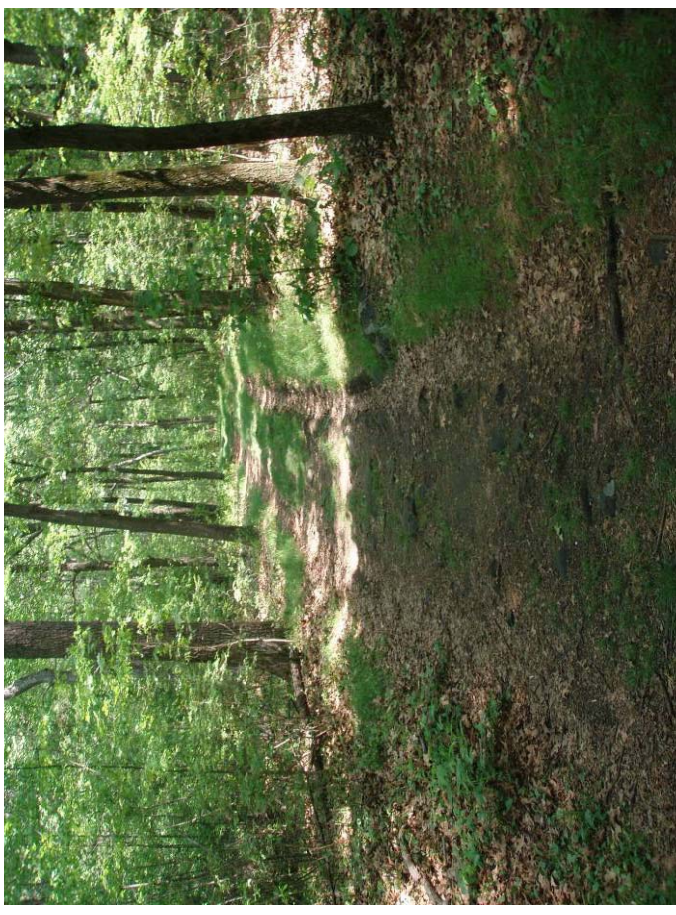
Figure 6b: Where the tree canopy allows in sunlight, grass is growing in the median of the trail between the compacted tire treads.

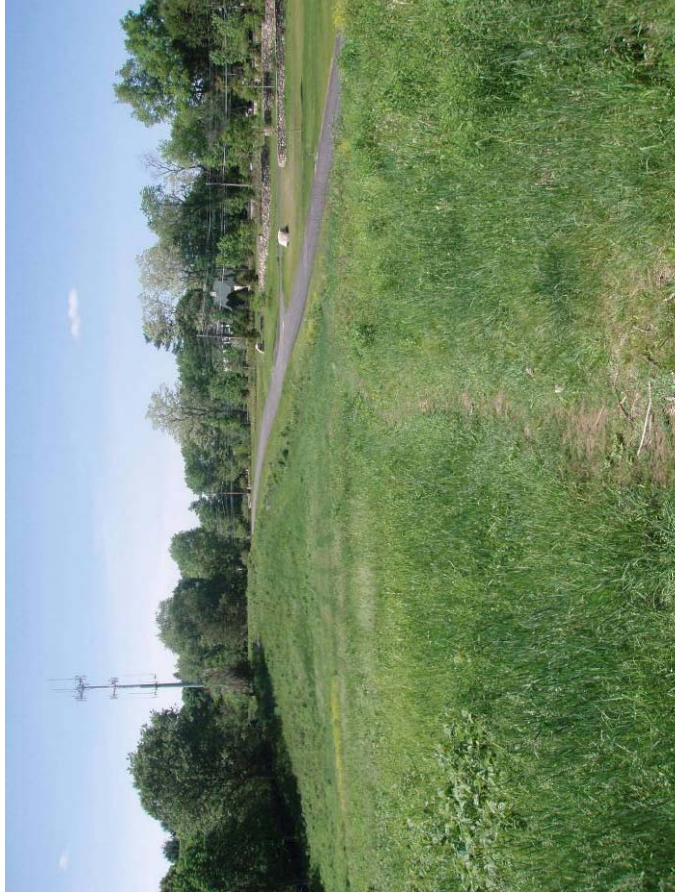
Figure 7a: The narrow 1- to 2-foot tread of Trail 7 skirts parallel to the Highland Cemetery vehicular drive and through the Heart-Shaped Meadow.

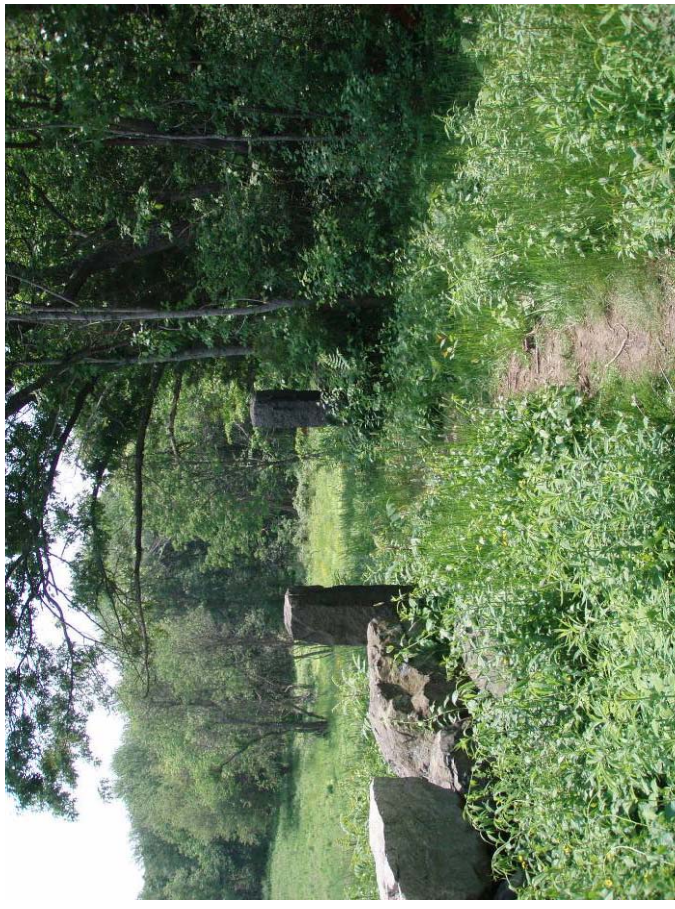
Figure 7B: The northern Trail 7 trailhead (Trailhead VII) goes through a opening in the stone wall near the Highland Cemetery entrance..

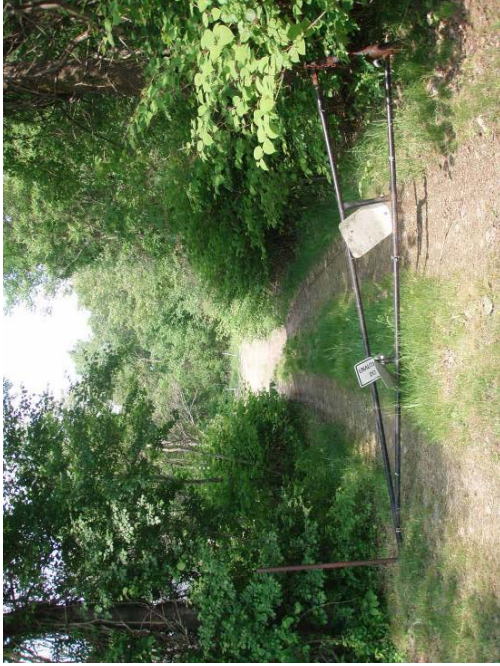
Figure 9a: Broken, vehicle gate at the trailhead of Trail 9 (Trailhead VII) as seen from the McLean Hospital property.

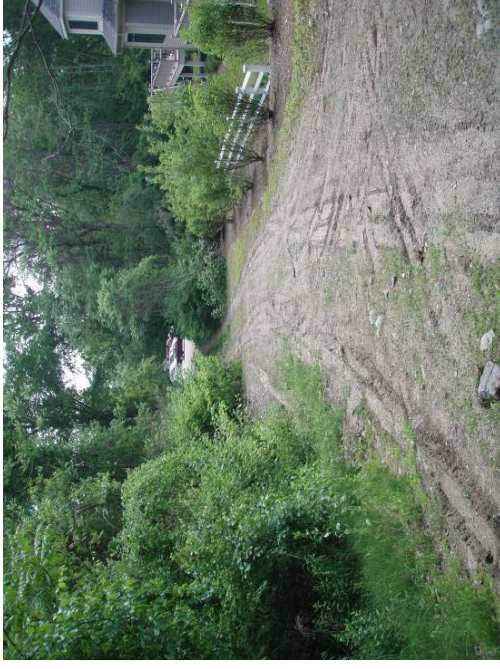
Figure 9b: Section of Trail 9 immediately adjacent to the new Woodlands at Belmont Hill development.

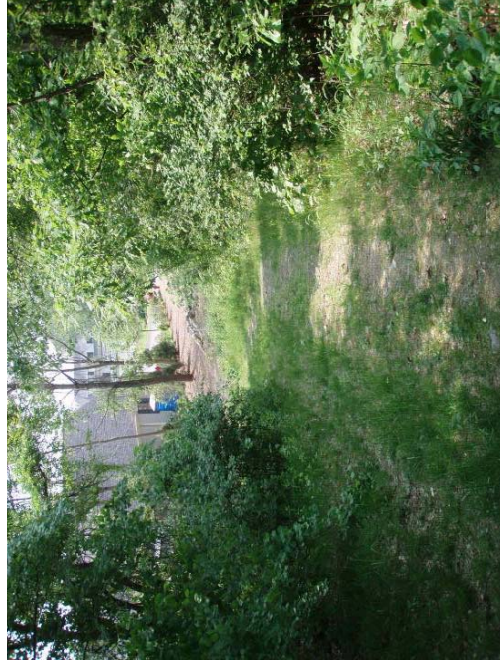
Figure 9d: Looking southwest down Trail 9 from the intersection with Trail 8 and towards the Woodlands development.

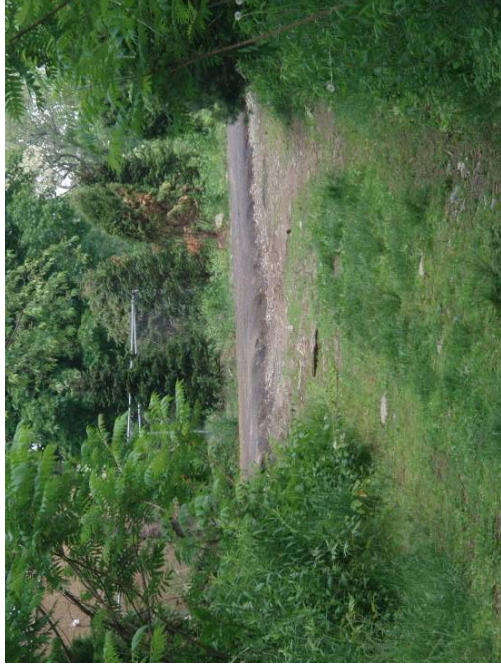
Figure 10c: Existing northern terminus of Trail 10 at the cell tower maintenance driveway.

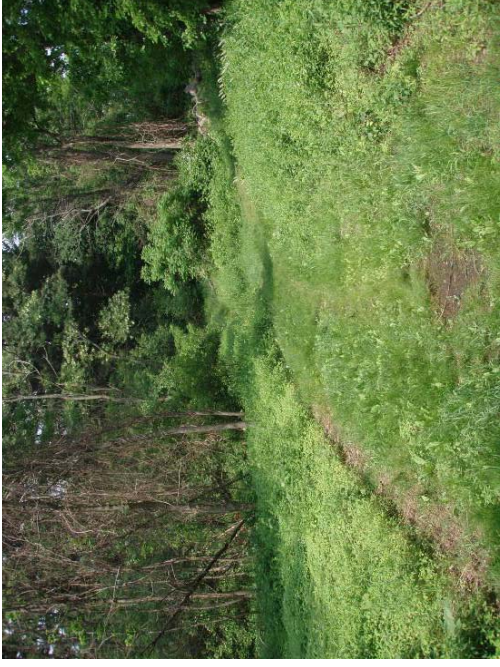
Figure 10b: Trail 10 approaching the eastern end of the Pine Allee. A short and narrow spur trail connects to the Pine Allee and then out to Concord Avenue.

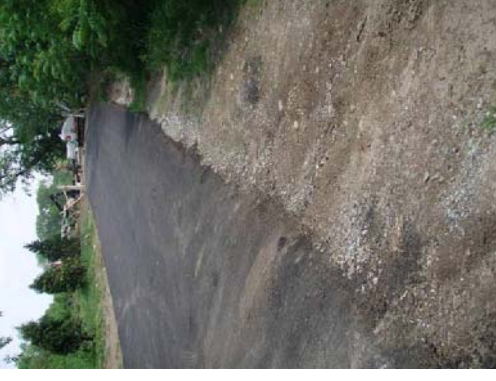
Figure 10d: Worn and eroded trail surface at the cell tower maintenance driveway. Water flow sheets from the driveway onto the trail (from left to right in this photo).

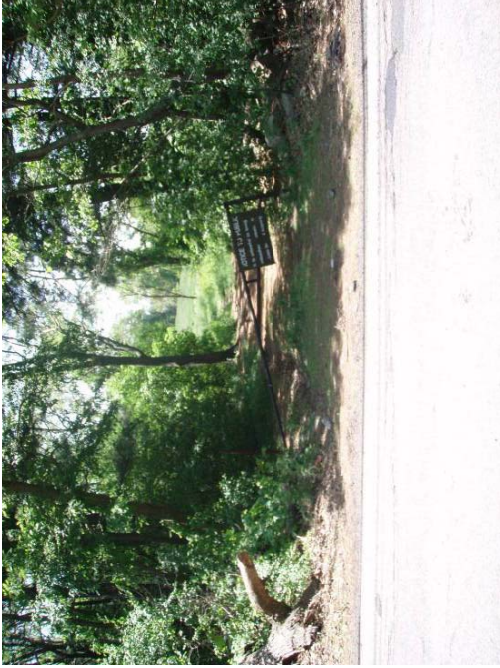
Figure 11a: Broken, vehicle gate at the Trail 11 Concord Avenue trailhead (Trailhead IX).

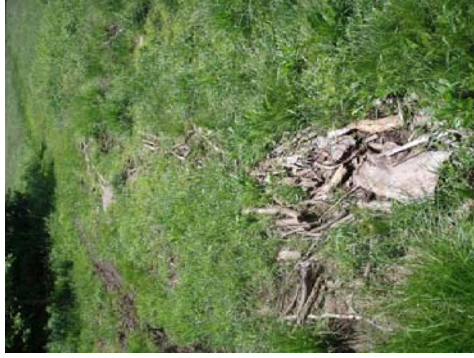
Figure 11c: Seasonally wet area on Trail 11. Notice braided trail treads and improvised area of collected wood to facilitate crossing of muddy area. This area of the trail typically dries up in the summer and fall months and returns to a single trail tread.

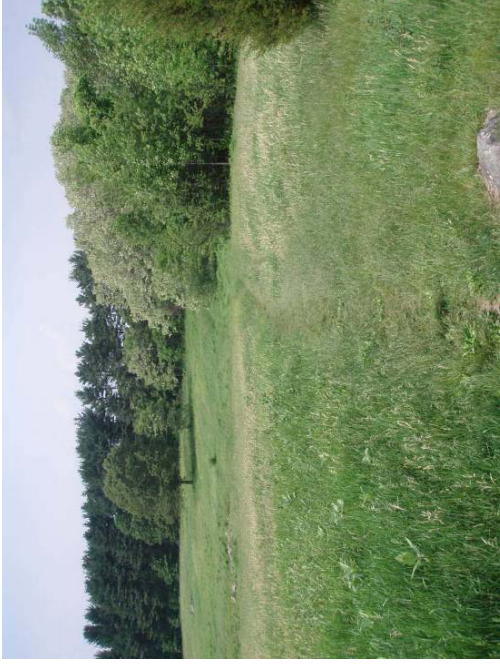
Figure 11b: Looking north along Trail 11 from the Lone Tree Hill. Tread is composed of dual vehicular tracks but traffic generally follows only one of these tracks allowing the other track to grow in during the summer.

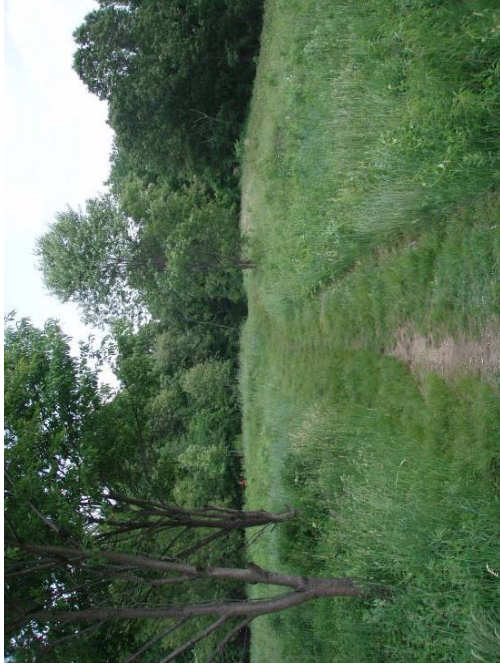
Figure 11d: Looking east along Trail 11 across the Lone Tree Hill. As in the northern stretch (Fig. 11b), this section is composed of compacted vehicle tracks .

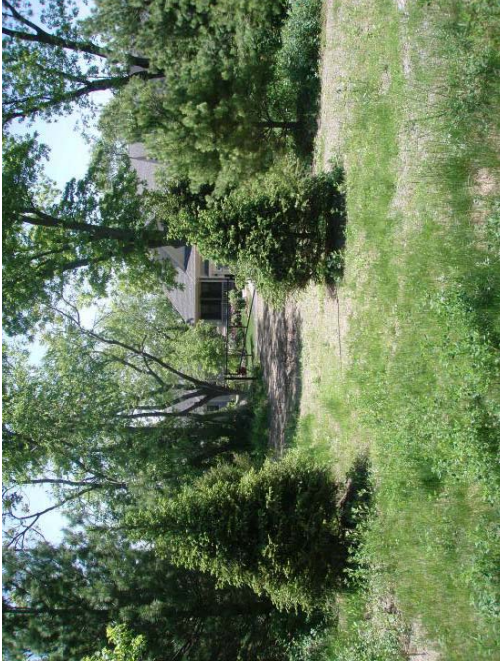
Figure 12b: View to the Trailhead XI from the Open Space Land. Notice newly planting buffer trees (mostly a mix of pines).

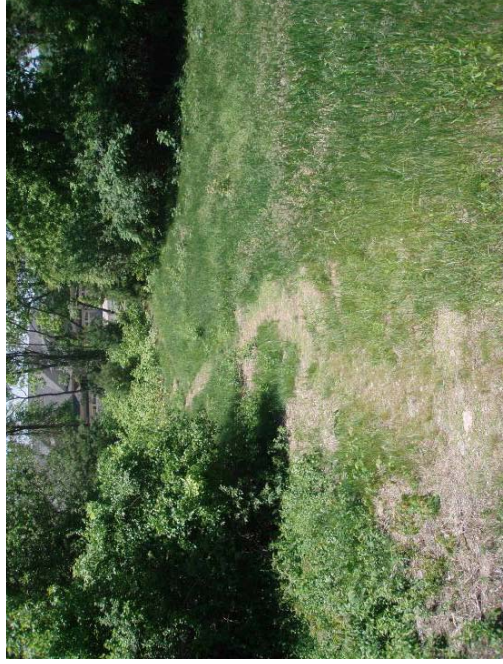
Figure 12c: Along Trail 12 looking southwest from near the intersection with Trail 11 and towards Trailhead XI. There is minor erosion of trail tread along this steeper section.

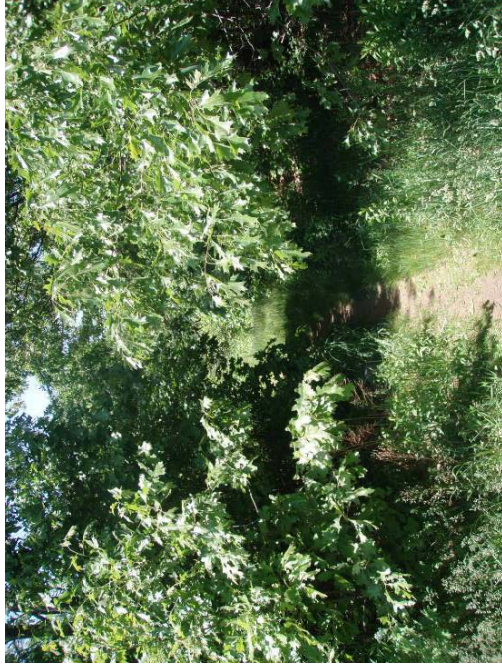
Figure 13b: Entering from the Lone Tree Hill meadow, Trail 13 passes through this vegetated area where low tree and shrub branches obstruct the passageway and limits sightlines.

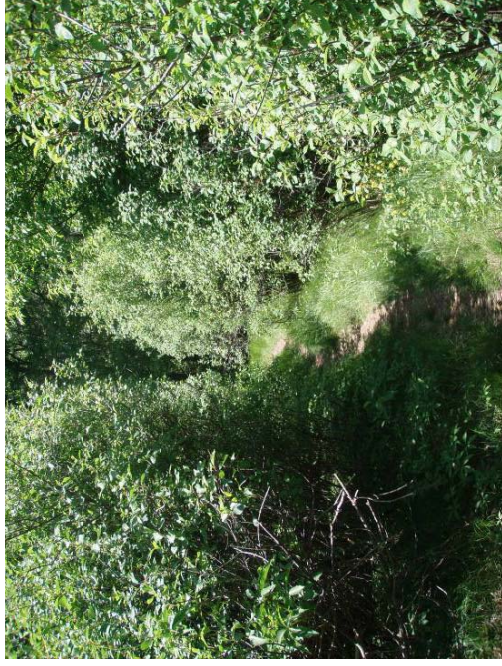
Figure 13c: Heading further east along Trail 13, the trail corridor twists and turns through an area dominated with woody shrub growth (including buckthorn). Plant growth limits sightlines and narrows the corridor width. This area presents potential for user conflict.

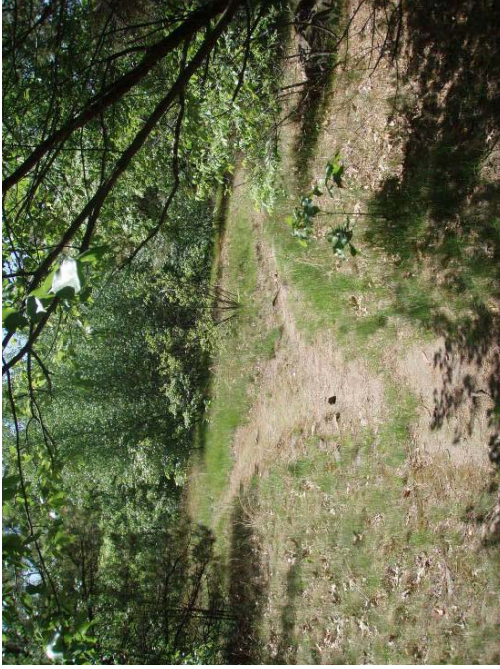
Figure 13d: At the intersection of Trails 13 and 14, Trail 13 opens into a small, grassy area. Trail 14 continues south (left in this picture) and Trail 13 (right) continues downhill to Mill Street.

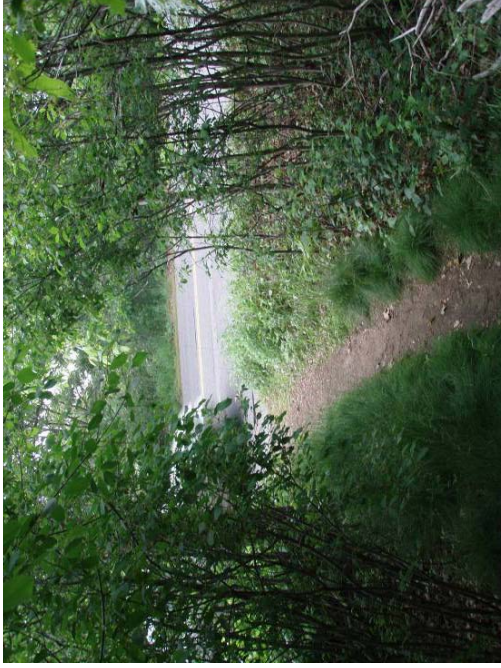
Figure 13g: View of Trail 13's trailhead at Mill Street (Trailhead XII) as seen from within the Open Space Land. Dense vegetation restricts clear views of this busy road and makes safe crossing difficult..

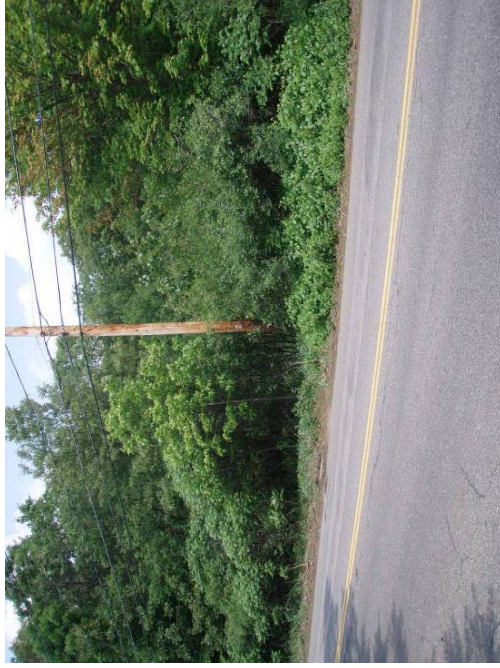
Figure 13i: View of Trailhead XII at Mill Street as seen from the Rock Meadow driveway. Small Western Greenway marker sign hangs on the utility pole.

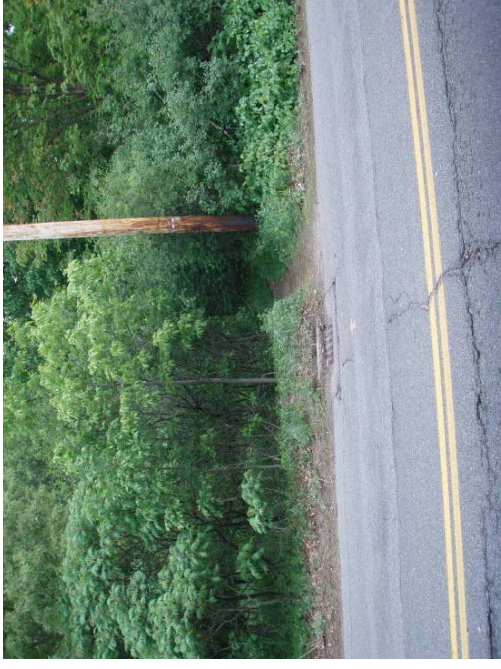
Figure 13h: View of Trailhead XII at Mill Street as seen from the western side of the road. Trailhead is not immediately discernable due to dense vegetation.

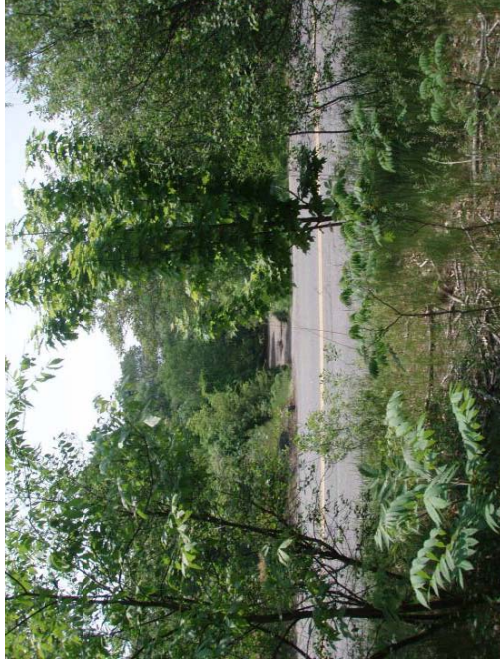
Figure 13j: View of the Rock Meadow driveway from the Open Space property. This is a possible area for a new roadway crossing between the two conservation lands. Such a crossing will allow for better sightlines once some of the vegetation is cleared.

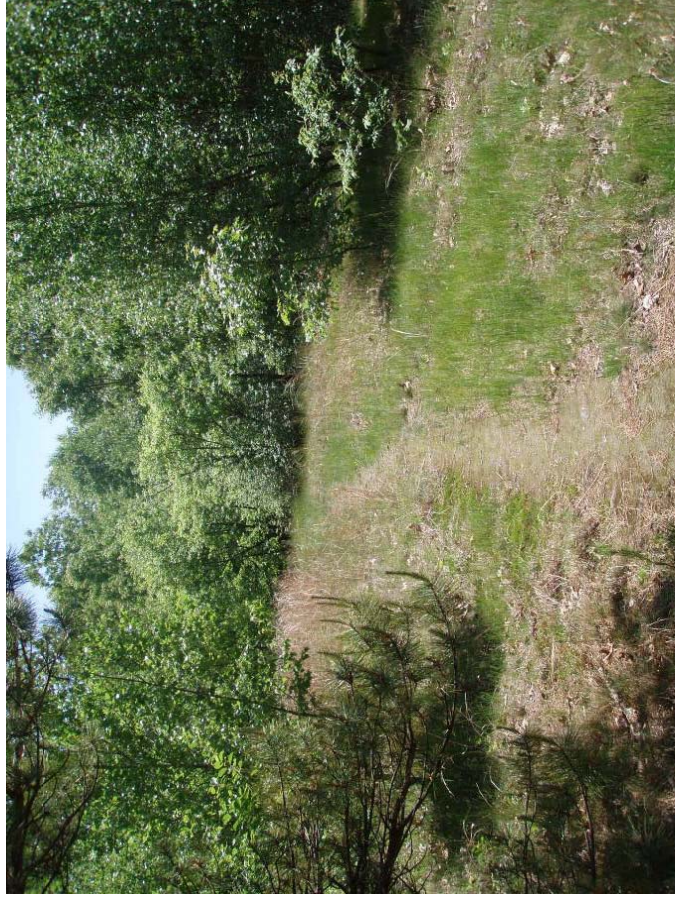
Figure 14a: Looking south along Trail 14 from the intersection with Trail 13. Trail 14 crosses this small, grassy area and then dips down into a densely wooded area. Trail tread is typically around 2-foot wide.

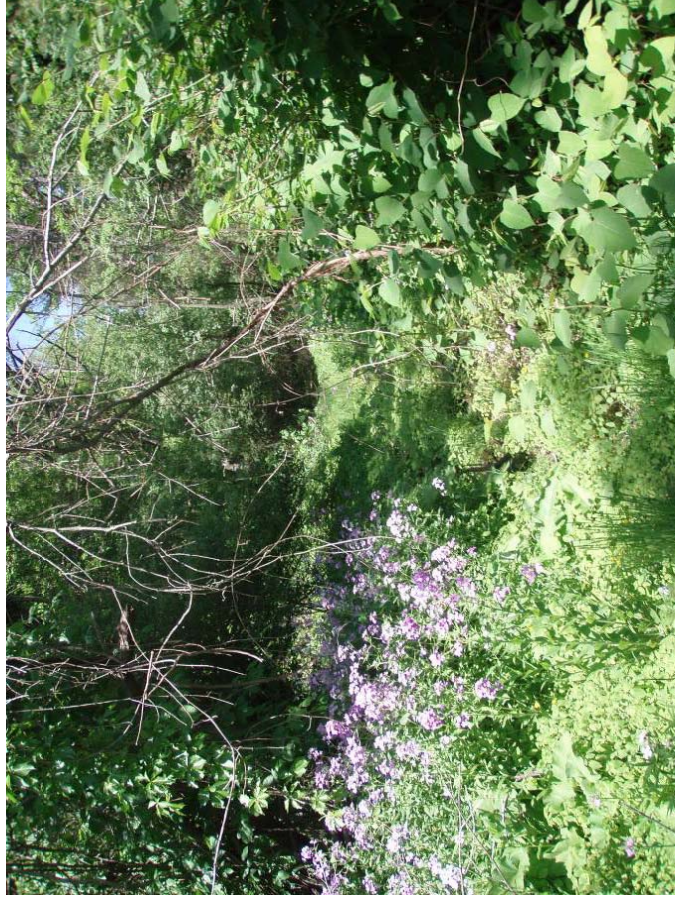
Figure 14b: Currently, Trail 14 essentially dead-ends in this seasonally wet and densely vegetated area. This section of trail once continued further south but was cut off by the new Woodlands development. Native and invasive perennial and woody vegetation have begun to take over this section of trail.

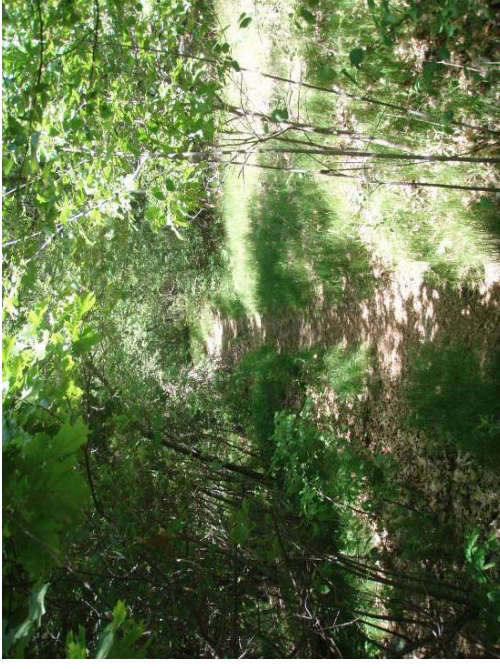
Figure 15b: Section of Trail 15 crossing alongside of one of the two small open grassy spaces in this area of the site. These grassy areas provide good opportunities for secluded rest or picnic areas within the Open Space Land.

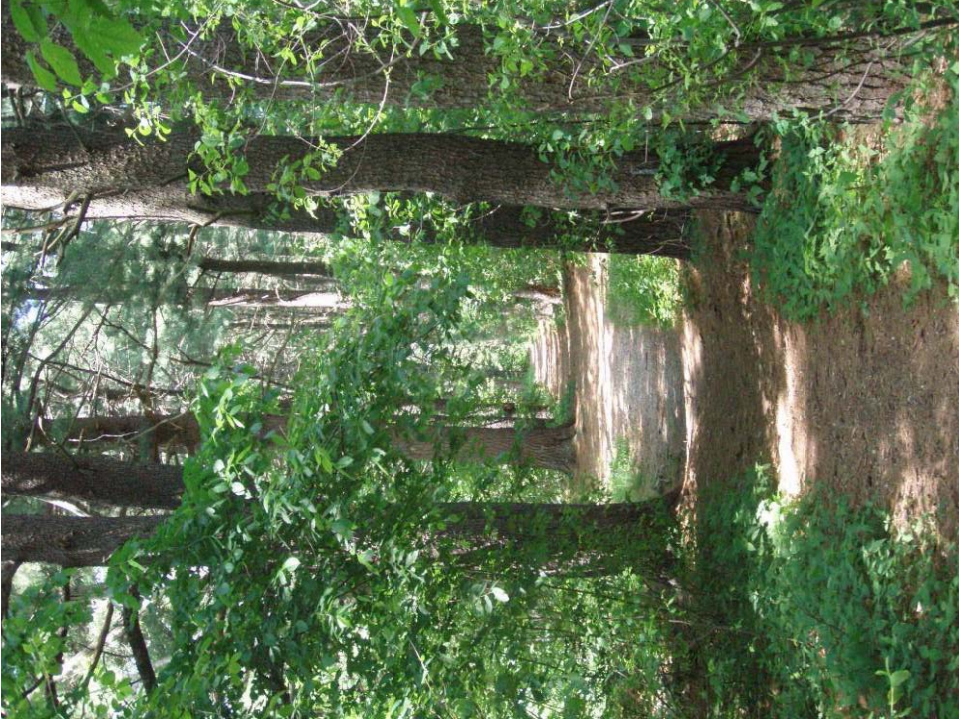
Figure 16a: Typical view along Trail 16 (the Pine Allee). The tread is typically 5-foot wide with a typical 8-foot clearance between the tree trunks. Tread is overlaid with pine leaf and bark duff presenting a softer trail surface.

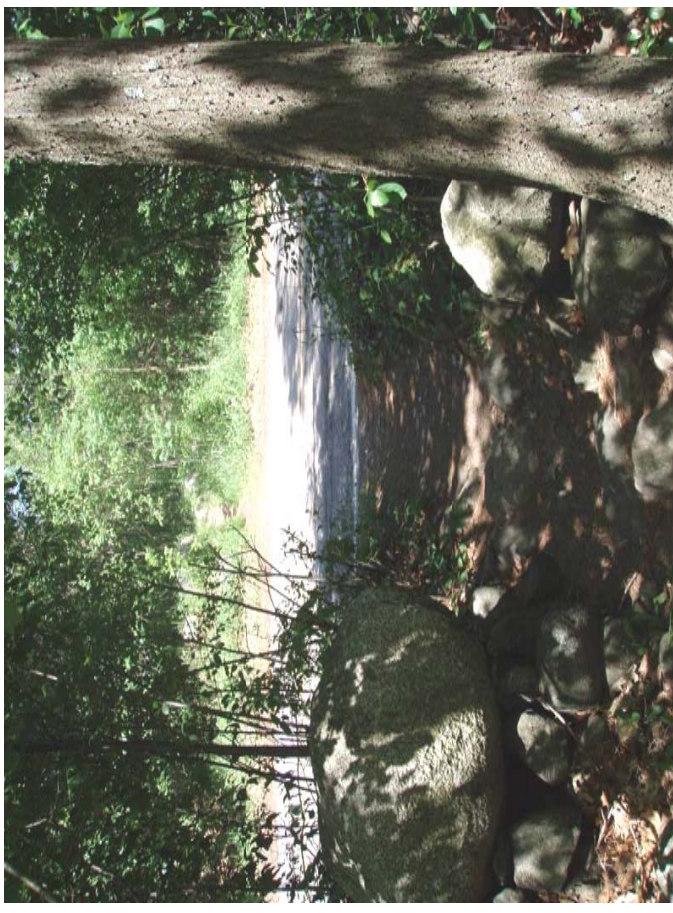
Figure 16b: View of one of the several connector paths to Concord Avenue from Trail 16. This particular connector path leads to the Audobon Habitat trails on the north side of Concord Avenue (Trailhead X). This trail is marked with a small trail marker indicating it is a part of the Western Greenway.

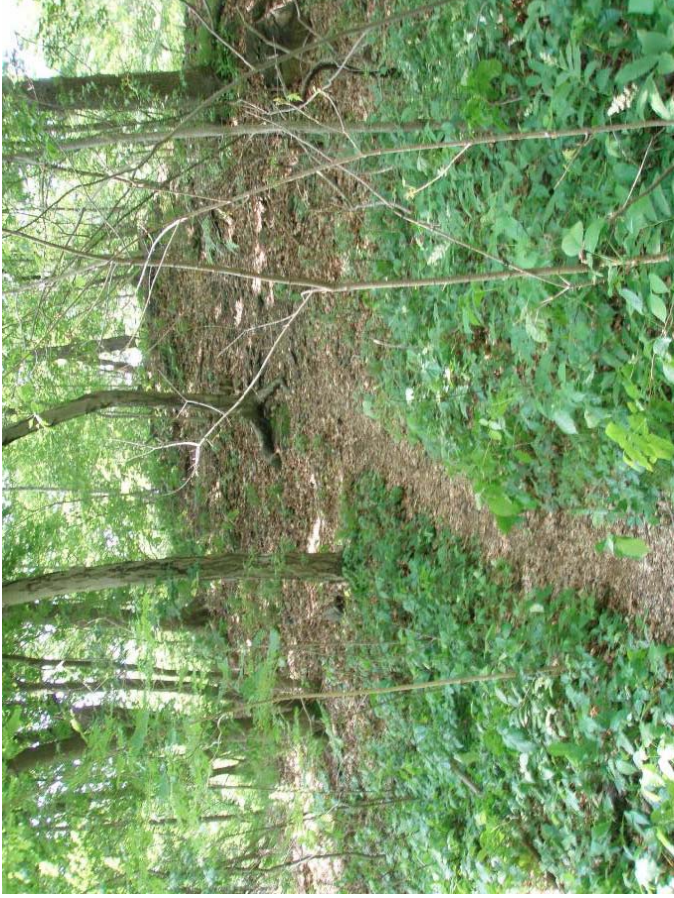
Figure A1: View of Trail A going directly up the fall line of this small hillock. Some minor erosion present. Trail A provides an alternate route to the steeper part of Trail 1.

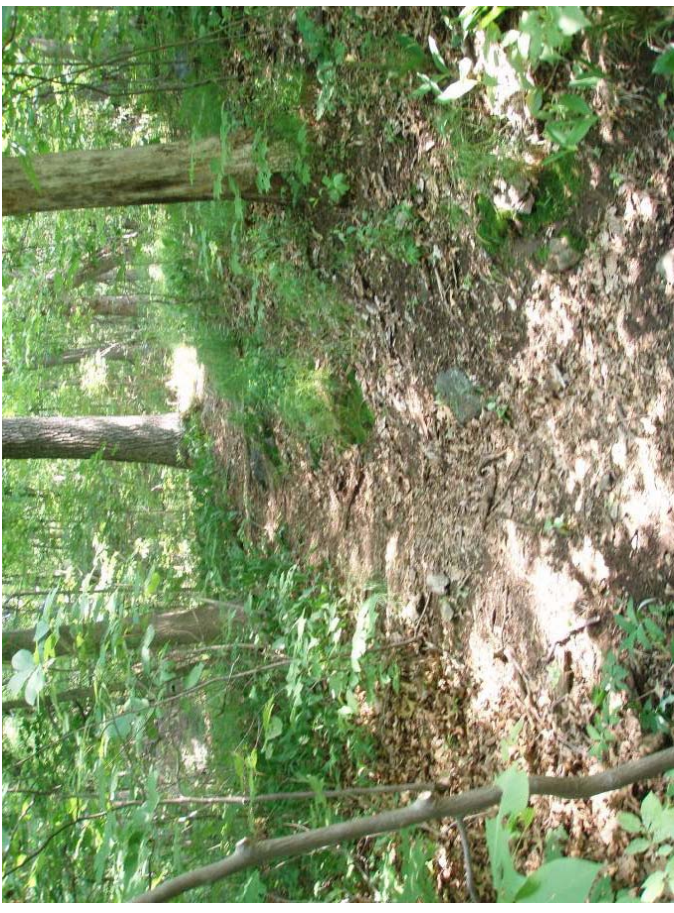
Figure A2: Section of Trail A near intersection with Trail 1.

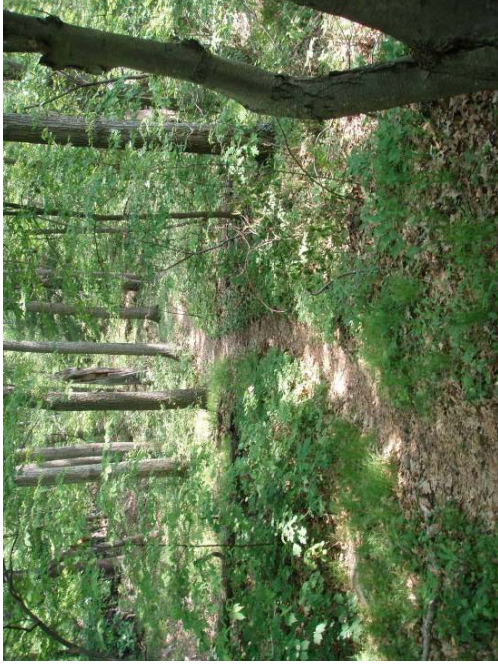
Figure B2: View of relatively flat area of Trail B. Like Trail A, Trail B provides a more narrow, alternate route to a portion of Trail 1.

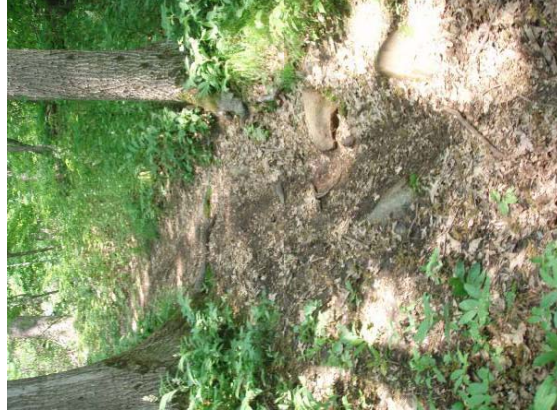
Figure B3: Minor tire rut damage to trail surface in a small seasonally wet area along Trail B.

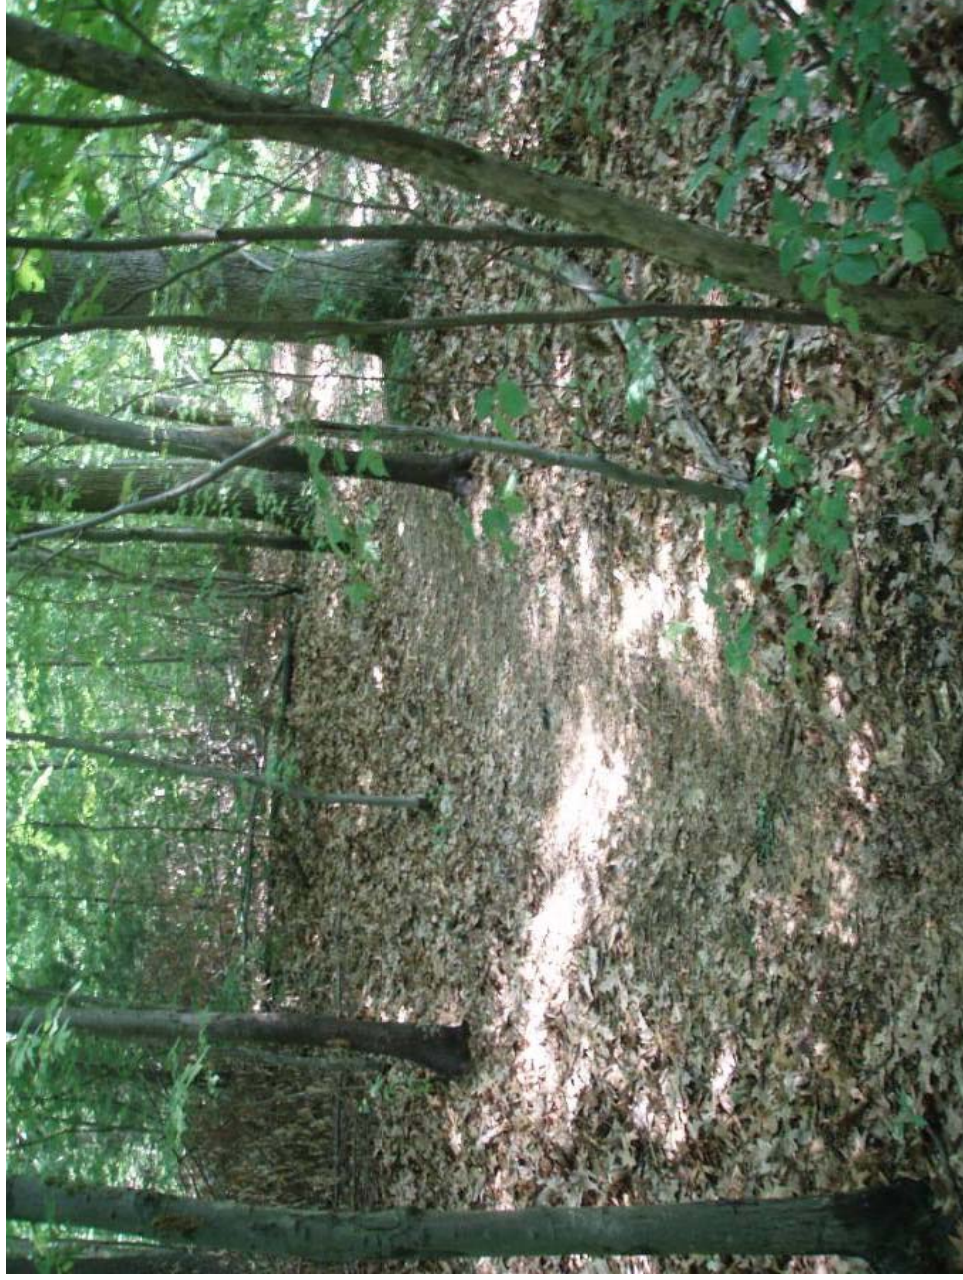
Figure C1: Typical view of Trail C that runs through a nicely wooded area. Trail C provides a short and narrow alternate route past a section of Trail 1. It is believed this trail formed as a result of a fallen tree that temporarily blocked a portion of Trail 1.

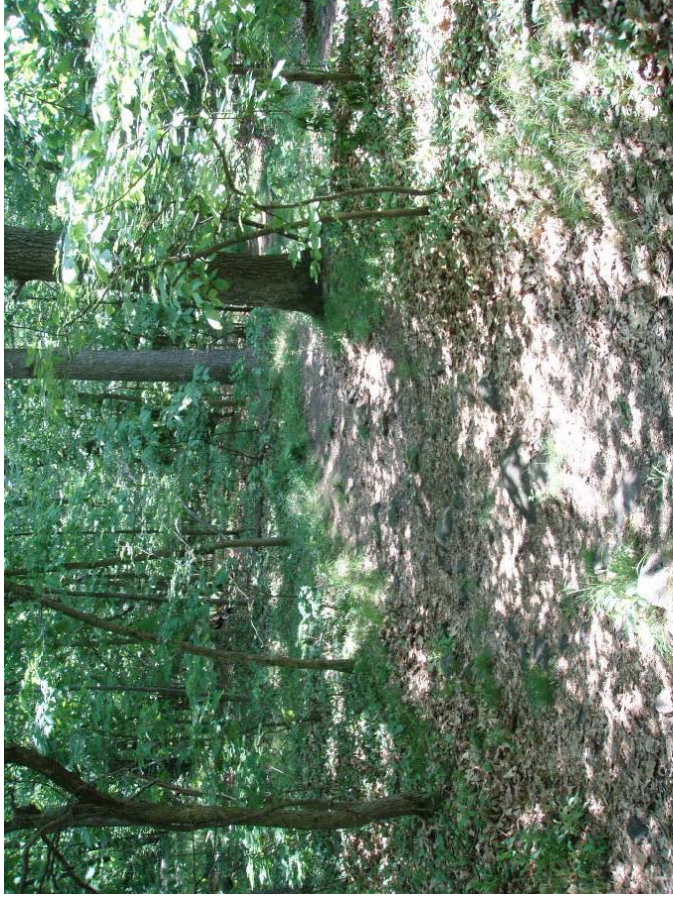
Figure D1: Steep area along Trail D near intersection with Trail 1. Notice exposed roots and native stone. Trail D provides a connection between Trail 1 and the end of Snake Hill Road.

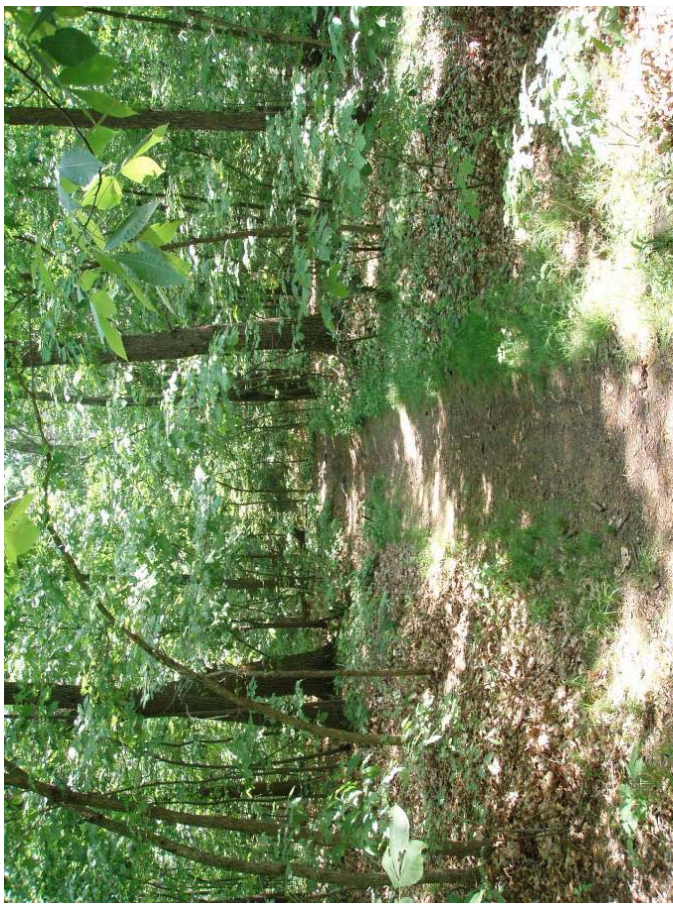
Figure D2: View of relatively flat trail section along eastern end of Trail D
