## **Appendix A**

### **Trail Analysis Existing Conditions Photographs**

**McLean Open Space Land**  
**Comprehensive Trail System Plan**

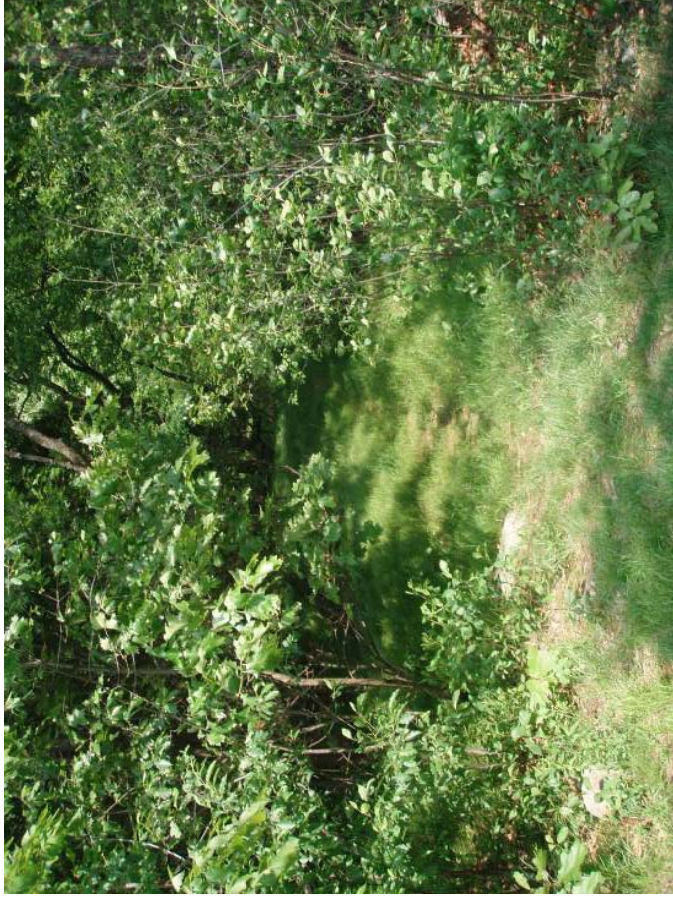
Figure E1: View of one of the Trails E going through woods over grass area. Note most of trail is grass covered due the sunlight filtering through the trees.

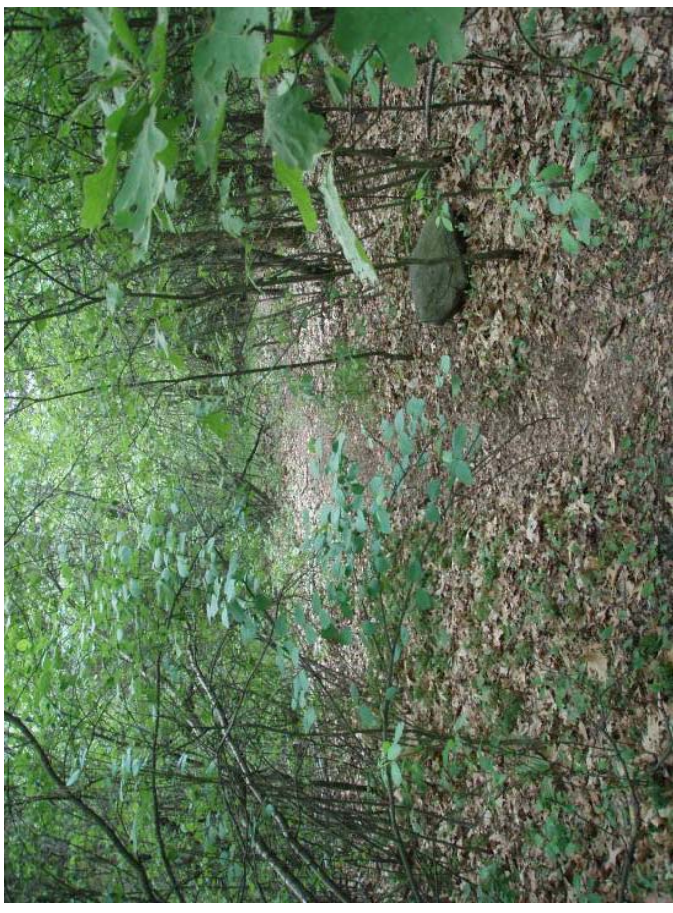
Figure E2: View of one of the Trails E going through a densely wooded area.

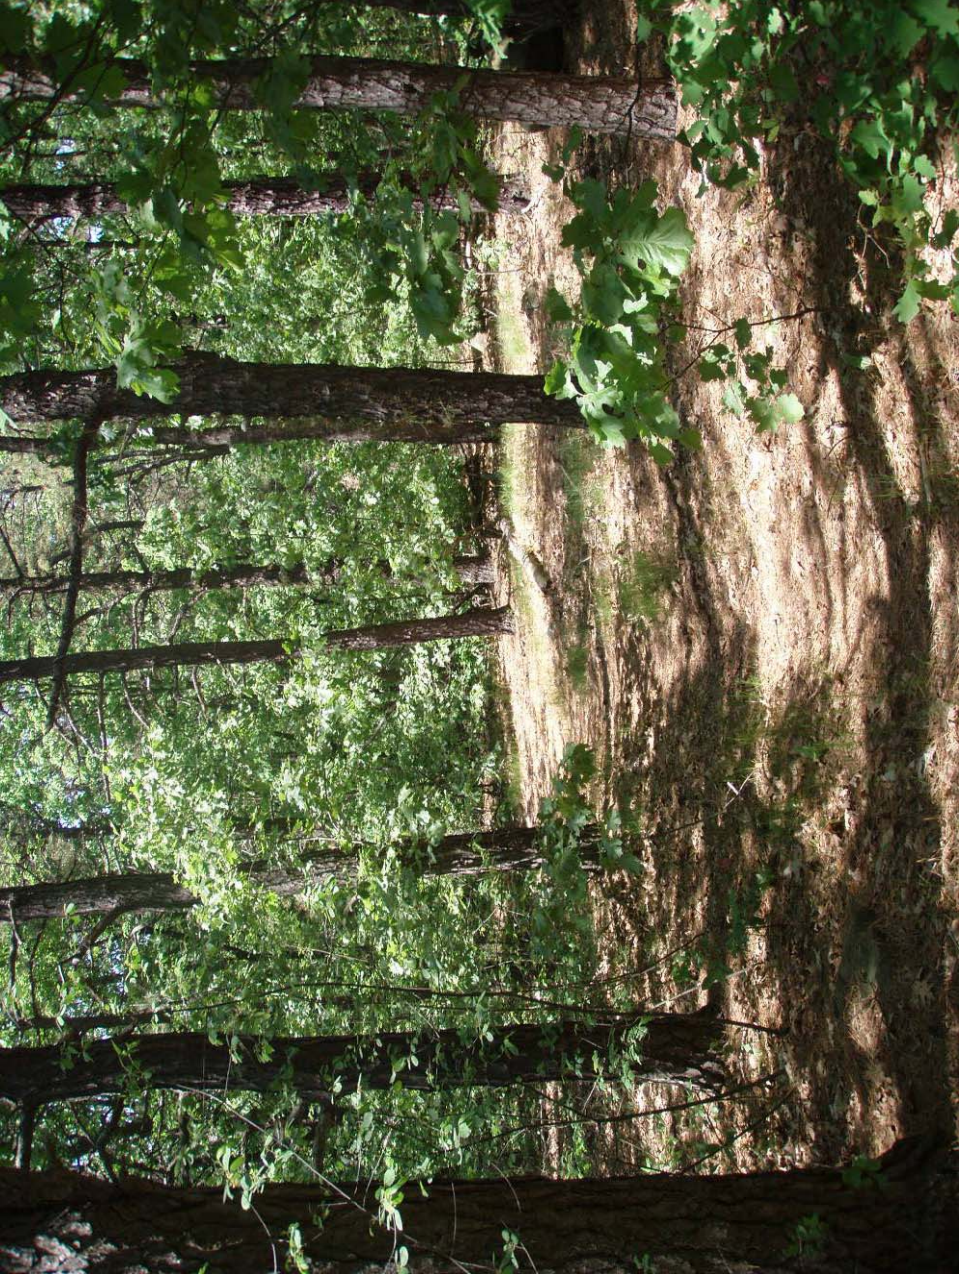
Figure F1: View of Trail F as it runs through the red pine forest. Trail F connects Trails 13 and 15 and provides an alternate and less steep route to and from Mill Street.
