Subject: Belmont, Massachusetts
Evaluation of Sewers and Storm Drains to Identify Illicit
Connections in Areas Tributary to Outfalls 1, 2 & 10
Report of Findings

This Report of Findings (ROF) outlines Fay, Spofford & Thorndike's (FST) sewer and storm drain investigations to identify illicit connections in areas tributary to Unity Ave. (Outfall 1), Huron Ave. (Outfall 2) and Winn's Brook (Outfall 10). Various neighborhoods in these areas have undergone sewer and storm drain rehabilitation including lining, service and mainline replacements, point repairs and manhole replacements. However, as described in the "2008 Storm Water Sampling and Analysis Program", December 2008 report, contamination levels at these outfalls have improved but are still above the DEP threshold (235 E. Coli Colonies per 100 mL Sample). This ROF includes a summary of investigations performed in each tributary area and provides recommendations for rehabilitation and/or further investigations.

**BELMONT, MA
UNITY AVE TRIBUTARY AREA**

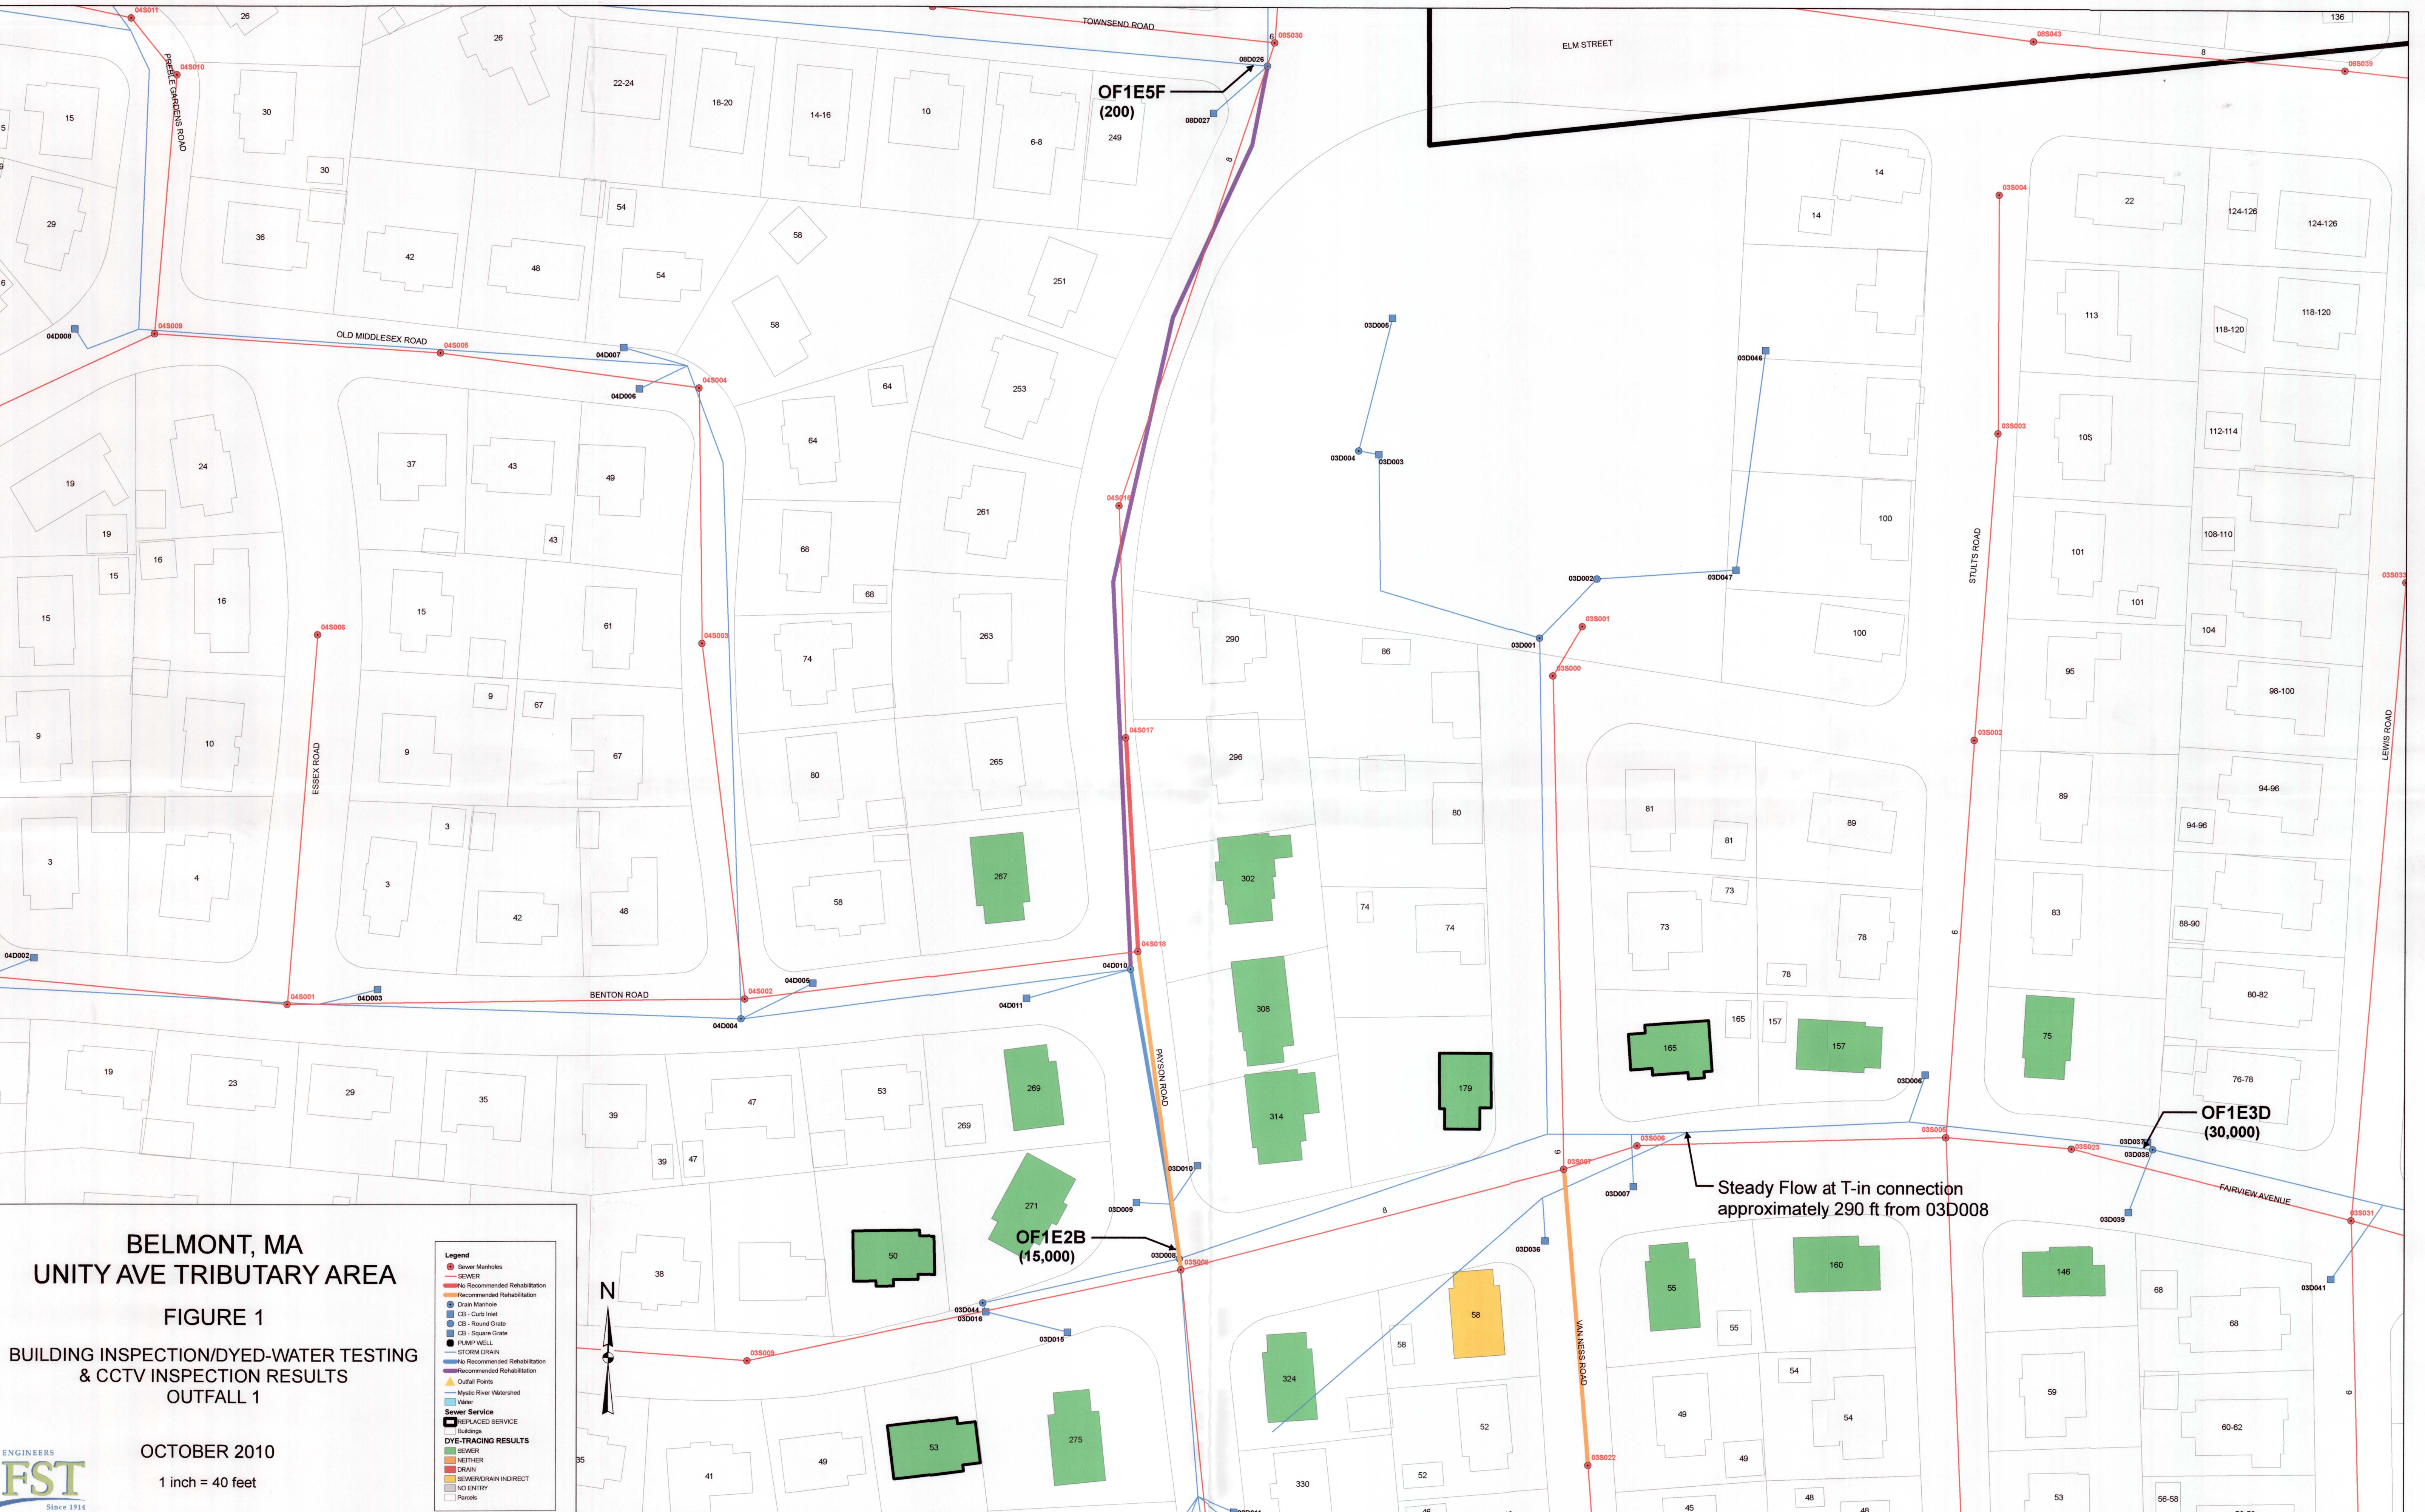
FIGURE 1

Approximately 300' of sewer and 690' of storm drain were CCTV inspected upstream of Sample OF1E2B. CCTV inspection showed both the sewer and the storm drain to be in fair to good condition. One sewer exfiltration point source was identified at a moderate/severe crack. However, with the sewer installed below the storm drain, the mainline does not appear to be a contributor of contamination. Sewer services from the targeted buildings were successfully dyed-water tested and showed no contamination to the storm drain. Table 3 shows that only the first of 5 samples returned a high E. Coli number (>15,000).

Dyed-water tracing identified 58 Van Ness Rd. (service to Van Ness Rd.) as an indirect source upstream of Sample OF1E3D. Sewer section 03S022-03S007 on Van Ness Rd. was televised and dyed-water flooded. However, the CCTV inspection was incomplete due to access limitations and broken service connection and did not reach the service from 58 Van Ness Rd. Dyed-water flooding identified no contamination to the storm drain, indicating the contamination emanates from the sewer service at 58 Van Ness Rd. House 58 was dyed-water tested in 2001/2002 with no dye observed in the storm drain. Both the sewer and storm drain mainlines on Fairview Ave. have been lined to Payson Rd. A 10" VCP drain that tees into the mainline, approximately 290 ft from 03D008, has steady flow but its origin is unknown.

As a result of these investigations, we do not believe a significant illicit connection exists in this area. To maintain structural integrity, we recommend two sewer point repairs and the lining of one section (172'). Refer to Table 2 for details.

We recommend replacement of the broken service connection to complete CCTV inspection of section 03S022-03S007 and the sewer service at 58 Van Ness Rd. The Town may also consider installation of a manhole on the 10" VCP drain to allow CCTV inspection.

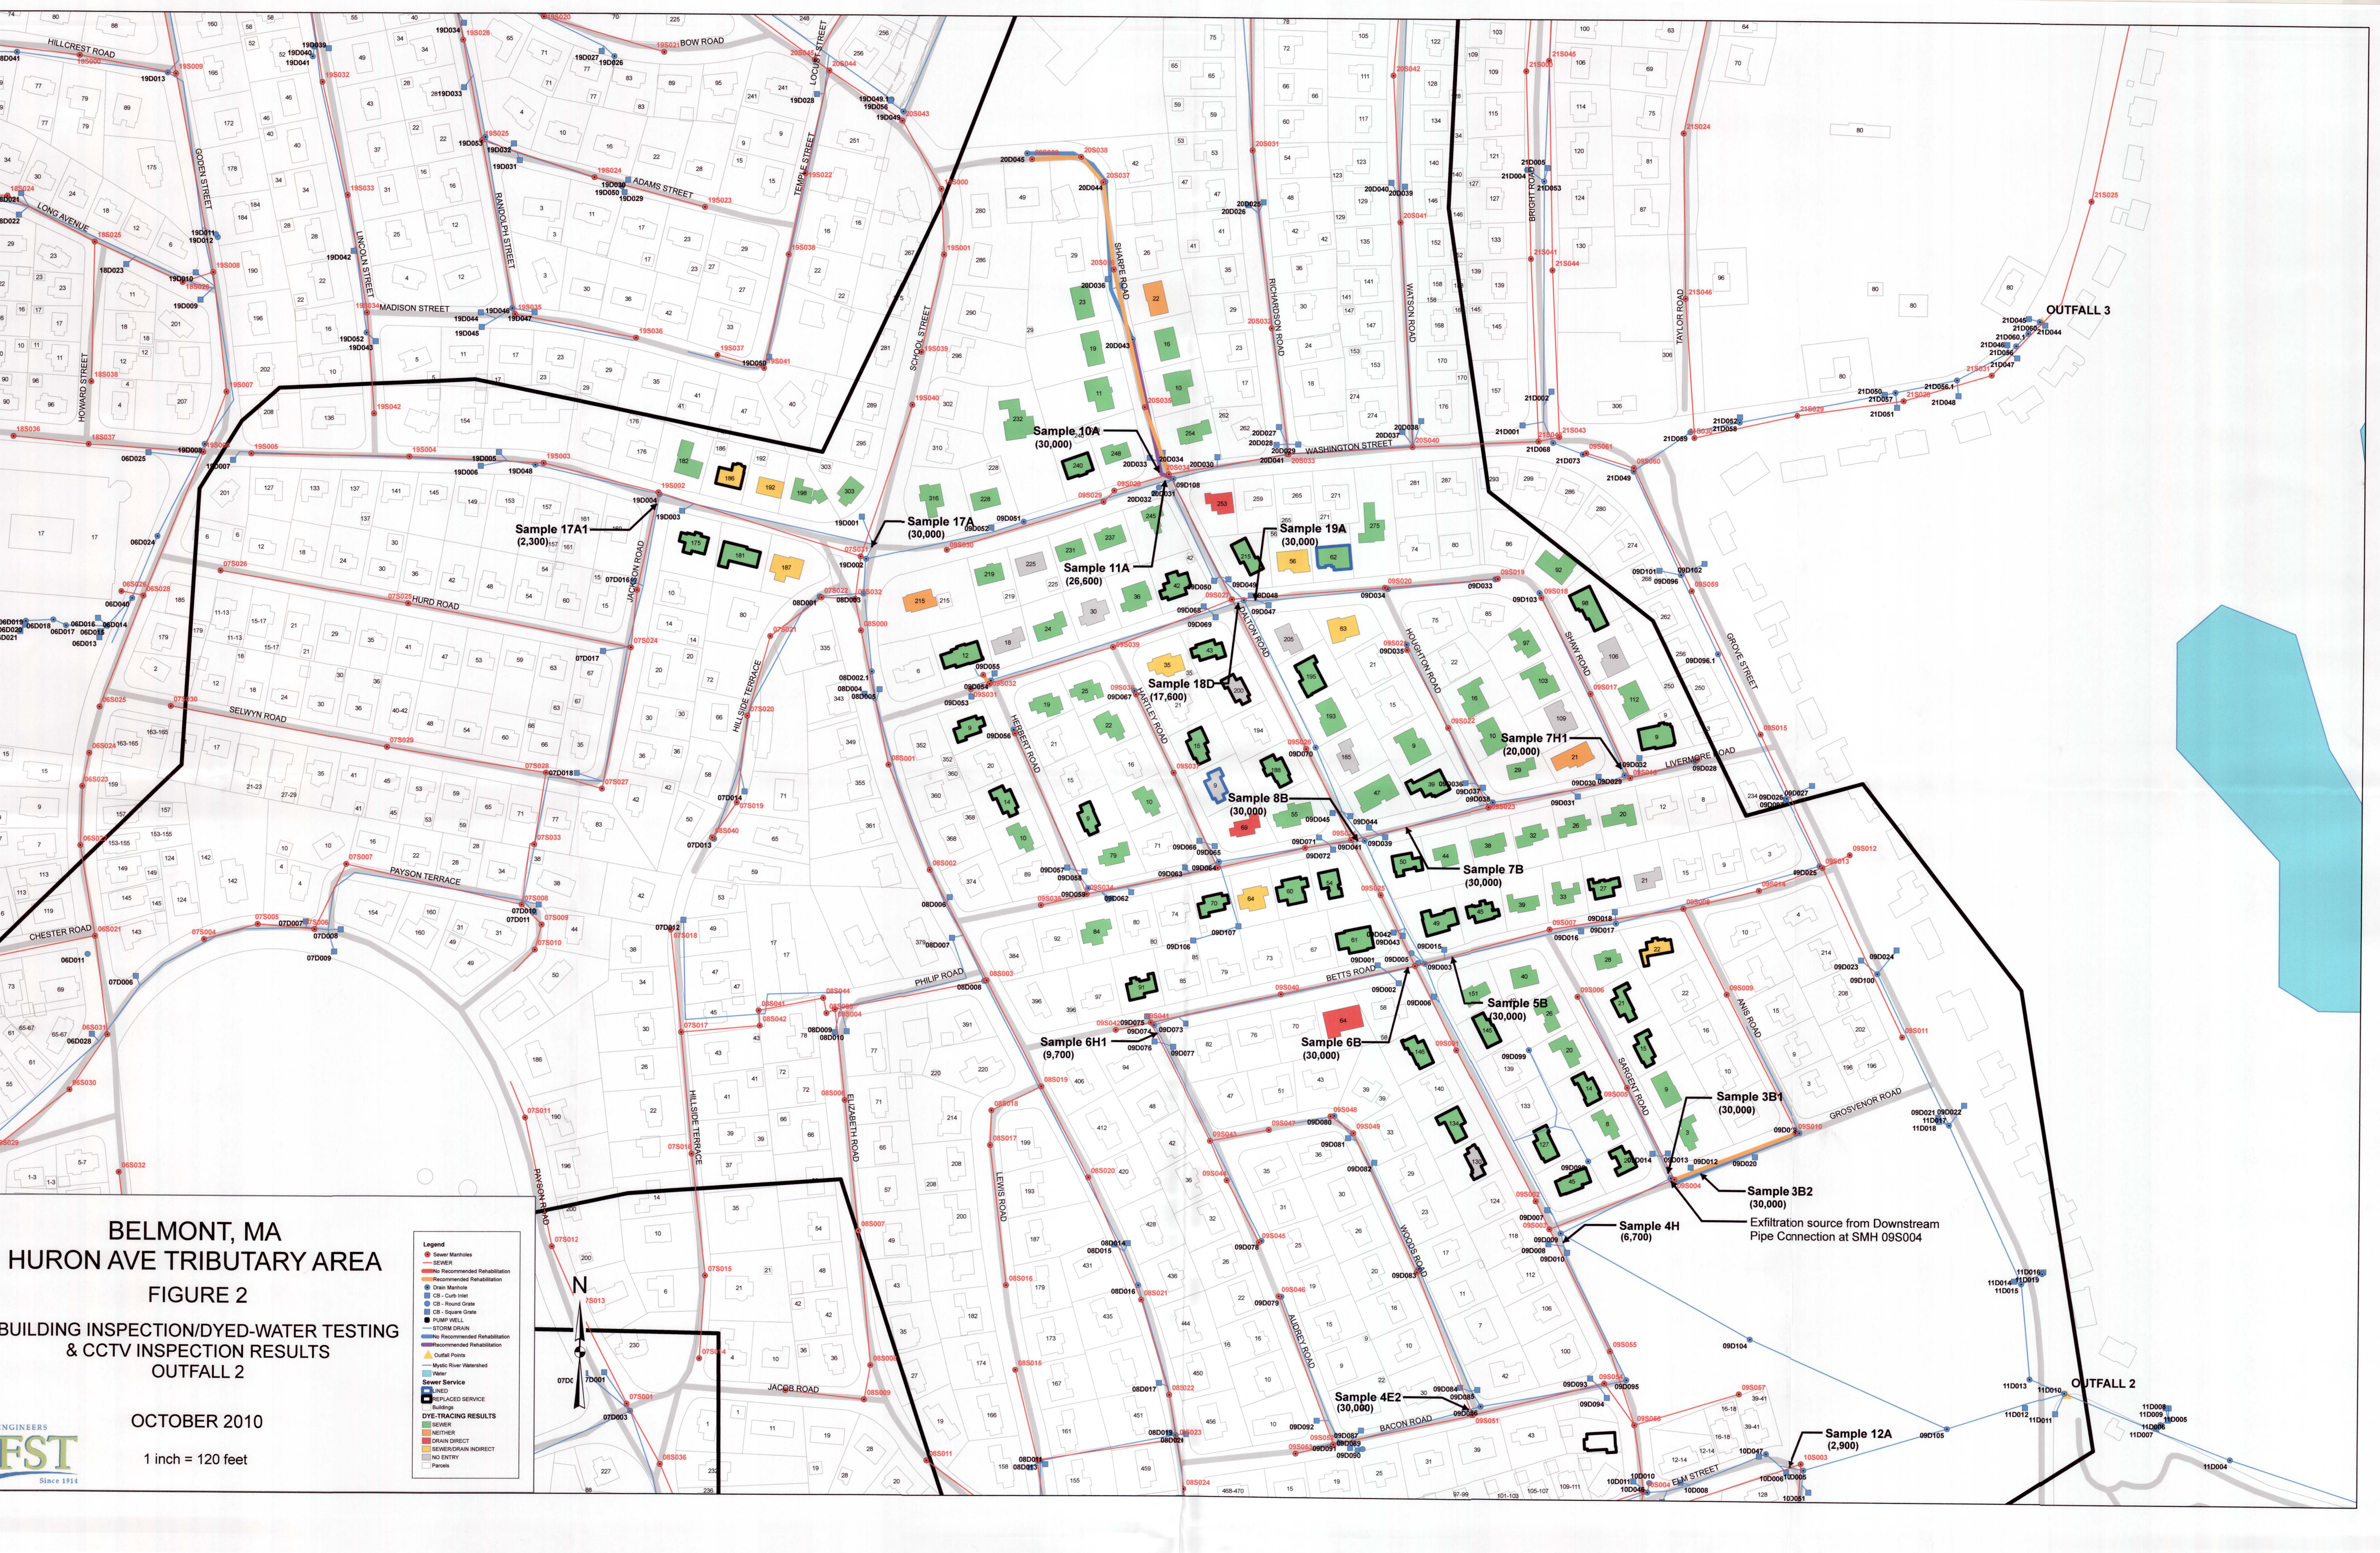
BELMONT, MA
HURON AVE TRIBUTARY AREA
FIGURE 2
BUILDING INSPECTION/DYED-WATER TESTING
& CCTV INSPECTION RESULTS
OUTFALL 2

All streets tributary to Dalton Rd. including Washington St., Sharpe Rd., Shaw Rd., Livermore Rd., Betts Rd., Grosvenor Rd. and Sargent Rd. exhibited dry weather storm drain samples greater than 15,000 E. Coli colonies per 100 mL. All but two tributaries along Dalton Rd. had dyed-water identified in the storm drain from either a direct or indirect source. The sewer in this area is generally located above the storm drain, allowing sewage exfiltration to easily infiltrate the storm drain below. With the exception of Sharpe Rd. and one section on Grosvenor Rd., the sewer mainlines in this area have been either replaced or lined based on previous illicit connection investigations.

Approximately 655' of sewer and 670' of storm drain were CCTV inspected upstream of Sample 10A. The sewer is located above the storm drain and is in poor condition. Many exfiltration sources were identified including moderate cracks and severely broken pipe sections at the invert. Sewer services from the targeted houses were successfully dyed-water tested and showed no contamination to the storm drain. Strangely, at 22 Sharpe Rd., dye was not identified in either the sewer or the storm drain, possibly due to a blockage.

Upstream of Sample 11A all sewer mainlines have been lined. Dyed-water testing showed three buildings to be indirect sources (186, 187, 192 Washington). One building at 215 Washington St produced an inconclusive dyed-water test due to the slope of the service (standing dyed-water was present in a service manhole in the yard). One building was not dyed-water tested.

Two indirect sources were identified upstream of Sample 18D. Dyed-water testing revealed one source to be the sewer service at 35 Shaw Rd. House 35 was dyed-water tested in 2001/2002 with no dye observed in the storm drain. The other source was a short section of non-rehabilitated sewer (09S064-09S032) that connects the sewer service at 12 Shaw Rd. to the mainline. CCTV inspection shows exfiltration sources evident by intruding roots at the joints. Two buildings were not dyed-water tested.

Upstream of Sample 19A, dyed-water testing showed sewer services at 56 and 63 Shaw Rd. to be indirect sources. Houses 56 and 63 were dyed-water tested in 2001/2002 with no dye observed in the storm drain.

Dyed-water testing showed all but three buildings upstream of Sample 7B connected to the sewer. 106 & 109 Shaw Rd. were not inspected or dyed-water tested. At 21 Livermore Rd., dyed-water was not identified in either the sewer or the storm drain. The 2001/2002 dyed-water testing program determined 109 to be an indirect source while no dye was observed in the storm drain from 106 and 21.

Investigations upstream of Sample 8B identified a direct connection from 69 Livermore Rd. and an indirect connection from 64 Livermore Rd. The 2001/2002 dyed-water testing program also determined 64 to be an indirect source, but no dye was observed in the storm drain from 69. According to the owner of 69 Livermore, the house has undergone significant renovations since the 2001/2002 investigations, including modifications to the main plumbing stack. The owner maintains that all work was done with proper permitting. However, we believe the plumbing stack may have been relocated and inadvertently connect to the drain service. One building was not dyed-water tested.

Upstream of Sample 5B, one indirect source was found at 22 Betts Rd. 22 Betts was categorized as a direct connection during the 2001/2002 dyed-water testing program and, consequently, the service was replaced to 37' in 2004. One building was not dyed-water tested.

A direct source was found from 64 Betts Rd., upstream of Sample 6B. Dyed-water placed in the sewer service was observed coming back into the house through a perimeter drain and then entering the storm drain service (cover photo). No dye was observed in the sewer main. It appears the sewer service is significantly damaged. 64 Betts was categorized as an indirect connection during the 2001/2002 dyed-water testing program.

Approximately 227' of sewer and 241' of storm drain were CCTV inspected upstream of Sample 3B2. The sewer is located above the storm drain and has two potential exfiltration point sources of moderate and severe broken pipe. Downstream sewer manhole 09S004 is potentially exfiltrating from the pipe connections.

All houses upstream of Sample 3B1 were inspected and dyed-water tested with no dye observed entering the storm drain. The entire sewer on Sargent Rd. (2 sections) has been replaced or lined.

House 253 Washington St. is determined to be an indirect source. This house has three separate plumbing stacks installed below the floor slab. Each stack was separately dyed-water tested with two showing 100% dyed-water to the storm drain on Dalton Rd. and one showing dyed-water to both the sewer and the storm drain on Dalton Rd. The sewer on Dalton was lined in 2006.

We recommend lining of sewer sections 20S037-20S034 (510') on Sharpe Rd. and CCTV inspection of the service from house 22. One point repair and four service replacements are required prior to lining. One storm drain point repair is also required. Refer to Table 2 for details.

We recommend CCTV inspection of the sewer services from house numbers 186, 187 and 192 Washington St.

We recommend replacement of section 09S064-09S032 (16') and CCTV inspection of the sewer services from house numbers 35, 56 and 63 Shaw Rd.

We recommend the Town verify that the plumbing in house number 69 Livermore Rd. has been installed in accordance with the plumbing code and direct the owner to correct any deficiencies. We also recommend CCTV inspection of the sewer services from house numbers 109 Shaw and 21 & 64 Livermore and continued efforts to dyed-water test 106 & 109 Shaw.

We recommend CCTV inspection of the sewer services from house numbers 22 and 64 Betts Rd. At 22 Betts, it is possible that the cast iron portion of the service, close to and under the house, has developed a leak. Replacement of at least a portion of the sewer service at 64 Betts Rd. appears likely.

We recommend lining of section sewer 09S010-09S004 (227') and rehabilitation of manhole 09S004.

We recommend rehabilitation of manholes 09S005 and 09S006 as a final mitigation measure in this area.

We recommend CCTV inspection of the sewer service(s) from house number 253 Washington St. Given that two of the dyed-water tests went 100% to the storm drain, we suspect a service break close to the storm drain in the street. Replacement of at least a portion of the sewer service(s) at 253 Washington St. appears likely.

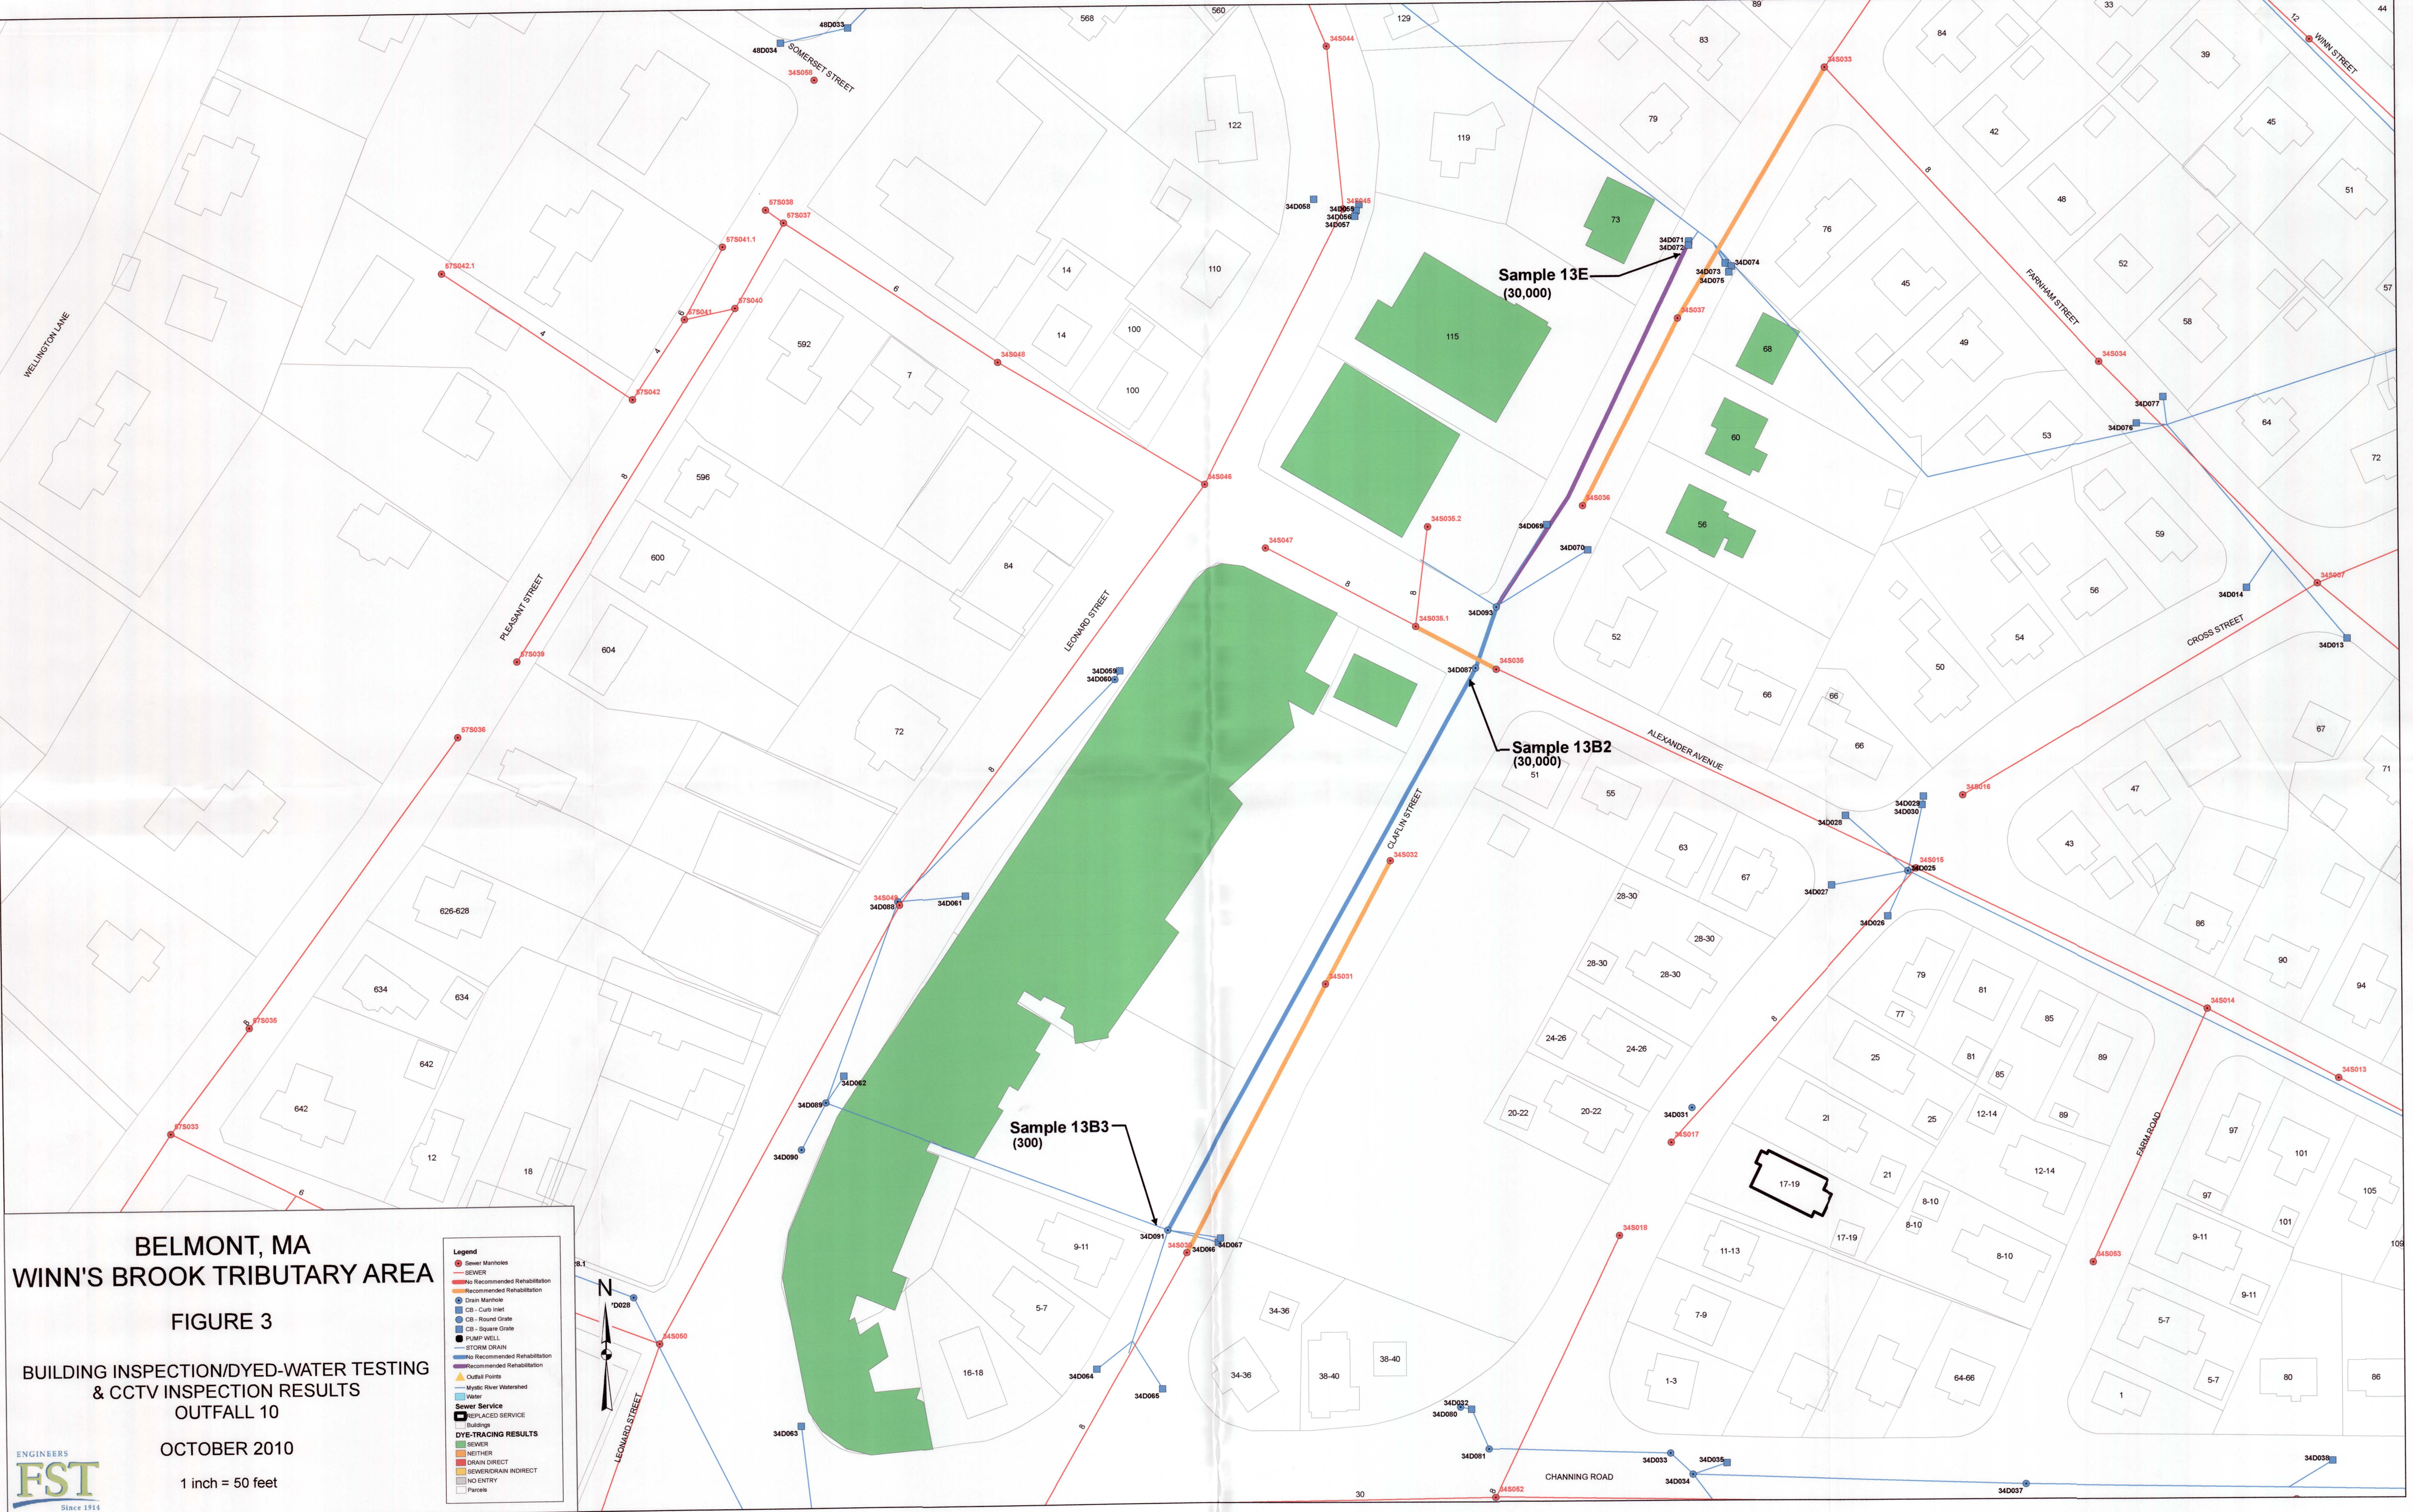
FIGURE 4

Approximately 720' of sewer and 790' of storm drain were CCTV inspected upstream of Sample 13E. The sewer was in fair to poor condition and the storm drain good to fair condition. In general, the storm drain is installed above and offset from the sewer. At the intersection of Clafin St. and Alexander Ave., the storm drain crosses under the sewer. This section of sewer on Alexander Ave. (34S035.1-34S035) was dye flooded during televising of the storm drain with no dye observed in the storm drain. This procedure was also performed in sewer sections 34S032 to 34S030 with similar negative results. All buildings dyed-water tested were connected to the sewer.

Approximately 418' of sewer and 688' of storm drain were CCTV inspected upstream of Sample 9E3. The sewer was in fair condition with some minor/moderate cracks, intruding roots at some joints and one collapsing pipe section. The storm drain was in good condition with only some minor cracks. Sewer section 47S018-47S017 was dye flooded during the televising of the storm drain with no dye observed in the storm drain. Dyed-water testing identified no sources, with two buildings not inspected.

Approximately 524' of sewer and 510' of storm drain were CCTV inspected upstream of Sample 9B6. Both the sewer and storm drain were in overall fair to poor condition. Sewer section 44S006-44S007 had offset joints with roots intruding along with a minor sag and some cracks exhibiting potential exfiltration sources. Dyed-water testing identified two indirect sources upstream of Sample 9B6. Both indirect sources, house nos. 22 and 23 Chilton St., are connected to deteriorated section 44S006-44S007 described above.

Approximately 524' of sewer and 510' of storm drain were CCTV inspected in the vicinity of sample 5B. The sewer and storm drain appeared to be in overall good condition. The sewer was dye flooded from manhole 37S022 during televising of the storm drain with no dye observed in the storm drain. Dyed-water testing identified two indirect sources upstream of Sample 5B from house 99 Sherman St. and 70 Waterhouse Rd. Both houses identified as an indirect source have sewer and storm drain services in close proximity to each other, with the storm drain located below the sewer.

All buildings upstream of Sample 3B were inspected and dyed-water tested with no sources identified. The entire sewer on Westlund Rd. (3 sections) has been replaced or lined. However, flow in the sewer is sluggish and standing sewage is evident in sewer manhole 37S030. The storm drain under manhole 37S030 (37D050-37D053) has not been rehabilitated. It is plausible that sewage is slowly exfiltrating from manhole 37S030 and not observed in the dyed-water testing.

Dyed-water testing identified two sources upstream of Sample 4H. A direct connection was found at 67 Hoitt Rd. and an indirect connection from 55 Hoitt Rd. House 67 was dyed-water tested in 2001/2002 with no dye observed in the storm drain. House 55 was not dyed-water tested in 2001/2002. House no. 45 Waterhouse Rd. was not dyed-water tested during these or the 2001/2002 investigations. All sewer sections upstream of Sample 4H have been lined.

As a result of these investigations, we do not believe a significant illicit connection exists in this area. To maintain structural integrity, we recommend the lining of three 8-inch sewer sections (510') and one 15-inch storm drain section (276'). One point repair and one service replacement are also required. Refer to Table 2 for details. Sewer section 34S035.1-34S035 on Alexander is scheduled for lining in 2011 as part of the Winn's Brook Sewer Overflow Mitigation project.

We recommend lining of sewer sections 47S018-47S017 and 43S006-43S008 (418' total). One point repair and two service replacements are required prior to lining.

We recommend the lining of sewer sections 44S006-44S009 and storm drain sections 44D005-44D015 (925' total) and three service replacements. We also recommend CCTV inspection of the sewer services from house numbers 22 and 23 Chilton St.

We recommend CCTV inspection of the sewer and storm drain services from house numbers 99 Sherman St. and 70 Waterhouse Rd. One structural storm drain point repair is also required.

We recommend rehabilitation of manholes 37S029, 37S030 and 37S031 as a final mitigation measure in this area.

We recommend the sewer service be disconnected from the storm drain and reconnected to the sewer. The sewer is approximately 1'-6" above the storm drain so that complete relaying of the

service and internal plumbing modifications may be necessary for a gravity service to be maintained. We also recommend CCTV inspection of the sewer service from house number 55. Entry to 45 Waterhouse is required for 100% complete dyed-water testing in this area.
