September 16, 2011

Subject: Belmont, Massachusetts  
2011 Illicit Connection Identification Program  
Outfall Areas 1, 2 & 10  
**Report of Findings**

BELMONT, MASSACHUSETTS  
2011 PRELIMINARY DESIGN REPORT

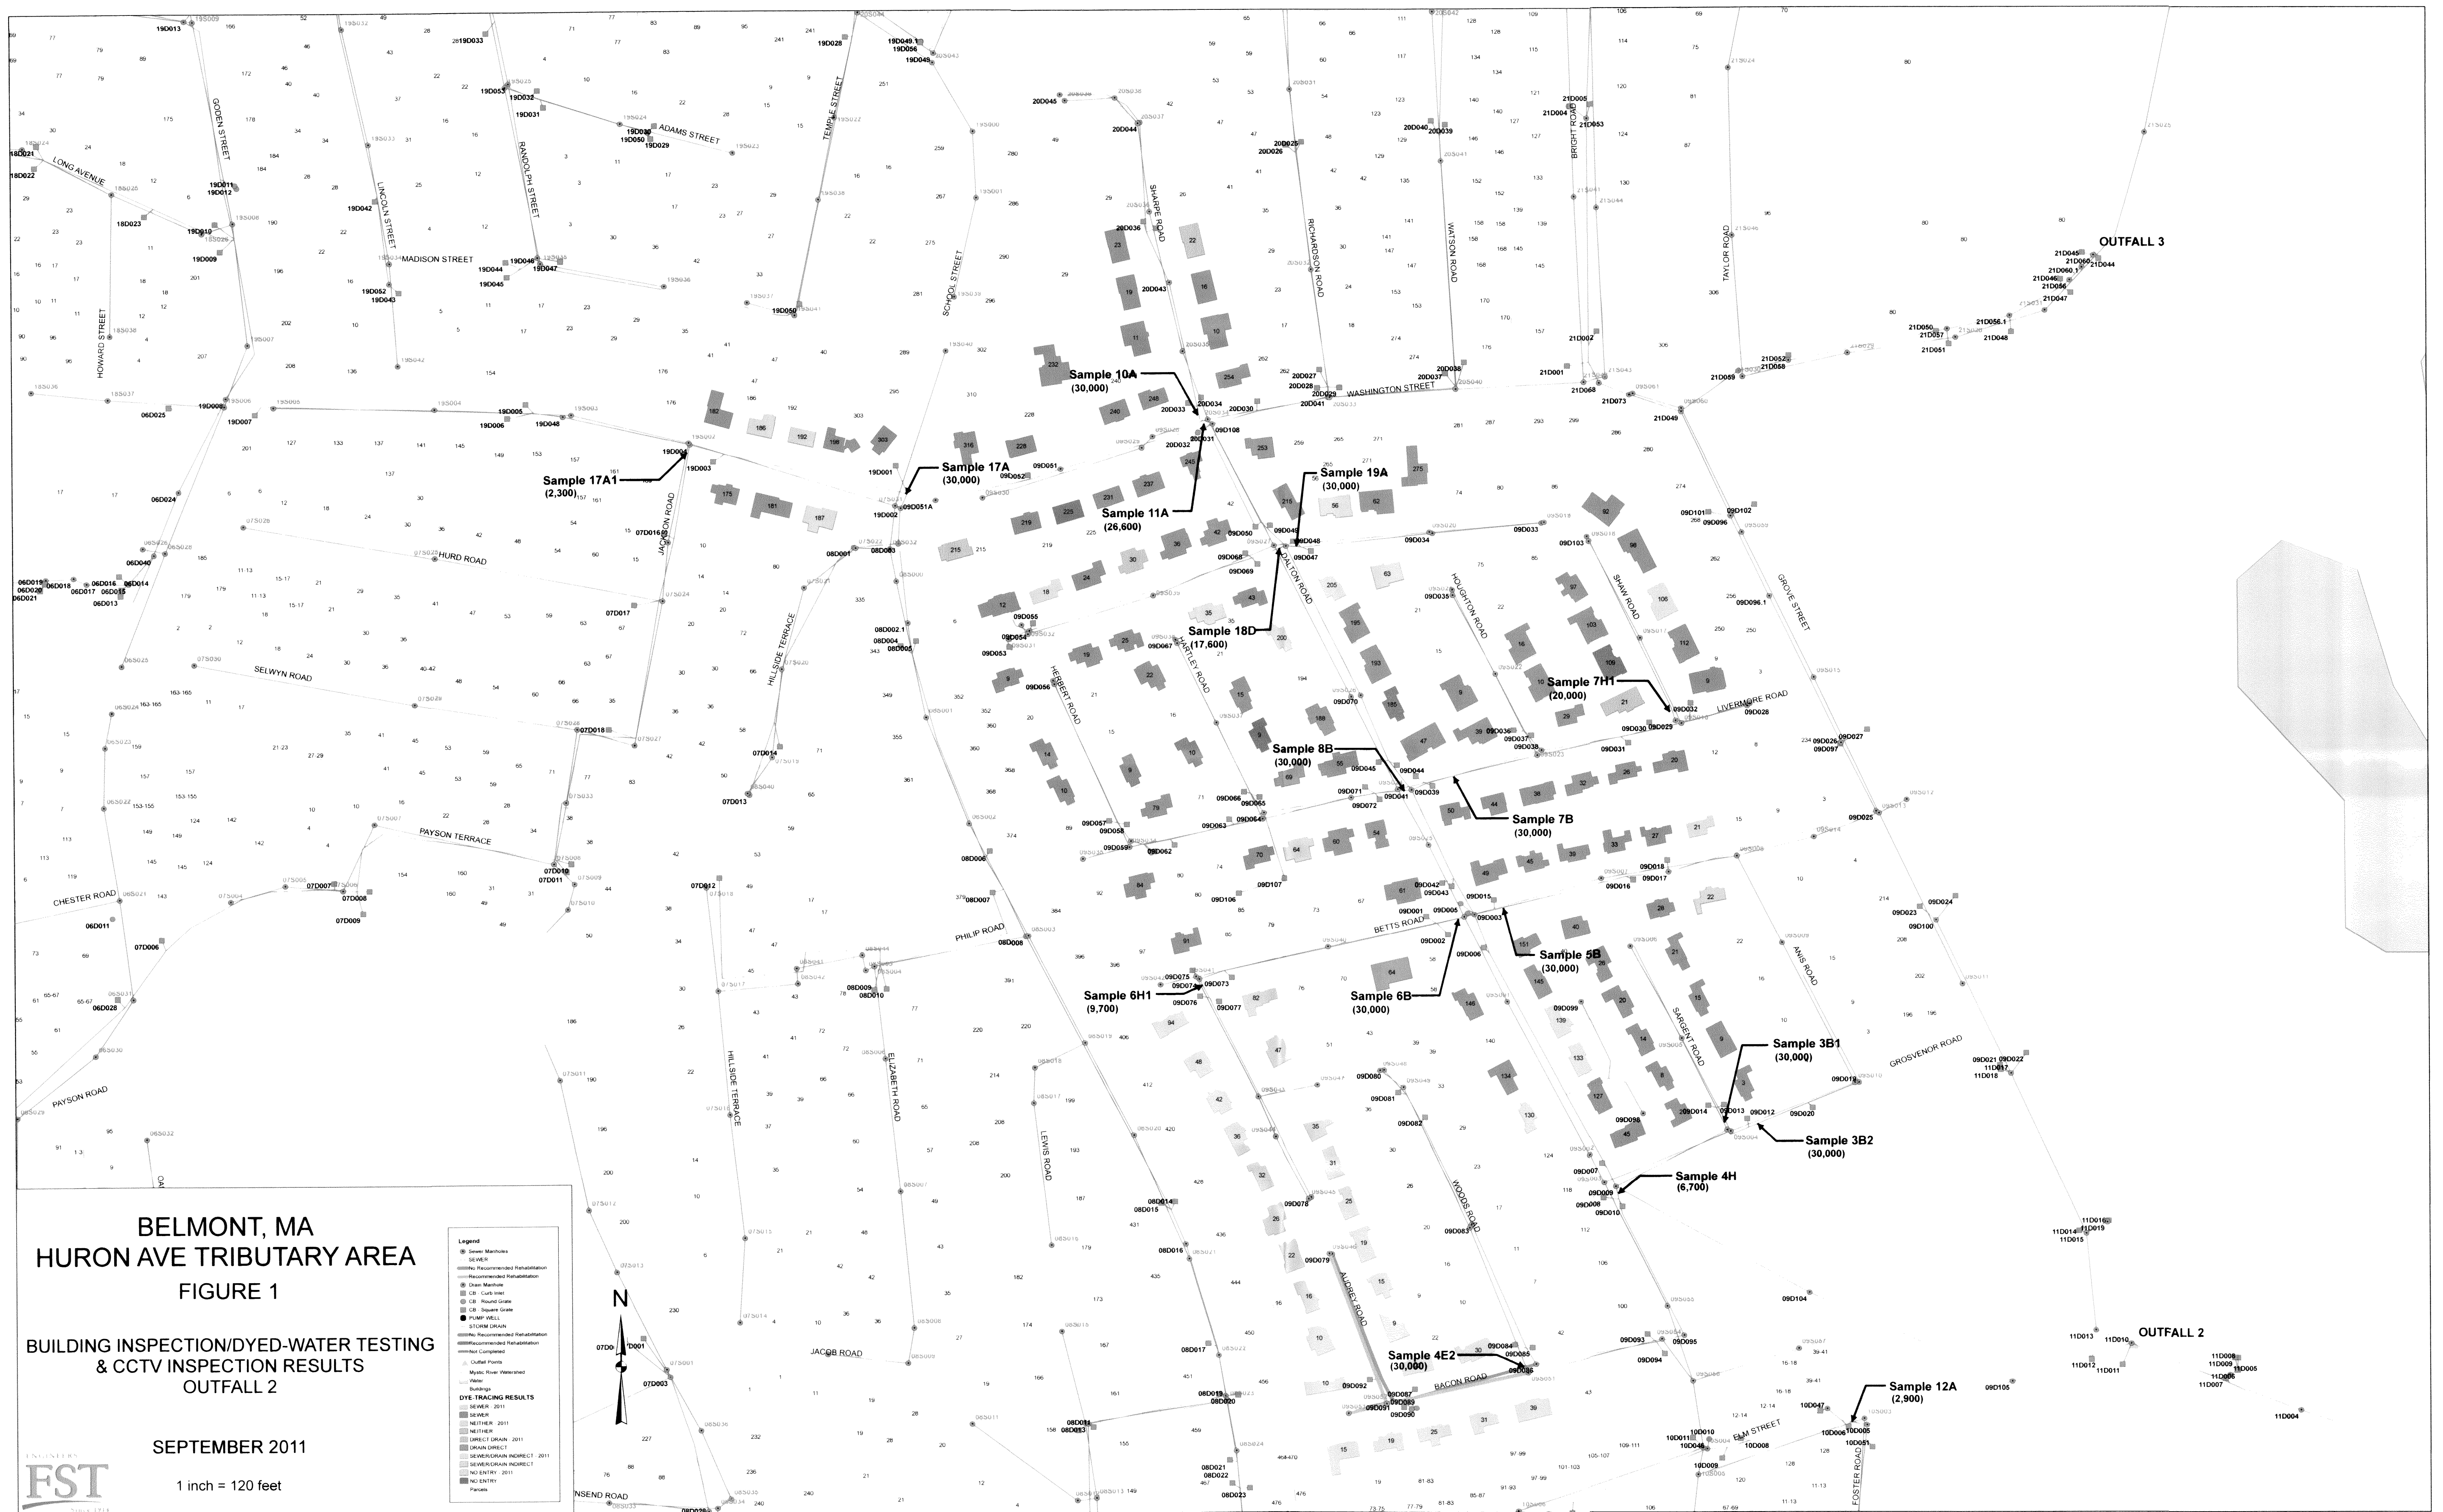
#### **OUTFALL AREA 2 (Figure 1)**

Three sewer sections (595') and three storm drain sections (593') were CCTV inspected upstream of Sample 4E2. All three sewer sections were found to be in poor condition. Several exfiltration point sources were identified throughout the sewer sections that included severe broken pipe, longitudinal cracks and poor services connections. The storm drain was found to be in good structural condition with some minor roots and offset joints found throughout. Active infiltration was also identified in section 09D079-09D091. Infiltration into the storm drain is typically not an immediate concern. However, in this location the sewer is installed above the storm drain and, with several exfiltration point sources identified, contamination is probable.

All sewer services within this area were successfully dyed-water tested. Potential indirect sources were identified from 9 Audrey Rd. and 10 Bacon Rd. 10 Bacon Rd. was initially dyed-

water tested with no dye observed in the storm drain. Approximately one hour later, 9 Audrey Rd. was dyed-water tested with indirect dyed-water observed emanating from storm drain section 09D091-Stub, adjacent to 10 Bacon Rd. Both sewer services were subjected to CCTV inspection and contain minor/moderate defects. Sewer section 09S053-09S052, adjacent to 09D091-Stub, was dyed-water flooded for 40 minutes with no dye observed in the storm drain.

The area tributary to Sample 6H1 has undergone previous rehabilitation which included full-length pipe replacement or cured-in-place lining of the three sewer sections. Therefore, CCTV inspection of the mainline was not conducted in this area. All sewer services within this area were successfully dyed-water tested with indirect dyed-water observed at 47 Audrey Rd. This house was dyed-water tested in 2001/2002 with no dye observed in the storm drain. The sewer service at 47 Audrey Rd. was CCTV inspected and contains a separated joint and minor cracks.

Eight buildings were successfully dyed-water tested as carryover from the 2010 investigations. At seven locations dyed-water was observed only in the sewer. At 30 Shaw Rd. 100% of the dyed-water was observed in the storm drain system, indicating a direct connection. However, 2001/2002 dyed-water testing determined 30 Shaw Rd. to be an indirect connection with 90% of the flow still going into the sewer. It is likely that the service lateral has now completely failed. Four houses remain uninspected and will continue to be incorporated into future investigations.

*We recommend lining of the three 8-inch sewer sections upstream of Sample 4E2 (595') and 2 services at 10 Bacon Rd. and 9 Audrey Rd. Three additional services are recommended for lining and 2 point repairs are required prior to lining. The Town may also consider installation of a drain manhole on Bacon Road at the capped drain line upstream of 09D091 for future access and maintenance.*

*We recommend lining of the service at 47 Audrey Road.*

*We recommend replacement of the sewer service at 30 Shaw Road.*

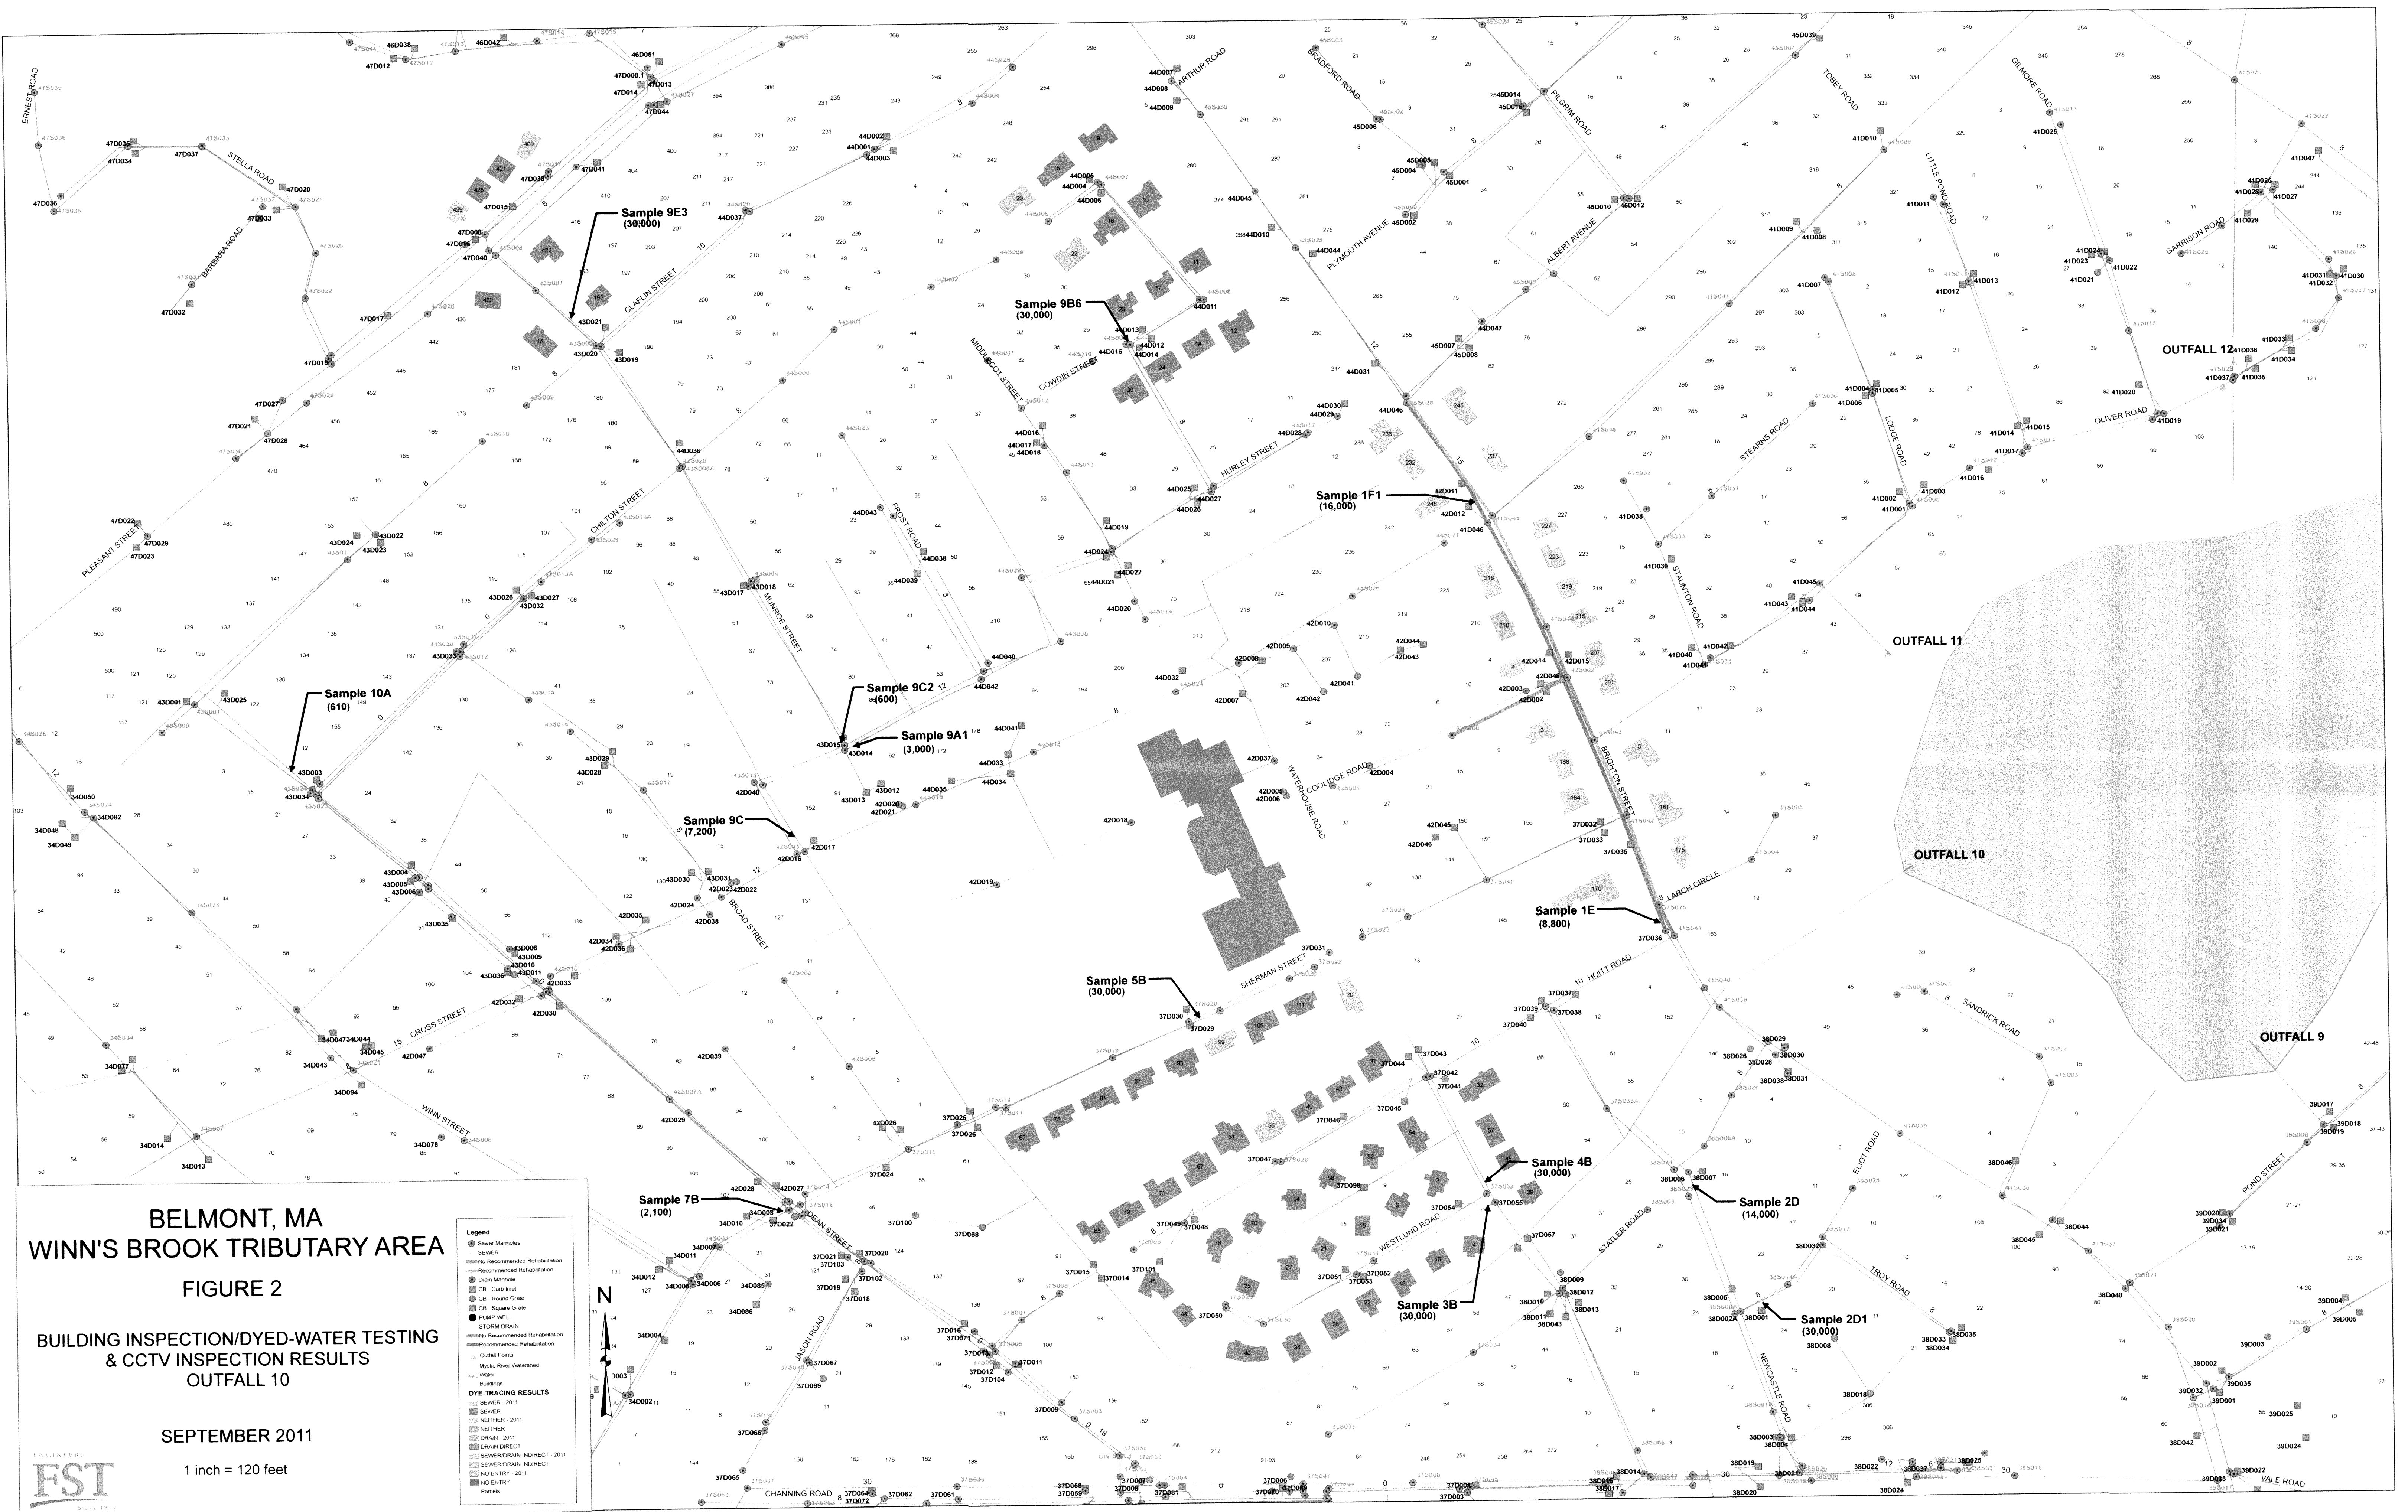
#### **OUTFALL AREA 10 (Figure 2)**

Approximately 1241' of sewer and 1016' of storm drain were CCTV inspected on Brighton St. upstream of Sample 1E (from Hoitt Rd. to Albert Ave.), including one perpendicular section of sewer on Coolidge St. The sewer varied from good to poor condition with defects consisting of cracks, broken pipe, active infiltration and several broken services. The sewer on Coolidge St. transitions to ductile iron and passes through drain manhole 42D048. The storm drain was in poor condition with lengthy longitudinal cracks at the top and spring lines of the pipe. The elevation of the storm drain is level with or below the sewer, with a varying horizontal offset of 3'-10'. Sewer services on the Northwest side of Brighton Street cross over the storm drain.

All buildings upstream of Sample 1E (Hoitt Rd.) to Albert Avenue were targeted for dyed-water testing. Direct dyed-water was observed from 210 Brighton St. and the CCTV video shows no sanitary connection in the vicinity. Indirect dyed-water was observed from 188 Brighton St. with CCTV of the lateral revealing a sag and minor cracking.

Attempts at four buildings were unsuccessful, including two along section 44D046-41D046. Notably, portions of the CCTV video of this section show what appears to be toilet paper visible in the flow. However, it can not be determined from the video if the source is from within section 44D046-41D046 or upstream.

No dyed-water was observed from 170 Brighton St. (corner of Hoitt Rd.) in either the sewer or the storm drain. CCTV inspection was expanded to include sewer section 09S041-37S026 on Hoitt Rd., however, the only sewer service identified was at 173' from 09S041, which is past the property line of 170 Brighton St. Section 41S042-37S025 on Brighton St. contains two services in the direction of house 170. Upon subsequent lateral CCTV inspection, one sewer service located at 110' from 41S042 was capped. A second service located at 139' from 41S042, contained a severe blockage at 22' due to an apparent root ball.

*We recommend lining three sections of 15-inch sewer (604'), three sections of 24-inch storm drain (1,016') and 2 services at 170 and 188 Brighton Street. Two additional services are recommended for lining and 2 service replacements are required prior to lining. The sewer service for 210 Brighton Street must be disconnected from the storm drain and connected to the sewer. The storm drain is level with the sewer so that complete relaying of the service and internal plumbing modifications may be necessary for a gravity service to be maintained.*
