The Bradford (Former Cushing Village) Update

Presented Virtually
February 25, 2021

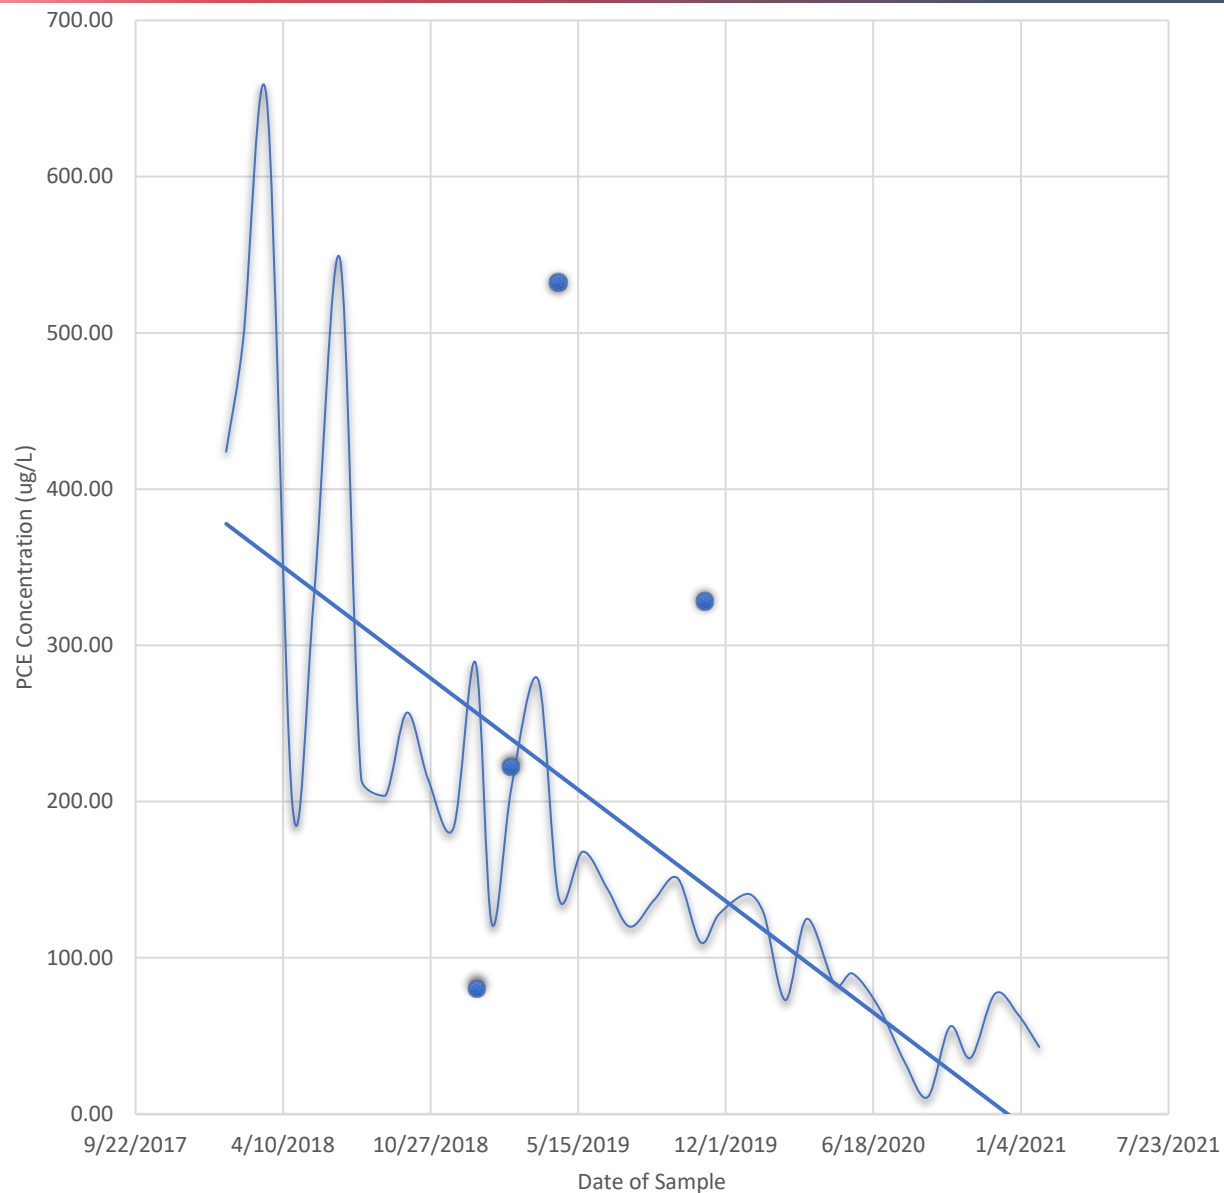
Influent PCE (ug/L)

Permanent Sub-Slab Dewatering System Influent Concentration Trend

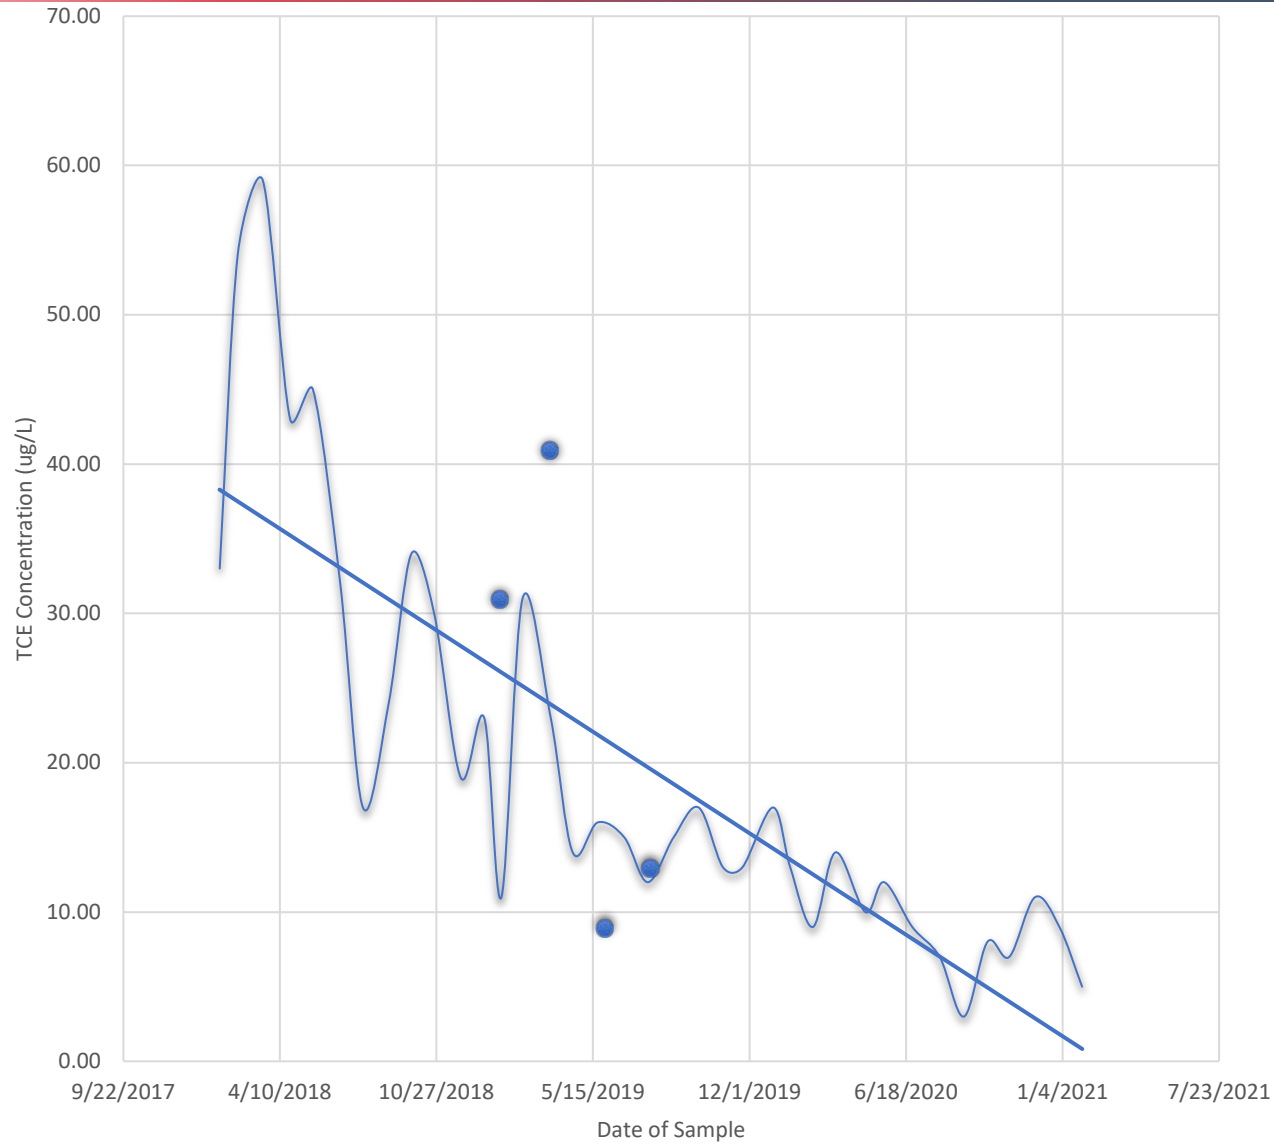
Influent TCE (ug/L)

Permanent
Sub-Slab
Dewatering
System
Influent
Concentration
Trend

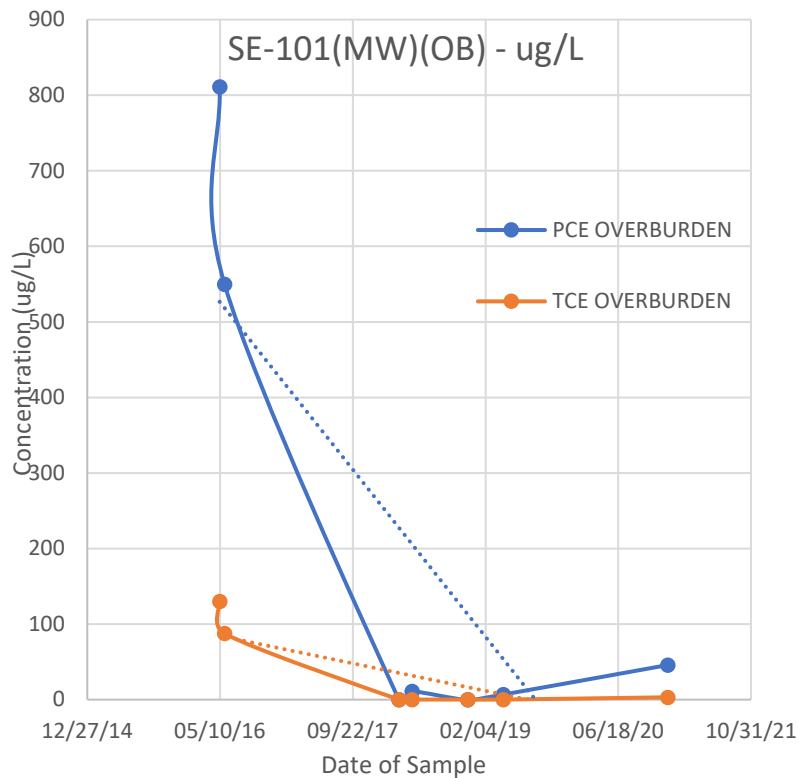
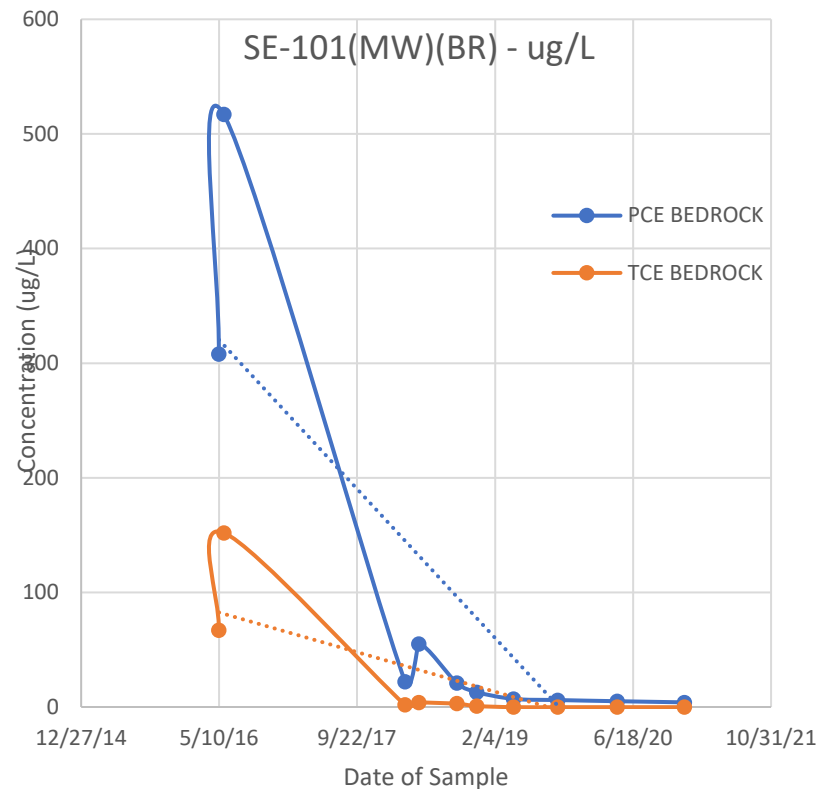
➤ Overall results continue to show a stable to decreasing trend

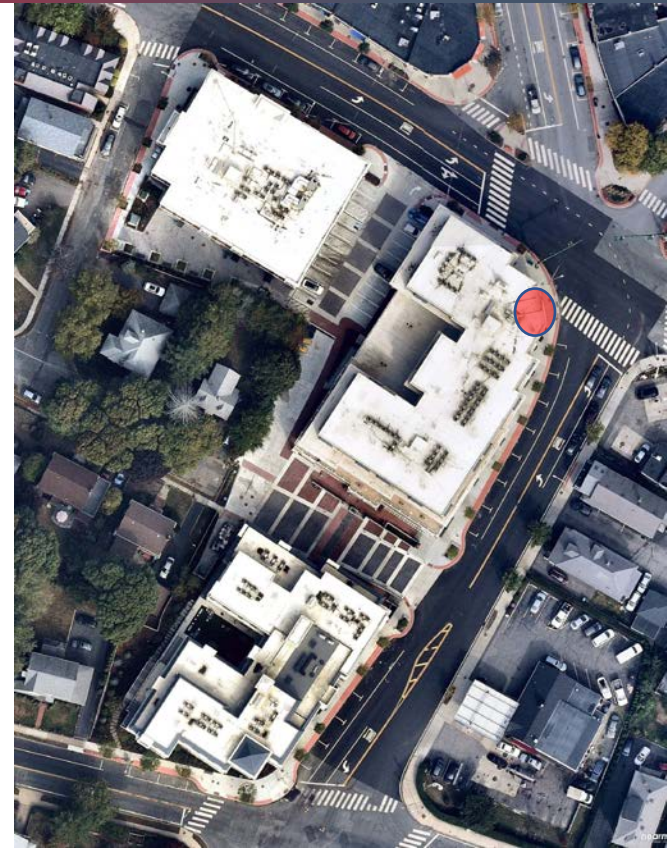
- Source of VOCs found to be coming from a small room in the garage known as the mechanical room.
 - This was derived after an extensive investigation of possible other sources which lead to the room.
 - The room contains garage heating units and controls for floor drain collection pumping equipment.
 - VOCs found to be entering the room from a number of different sources:
 1. Floor drain;
 2. Electrical conduits from the floor drain collection sumps; and
 3. Floor seam between the foundation floor and wall.

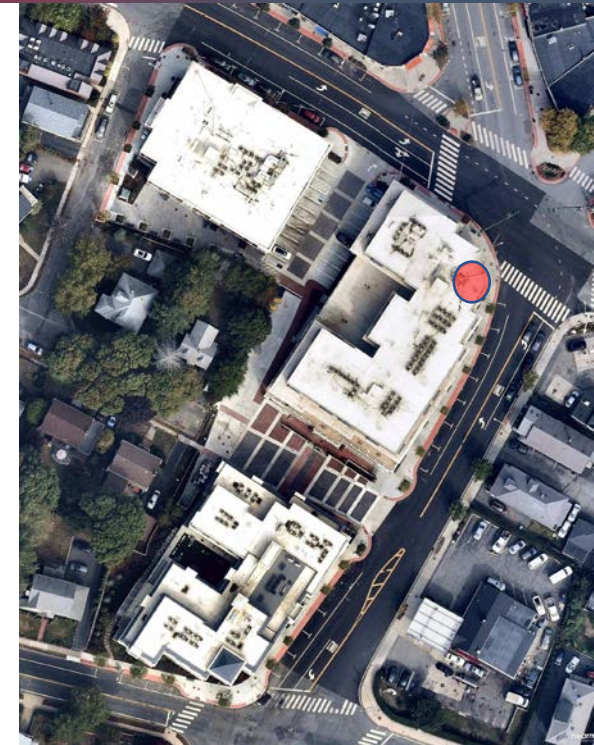
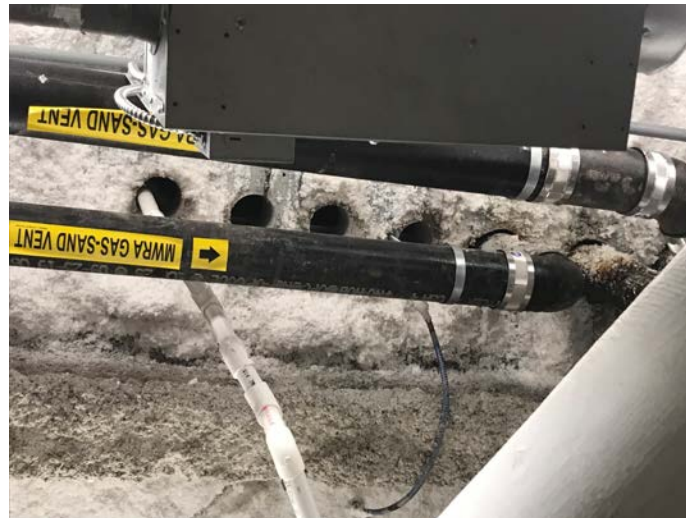
- Vapors are entering the mechanical room through a number of different paths/conduits which enter the room.
- From there, vapors appear to migrate up through the mechanical room into the plenum space of the lobby above by way of multiple utility penetrations.
- From there vapors are pulled through the plenum into the lobby by way of a dedicated HVAC system.
- Once in the lobby, they enter the upper floors through the elevator shaft and stairwell.
- Over the period of investigation, implementation of corrective actions in the mechanical room have had direct and immediate effect on indoor air levels.
