Underwood Playground

Belmont, Massachusetts

Recreational Feasibility Report and Preliminary Design

April 2, 2013

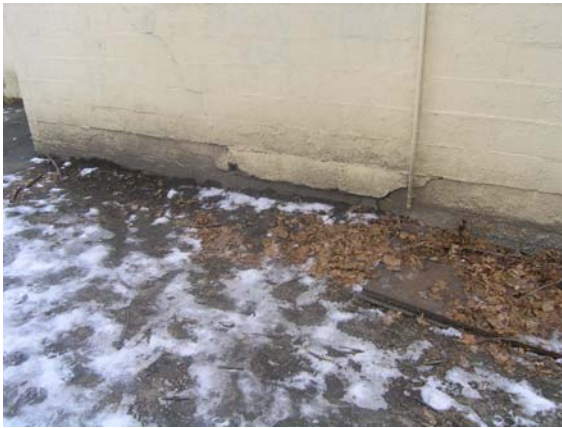
There is evidence of ground loss and movement at the foundation. Stepped cracks indicate a shifting of the foundation that have caused cracking up through the structure. Significant mortar loss was observed at the lower courses of concrete masonry.

Cracking at West Elevation

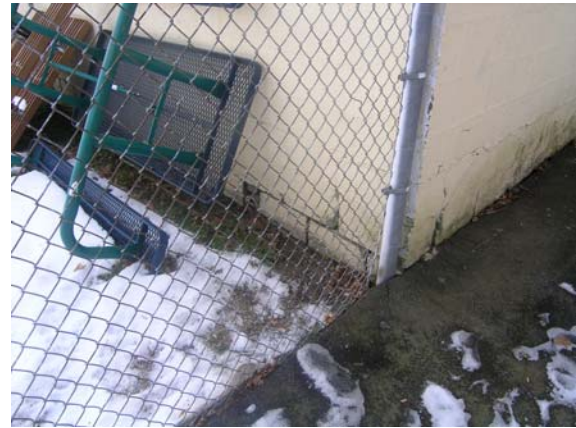
Open Masonry Joints at northwest corner.

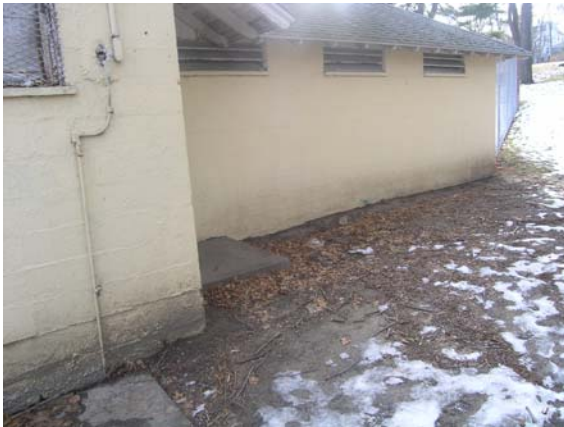
- Exterior surface has been parged to provide a smooth stucco like appearance.
- Cracks and weathered joints were observed in the masonry.
- The lower courses of CMU, closer to the ground are stained and show more weathering from splash back and run-off hitting the surface.
- Surface defects, minor chips and cracks are typical around the building.

Walls at southwest corner.

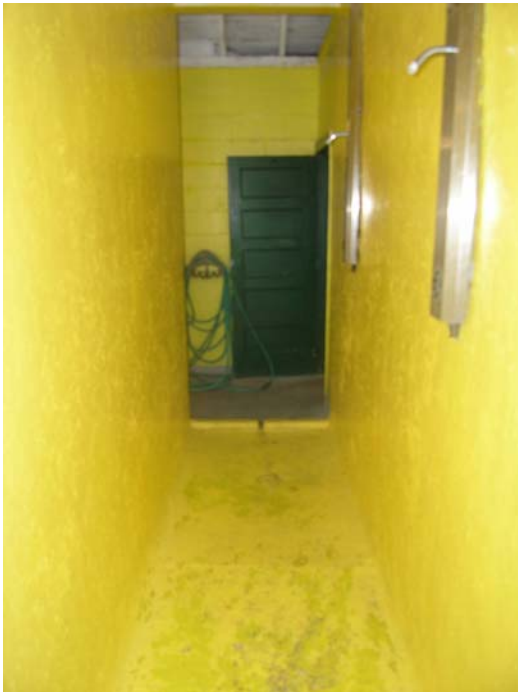
Existing showers

There are two showers located at the back of the entry lobby. The showers are screened from the entry but provide no privacy for users. The showers can be used as a rinse shower by bathers; bathers cannot take a cleansing shower with soap as required by code. The showers are not handicapped accessible. The hide-a-pipe shower units are appropriate for this application; similar units would be used for a new or renovated bathhouse.

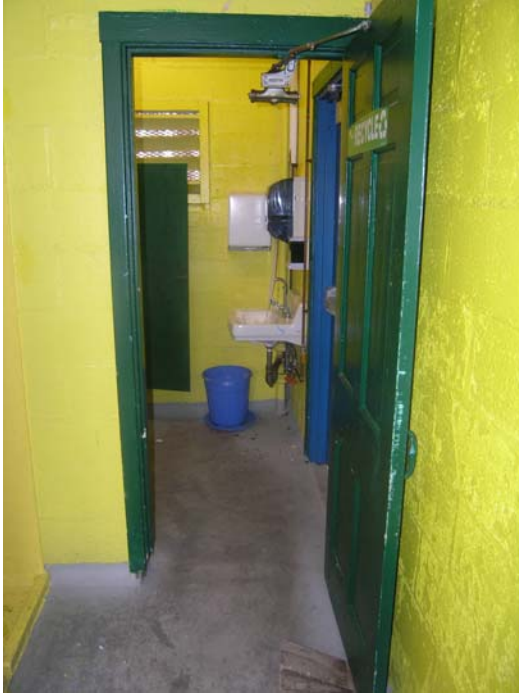
View into Men's Room

The quantity of toilet room fixtures is inadequate for the number of bathers. The fixtures do not provide provisions of individuals with disabilities.

All units are maintained and in fair condition.

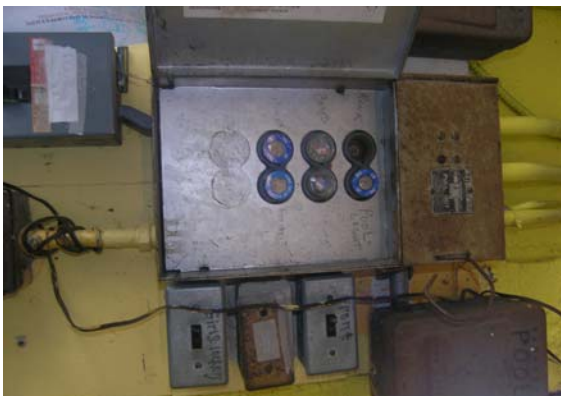
- The panels and conduit are older; corrosion is visible on devices. Older plug fuses are still used on certain panels.
- Light fixtures are caged fluorescent strip fixtures; the fixtures are not lensed which is required by code in a bathhouse building.
- There is no emergency lighting or exit signs that are required by code. The building is not equipped with a fire detection or alarm system.

Sub-panels in lobby

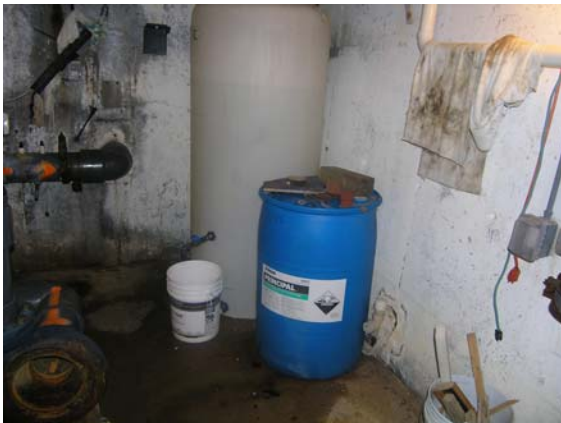
- The filter room is constantly wet from ground water and must be pumped. The room has been flooded in the past.
- The building is considered a confined space and should have two means of egress.
- The lighting and electrical components are showing signs of corrosion. Light fixtures are not guarded.
- Working clearances between equipment and switches are minimal and not ideal for service.

Active Leaks

The filter equipment must be moved above grade to avoid the continual leaks and periodic flooding experienced at the existing structure. Modern filtration equipment can be housed in a simple structure that will provide easy and safe access to Town personnel maintaining the pool.

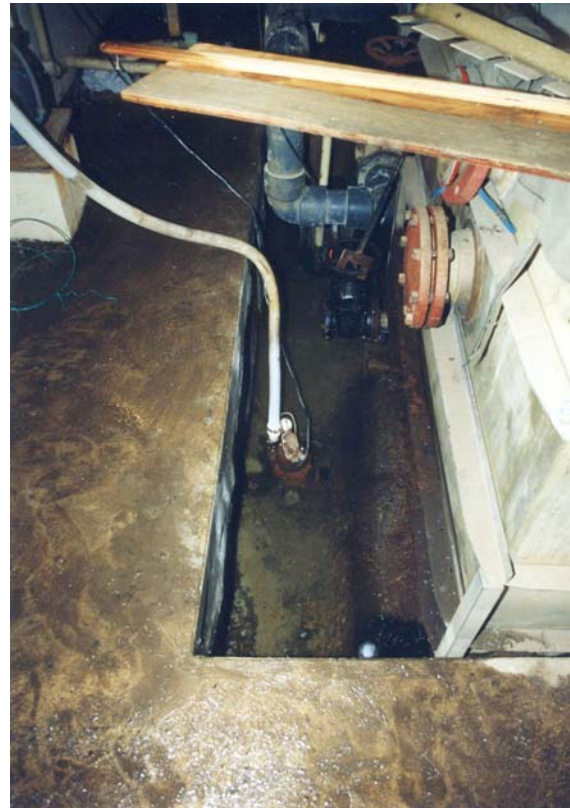
Submersible Pump in Operation to remove ground water
