# 3.1.4 EVALUATION OF EXISTING CONDITIONS

# 3.1.4 - EVALUATION OF EXISTING CONDITIONS

**RE: Historic Status, Belmont High School**

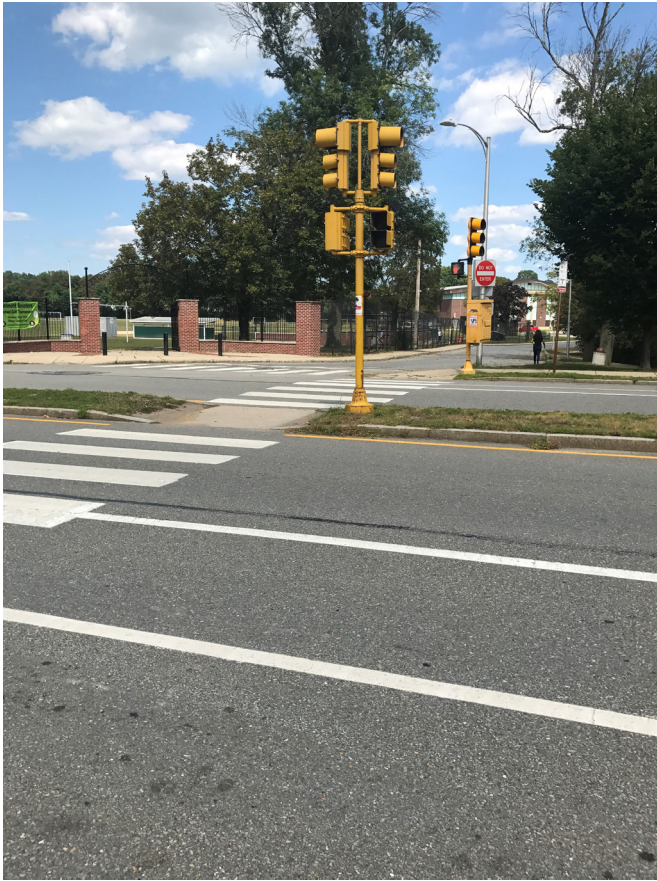
Figure 11 Pedestrian Crossing Signal at Concord & Orchard

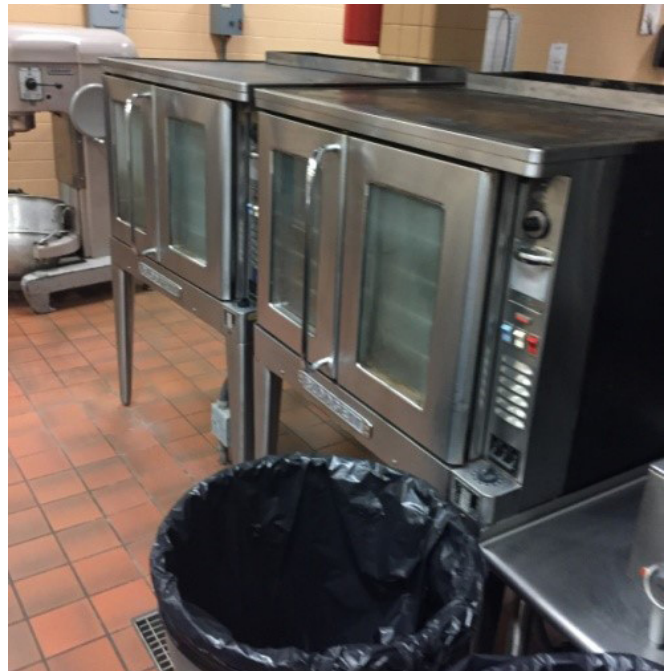
*Shown here are two single convection ovens which are nearing the end of the life cycle (ten years). New gas fueled units are Energy Star rated which qualifies them for a rebate from the gas company.*

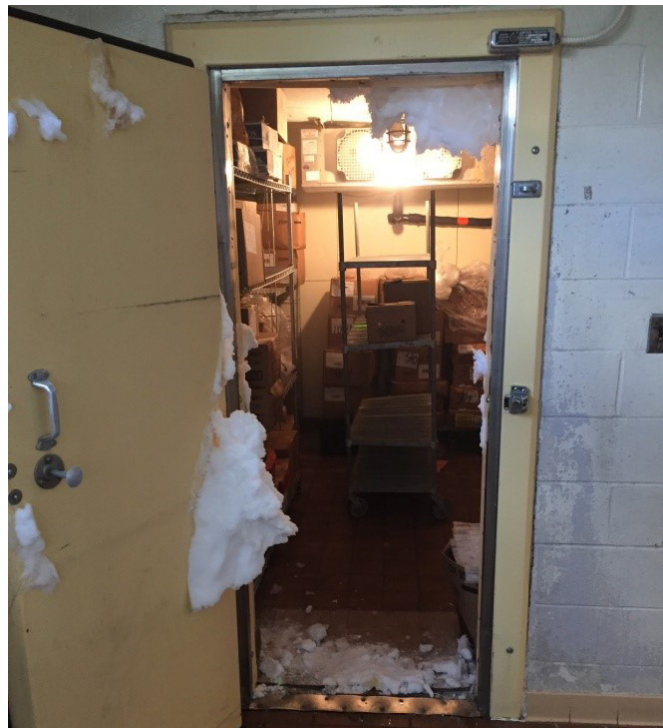
*The walk-in refrigerated rooms are old and constructed from masonry with a stucco rough texture finish on the walls and ceiling. The picture above shows mold spores growing on the surface of the ceiling. The picture above shows ice build-up around the door frame which is indicative of poor room insulation and broken or missing door seals. A new walk-in will provide additional storage capacity and Energy Star rated refrigeration systems that will save energy. It'll provide insulated walls and door panels to that meet the requirements of the National Sanitation Foundations. The panel surface finishes will meet the board of health requirements for cleaning. Doors will be equipped with a view port window for safety.*
