# MASTER PLAN AND FEASIBILITY STUDY FOR RENOVATIONS TO BELMONT HIGH SCHOOL

Submitted October 15, 2004

Design Partnership of Cambridge, Inc.  
Architects, Planners, Programmers  
Hood Business Park  
500 Rutherford Avenue  
Charlestown, MA 02129  
Robert Vogel, AIA

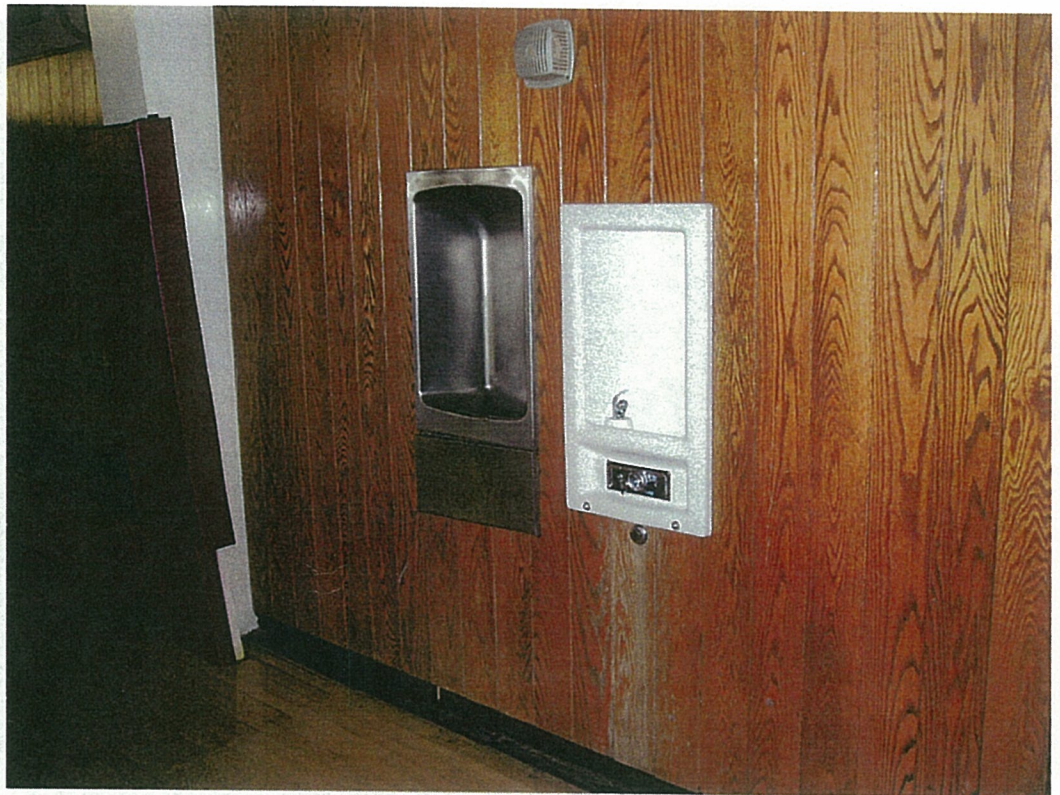
NON-ACCESSABLE DRINKING FOUNTAIN

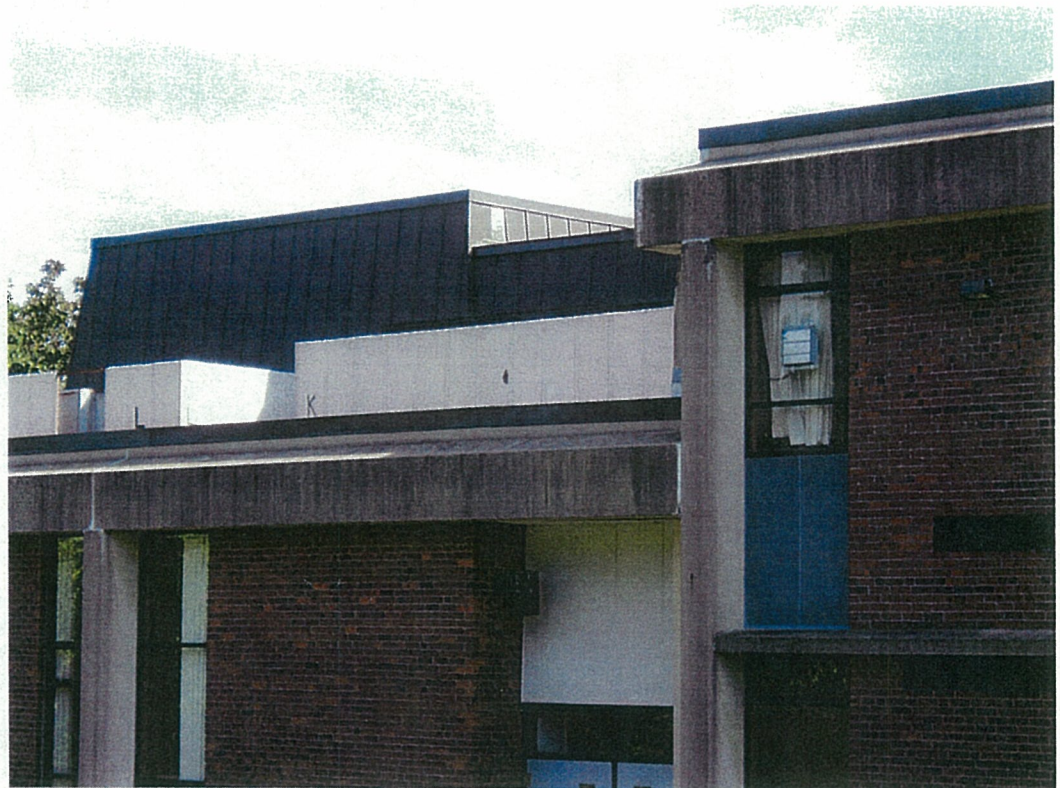
STAGEHOUSE METAL SIDING

- Replace existing elevator with new, larger shaft and cab to meet barrier-free access and fire department regulations.
- Repair missing and worn areas of metal roof and siding on Stagehouse.

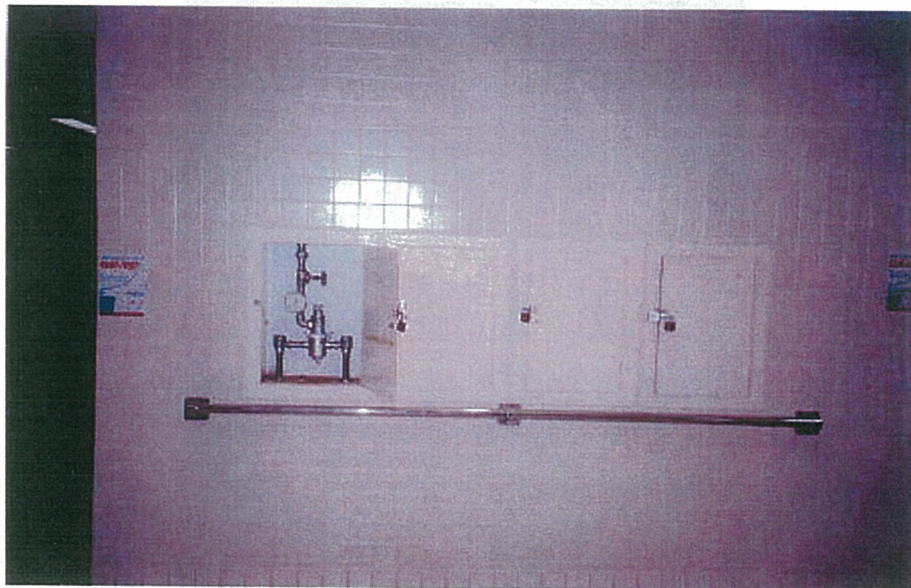
Picture 6

The Boys' Locker Room is in fair condition. The showers are controlled by means of four master control mixing valves, behind recessed cabinets, outside of the shower area (see photograph #6). The shower areas themselves are a series of separate gang showers (see photograph #7). The number of showerheads within each gang shower varies, but each showerhead can be individually turned on. The showers within each gang shower are the Symmons Hyda-Pipe system. It could not be determined if the showerheads were a code compliant 2.5 GPM head. Within each gang shower there is a single floor drain. This does not meet the current codes. The Massachusetts State Sanitary Code does not allow the water from one shower to cross into another shower area.

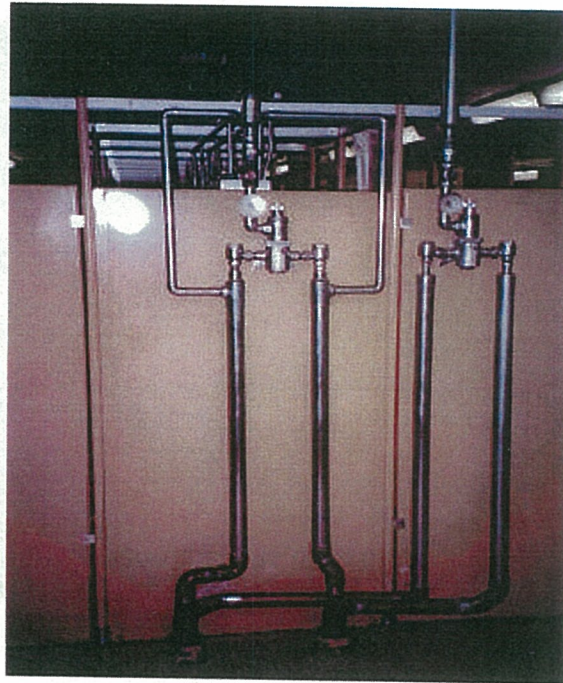
Picture 8

The Girls' Locker Room is in fair condition. The showers are controlled by means of a series of master control valves. Each valve controls one bay of showers (see photograph #8). The mixing valves are exposed outside each shower bay. The shower units are separated into individual shower areas. Each shower area is controlled by a single Symmons Hyda-Pipe shower valve and head (see photograph #9). Floor drains are located between each shower area. The shower water never passes from one shower area to the next. It could not be determined if the showerheads were a code compliant 2.5 GPM head.

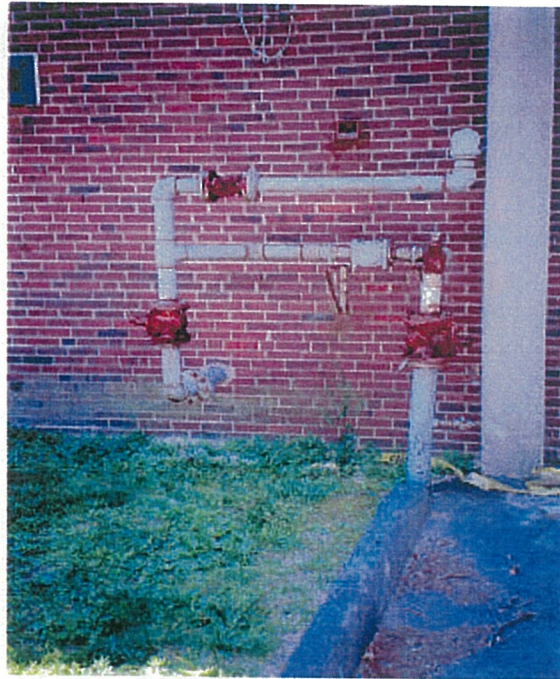
Picture 12

The gas service to the building enters into the Mechanical Room #104 in Unit 1 (see photograph #12). At the service entrance, the gas splits into two separate lines. There is a 4" line, which is a dedicated service to the emergency generator, located in Room #139 just outside of the Mechanical Room #104, and a 3" line, which feeds the gas pilot to the boilers as well as the gas requirements in the science wing. It was noted by the facilities personnel that the gas to the science wing has been turned off. The gas piping itself is in fair condition.
