To: Belmont Historic District Commission  
Re: Proposed Repair to Front Vestibule and Rear Deck at 596 Pleasant Street, Belmont

## ENTRY VESTIBULE

**Patalas/Schaffer Residence**  
 596 Pleasant Street  
 Belmont, MA

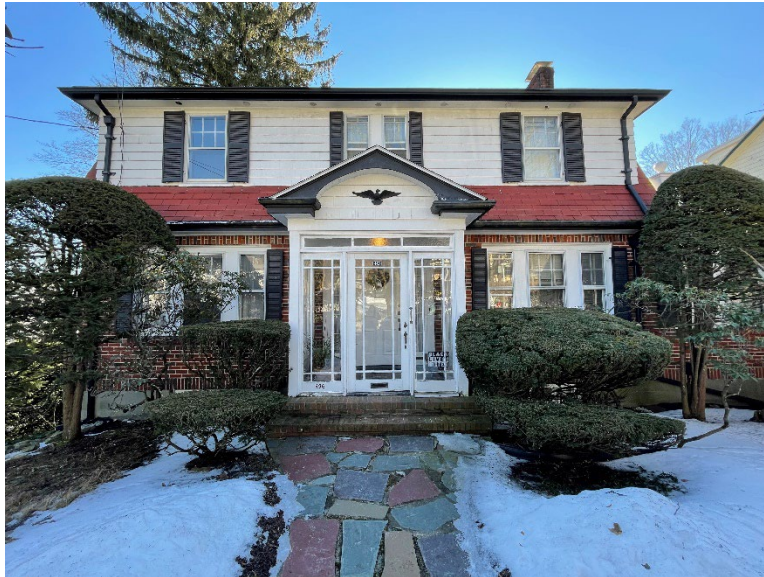
The front vestibule and access path at 596 Pleasant Street has sustained significant water damage as well as some general wear and tear over the years. The key areas in need of attention are: the loosening flagstones with large gaps between; the deteriorated vestibule sill plates and threshold; the glazing beads on the enclosure panels; and the compromised first floor gutters. As the building is in a Historic District, all proposed repairs must maintain the integrity of the original design. The intention is to repair all components in kind while considering long term durability in the detailing.

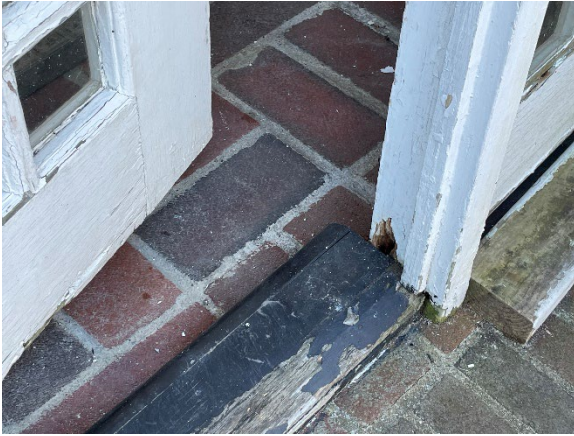
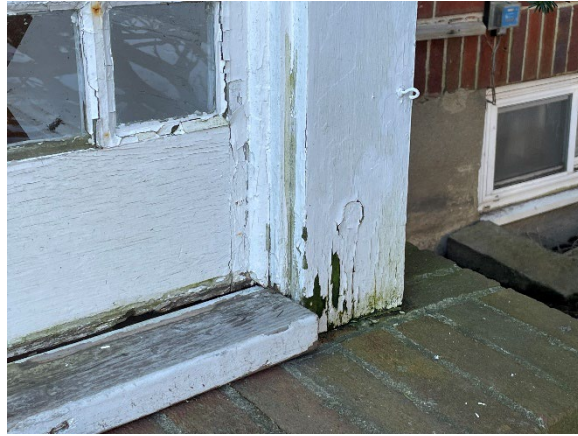
The existing sill plate is a 2x4 laid flat and it is assumed that this piece is not original to the home. It appears to be a pressure treated element, and especially when one compares its condition to the degree of rot visible on adjacent wood components it is obviously newer. The sill plates, threshold, door jamb, and corner boards have all sustained significant damage by wicking moisture up from the brick stoop below, and any repair will continue to do so unless a capillary break is introduced.

The proposed solution here will be to cut away any rotten material and replace with new. A capillary break will be introduced at the base of the structure to ensure long term durability of the assembly. See Appendix A for architectural details.

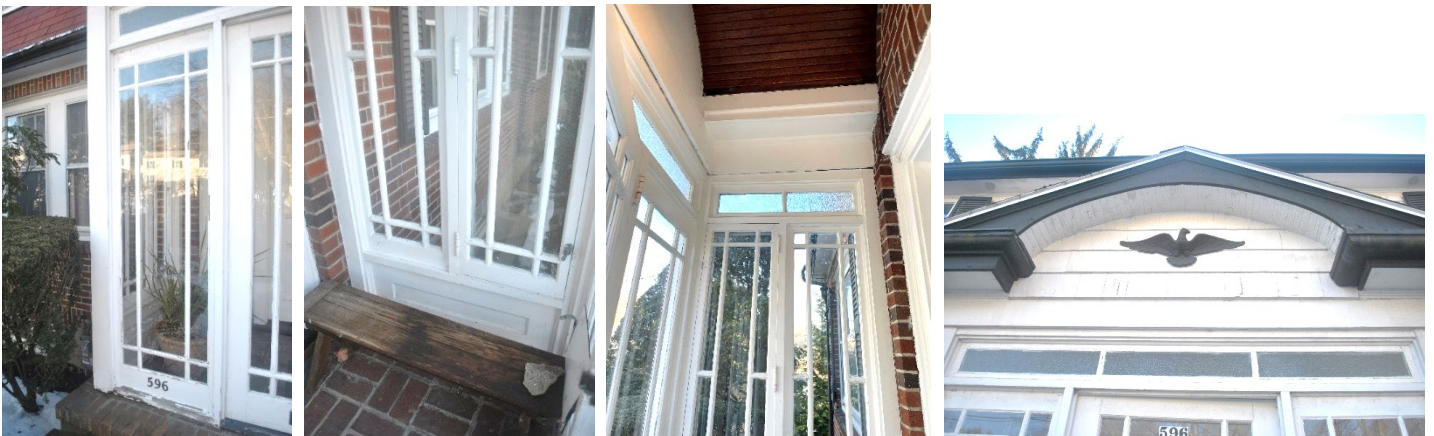
While most of the existing glazing beads have either started to deteriorate or have fallen out entirely, the glass panes themselves are still intact. The repair will entail removing all existing glazing, infilling dents and flaws in the wood components, sanding, preparing, and painting the wood components, and resetting the preserved glass panes with new glazing putty. Where hardware components are missing or broken, in-kind replacements will be installed.

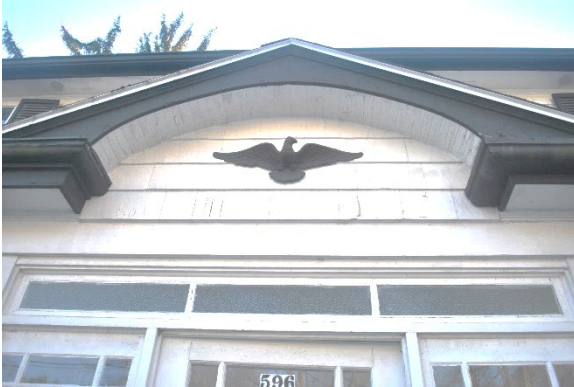
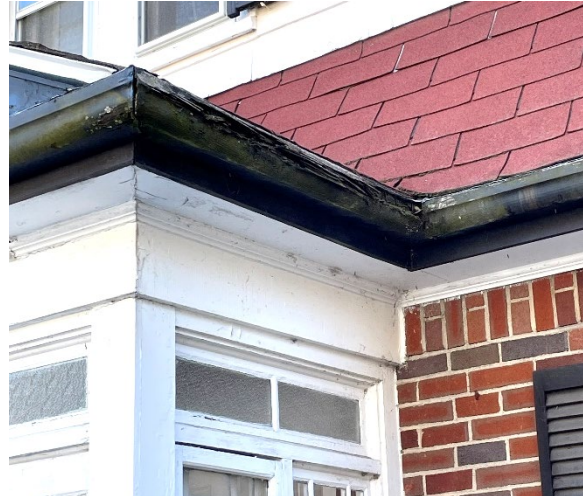
The existing first floor wood gutter, particularly on the right side of the house, is showing signs of irreparable deterioration, in part due to an insufficient gutter lining installation and possibly also due to an insufficient pitch to drain (note the different elevations at which the gutter returns at the vestibule eave). These gutters will be replaced in kind with fiberglass and pitched appropriately to ensure the longevity of the replacement components.

The product to be used is Fiberglass Gutter Company profile G-60 as shown below, finished with a gel coat to match the existing color.

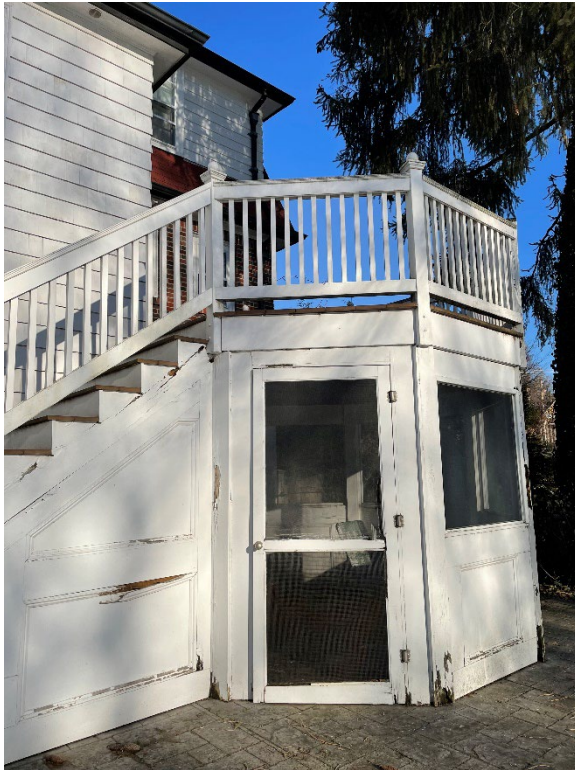
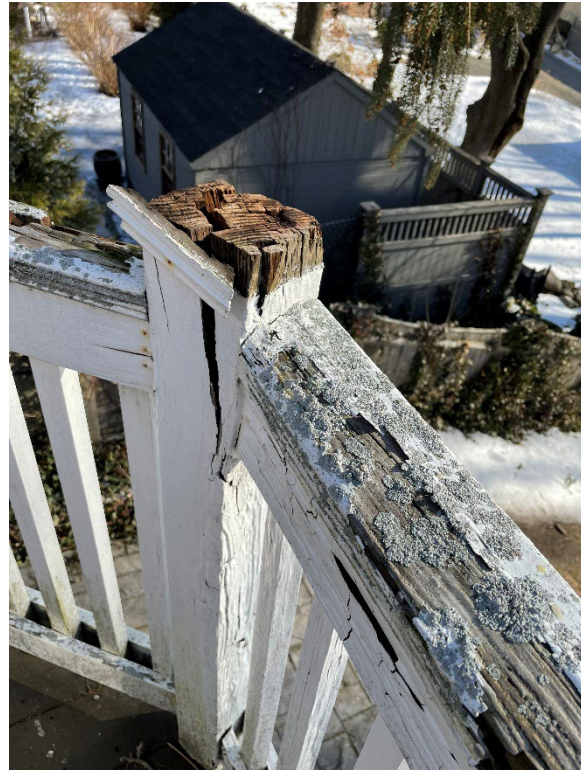
The existing rear deck was permitted and built in 2006 with approval by Belmont’s Historic District Commission. The structure consists of pressure treated columns and joists, composite decking, pine railings, and pine enclosure panels. Over the past 16 years, the pine components have all deteriorated significantly, introducing unsafe conditions particularly at the railings. The homeowners would like to replace the railings, update the decking, and remove the under deck enclosure except for at the stair. The layout of the deck is to remain as is, except for changing the rail posts to a top-mounted assembly as originally designed and adding a midpoint post on the stair run for increased stability. In an effort to improve the durability of the replacement components, however, the homeowners would like to use composite materials at the railings, column enclosures, and trim details.

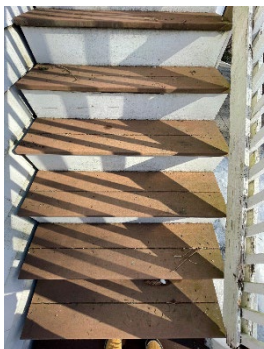
Existing

The current decking is a composite product and will be replaced in kind. The product selected is TimberTech Azek in Weathered Teak.

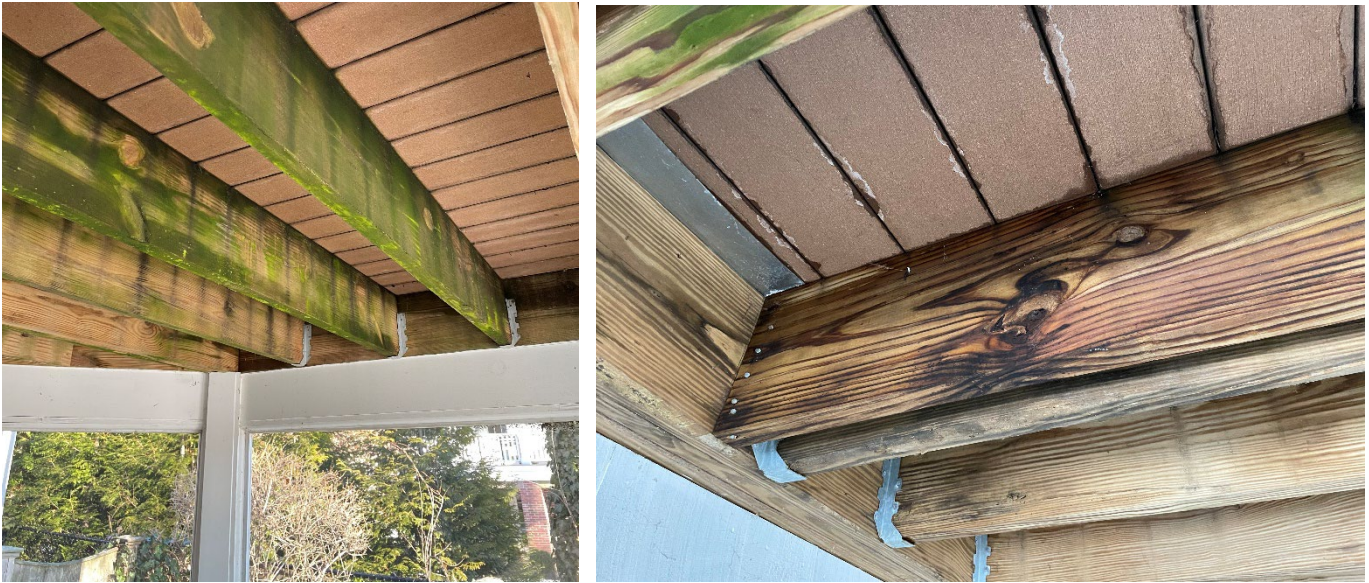
The existing deck and stair shall be stripped down to their structural components. Existing post structure to remain (assumed to be PT 4x4 posts) will be evaluated for rot and repaired as necessary. Existing joists to remain shall be cleaned of organic growth, evaluated for rot, and repaired and/or resupported as necessary.

A rain collection system – Trex RainEscape or DEK Drains Topside Panels shall be installed at the deck joists prior to the installation of the new decking. The new decking shall be installed with sufficient gaps to allow drainage to the rain collection system below, which will then shunt the collected rain to a gutter installed at the inside edge of the perimeter joists. The gutter will be largely concealed by the new PVC deck fascia boards. A beadboard ceiling will be installed at the underside of joists to provide a finished ceiling, and the posts will receive sleeves and bases. See Appendix A for Architectural Details.
