Town of Belmont Intersection Improvements at Lexington Street & Sycamore Street

Transportation Advisory Committee Meeting

September 5th, 2019

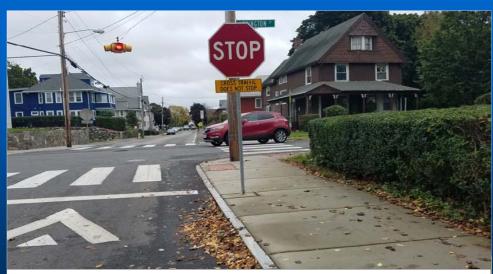
Sightline diminished by hedge at Sycamore Street eastbound approach

- Install fully actuated traffic signals, coordinated with existing signals at Lexington Street, Thayer Road, and Church Street
- Provide exclusive pedestrian phase
- Remove raised intersection
- Install "No Turn on Red" at all approaches
- Install new pedestrian ramps at crosswalks
- Trim hedges at intersection approaches to improve sight lines

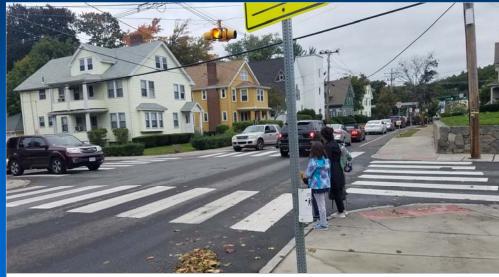
Traffic backed up into intersection as pedestrians look for safe gap to cross

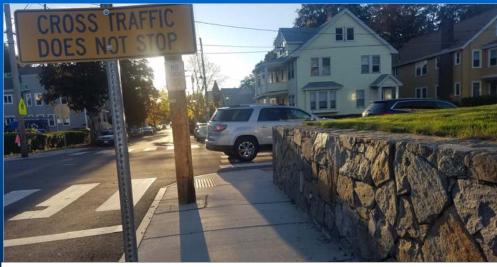
Stone wall causes poor sightline for westbound approach

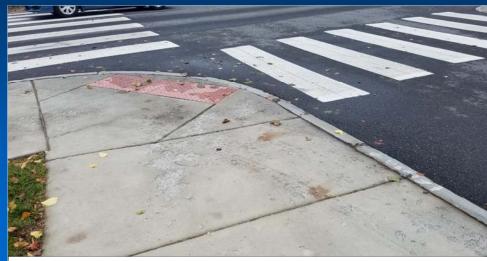
Tire marks visible on sidewalk

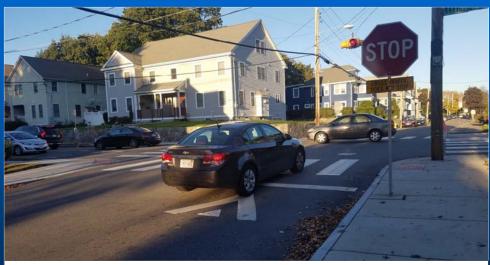
Vehicle encroaching on crosswalk looking for available gaps

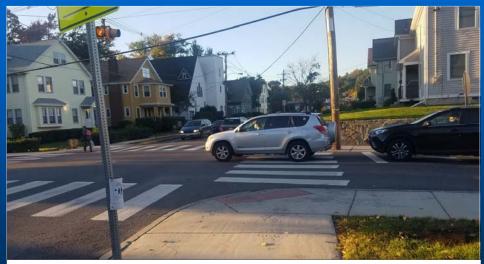
Lack of visibility and gaps in traffic on Sycamore Street approaches
