Town of Belmont
Zoning Board of Appeals

APPLICATION FOR A SPECIAL PERMIT

Pursuant to the provisions of Massachusetts General Laws, Chapter 40A, Section 9, as amended, and the Zoning By-Laws of the Town of Belmont, I/we the undersigned, being the owner(s) of a certain parcel of land (with the buildings thereon) situated on 32 Chester Road Street/Road, hereby apply to your Board for a **SPECIAL PERMIT** for the erection or alteration on said premises or the use thereof under the applicable Section of the Zoning By-Law of said Town for Rebuild structurally failing porches (front and back). Add roof to 2nd floor front porch, extend 2nd floor back porch to match the footprint of 1st floor back porch, Re-side House.

4. GROUNDS AND PROPERTY DRAINAGE

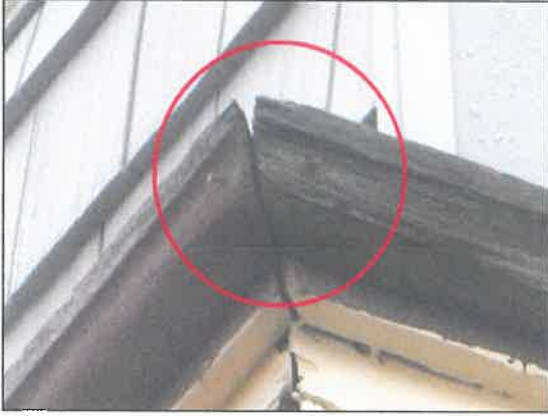
4.0 Item 1(Picture)

4.0 Unlined wood gutters need to be oiled periodically to help resist decay. At least, once a year is recommended. Several sections of wood gutters show signs of decay. They should be replaced as needed.

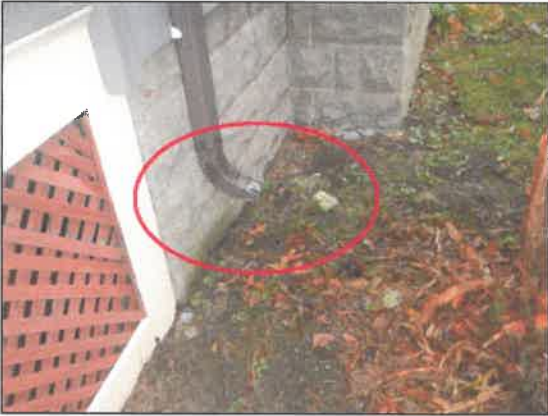
4.2 Item 1(Picture)

4.2 Downspouts that discharge against the foundation can contribute to cellar water issues. Extensions of at least 3-5 feet in length should be added at all points of downspout discharge. Caution should be given to not directing water on to walkways, public right of ways and the driveway as icing hazards may result in the colder months.

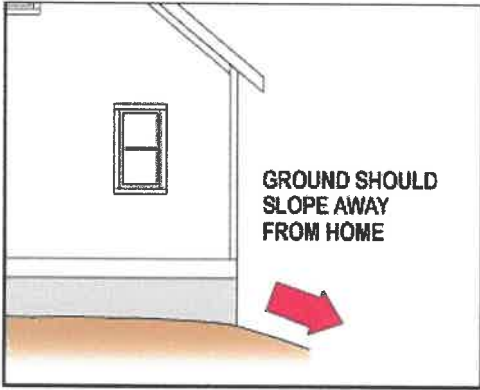
4.3 Item 1(Picture)

4.3 Negative grading that directs water to the foundation will contribute to basement water issues. For proper drainage, it is recommend that the grade slope away from the foundation a minimum of 1" per foot for 5 feet wherever possible. Periodically, fill will be needed to maintain this grade. If available, clay should be used. Foundation grading should be kept free of wood mulch as it is conducive to wood destroying insect problems such as termites.

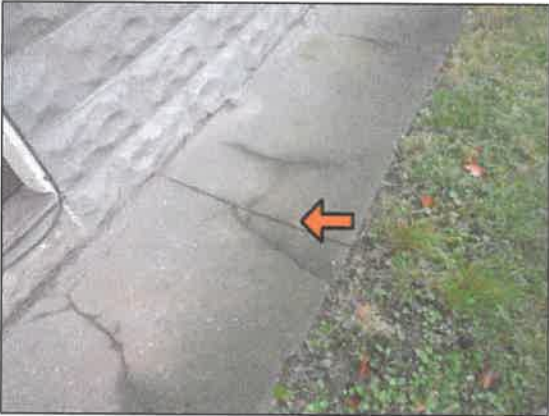
4.5 Item 1(Picture)

4.5 Uneven settlement and deterioration of walks has created safety hazards. Correction is needed.

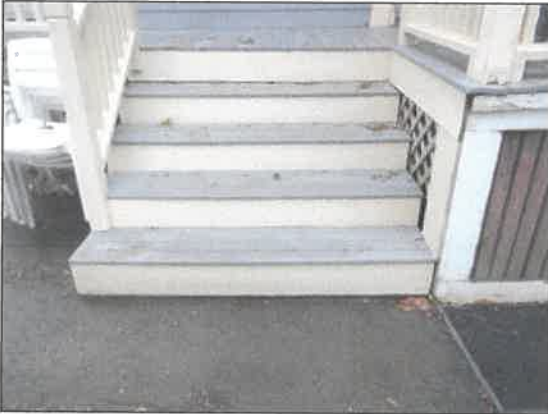
4.6 Item 1(Picture)

4.6 Rear stairs have inconsistent rise. This poses a trip hazard and should be corrected. The risk of personal injury exists

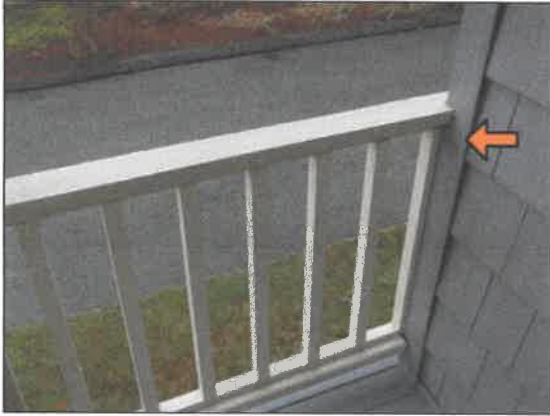
4.7 Item 1(Picture)

4.7 (1) The left end front porch railing is weak and unsafe. Immediate correction is needed.

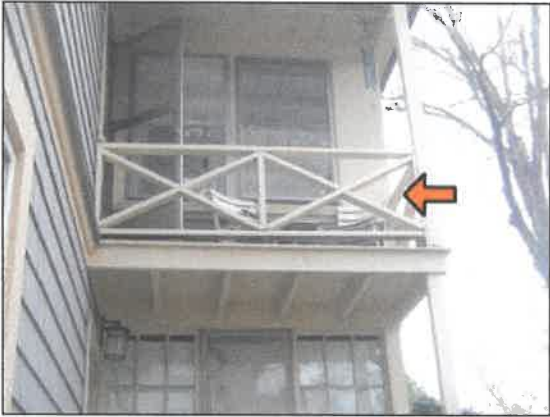
4.7 Item 2(Picture)

4.7 (2) Rear 2nd floor porch guard rails have excessive openings, are decaying and should be rebuilt to current safety standards.

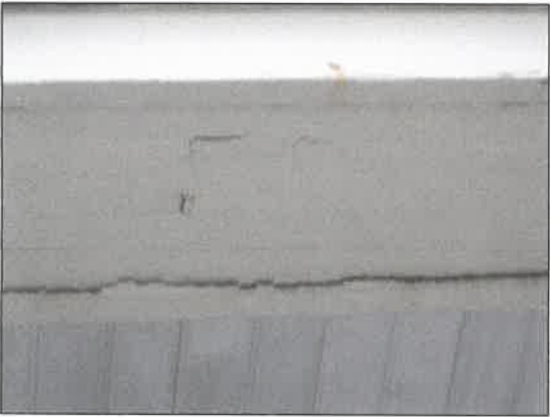
4.8 Item 1(Picture)

On Structure: Our current porches are beginning to fail. Our home inspection, which occurred in December 2017 highlighted a number of structural issues with the porches and we would like to address those issues with this permit. Section 4 of the report (enclosed below) highlights some of the structural concerns with the property. In regards to the front porch they call out that “the front porch box header shows signs of active and on-going water penetration. Underlying decay is evident.” The columns of the front porch also show signs of decay.

4.8 (1) The front porch box header shows signs of active and on-going water penetration. Underlying decay is evident. The extent of which is unknown. Further investigation requiring destructive measures will be needed.

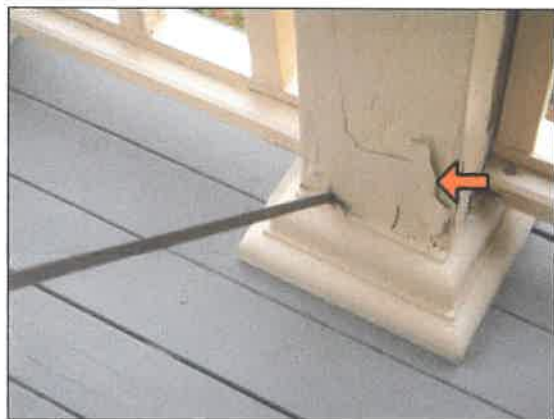
4.8 Item 3(Picture)

4.8 (2) Decaying front porch columns should be replaced as needed.

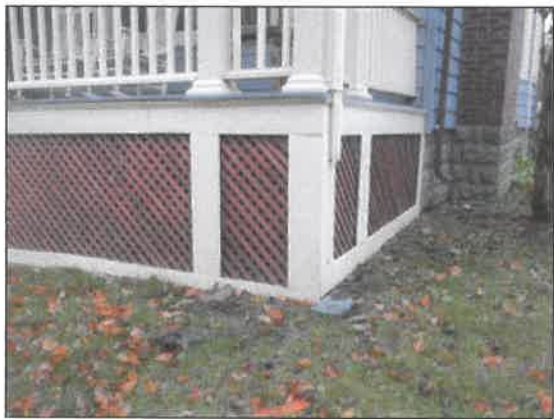
4.8 Item 6(Picture)

4.8 (3) The under side of the front porch was not accessible for inspection. The condition of the structure and the quality of workmanship is unknown.

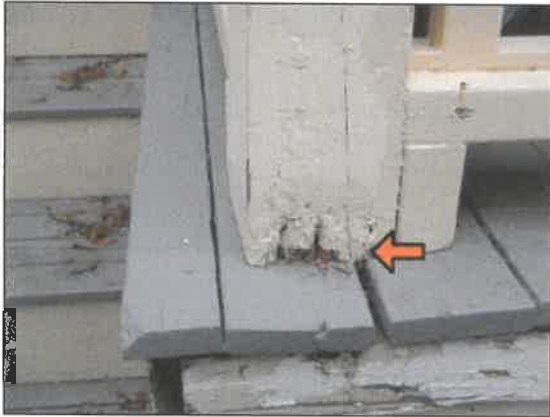
4.8 Item 7(Picture)

4.8 (4) The base of the upper rear porch support column and header below show signs of decay and compression.

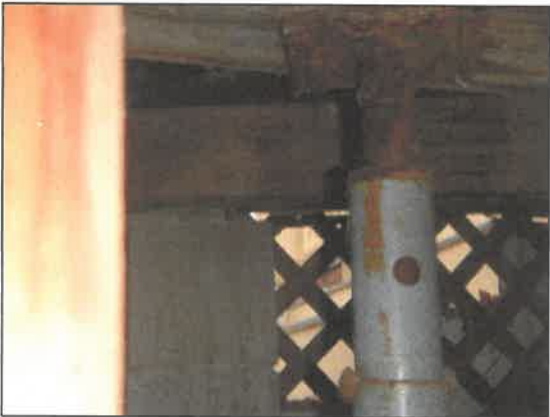
4.8 Item 9(Picture)

The rear porch appears to have been built on a temporary jack which remains in place today. That jack is not properly footed. The report also indicates that “The rear enclosed porch structure sags. The lack of proper support at points of load appears to be the cause. Correction is recommended.”

4.8 (5) The temporary support below the rear porch structure is not properly footed.

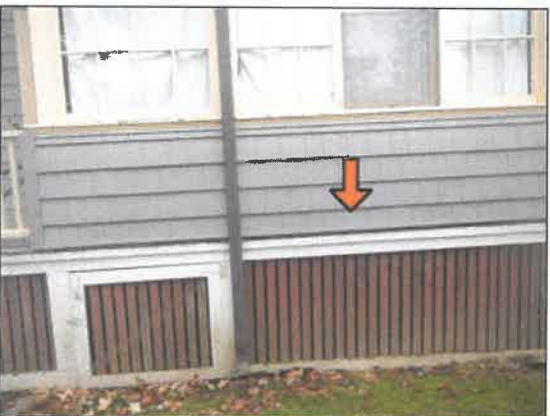
4.8 Item 11(Picture)

4.8 (6) The rear enclosed porch structure sags. The lack of proper support at points of load appears to be the cause. Correction is recommended.

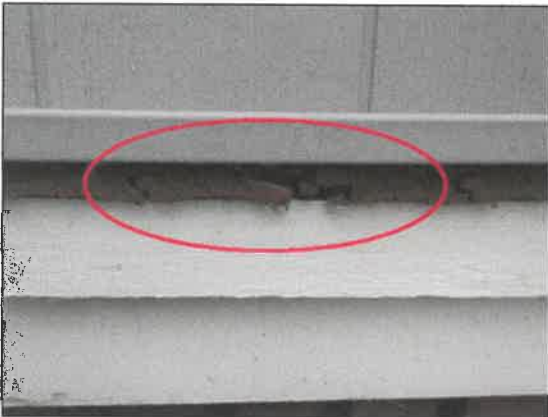
4.8 Item 14(Picture)

4.8 (7) Some of the rear porch decking is rotted and needs to be replaced.

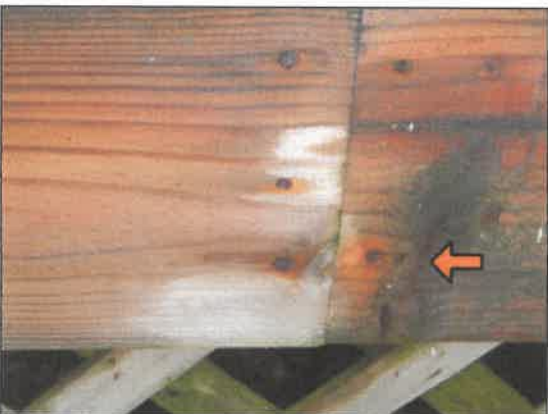
4.8 Item 16(Picture)

4.8 (8) The exposed lower deck of the rear porch structure was constructed with non-corrosion resistant fasteners. The joists of this structure are under sized and lack required hangers. ***All of these issues compromise the integrity of this structure and the safety of those who use it. Immediate correction is needed. The risk of personal injury exists.***

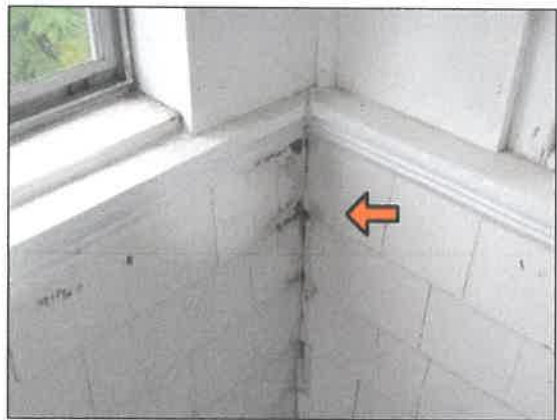
4.8 Item 18(Picture)

4.8 (9) The rear 2nd floor enclosed porch shows signs of past water entry. All was dry at this time.

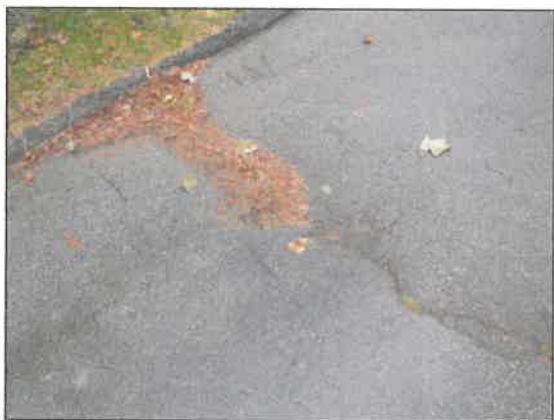
4.9 Item 1(Picture)

4.9 Portions of the driveway are cracked, breaking apart and need to be replaced as they are beyond repair.
