TOWN OF BELMONT, MASSACHUSETTS

SEWER SYSTEM REHABILITATION  
INFLOW/INFILTRATION REMOVAL  
MWRA PROJECT NO. WRA-P11-04-3-1116

### **CCTV Inspection Figures and Locations**

BELMONT, MASSACHUSETTS  
2020 IDDE INVESTIGATIONS - EPA Compliance Report July 2020

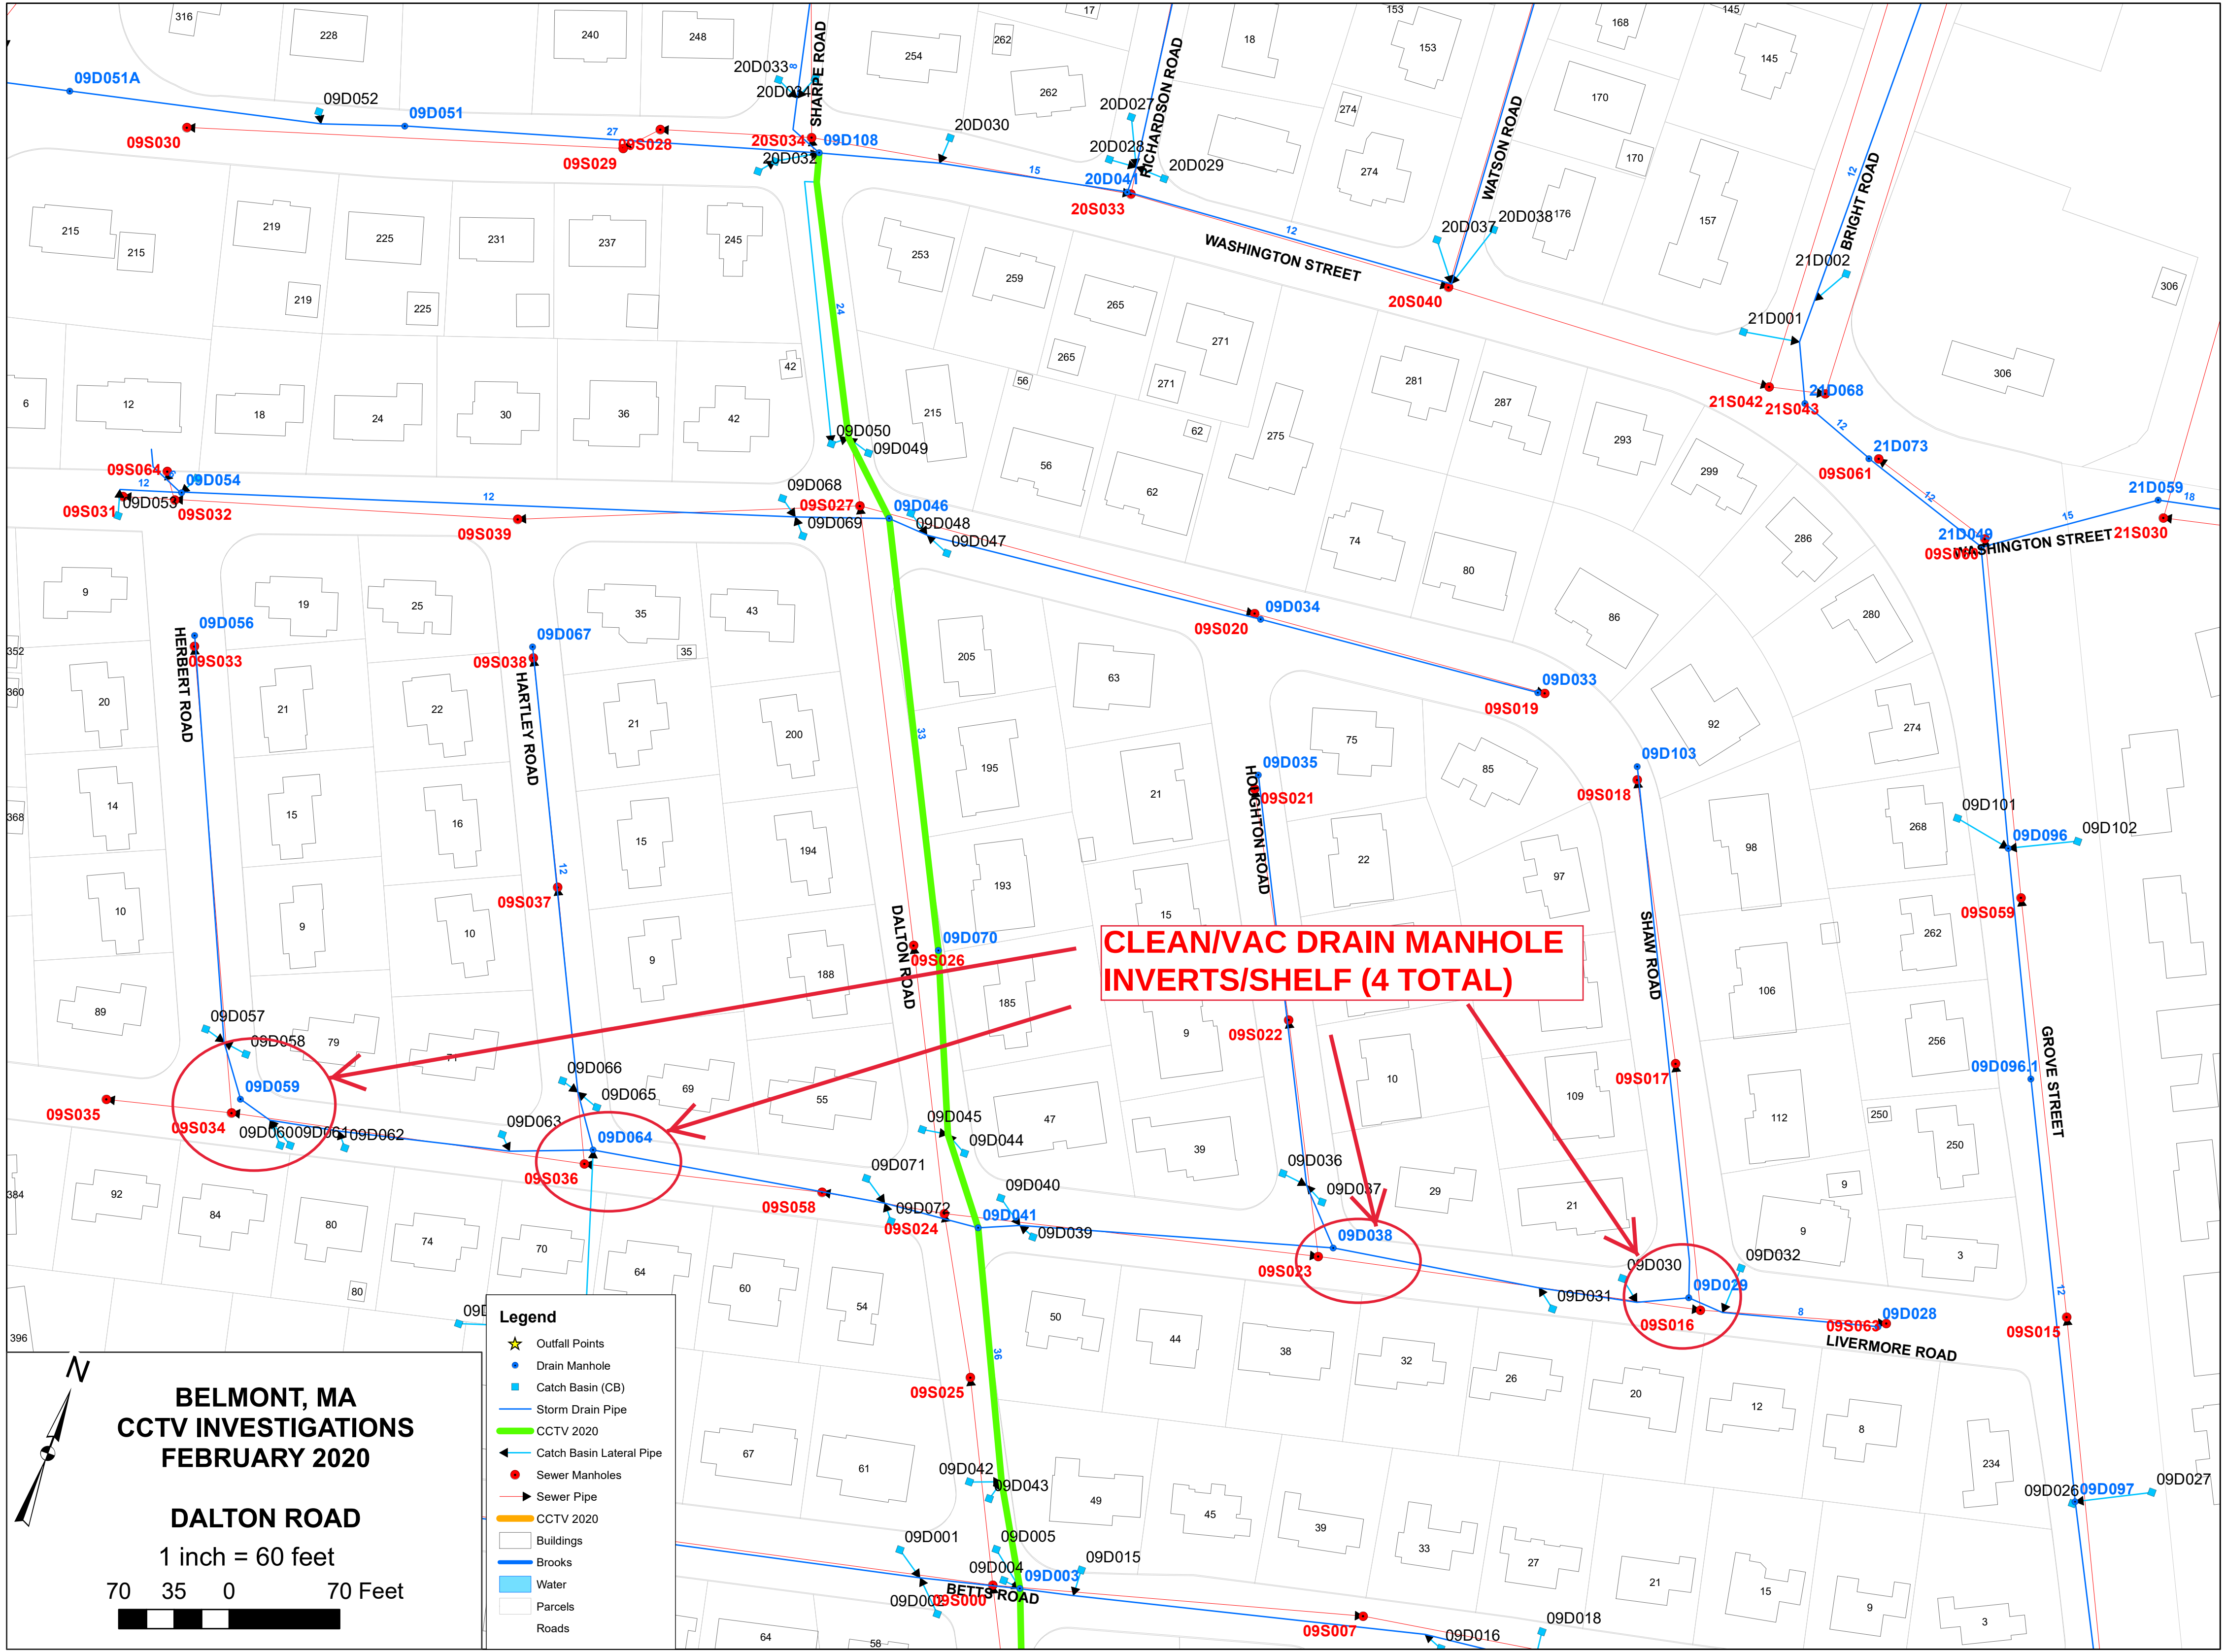
DALTON ROAD

**CLEAN/VAC DRAIN MANHOLE  
INVERTS/SHELF (4 TOTAL)**
