24 March 2023 Re: 711 Pleasant Street – HDC Application 1 – Façade Restoration

Applicant Statement

Façade restoration project (deferred maintenance). Replace in kind / paint to match various existing rotted wood: front porch (except roof); replace siding and trim (northeast façade, limited area at tool porch first floor); rear wood gutters and trim boards; basement door and window; trellis over deck. See scope photos, plot plan, site section attached.

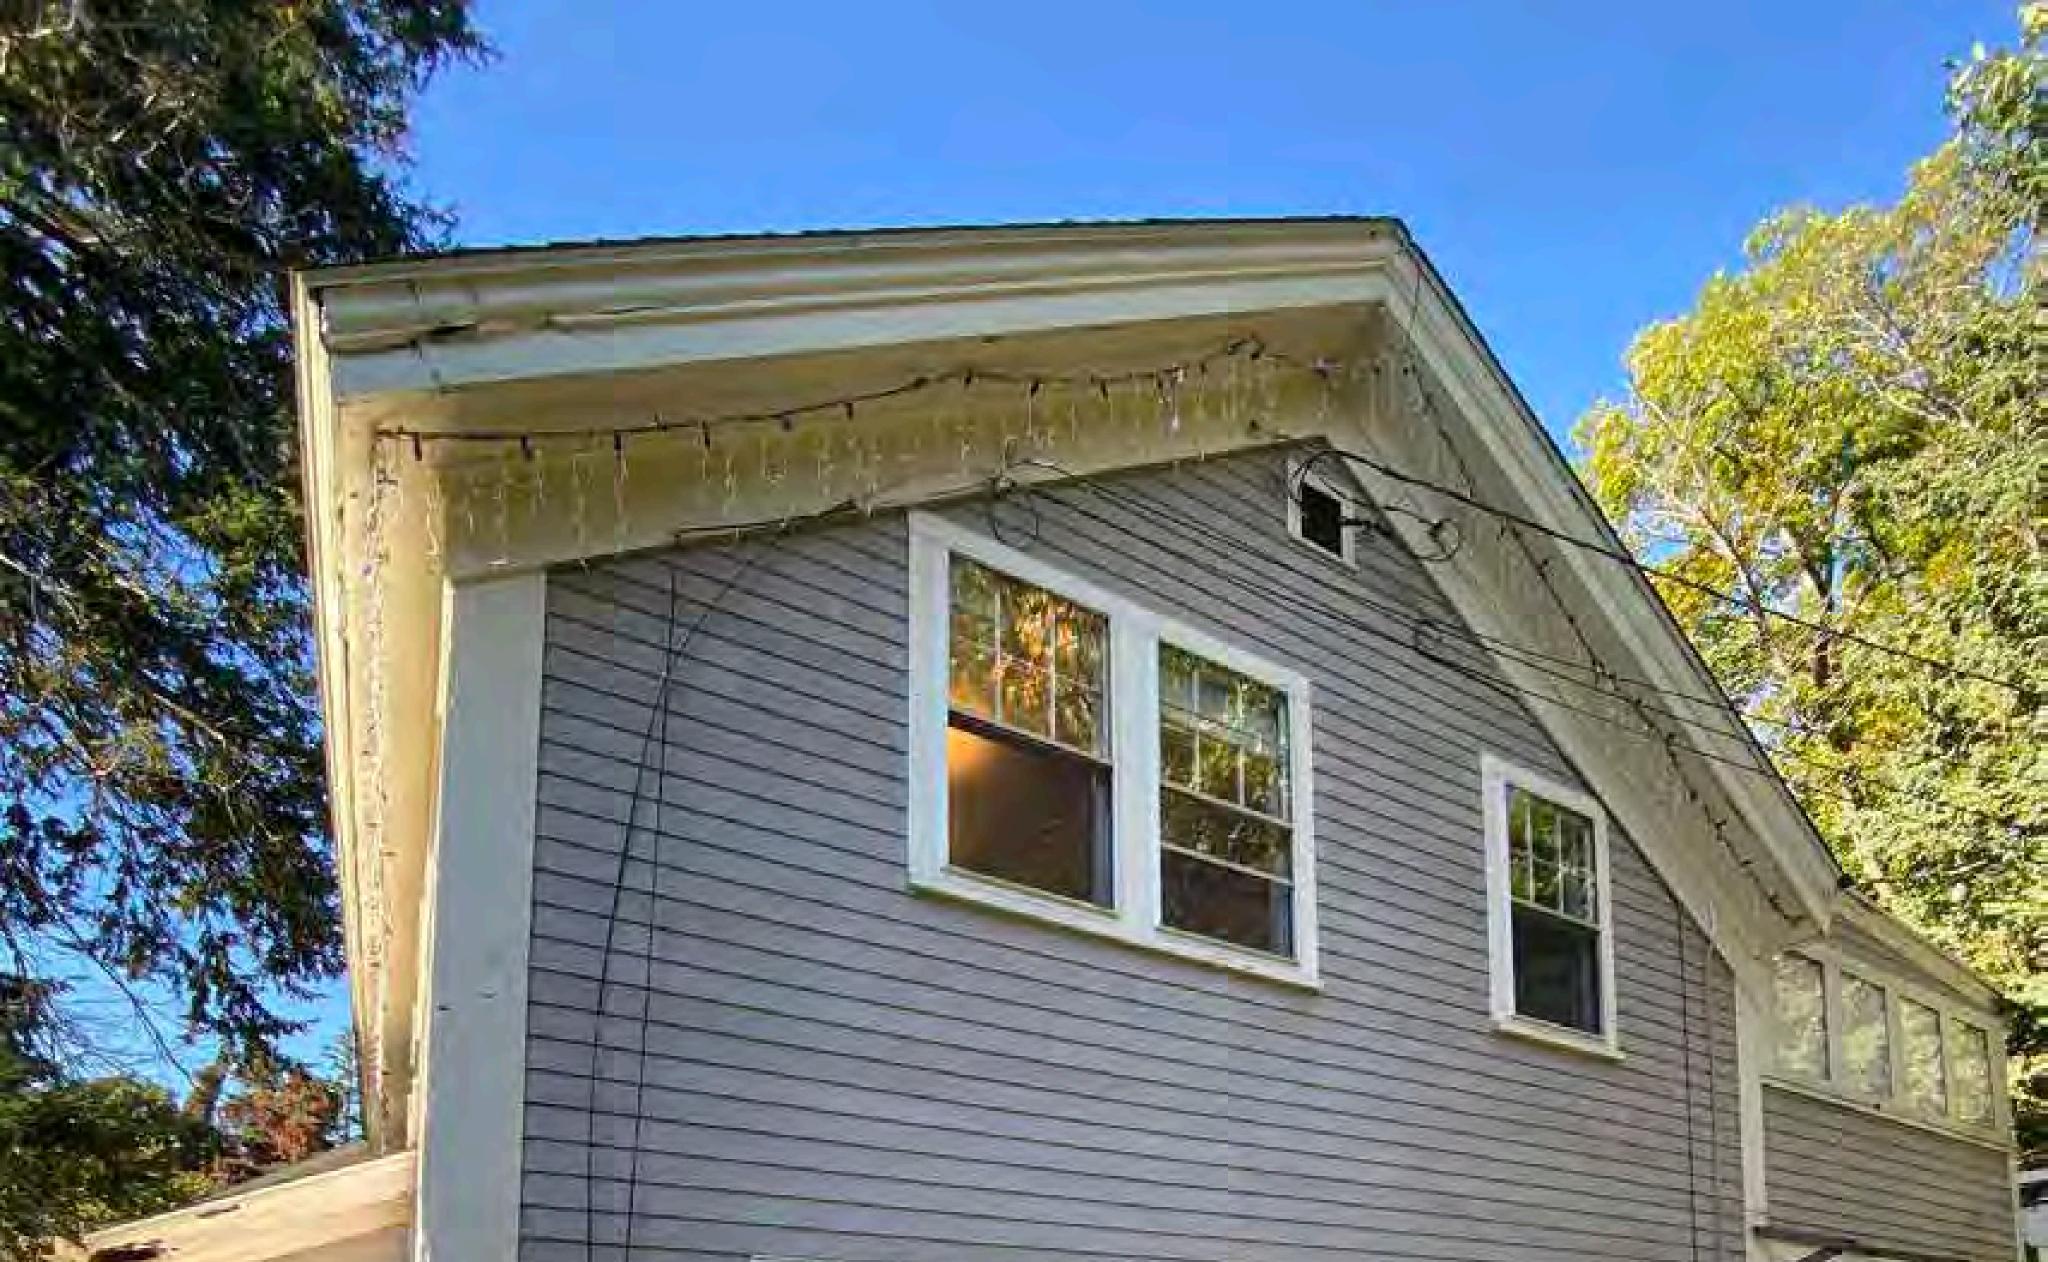
SCOPE 2 - RELAMP EXISTING CHRISTMAS LIGHTS

STRUTS HOLDING WISTERIA AT BRICK PATIO WEST SIDE. INSTALL NEW PLEXIGLAS SHIELDS AT THREE

EXISTING SKYLIGHTS IN MASTER BATHROOM,

CAULK IN WITH ROOFING MASTIC.

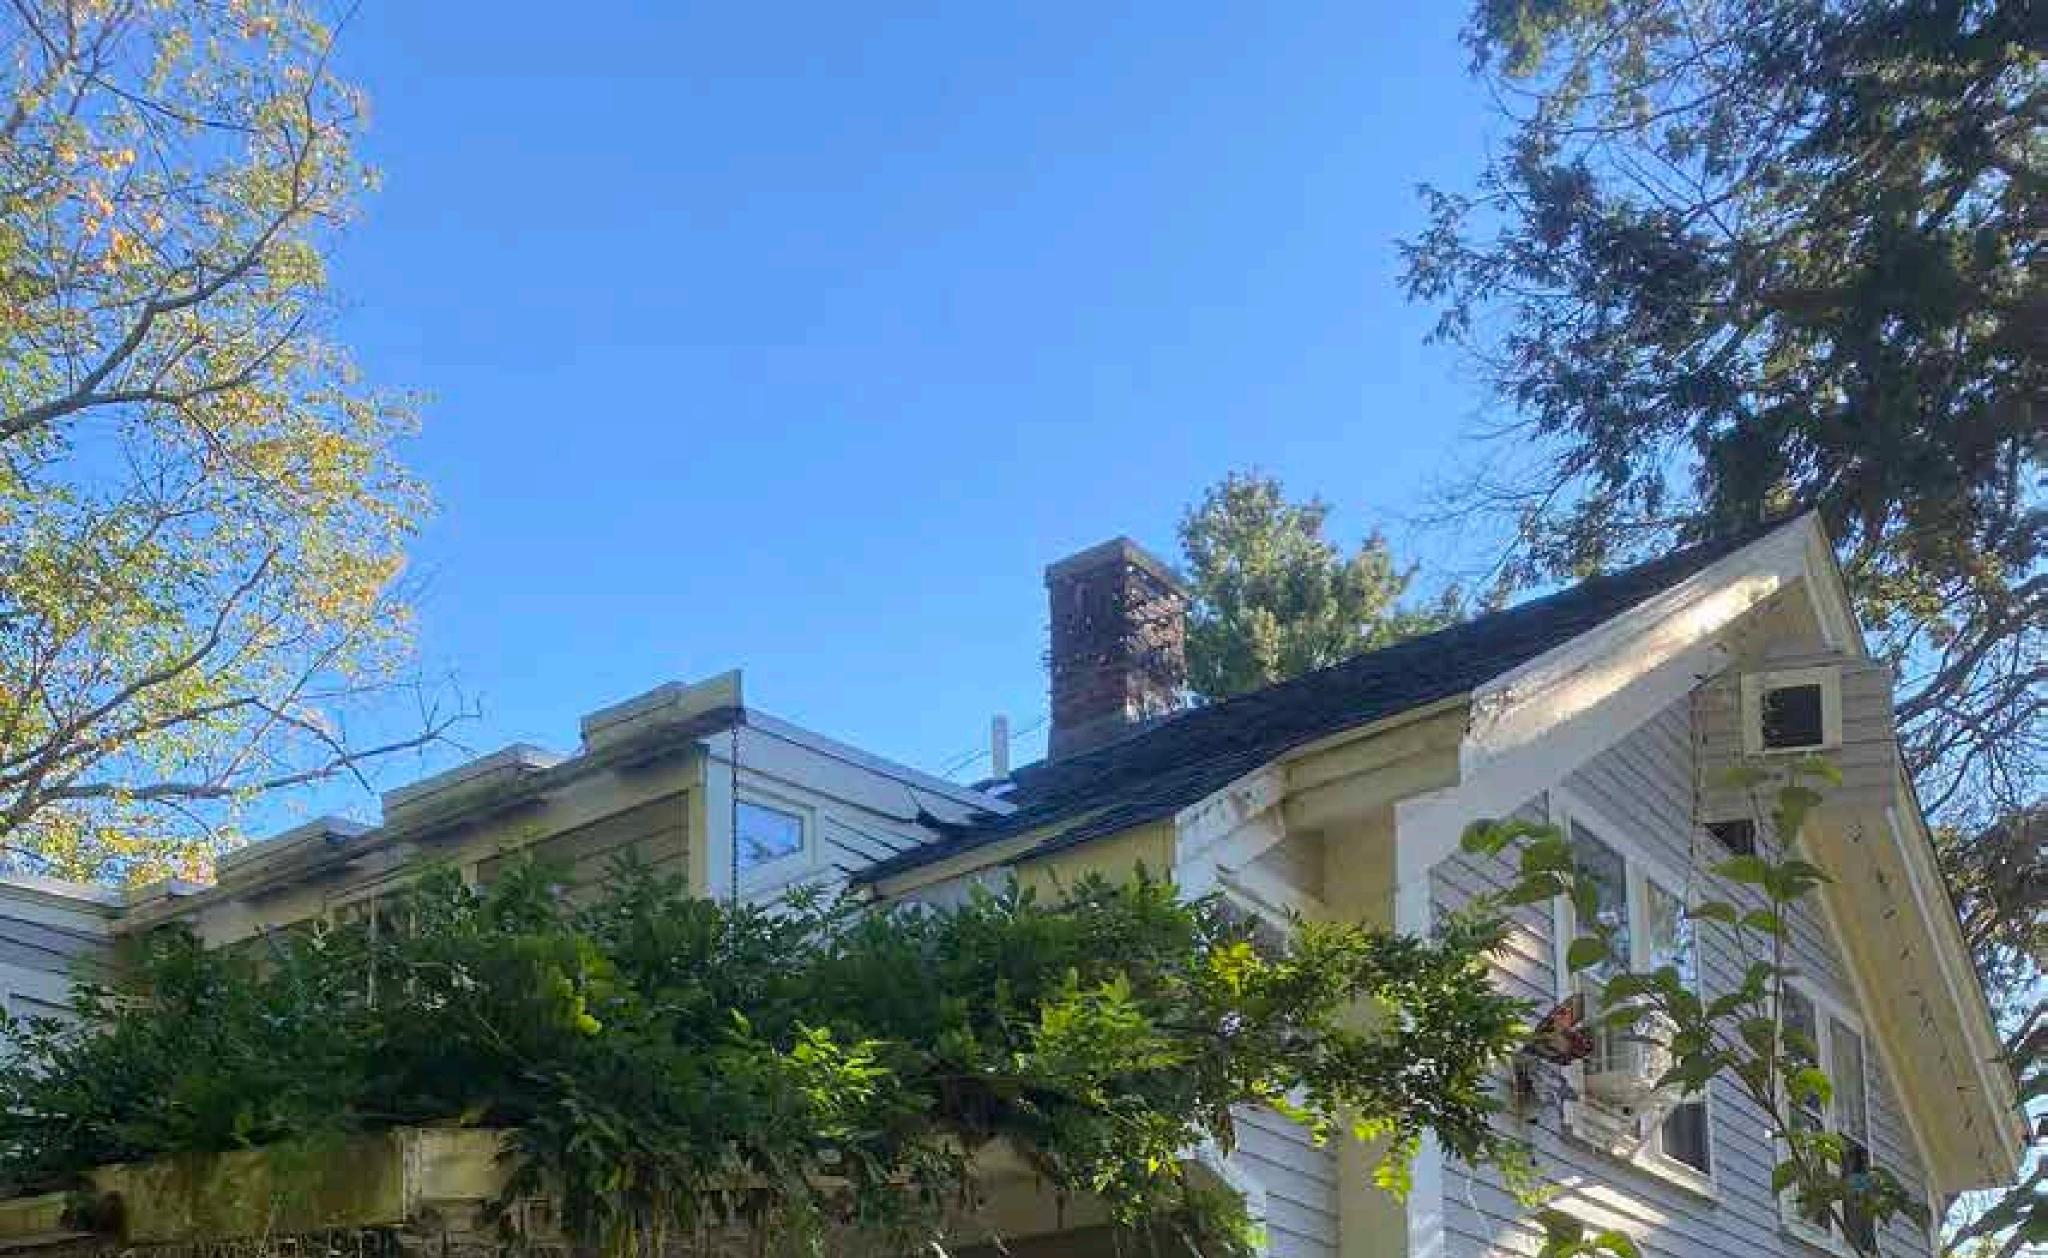
SCOPE 2 - RELAMP EXISTING CHRISTMAS LIGHTS UNDER EAVES.

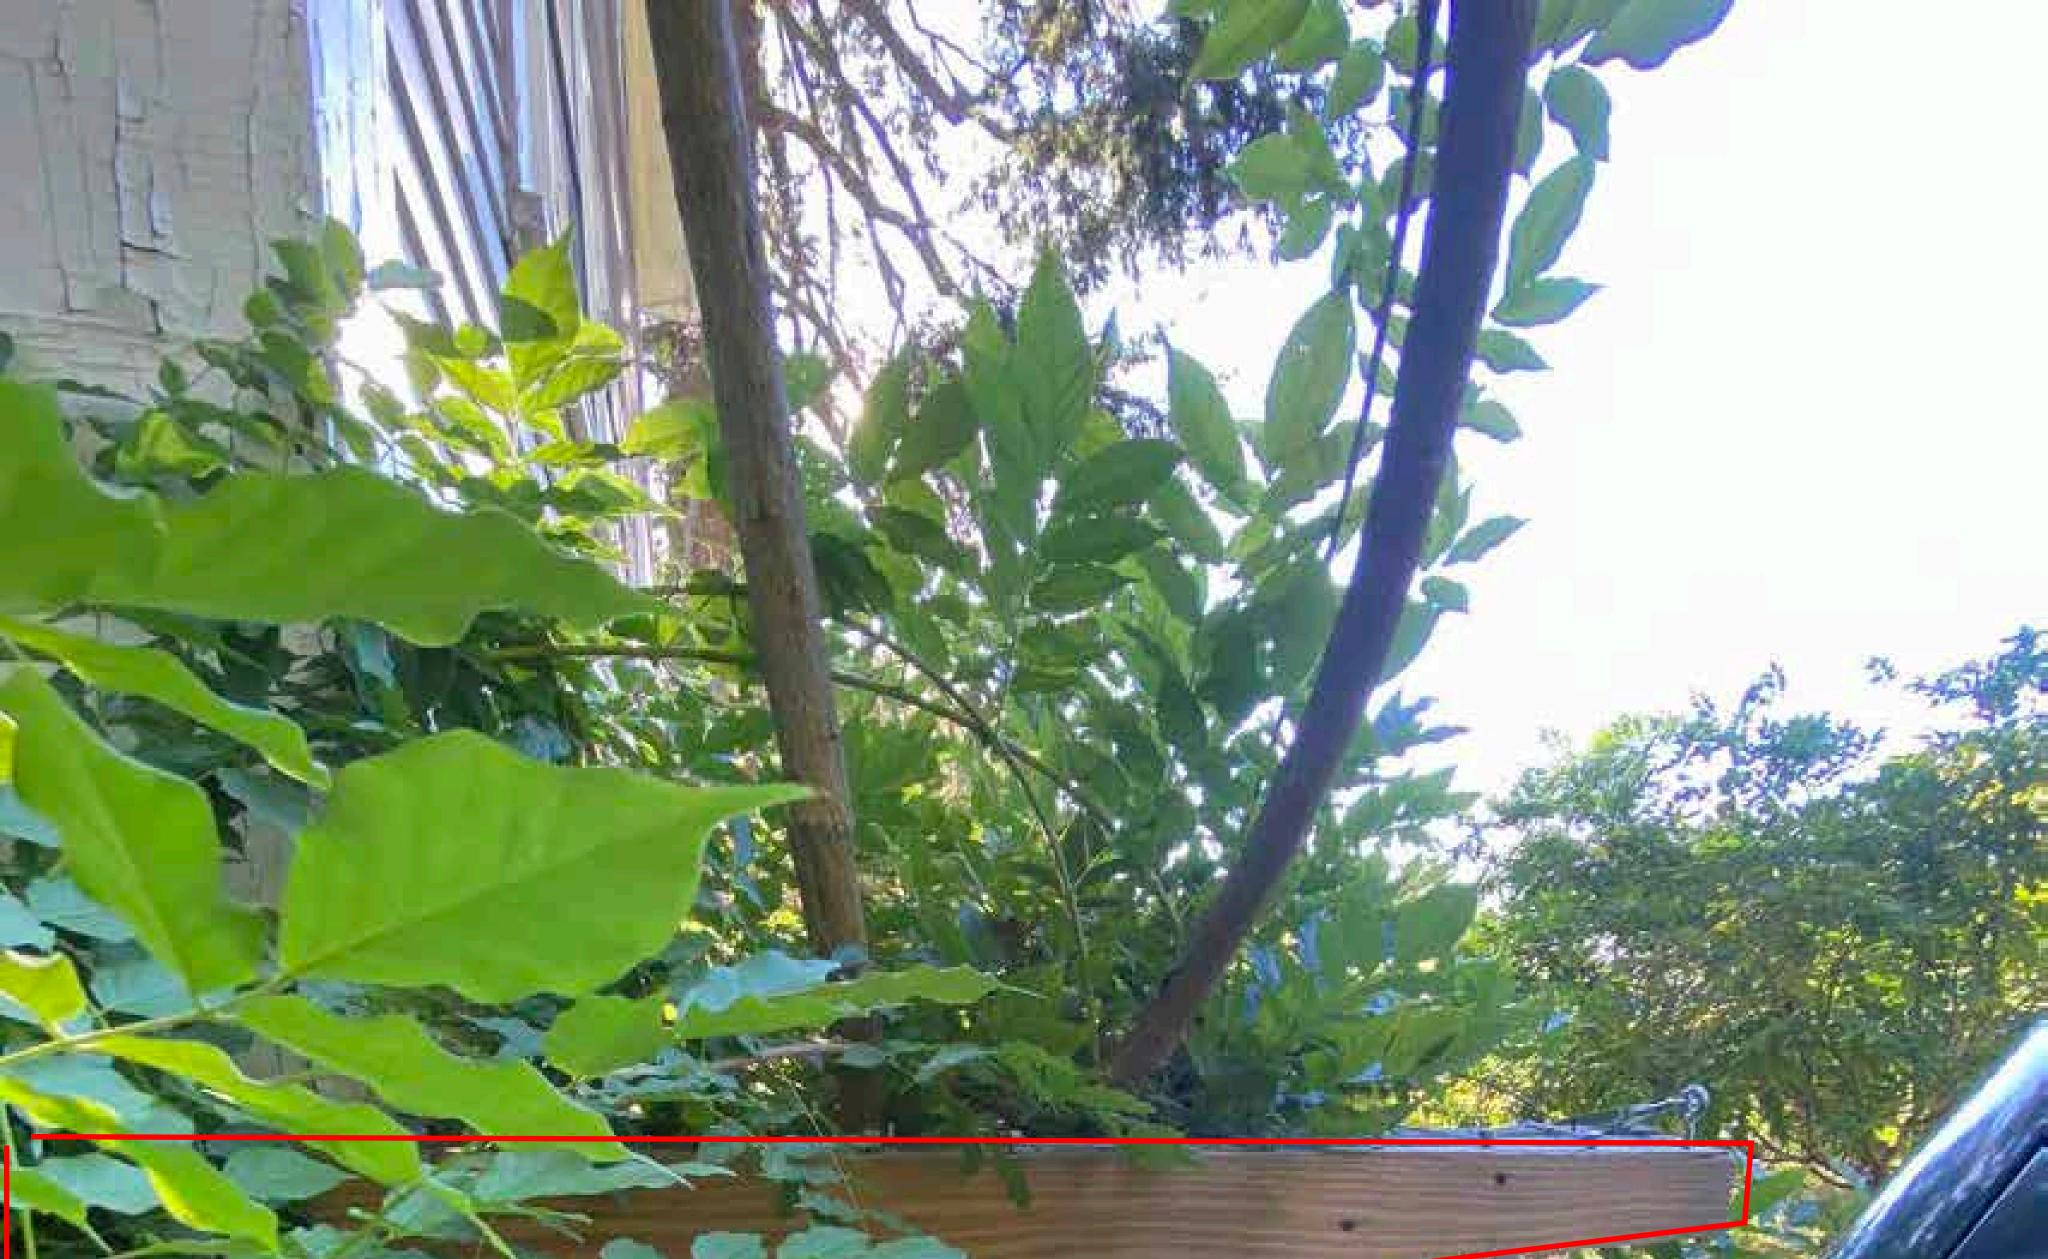
SCOPE 2 - PAINT 2 NEW STRUTS HOLDING WISTERIA AT BRICK PATIO EAST SIDE.

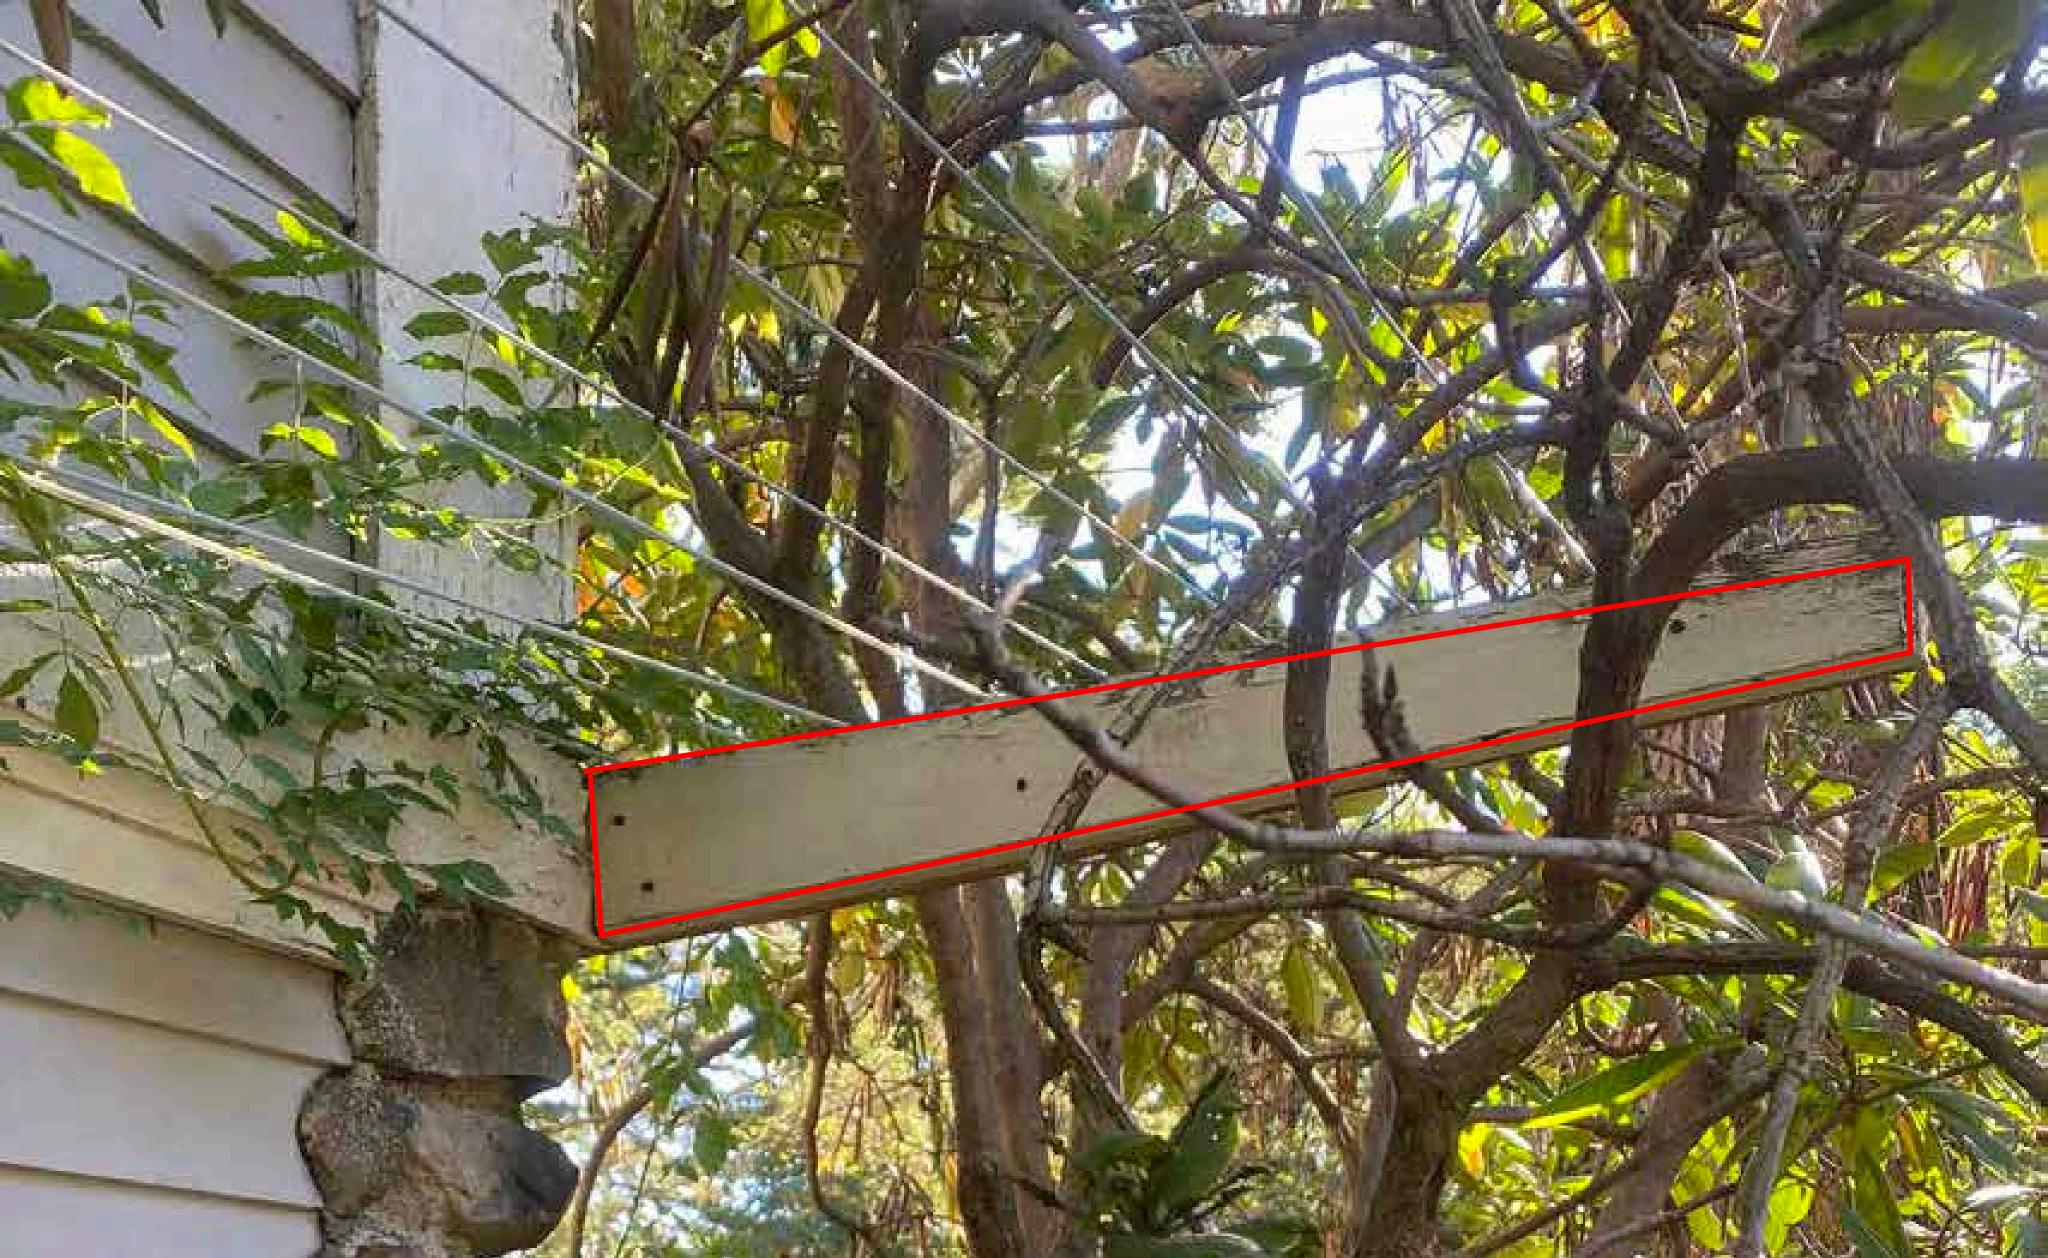
SCOPE 2 - PAINT 2 NEW STRUTS HOLDING WISTERIA AT BRICK PATIO EAST SIDE.

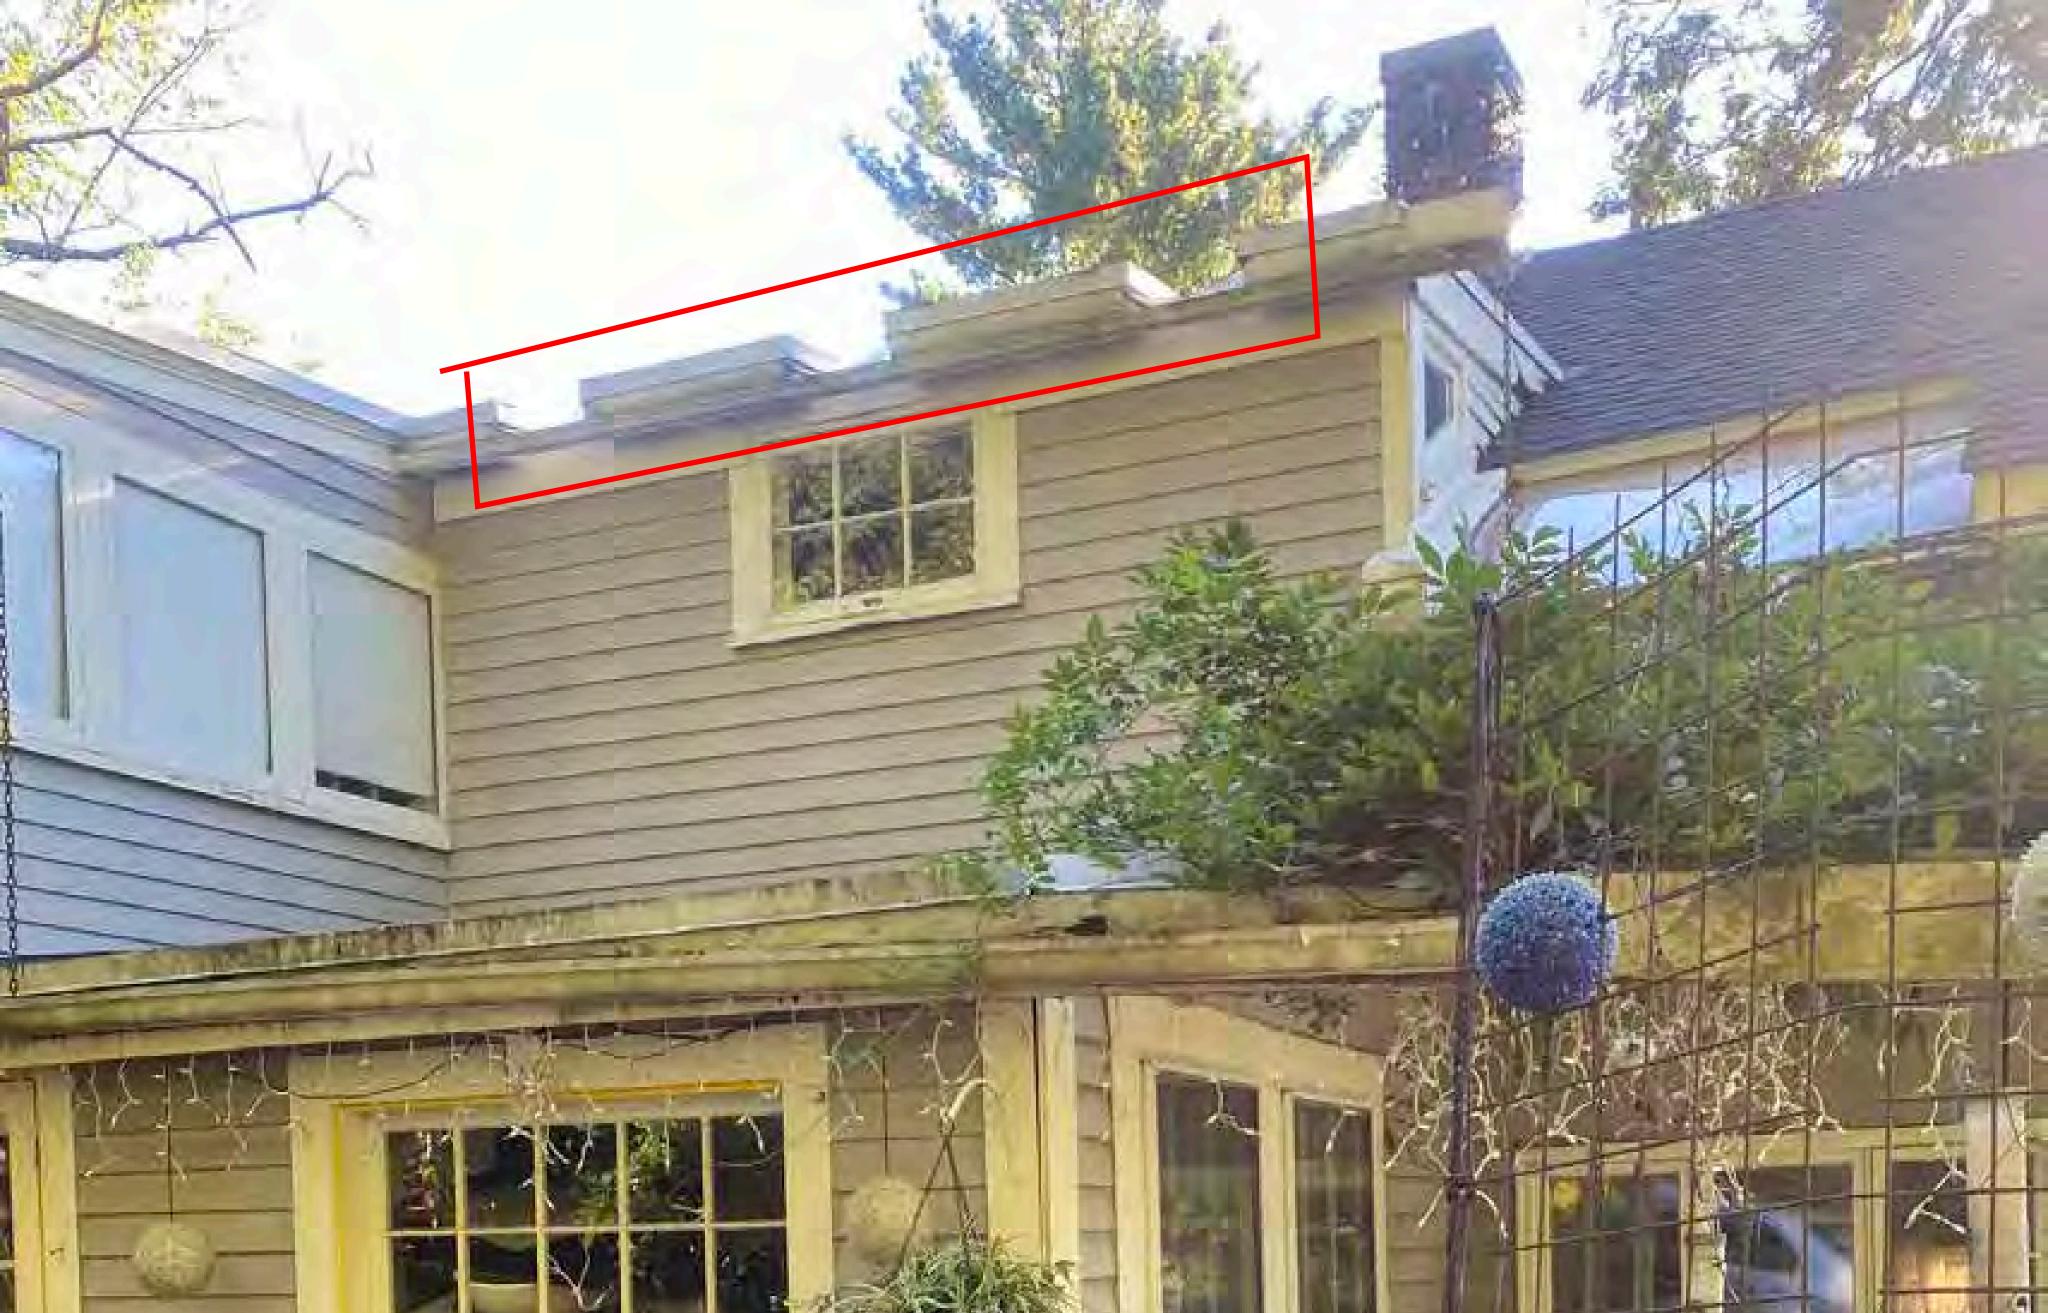
SCOPE 2 - INSTALL NEW PLEXIGLAS SHIELDS AT THREE EXISTING SKYLIGHTS IN MASTER

BATHROOM, CAULK IN WITH ROOFING MASTIC.

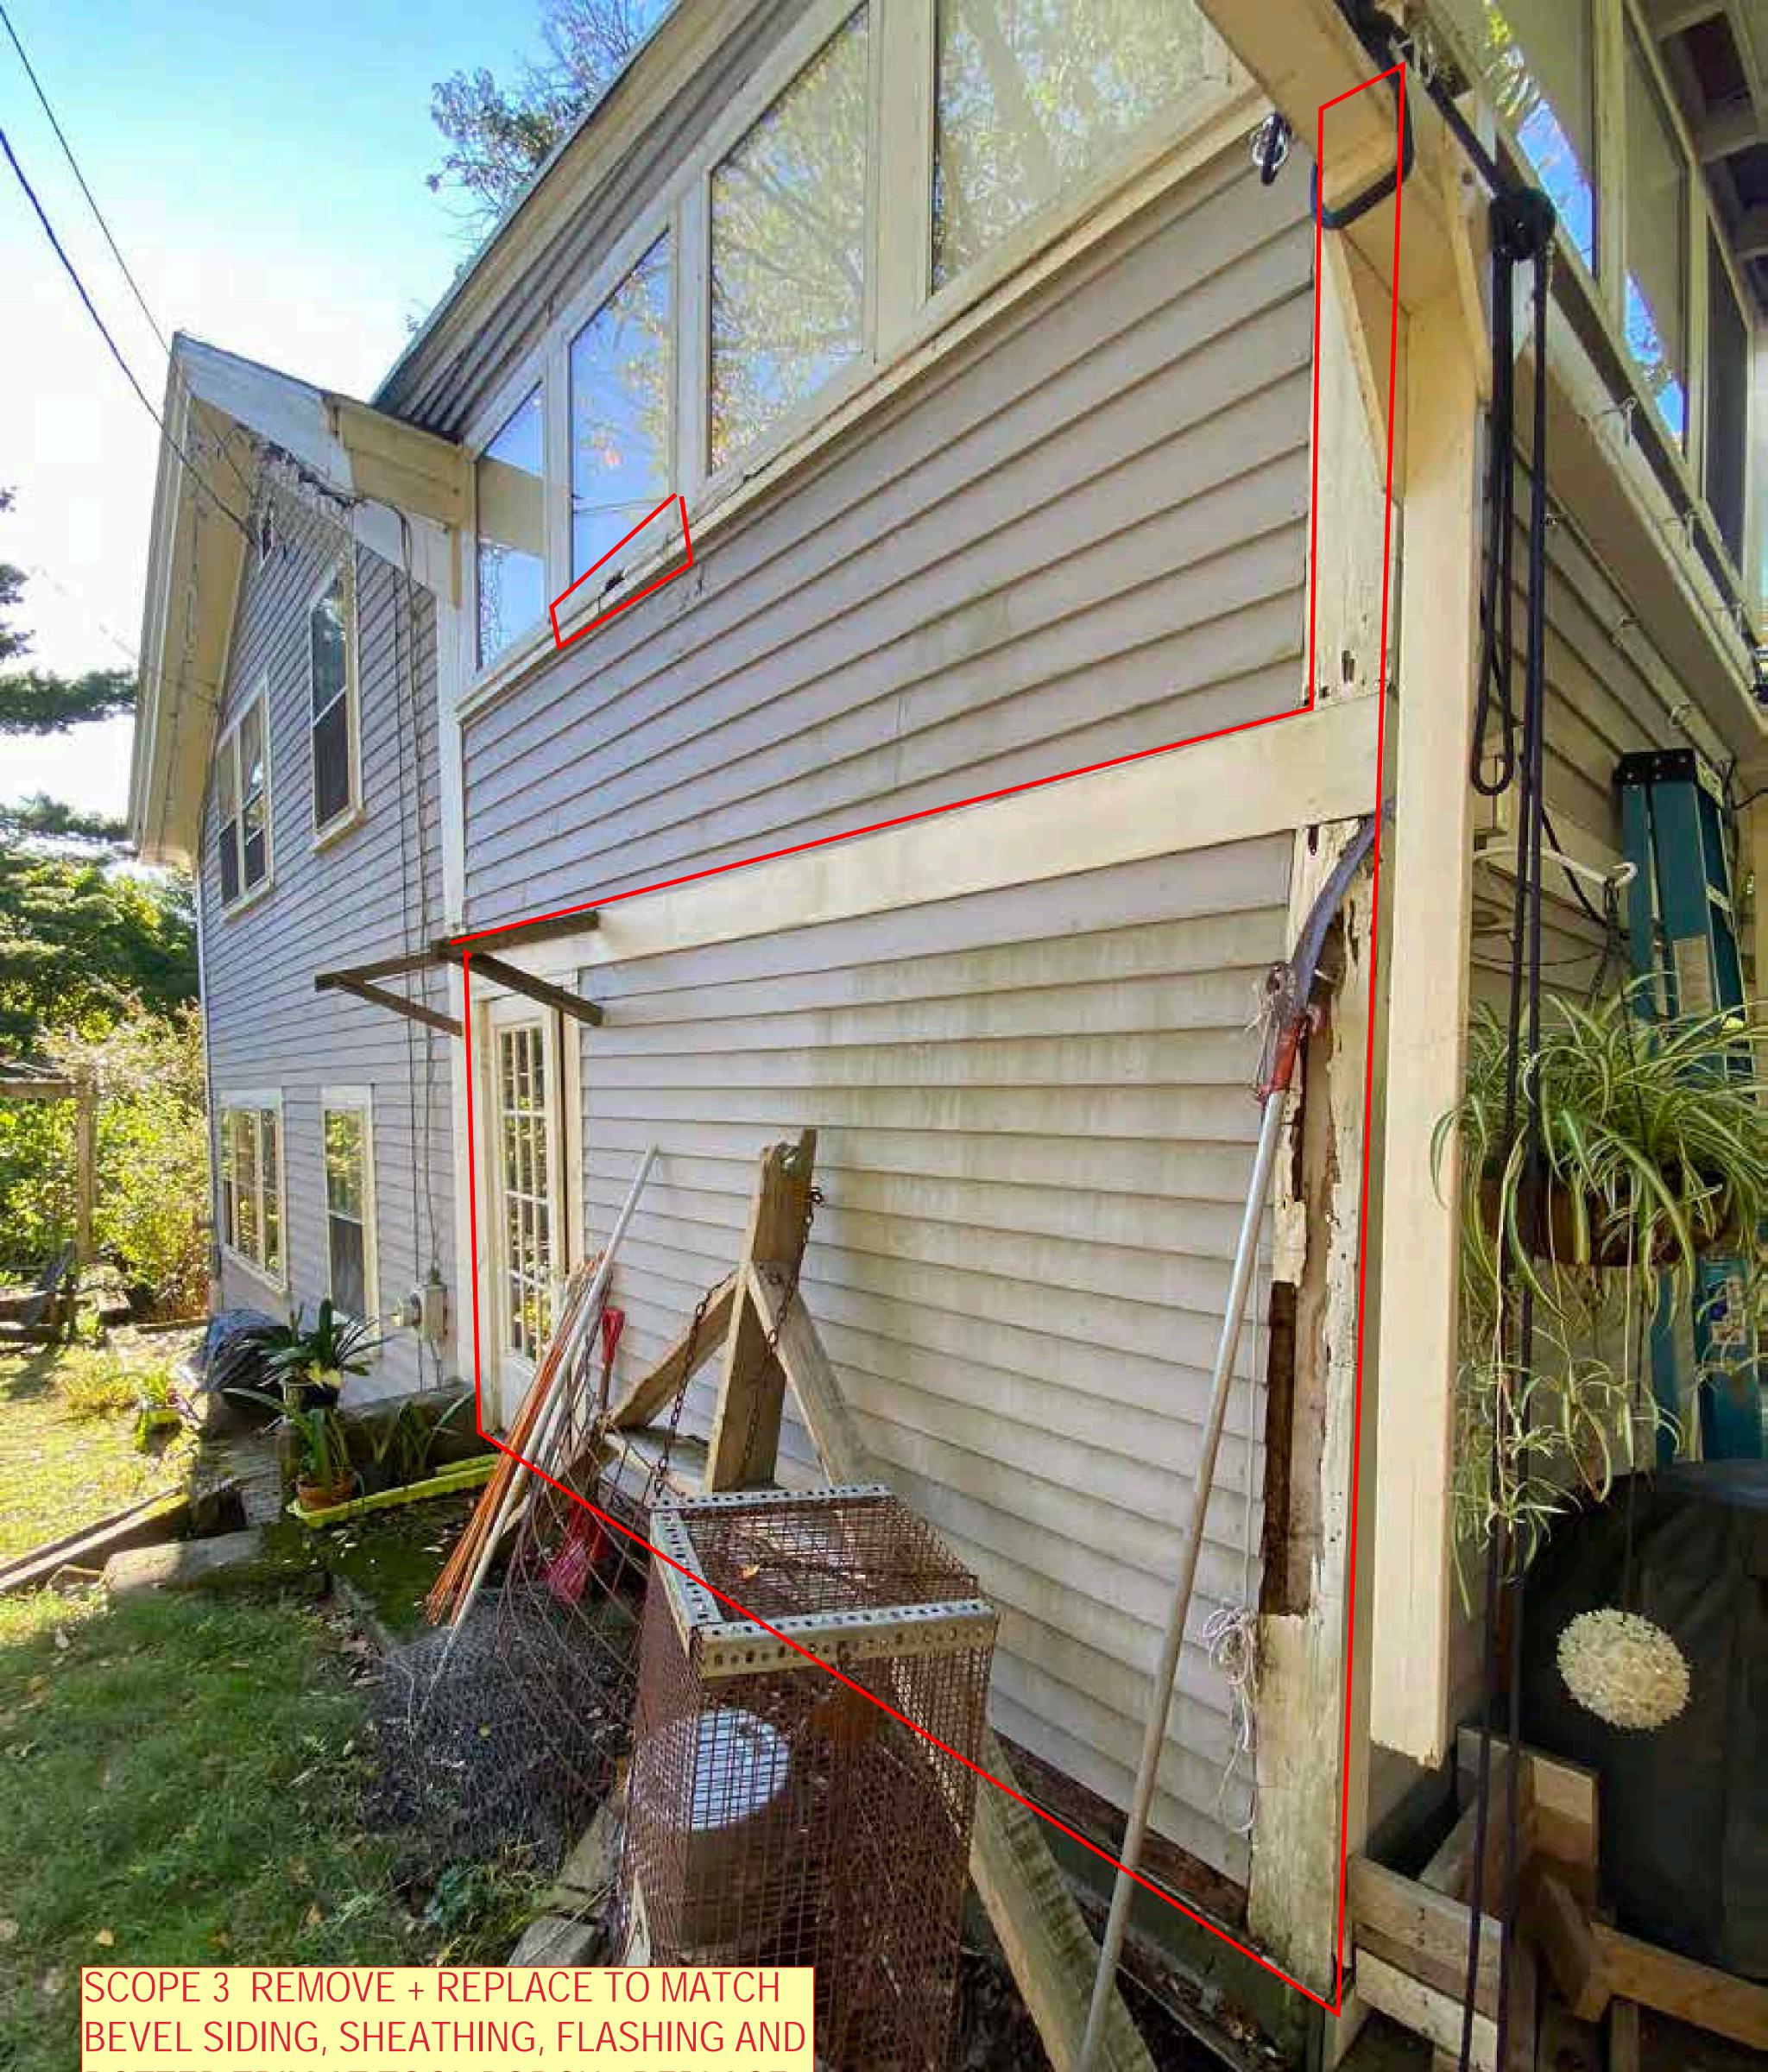
ROTTED TRIM AT TOOL PORCH. REPLACE

DAMAGED AND MISSING WINDOW SILL

BOARDS AT SECOND FLOOR PORCH

BEDROOM WINDOWS

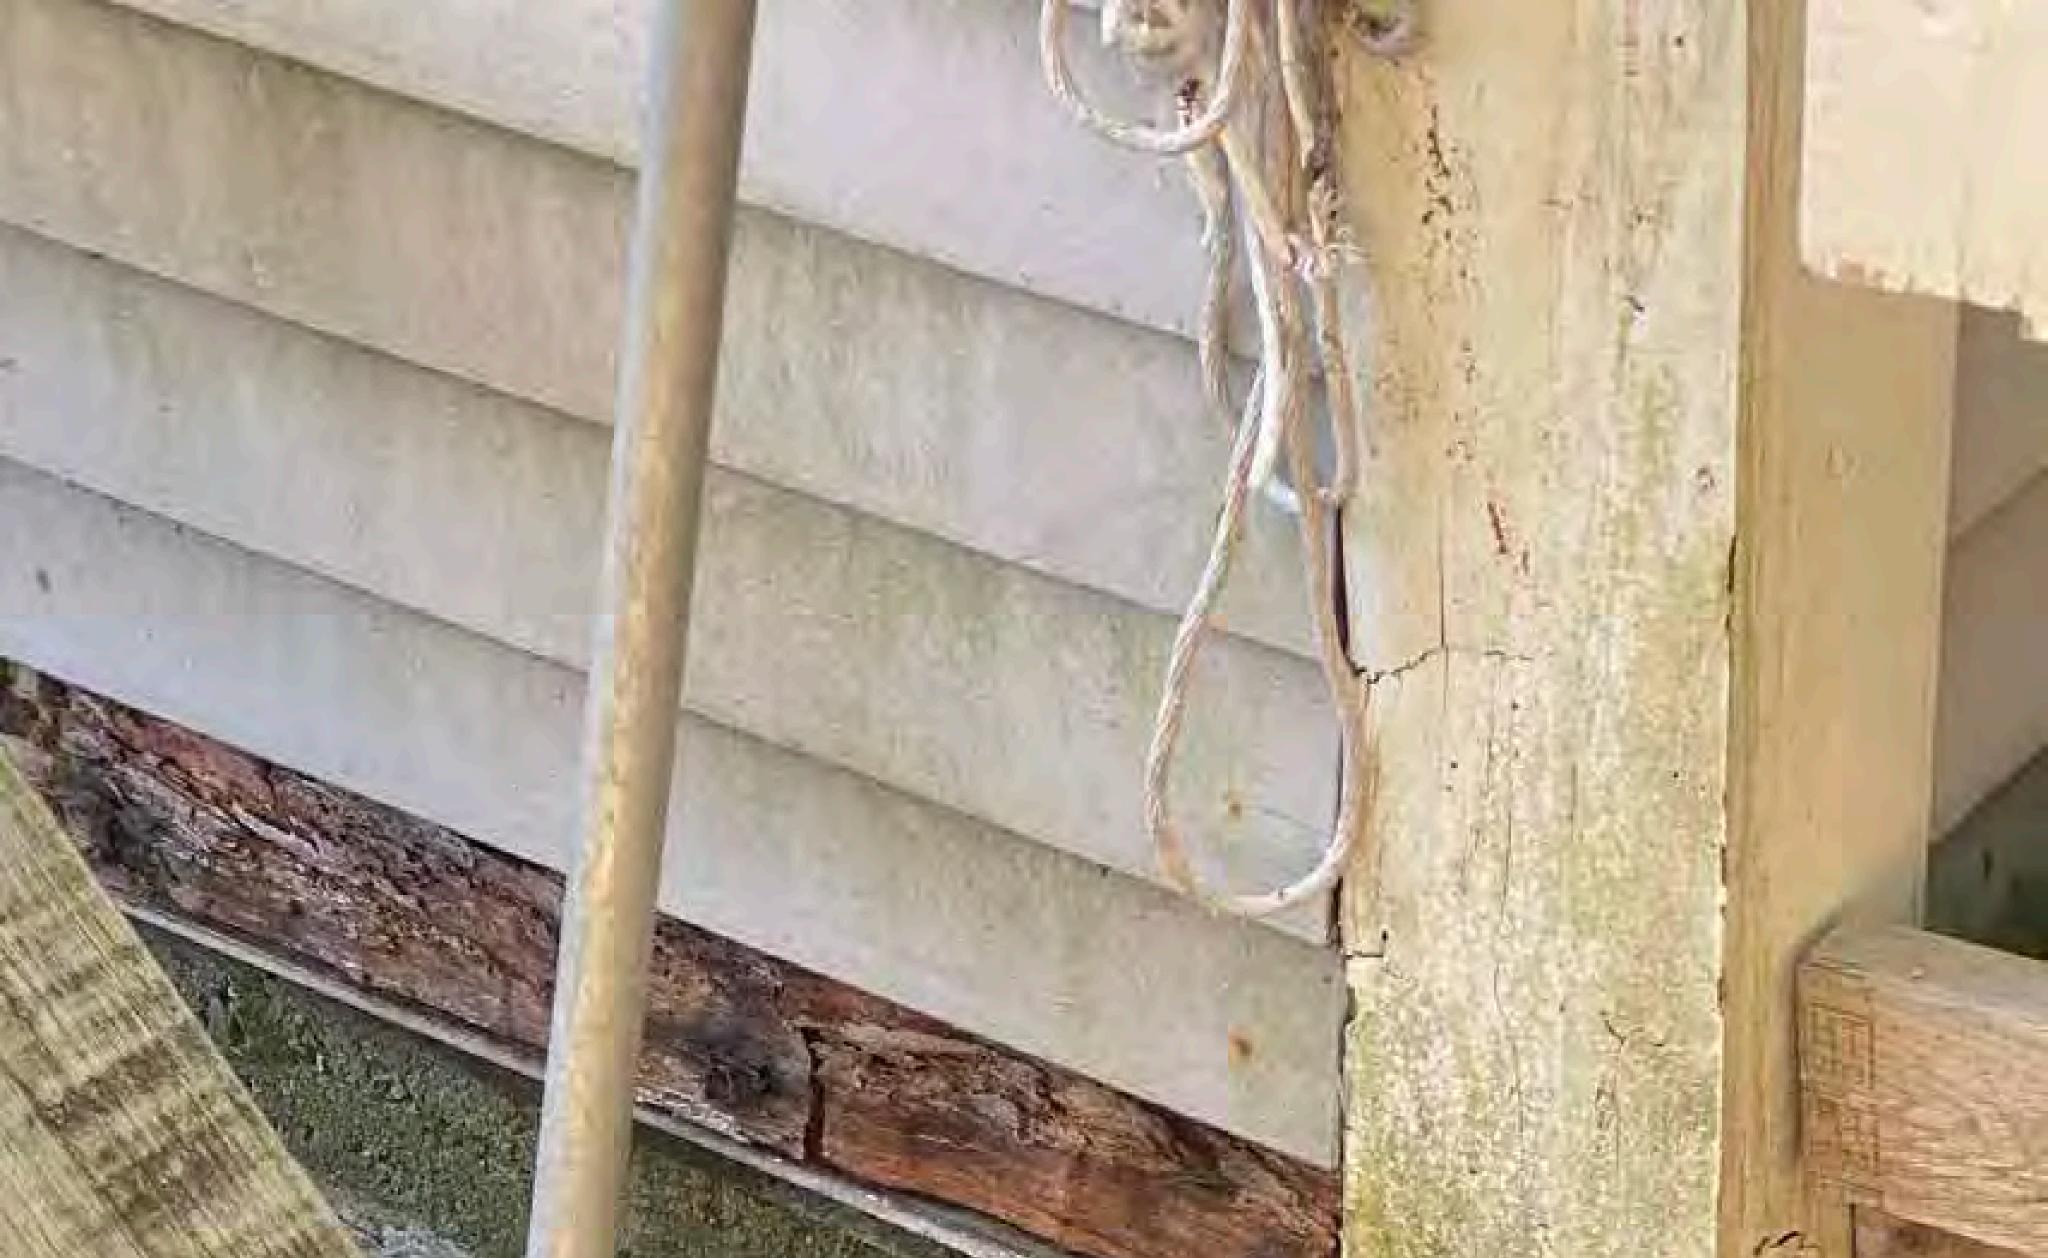
SCOPE 3 REMOVE + REPLACE TO MATCH BEVEL SIDING, SHEATHING, FLASHING AND

ROTTED TRIM AT TOOL PORCH.

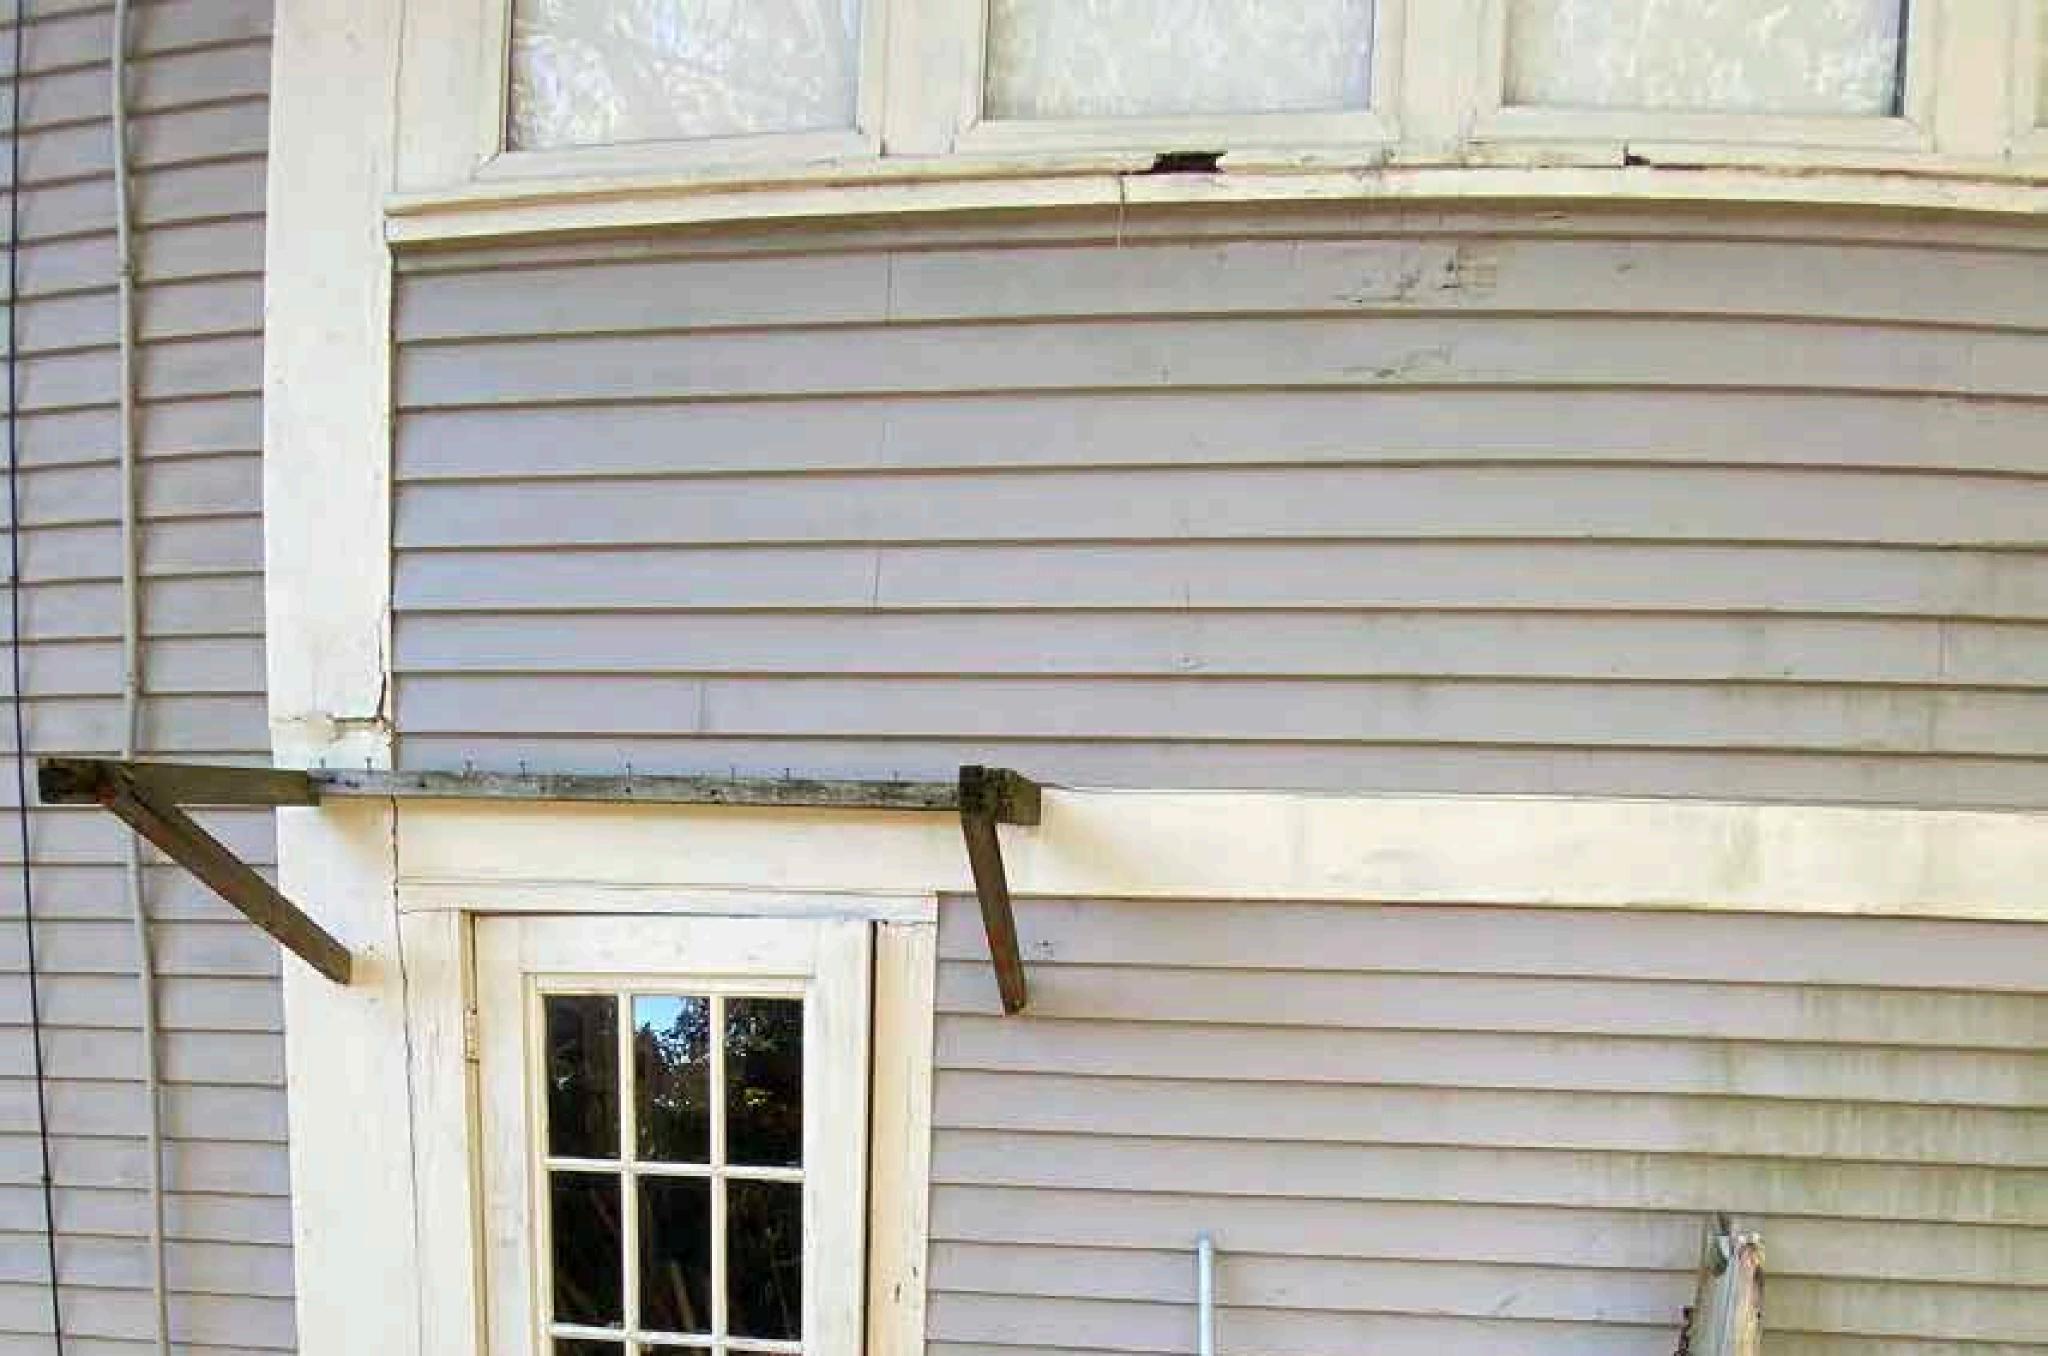
ROTTED TRIM AT TOOL PORCH. REPLACE

DAMAGED AND MISSING WINDOW SILL

BOARDS AT SECOND FLOOR PORCH

BEDROOM WINDOWS
