24 March 2023 Re: 711 Pleasant Street – HDC Application 1 – Façade Restoration

Applicant Statement

Façade restoration project (deferred maintenance). Replace in kind / paint to match various existing rotted wood: front porch (except roof); replace siding and trim (northeast façade, limited area at tool porch first floor); rear wood gutters and trim boards; basement door and window; trellis over deck. See scope photos, plot plan, site section attached.

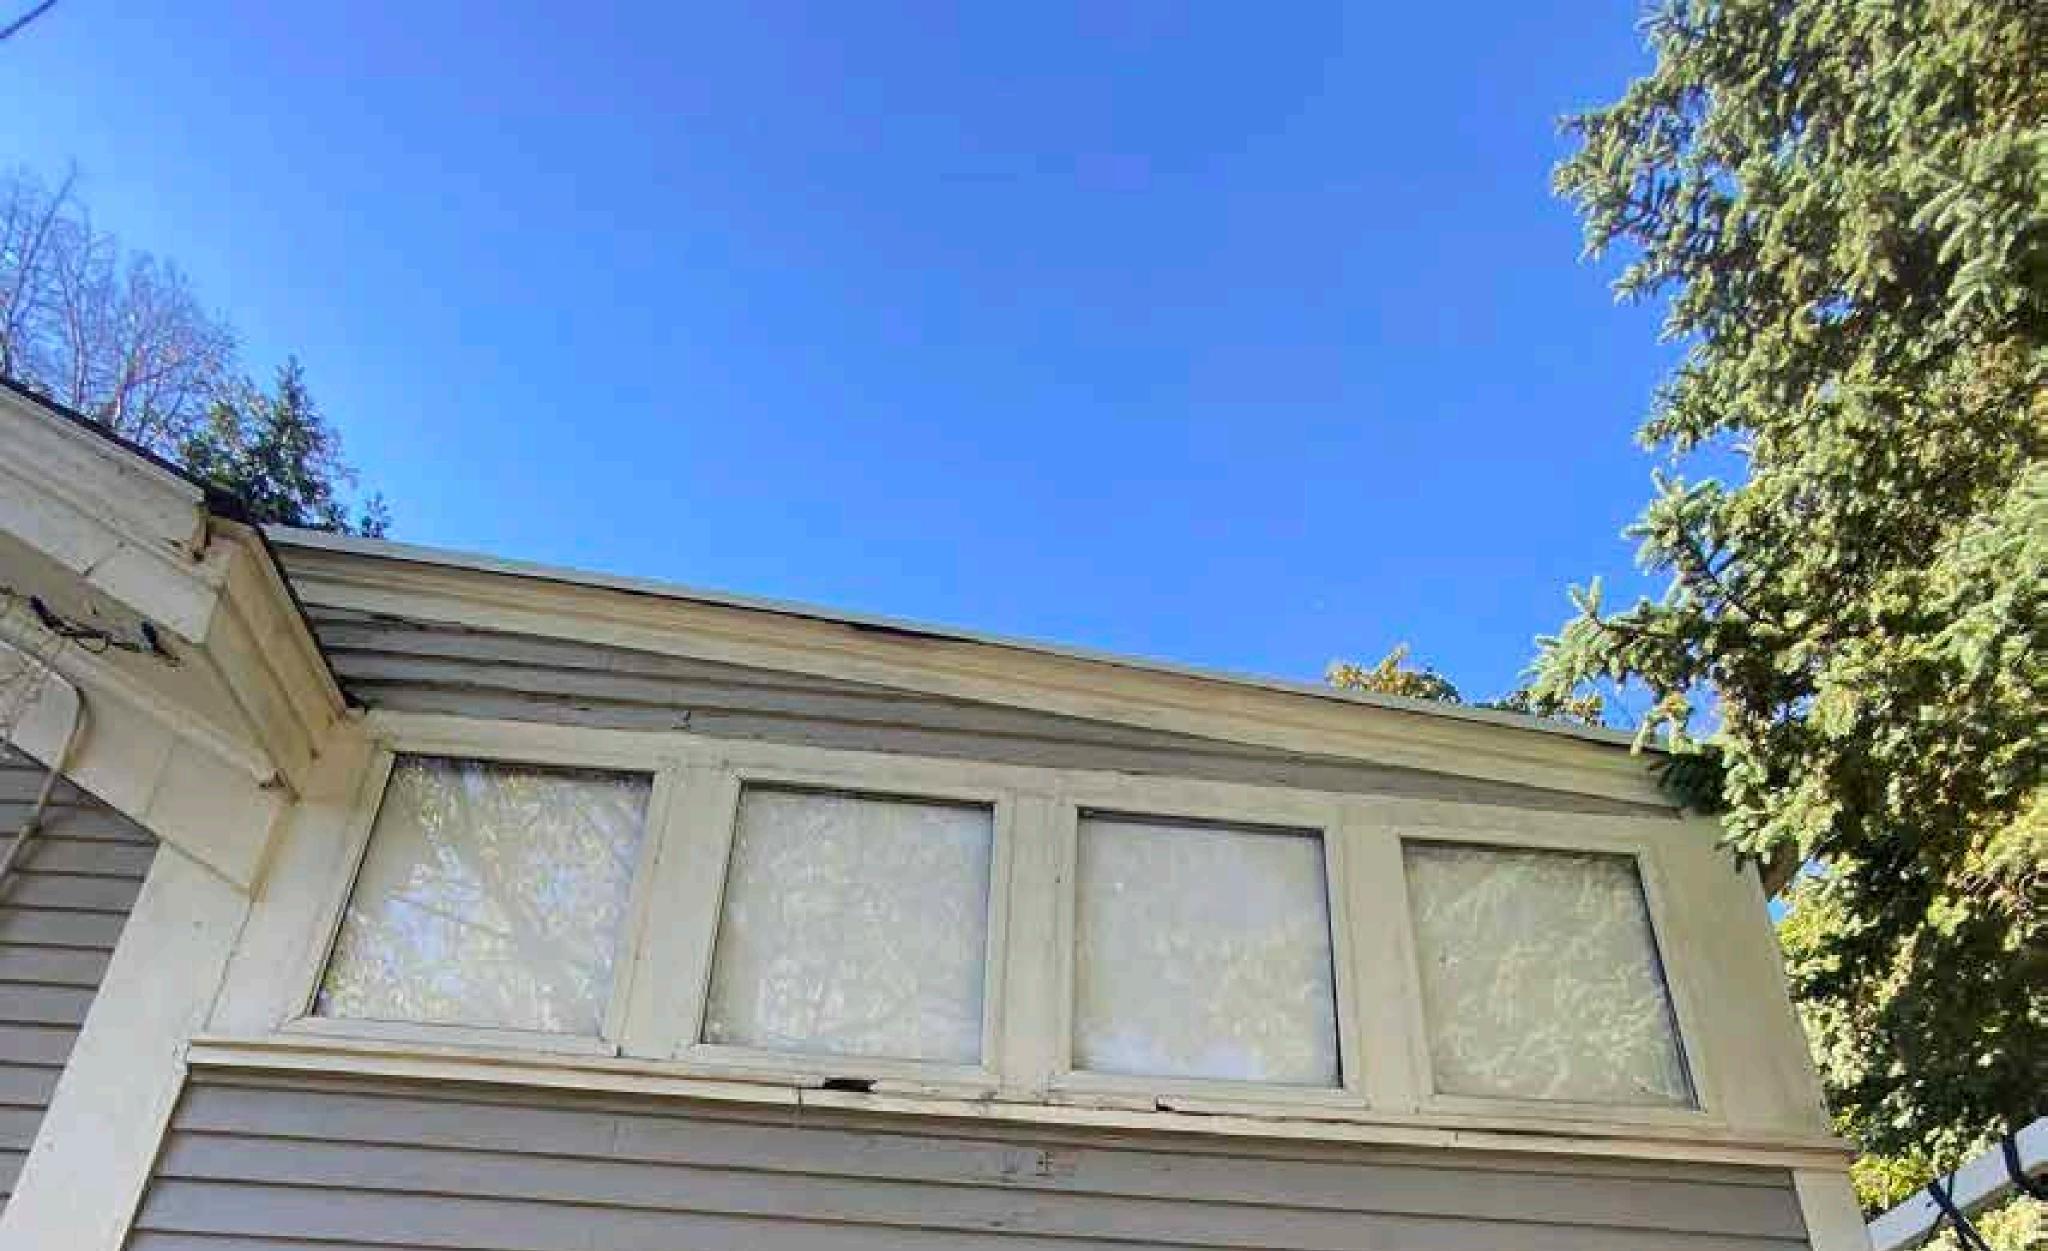
SCOPE 3 REPLACE DAMAGED AND MISSING WINDOW SILL BOARDS AT

SECOND FLOOR PORCH BEDROOM WINDOWS

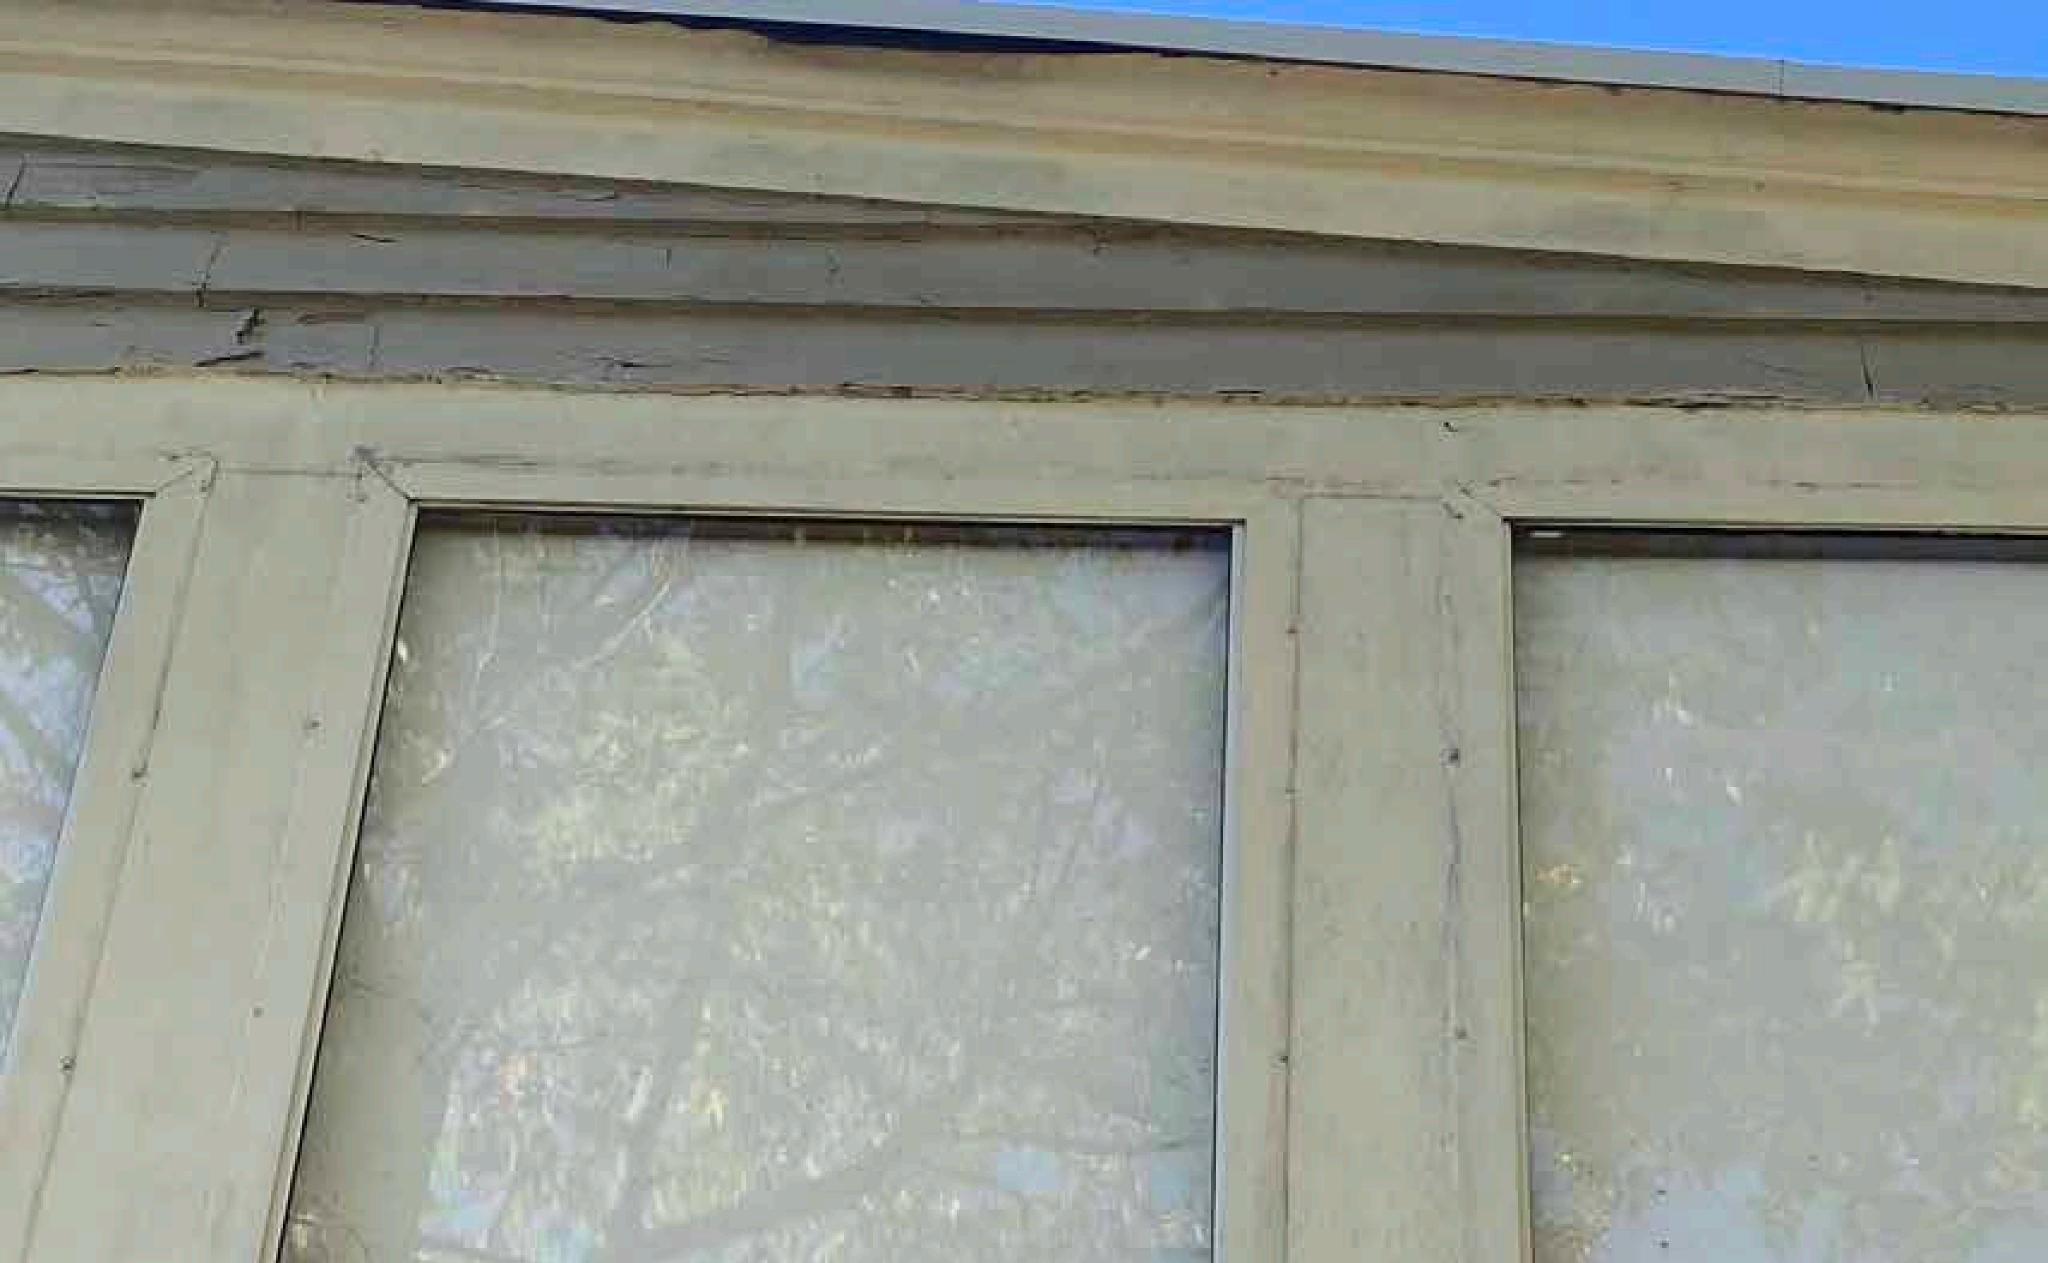
SCOPE 3 REPLACE DAMAGED AND MISSING WINDOW SILL BOARDS AT

SECOND FLOOR PORCH BEDROOM

WINDOWS

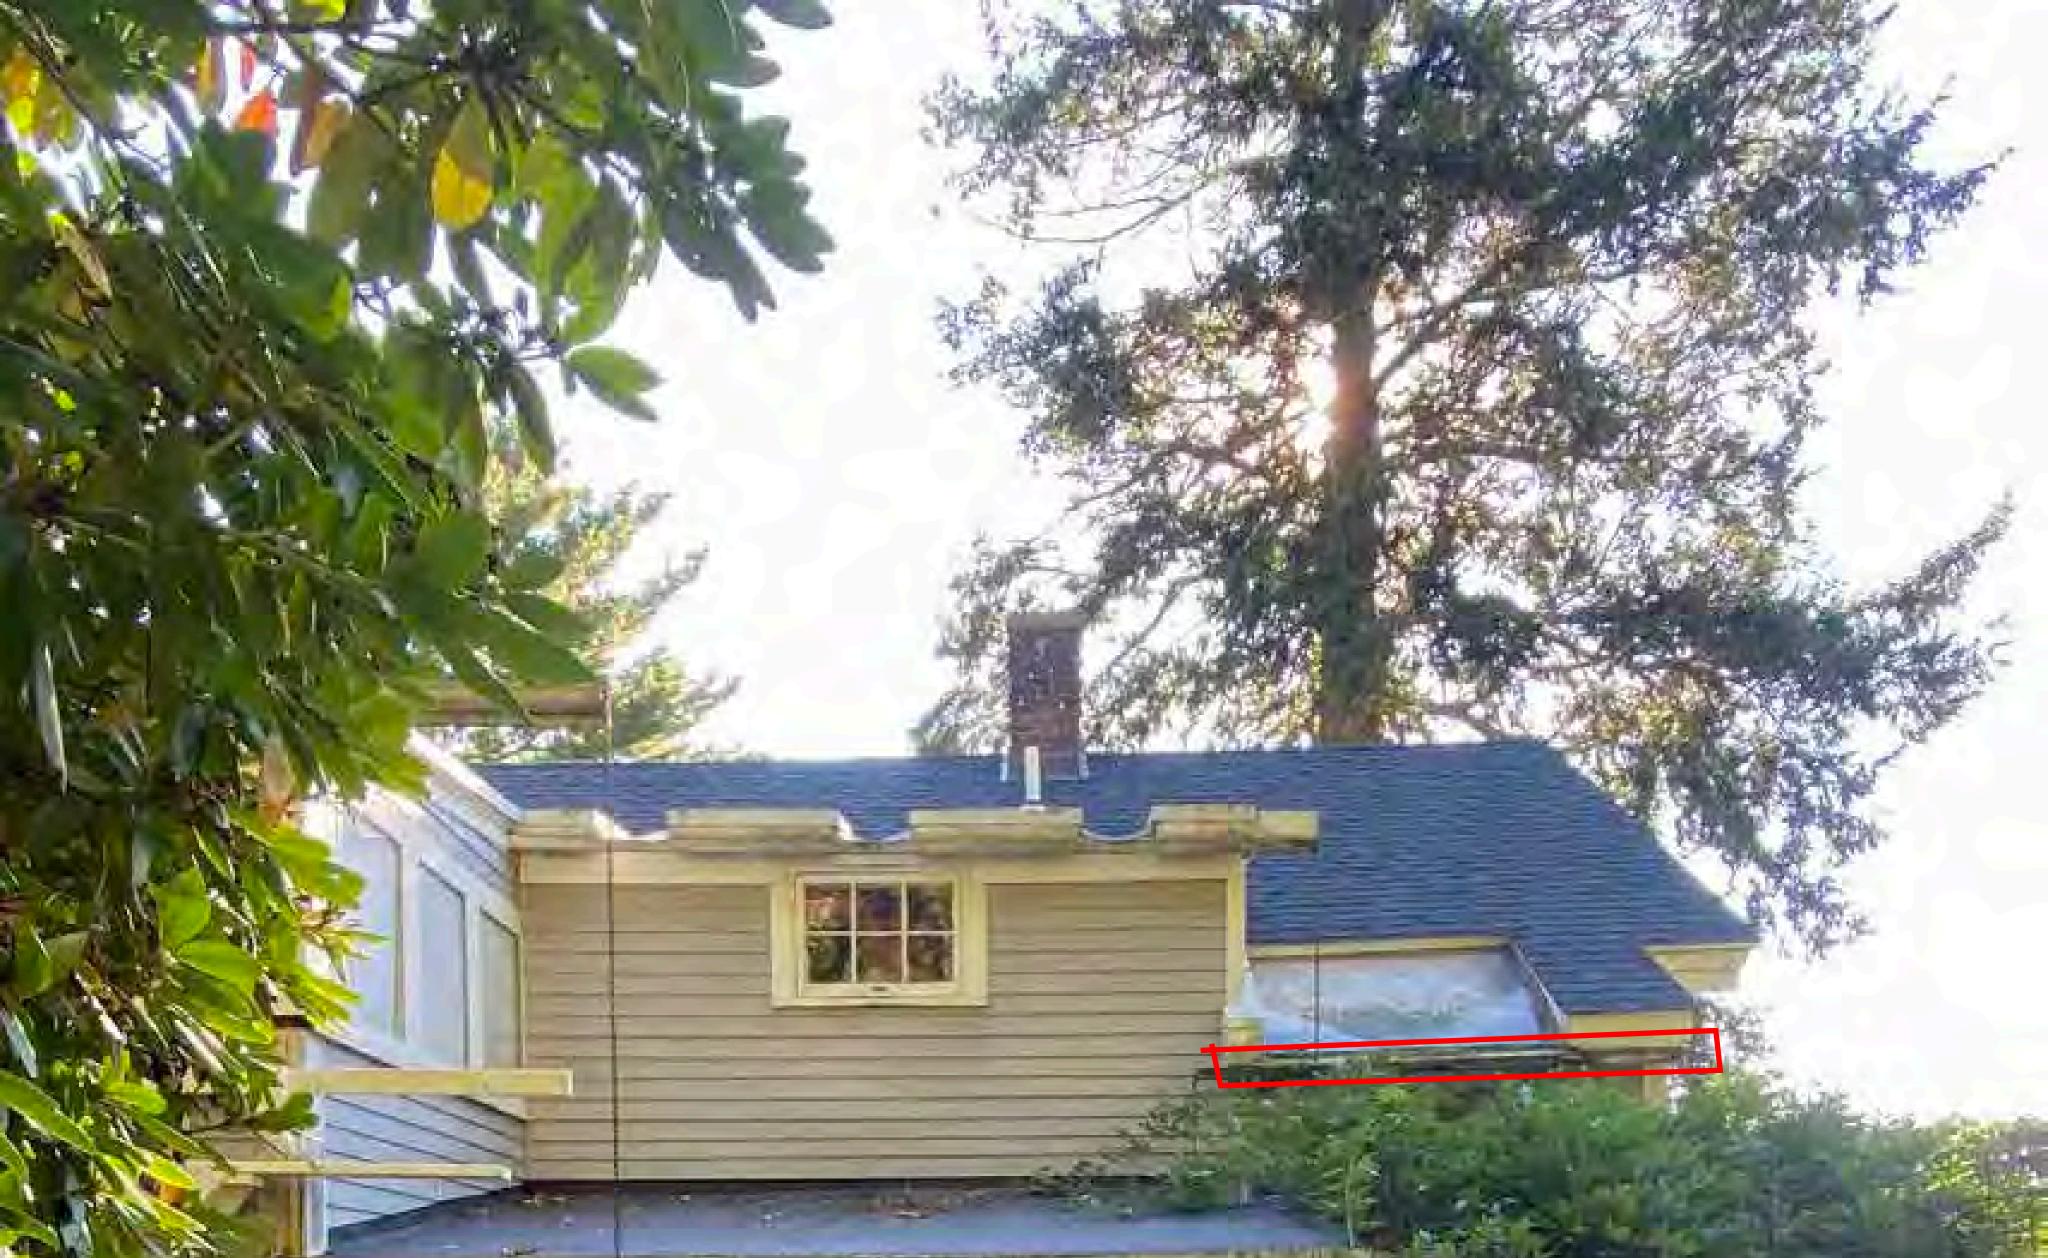
SCOPE 4 REMOVE AND REPLACE IN KIND THREE REAR GUTTERS AND BACKER BOARDS, PLUS ONE ROTTED TRIM BOARD AT TRIANGULAR WINDOW IN MASTER BATHROOM

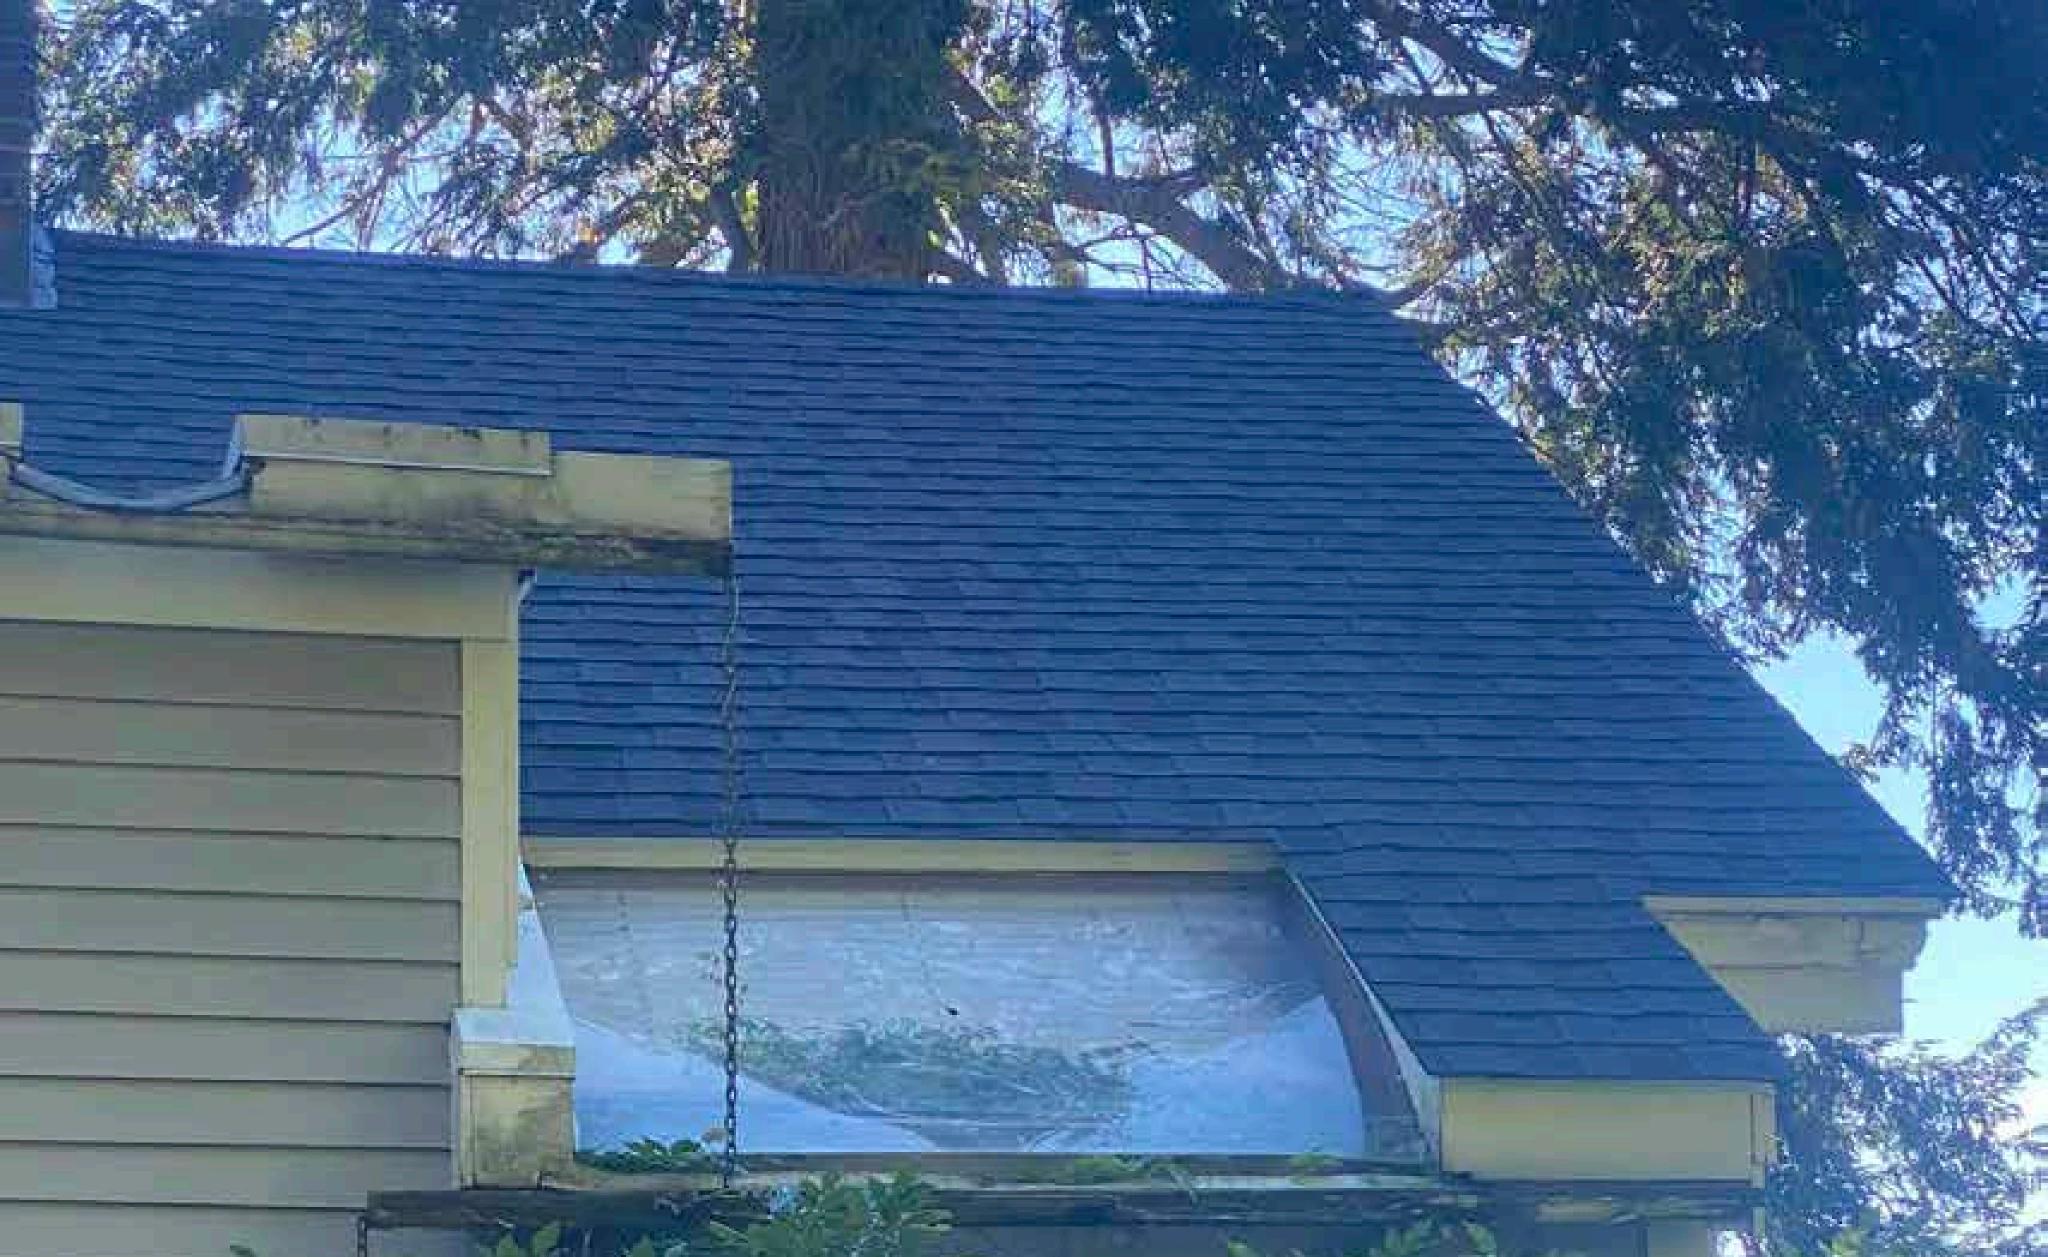
SCOPE 4 REMOVE AND REPLACE IN KIND THREE REAR GUTTERS AND BACKER BOARDS, PLUS ONE ROTTED TRIM BOARD AT TRIANGULAR WINDOW IN MASTER BATHROOM

ABOVE SKYLIGHT. NEW ROOF FLASHING AS REQUIRED.

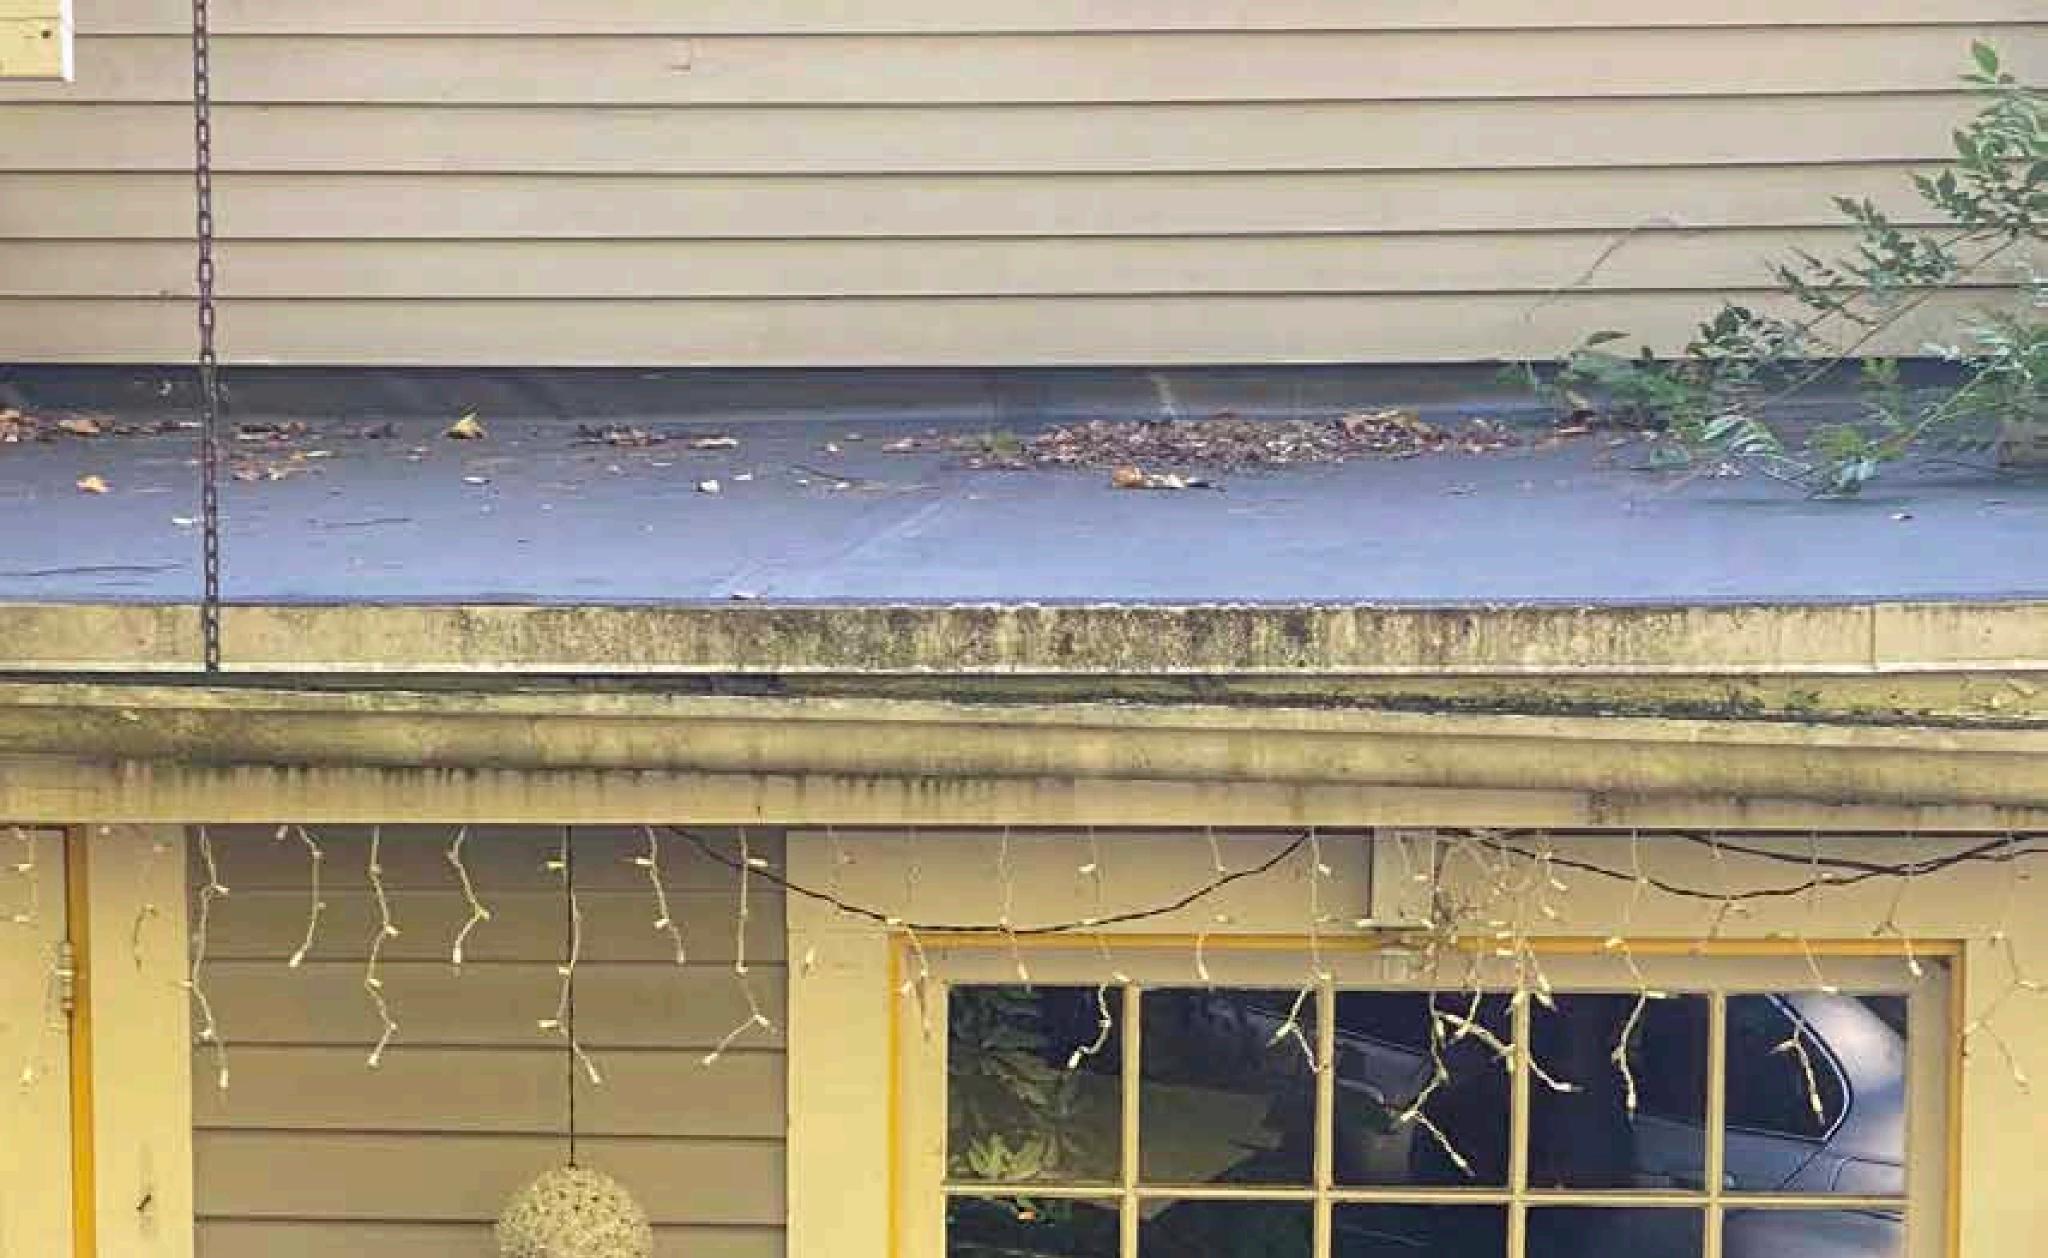
SCOPE 4 REMOVE AND REPLACE IN KIND THREE REAR GUTTERS AND BACKER BOARDS, PLUS ONE ROTTED TRIM BOARD AT TRIANGULAR WINDOW IN MASTER BATHROOM

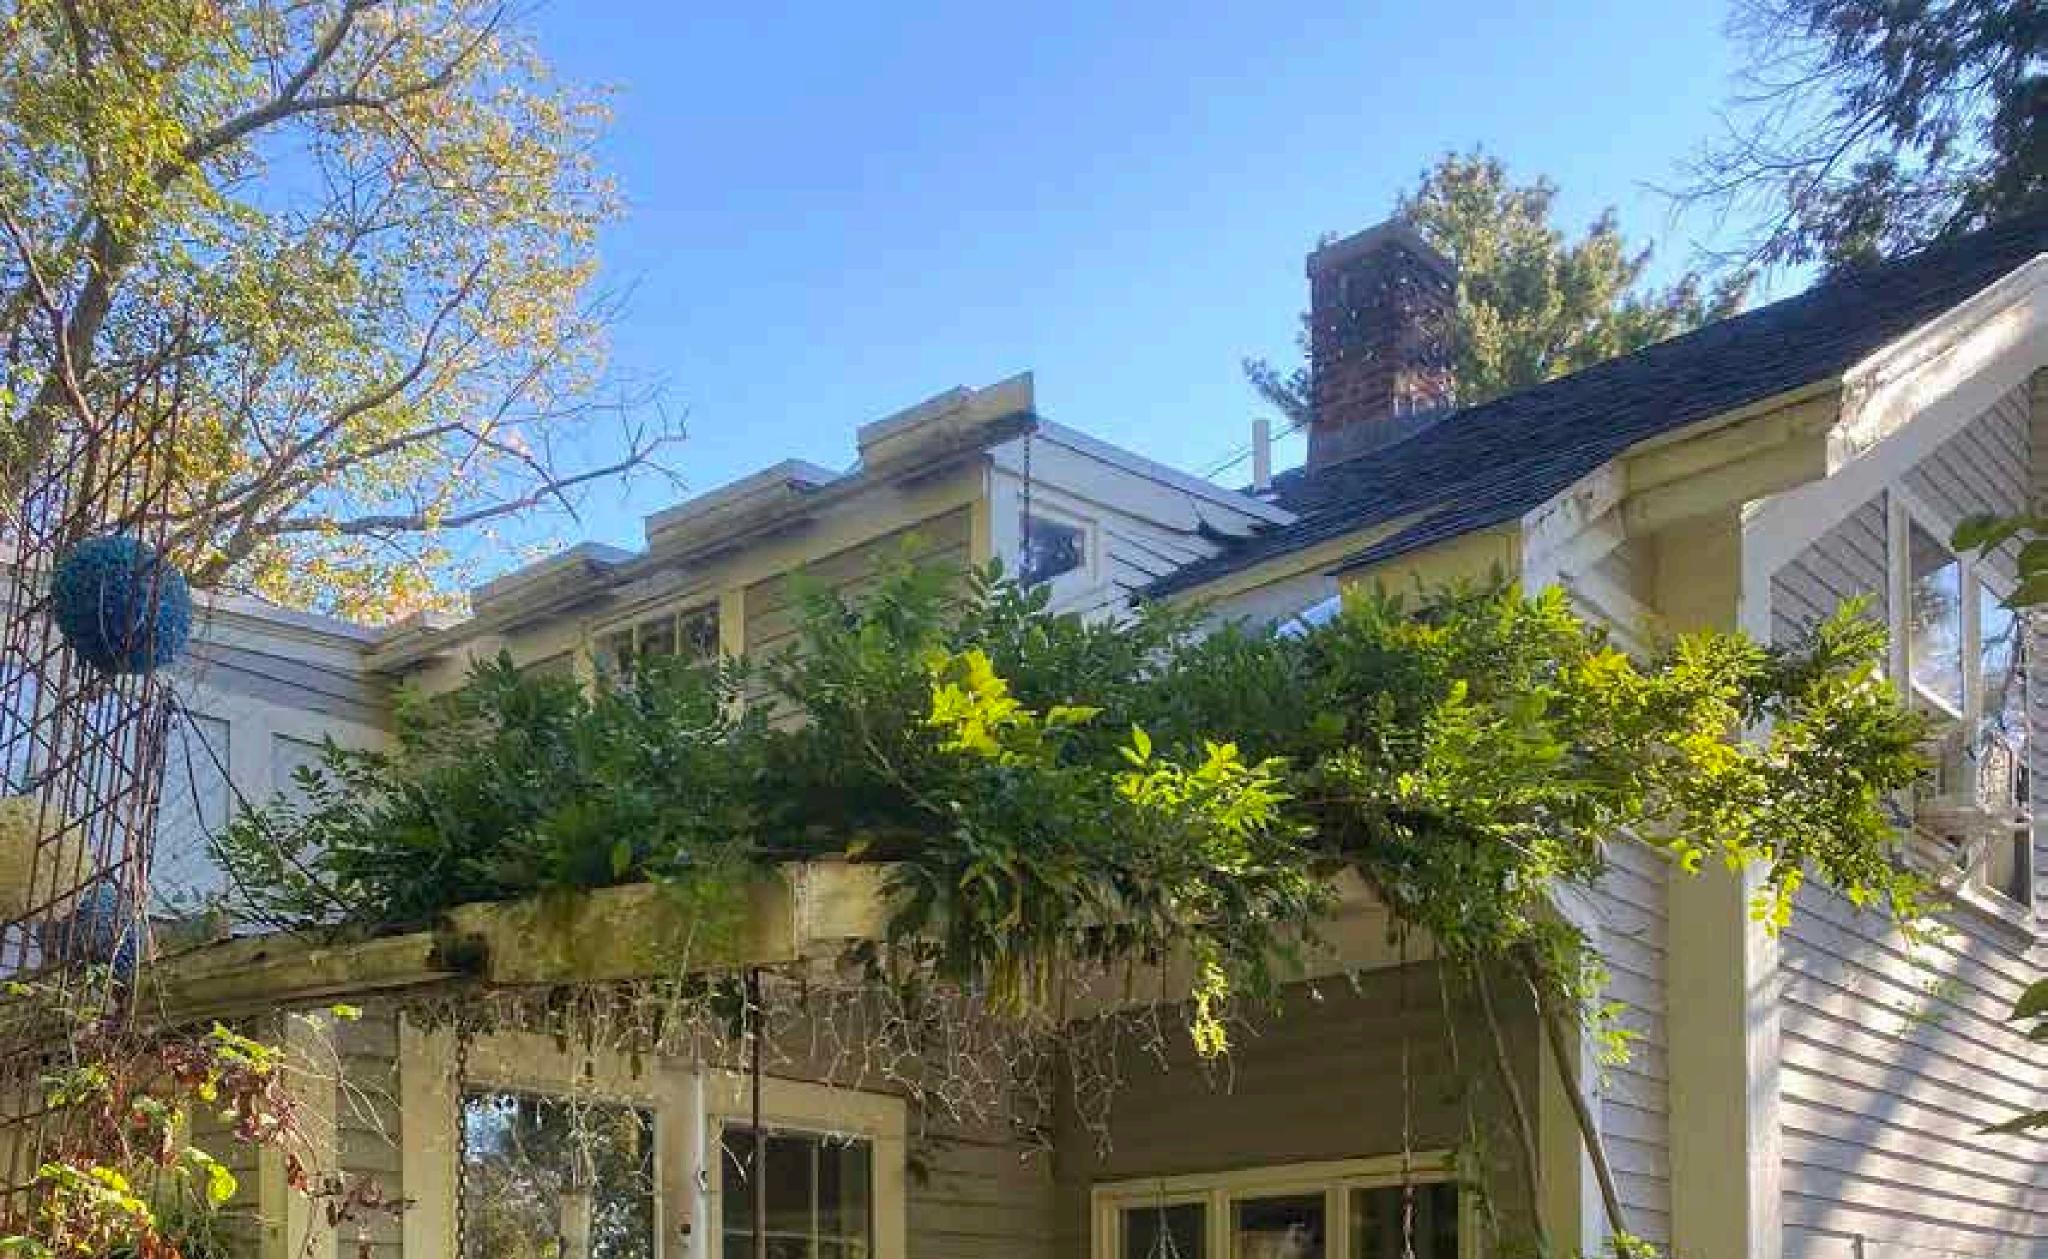
SCOPE 4 REPLACE EXISTING TRELLIS OVER DECK . PROTECT WISTERIA VINE AND REATTACH TO NEW TRELLIS.

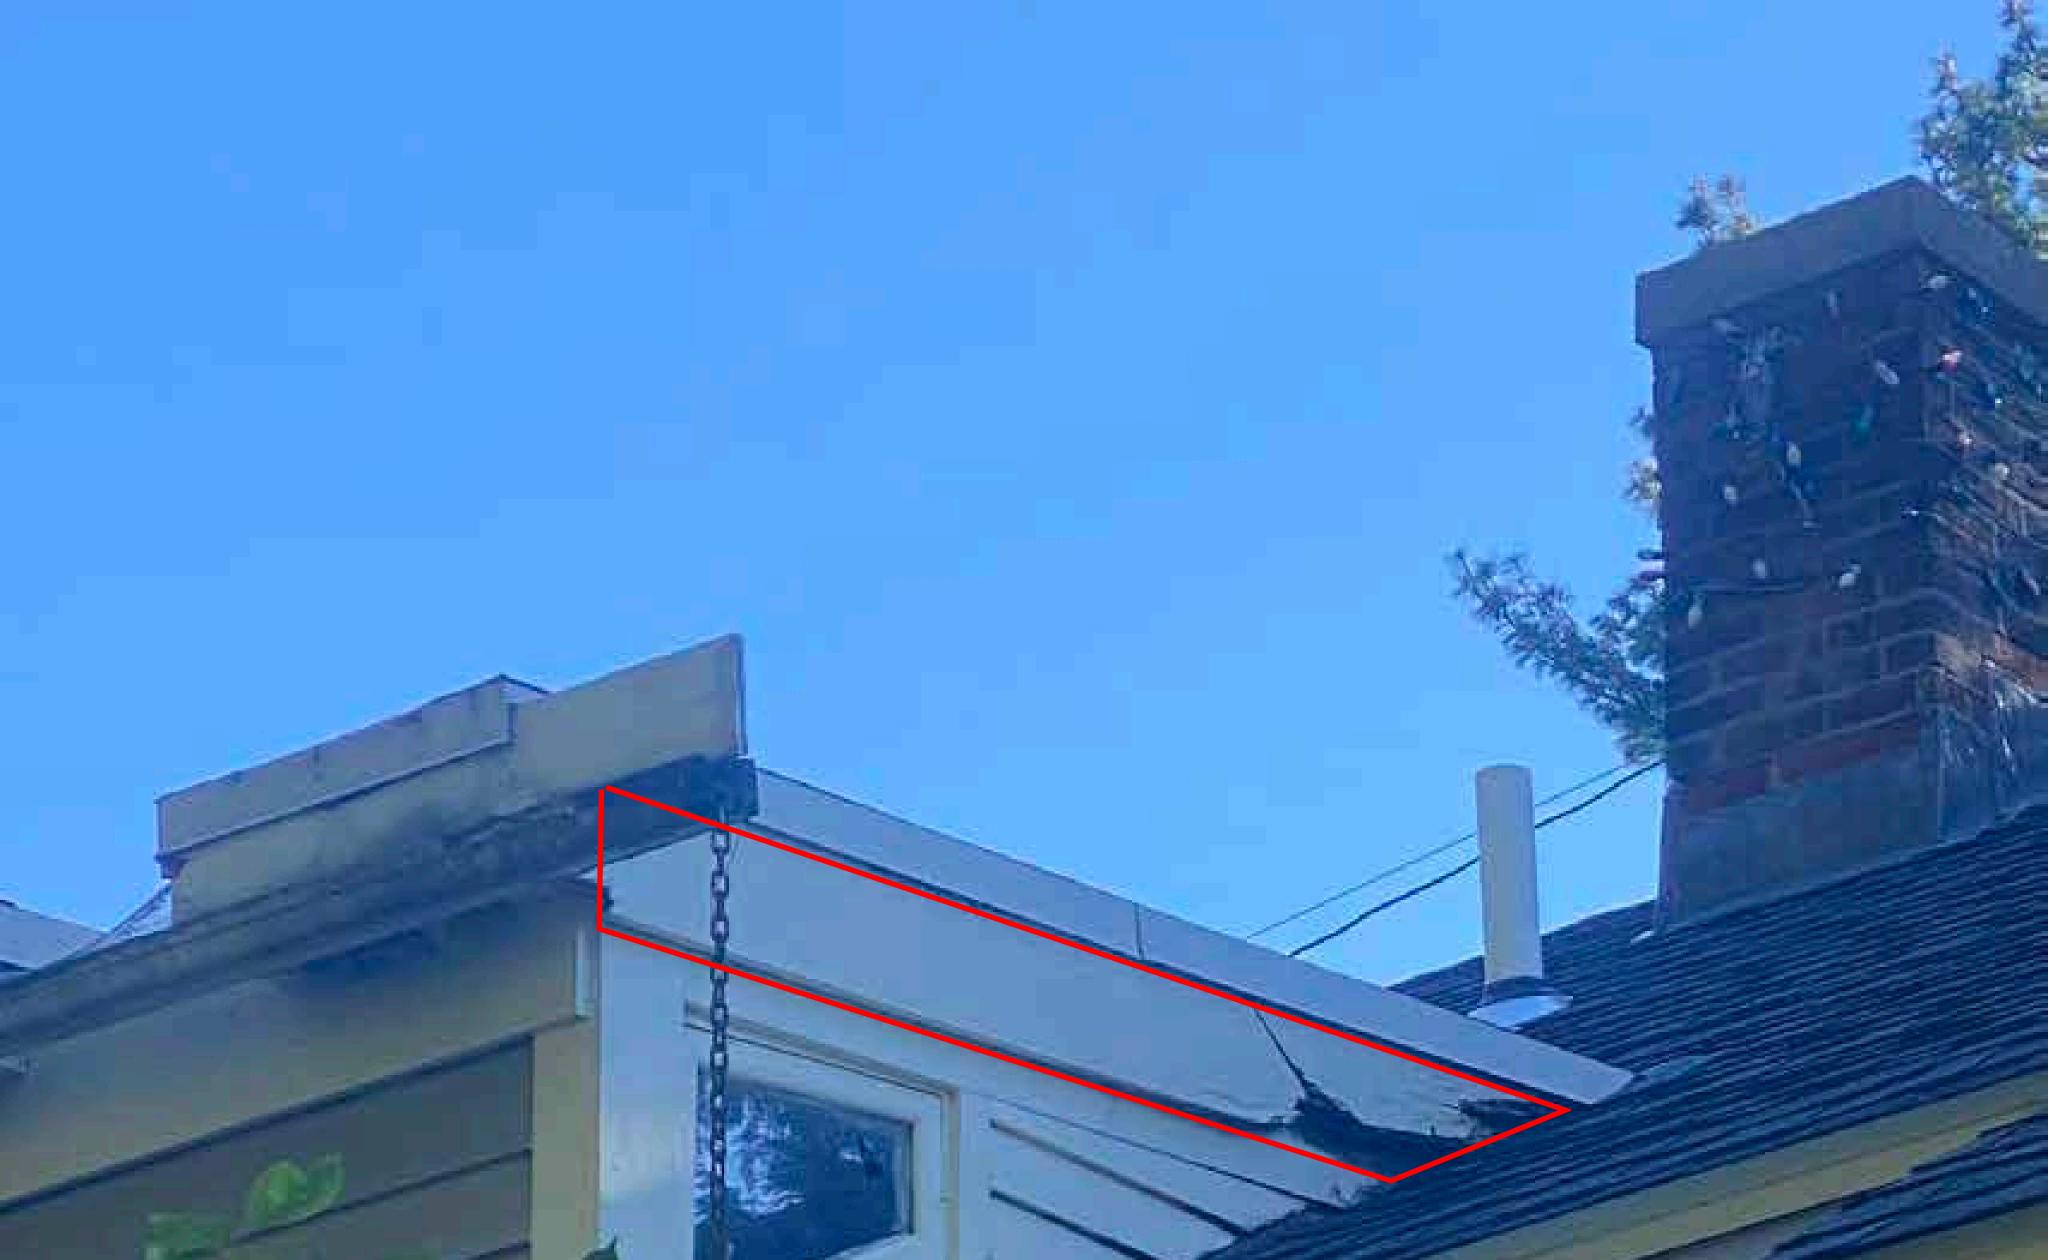
SCOPE 4 REMOVE AND REPLACE IN KIND ONE ROTTED TRIM BOARD AT TRIANGULAR WINDOW IN MASTER BATHROOM ABOVE TRAPEZOIDAL WINDOW.

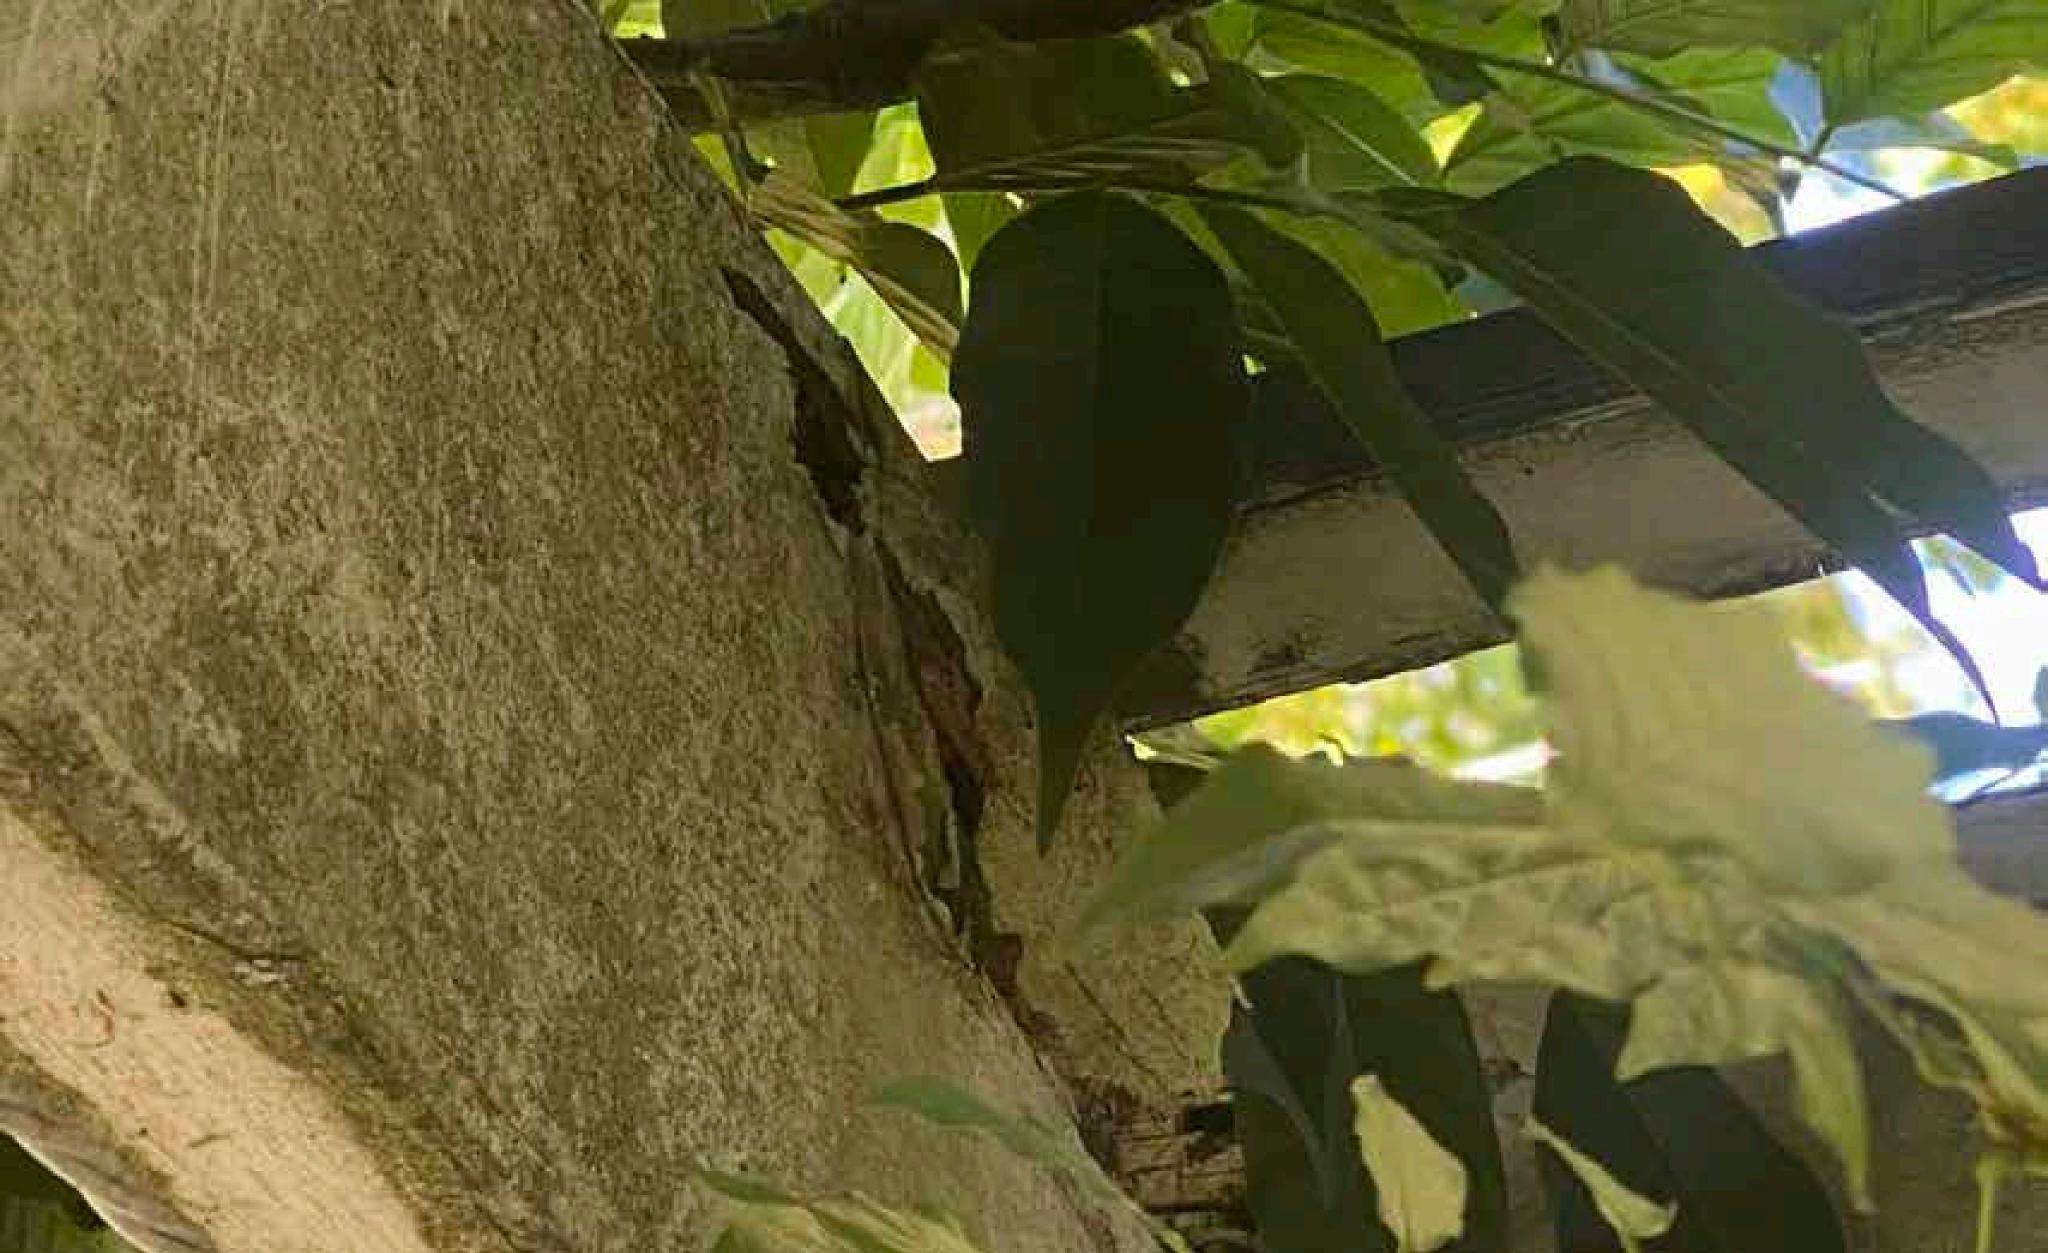
SCOPE 4 REMOVE AND REPLACE EXISTING TRELLIS OVER DECK. PROTECT WISTERIA VINE AND REATTACH TO NEW TRELLIS.
