24 March 2023 Re: 711 Pleasant Street – HDC Application 1 – Façade Restoration

Applicant Statement

Façade restoration project (deferred maintenance). Replace in kind / paint to match various existing rotted wood: front porch (except roof); replace siding and trim (northeast façade, limited area at tool porch first floor); rear wood gutters and trim boards; basement door and window; trellis over deck. See scope photos, plot plan, site section attached.

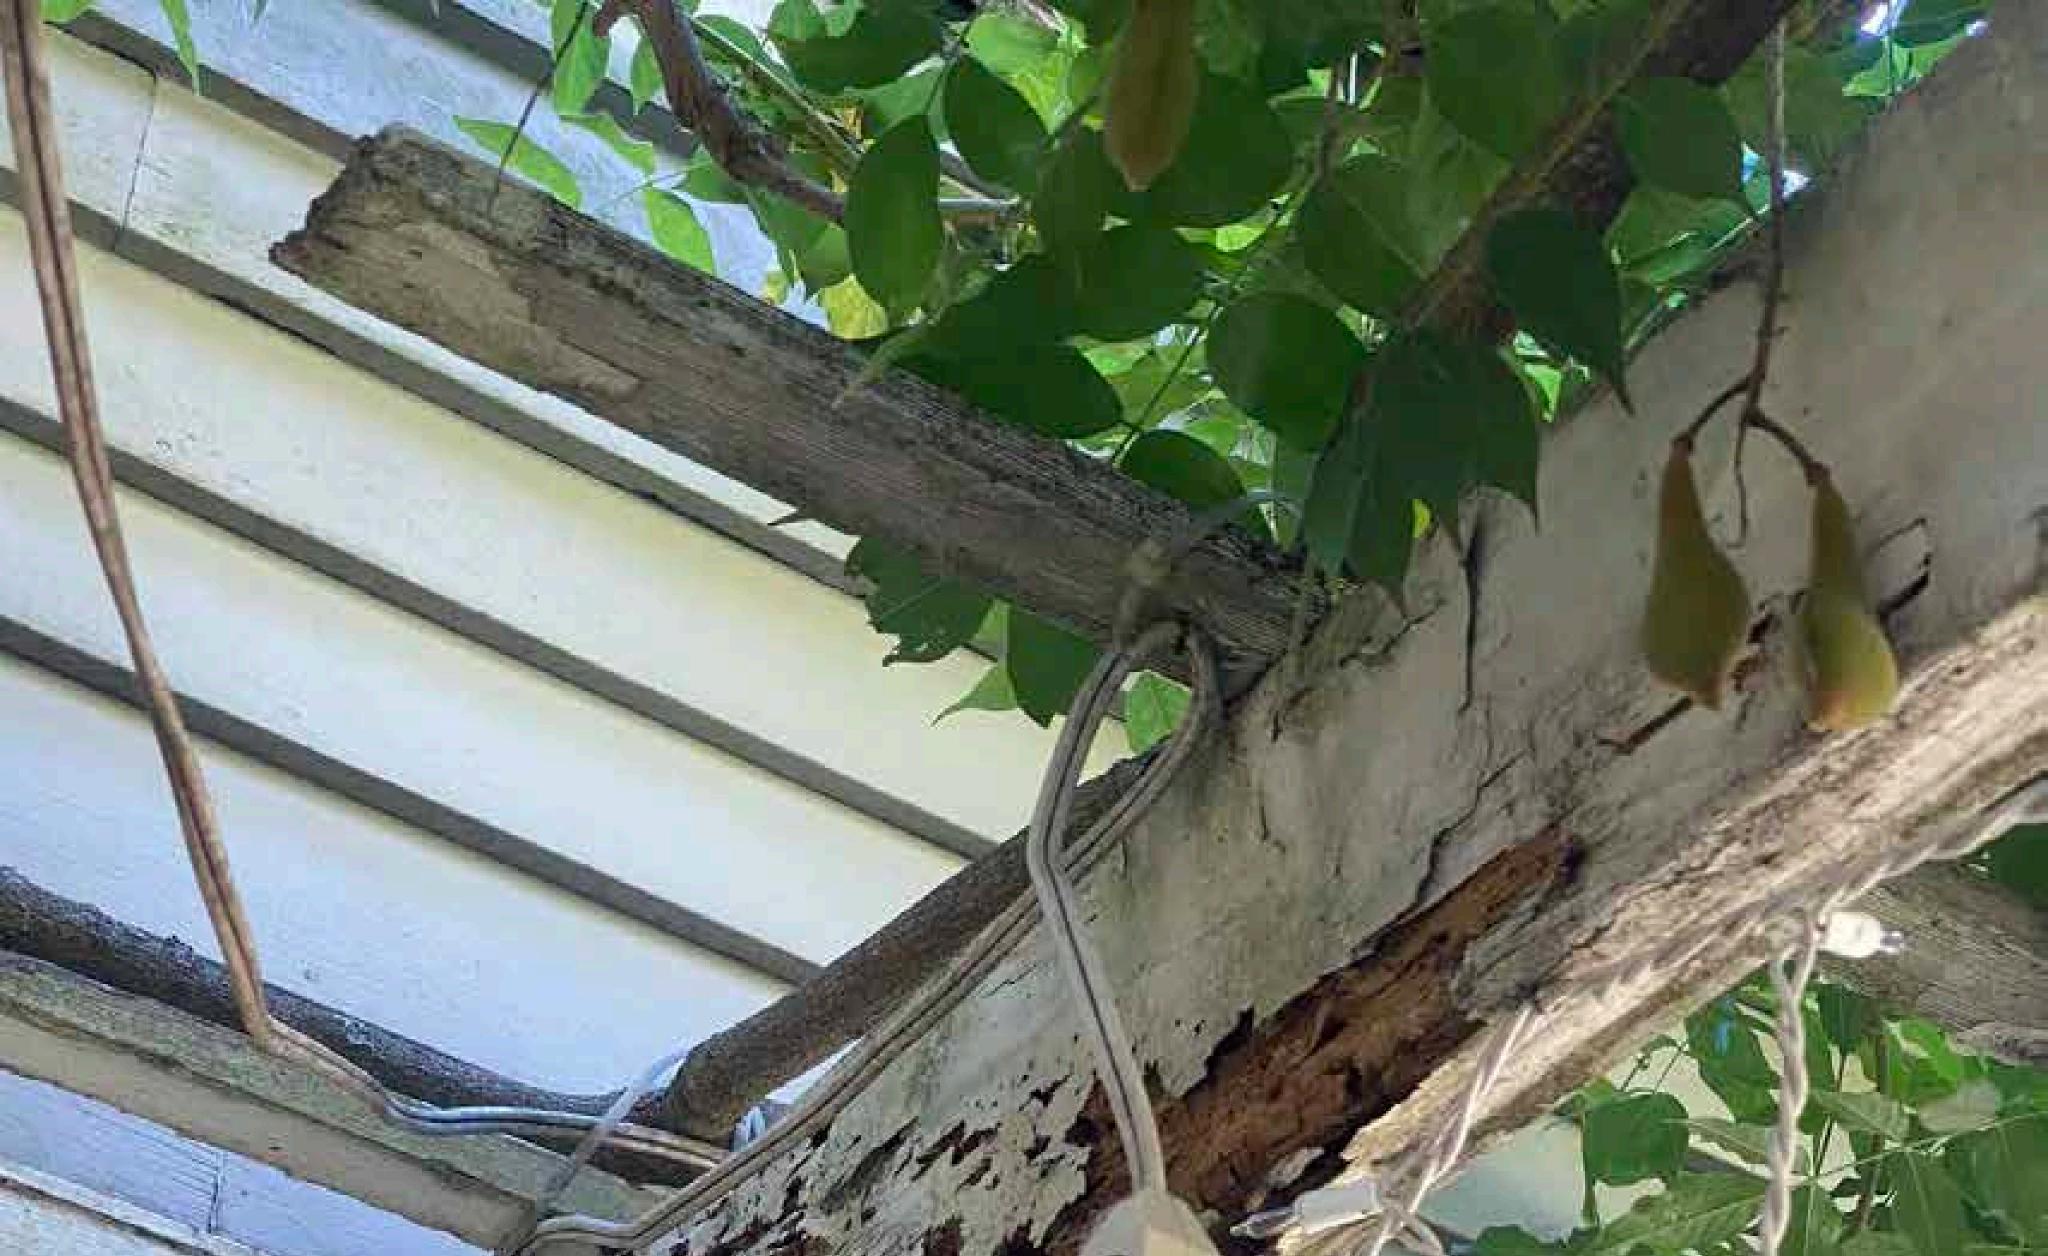
SCOPE 4 REMOVE AND REPLACE EXISTING TRELLIS OVER DECK PROTECT WISTERIA VINE AND REATTACH TO NEW TRELLIS.

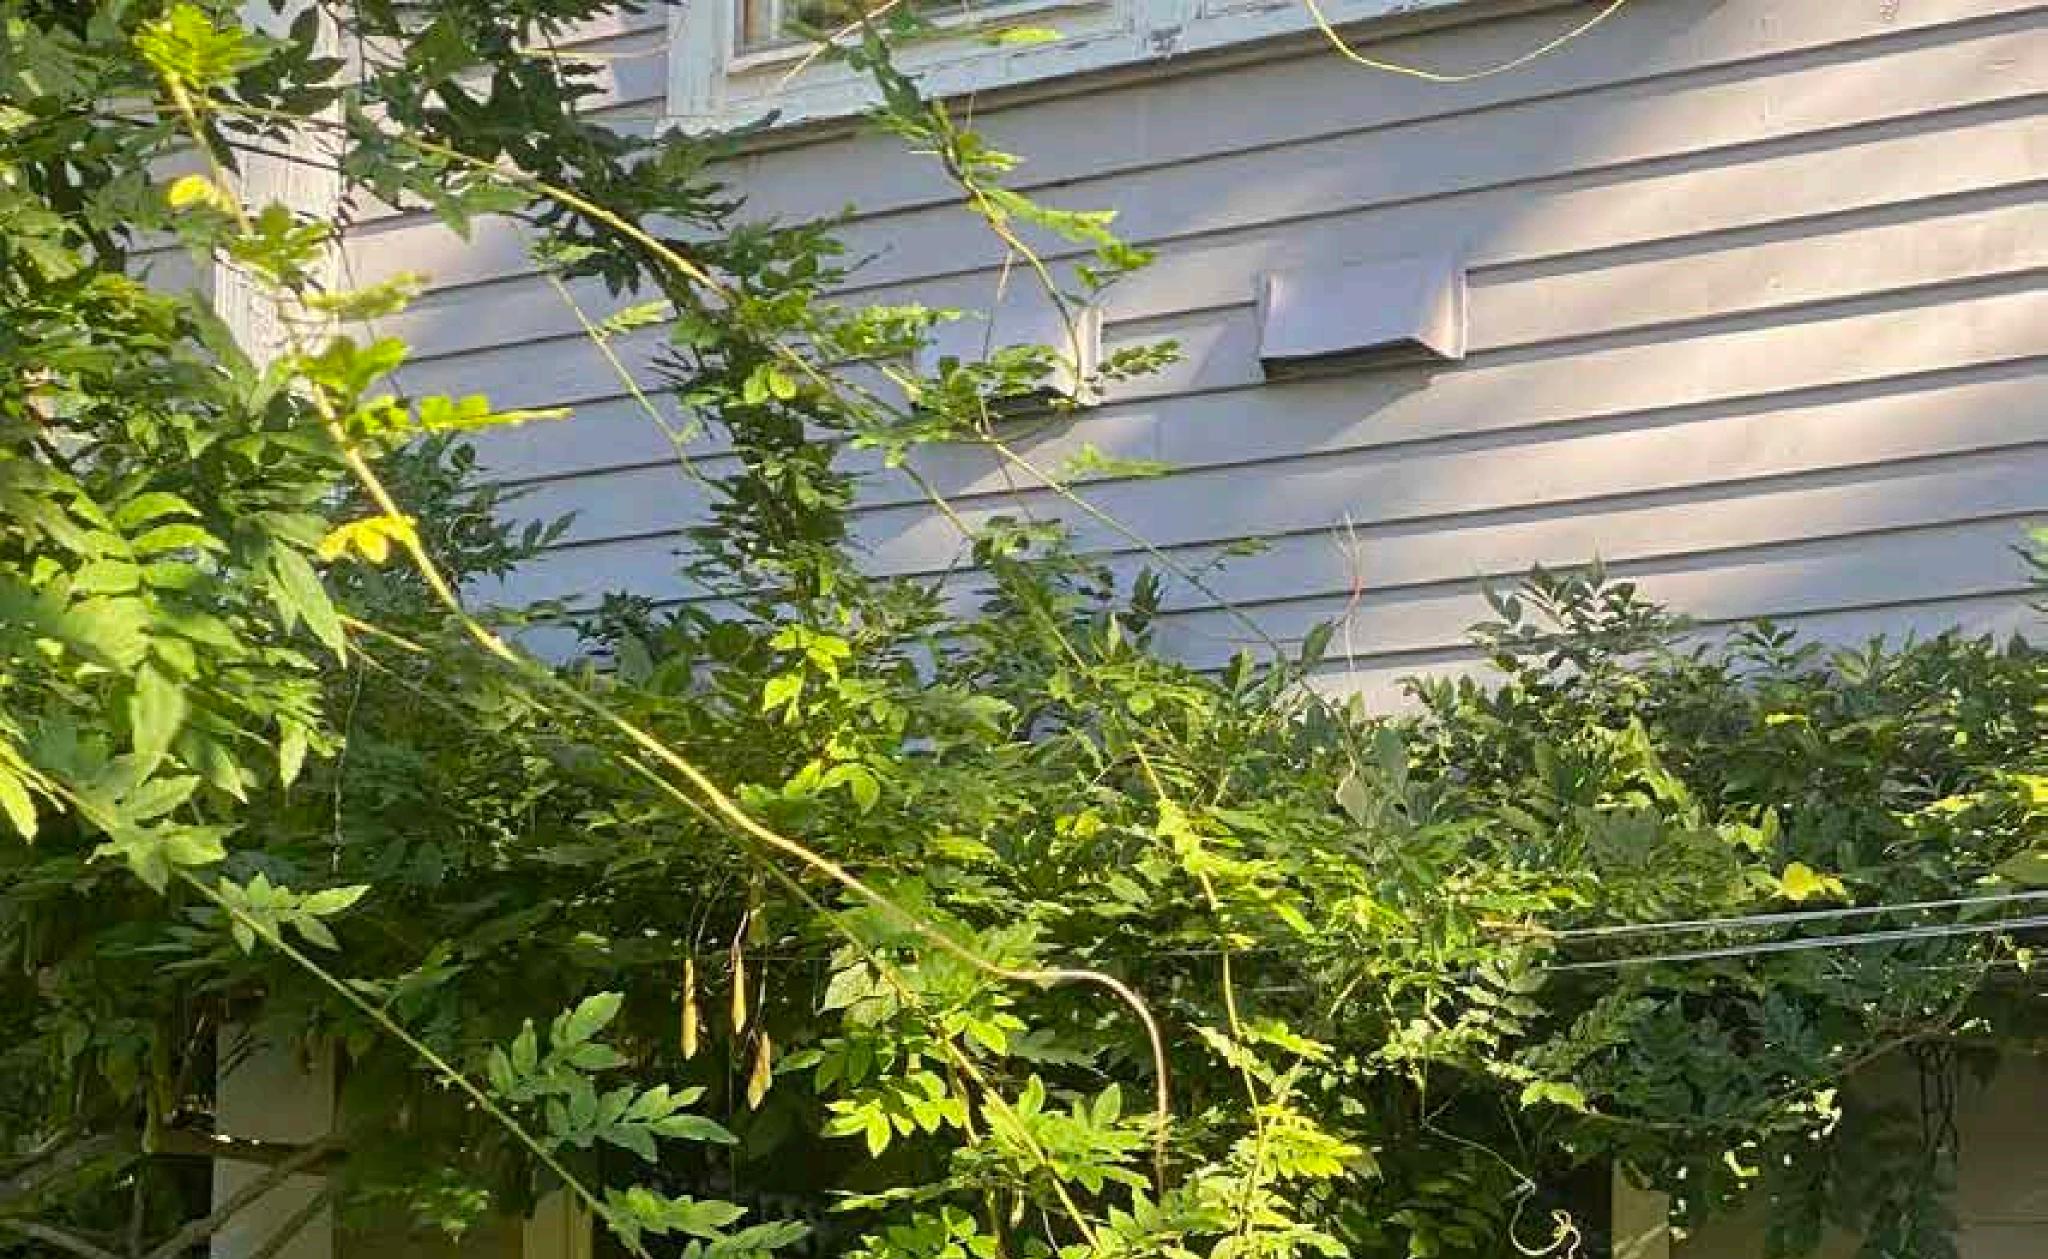
SCOPE 5 REGLAZE LARGE EXISTING THERMOPANE WINDOW TO BASEMENT (OUTER LIGHT BROKEN) 46.5" X 76.5", TO MATCH EXISTING REPLACE THERMOPANE DOOR TO BASEMENT (OUTER LIGHT BROKEN, NOT

REPLACEABLE) 32" X 6'-5", WITH FIR DOOR TO MATCH

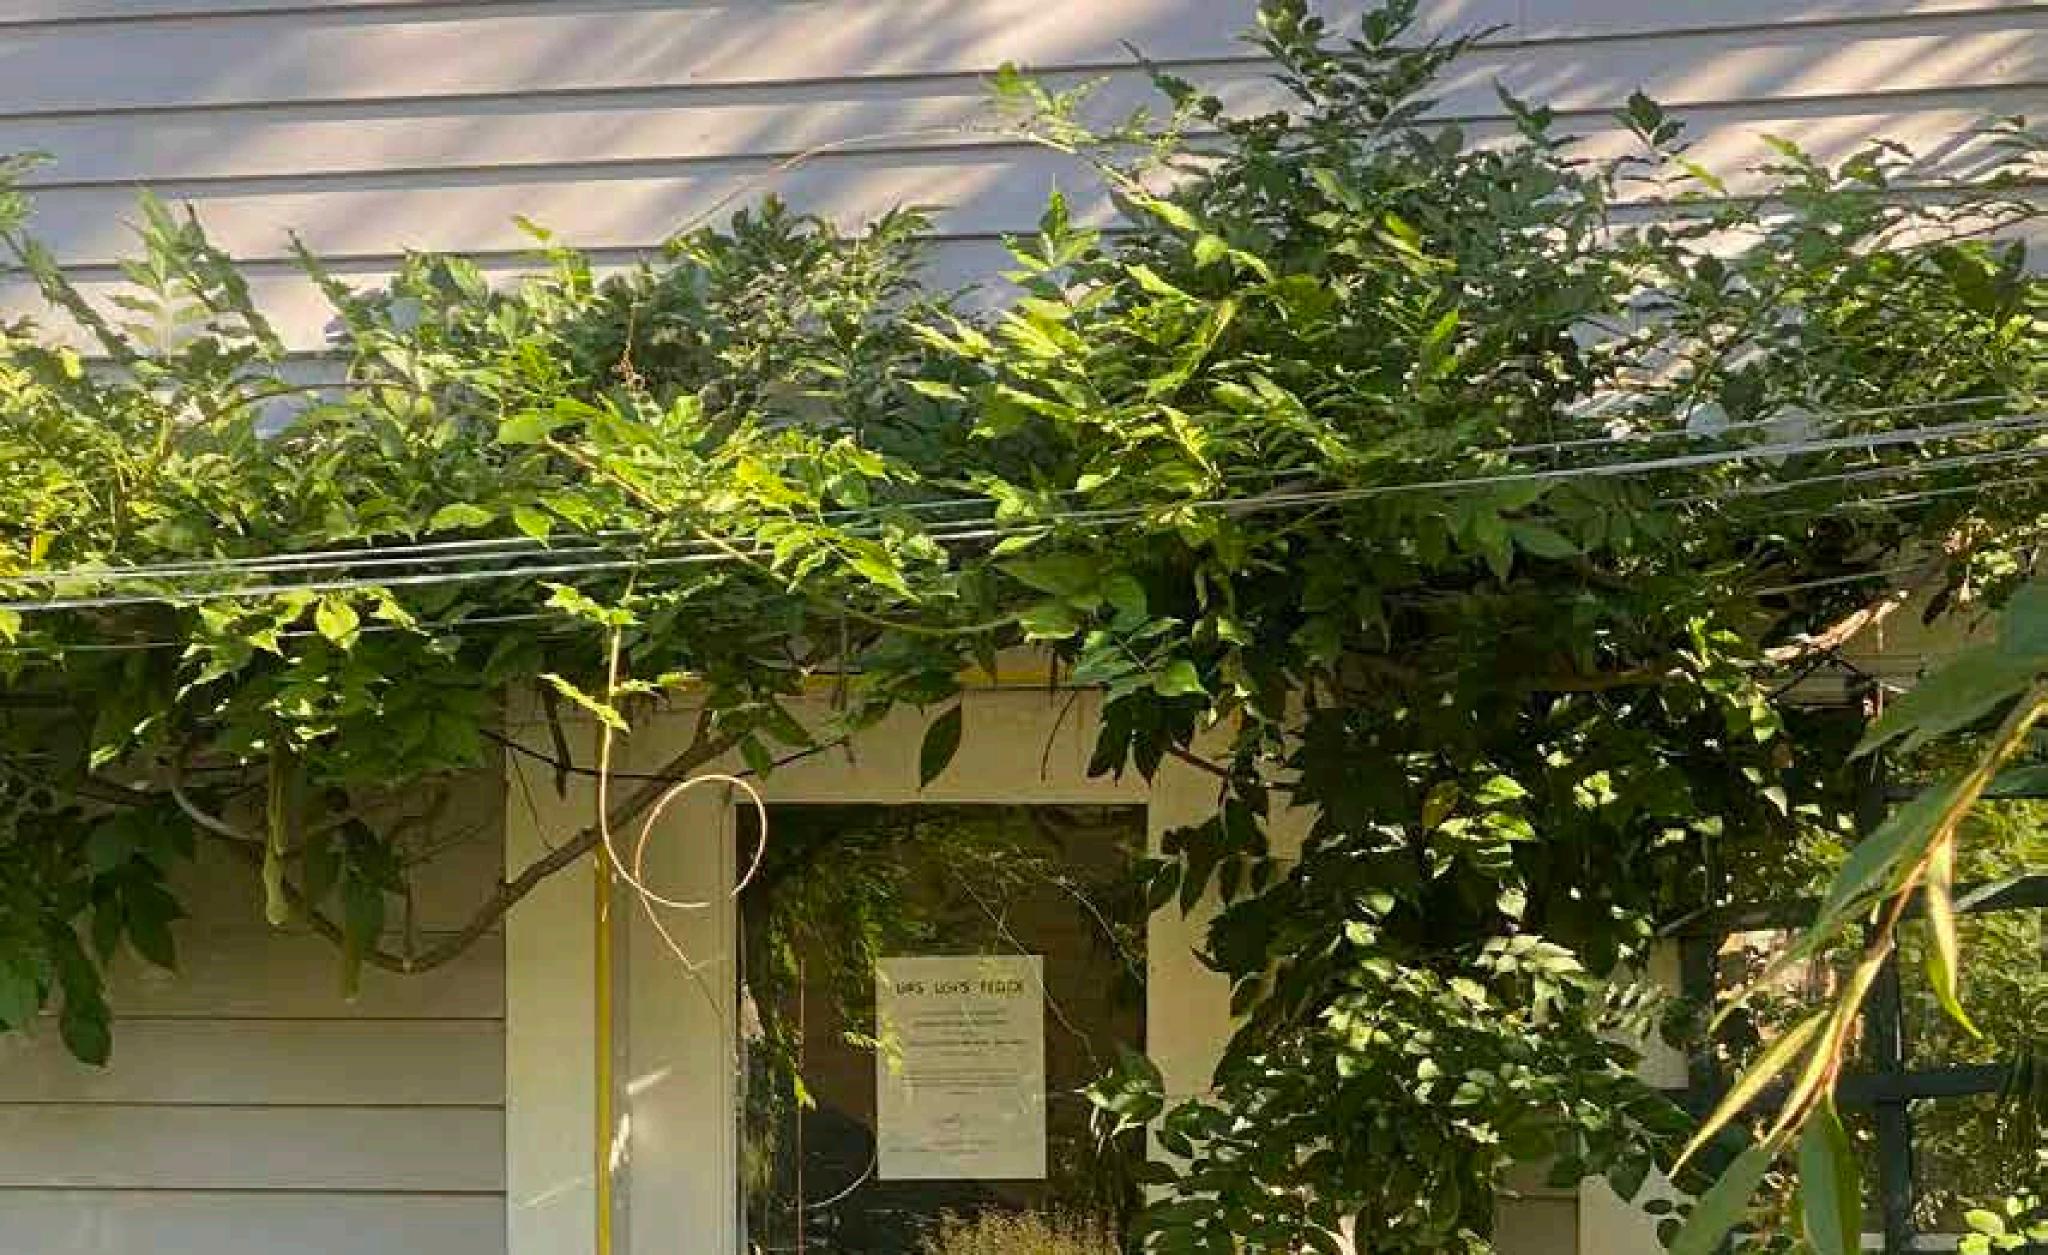
SCOPE 5 REPLACE THERMOPANE DOOR TO BASEMENT (OUTER LIGHT BROKEN, NOT REPLACEABLE(), TO MATCH EXISTING.

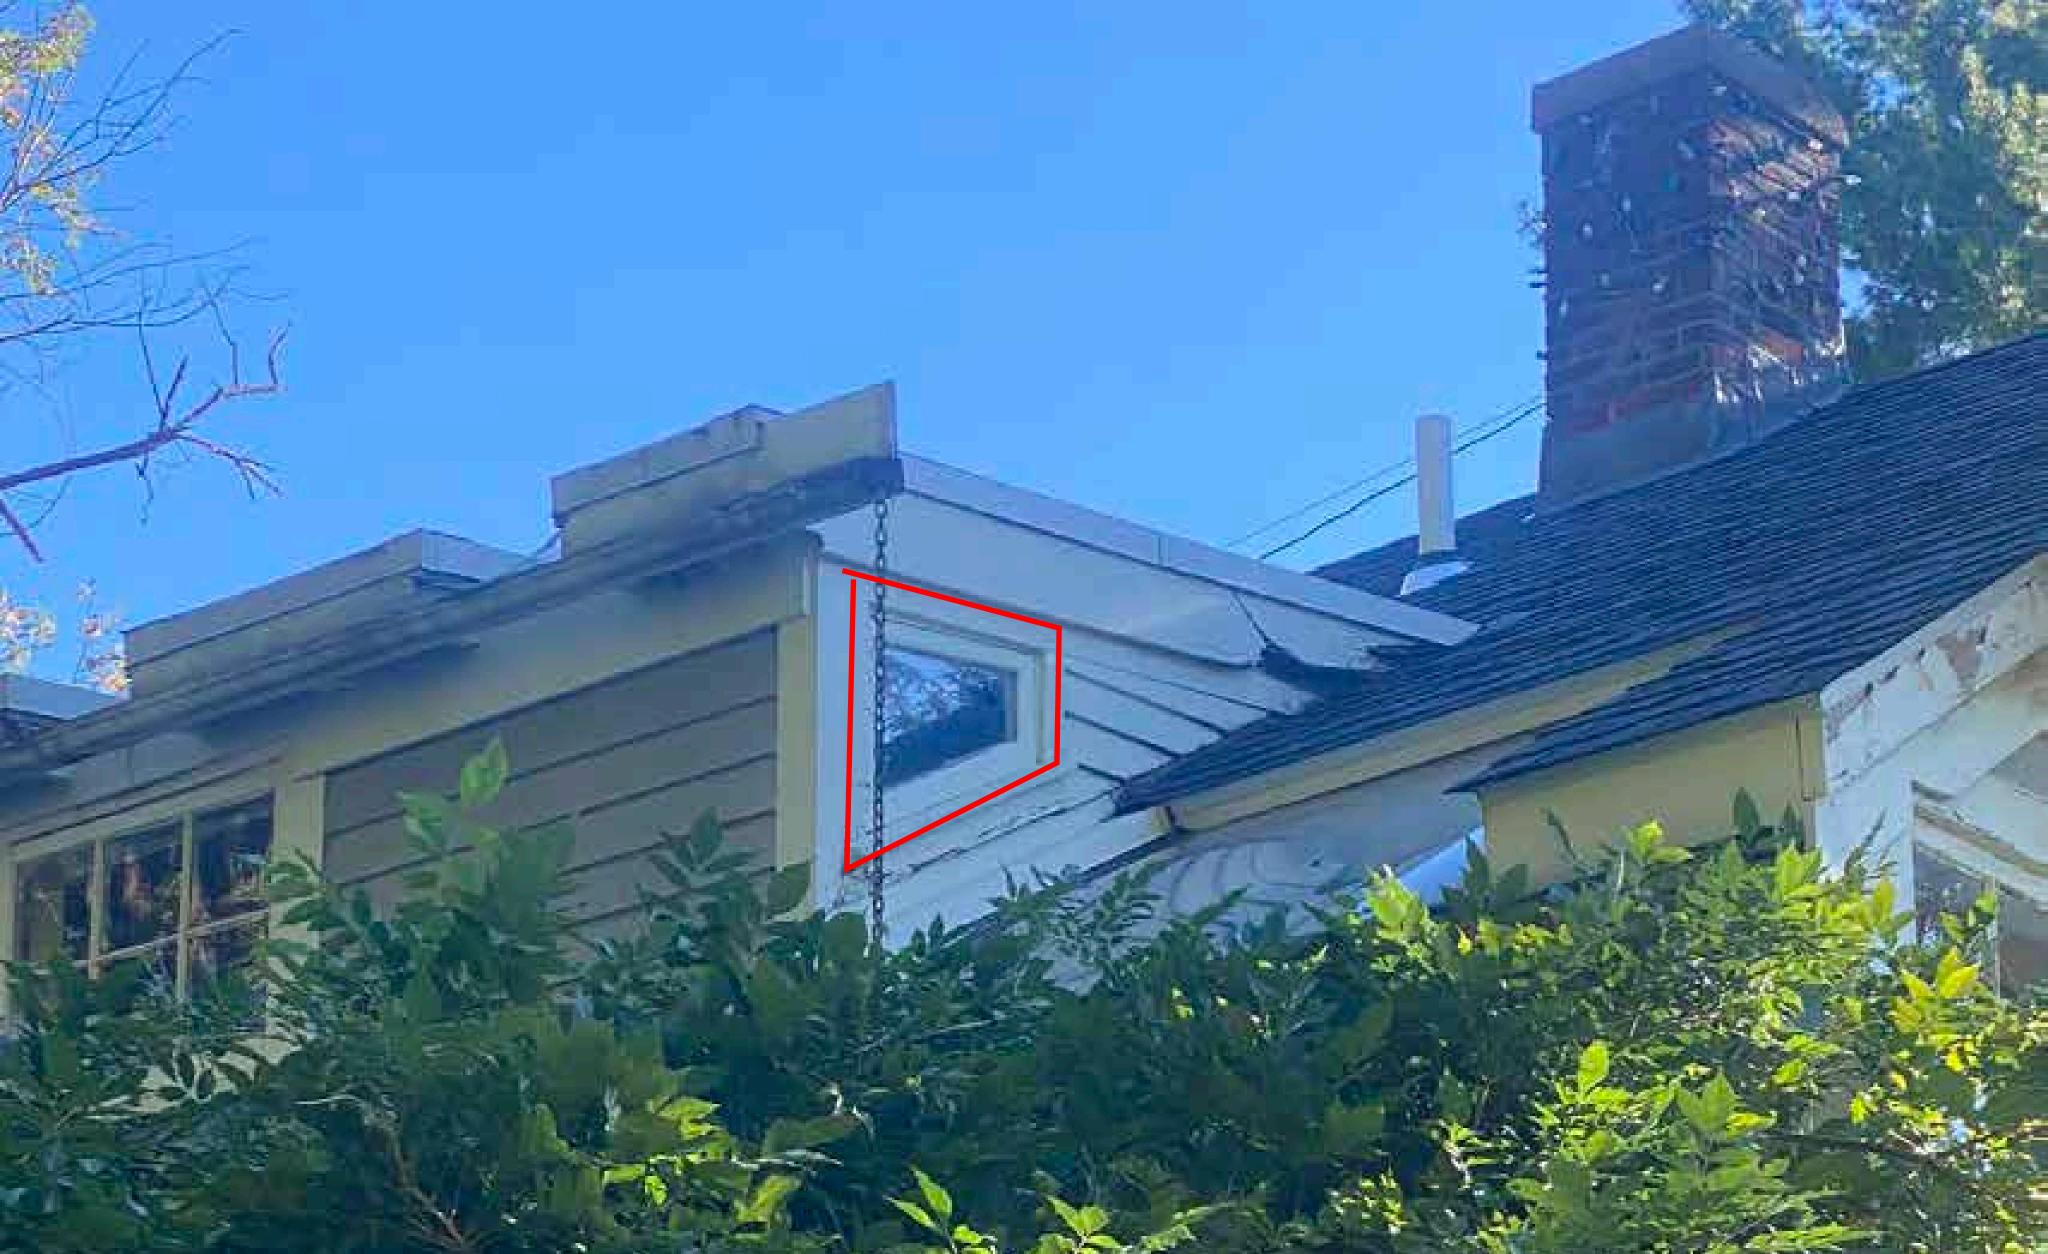
SCOPE 5 REGLAZE EXISTING TRAPEZOIDAL WINDOW IN MASTER BATHROOM (CRACKED).

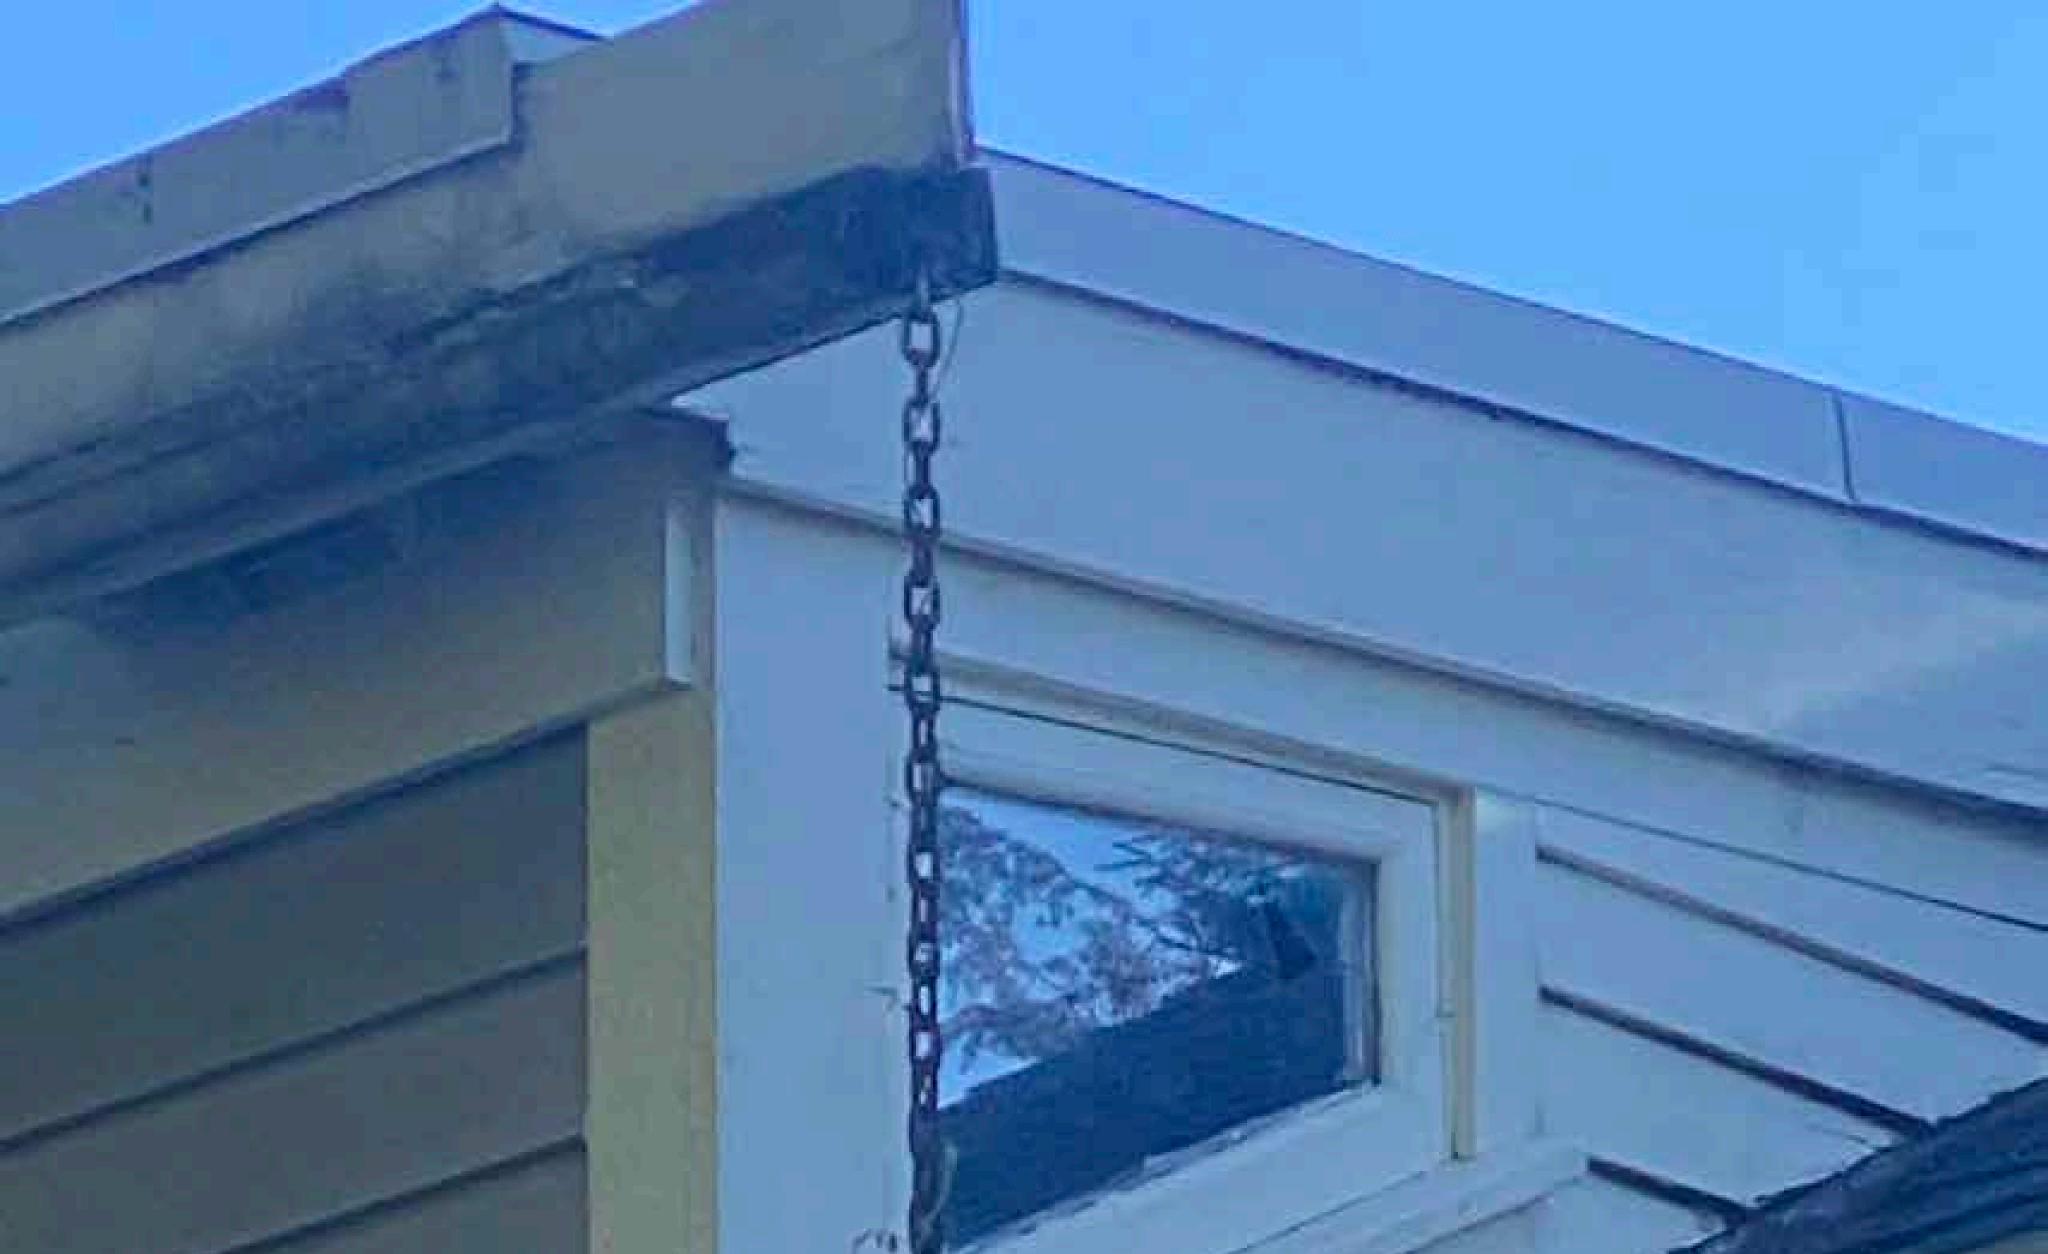
SCOPE 5 REGLAZE EXISTING TRAPEZOIDAL WINDOW IN MASTER BATHROOM (CRACKED).
