Town Belmont  
Historic District Commission  
Homer Municipal Building, 2nd Floor  
19 Moore Street  
Belmont, MA 02478

OFFICE USE  
Case Number: HDC – 23-19

### APPLICATION

Attachments to HDC application dated Oct. 29, 2023 by Plymouth Church

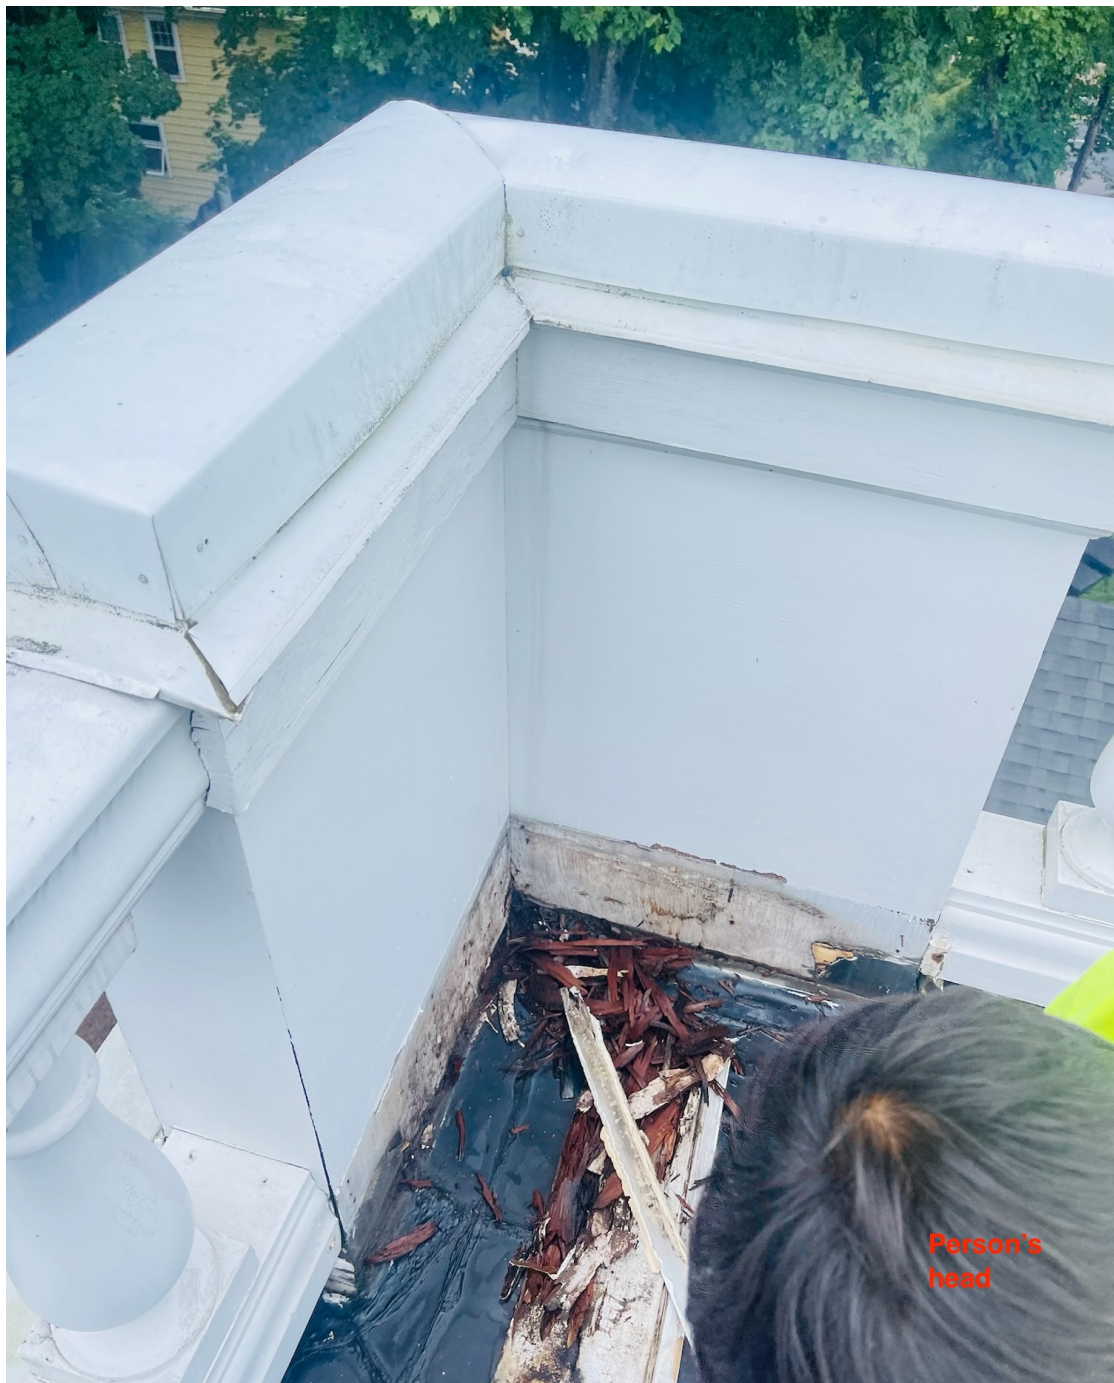
- Application Narrative
- Aerial Map of Plymouth Church Roofs and Facilities
- John Henry Roofing, Inc, proposal to Plymouth Church September 1, 2023
- Photo A - Rotting wood at base of elevator railing
- Photo B - Two (2) brown colored aluminum downspouts
- Photo C - One of four water proofed corner structures for elevator railing
- Photo D - painting of elevator railings
- Photo E - completed elevator railing and current railing below steeple

The JHR roof replacement work commenced on Monday, October 9 with the expectation of being completed by the end of the week avoiding fall rain storms and winter weather. The day after the start, the foreman informed me that the four corners of the railing would be rebuilt (rather than repaired) for stability due to internal rotting wood.

C) Replace rotted wood at roof railing with AZEK ,

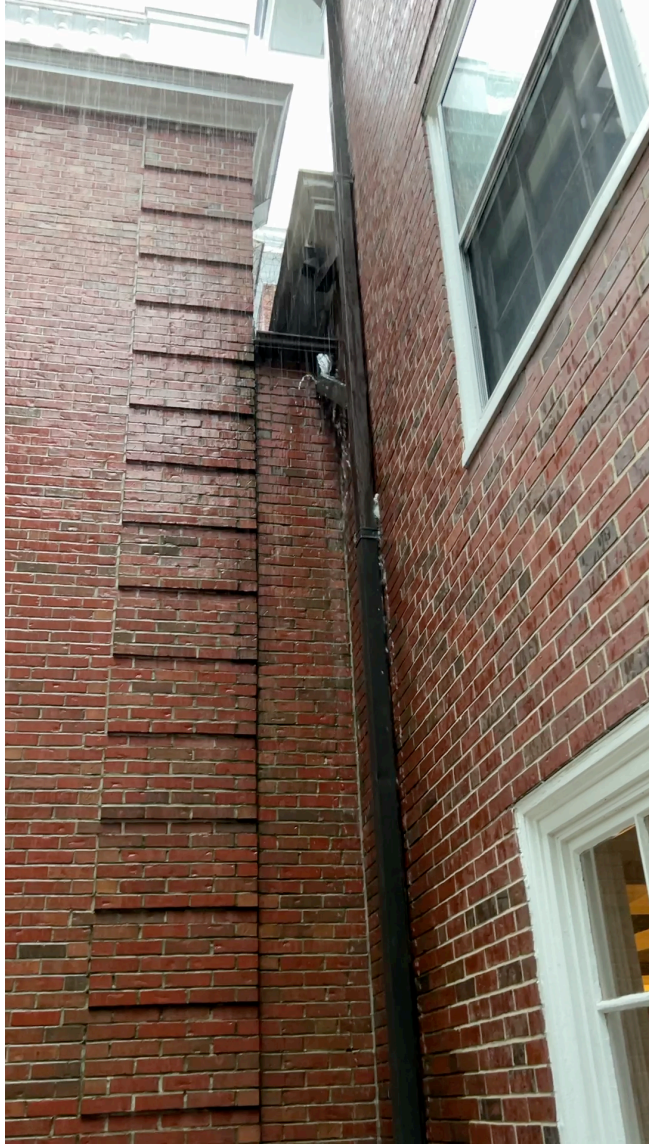
## Photo B

Downspout at Elevator Shaft

Both downspouts connect to leader pipes  
carrying water to drywalls

D) Replacement of three existing downspouts, each are 32' long, new 3" X 4" downspouts will be .032 bronze aluminum.

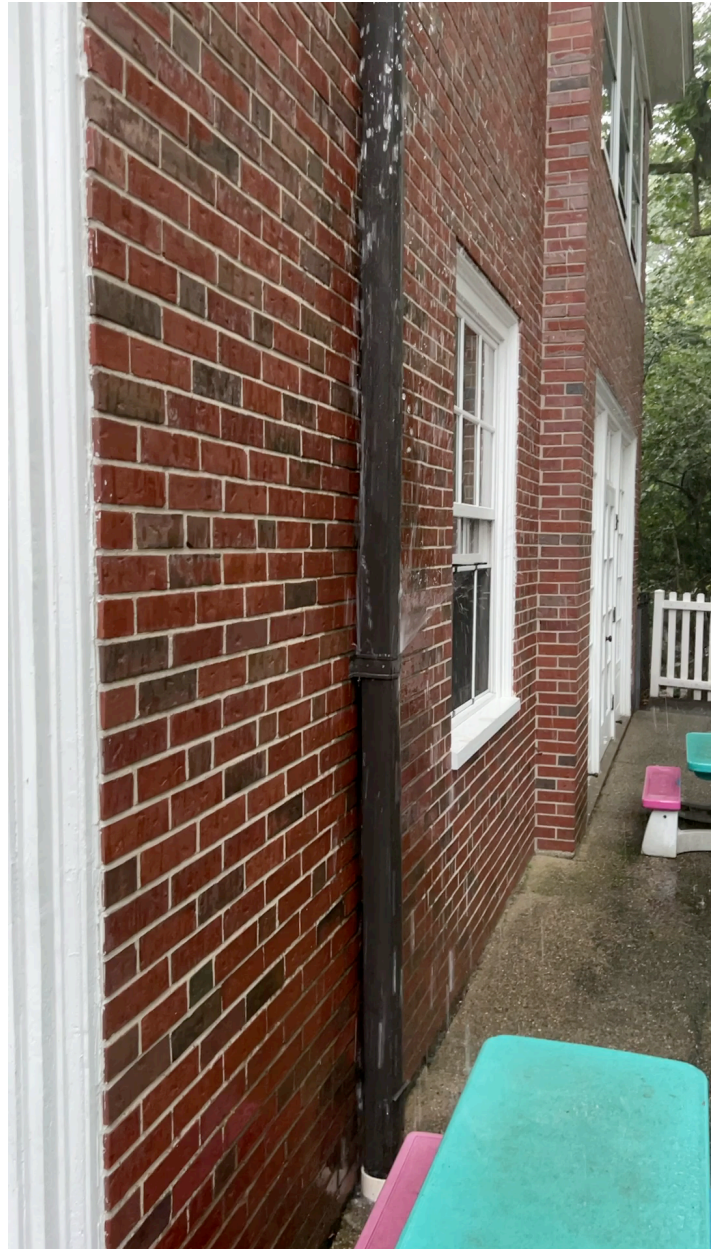
Downspout at Playground

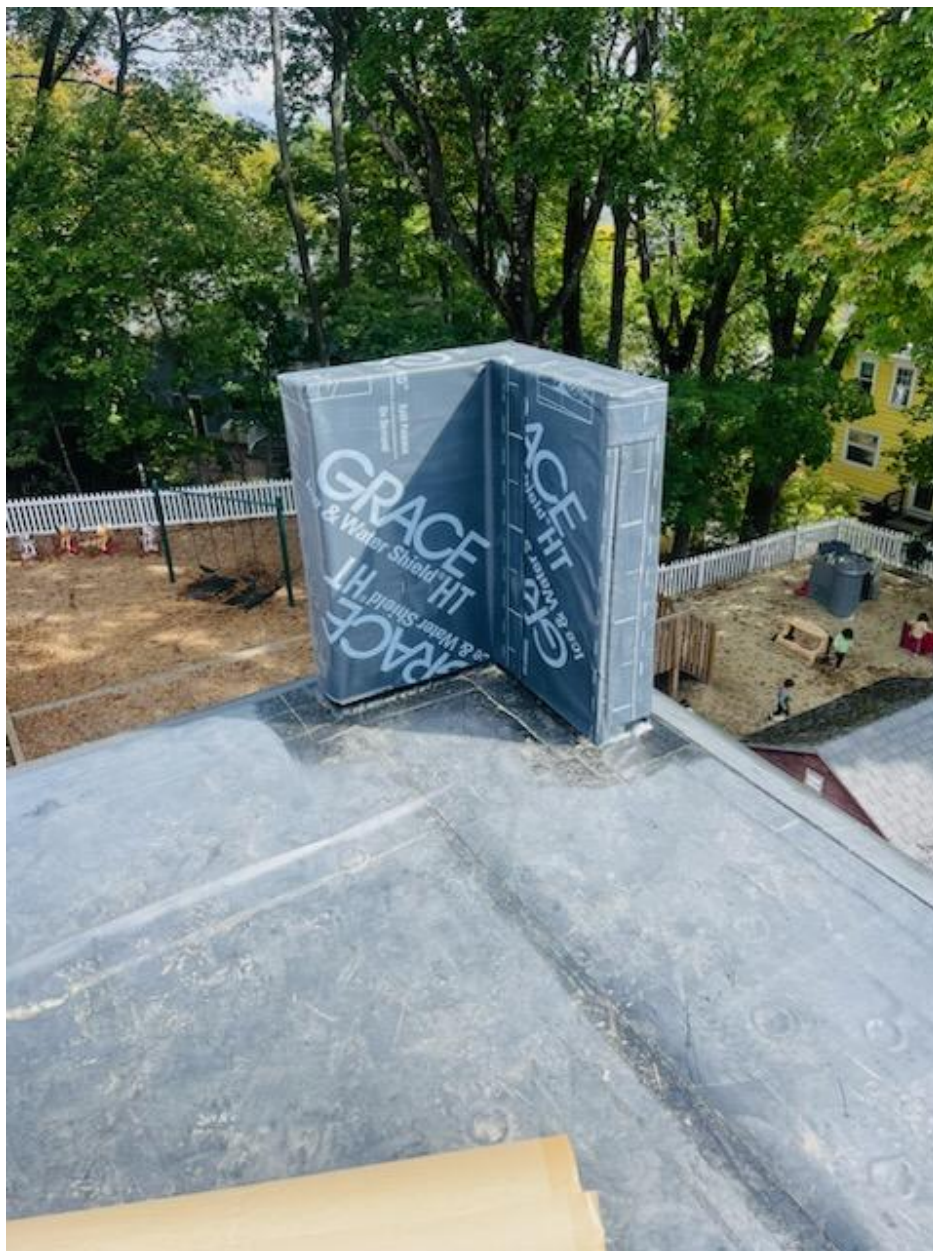
Photo C

One of four water proofed corner structures

The new corners were constructed and water proofed (Photo C). The exterior was modeled after the removed corners. The railings and balusters were painted (Photo D) and reinstalled. The finished railing resembles, as intended, the corners and railings on the base of the steeple (Photos E). The railing on the roof of the elevator is visible by the public and has been repaired consistent with the Guidelines of the BHDC.

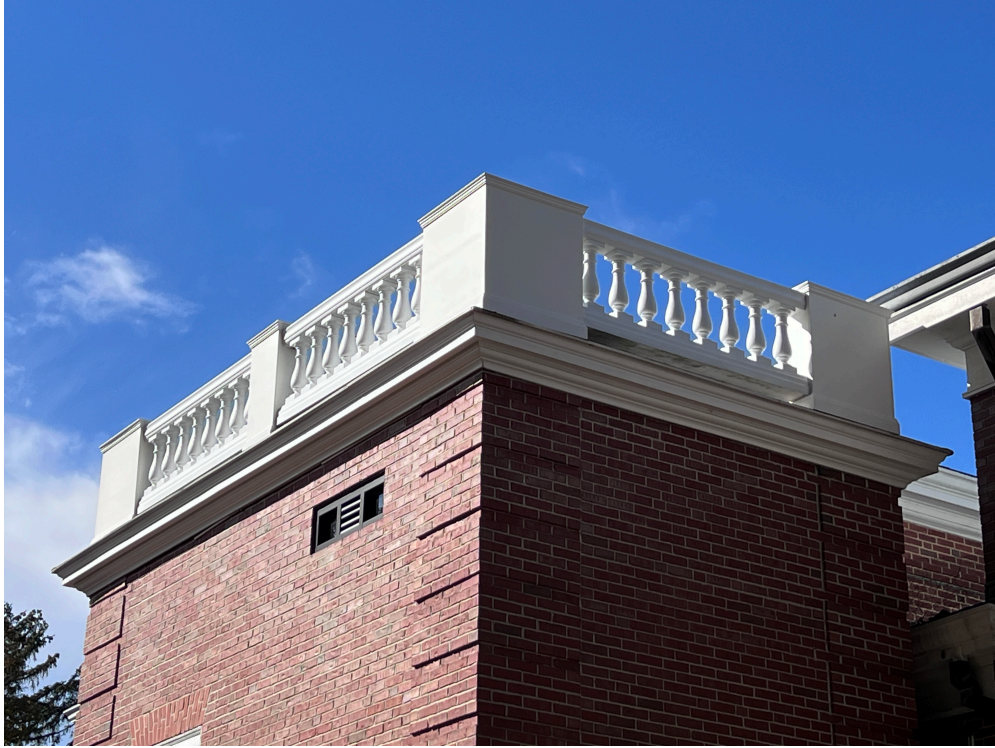
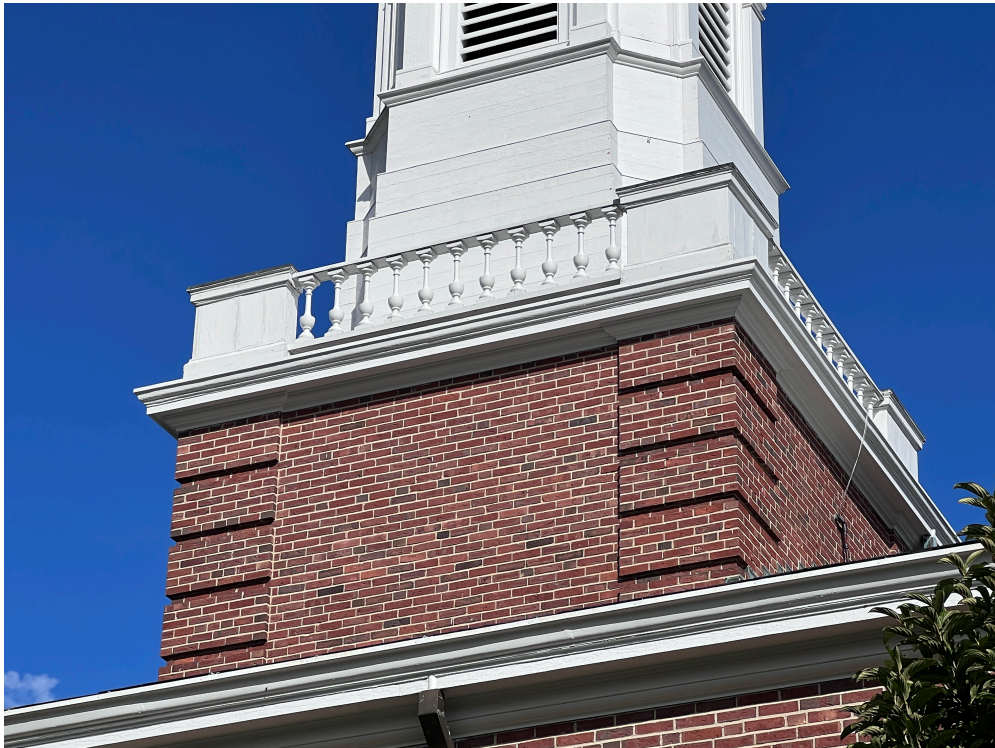
## Photo E

Completed Elevator Railing and Steeple Railing
