McLean Open Space Land

Comprehensive Trails System Plan

Prepared for the
Land Management Committee
Belmont, Massachusetts
FINAL - March 2008

Pressley Associates
Landscape Architects
Cambridge, Massachusetts

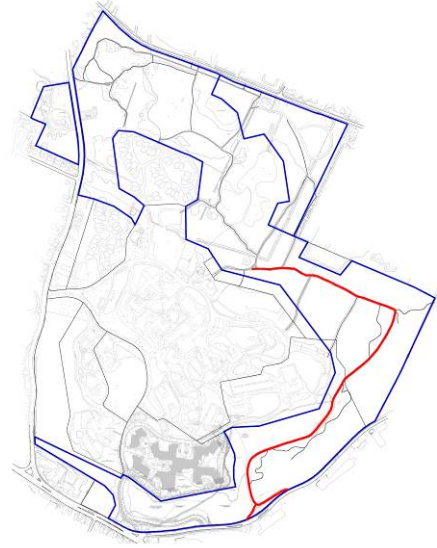
Trail Surface: At the base of hill near Pleasant Street, the trail is composed of a mix of gravel, larger stones, broken asphalt concrete, and loose dirt and sand. Further up the trail past the stone walls, the trail becomes composed mostly of compacted soil with some exposed native rock and tree roots. At the top of the hillside where the grade begins to flatten, the trail surface is composed of a good amount of compacted soil and organic duff. In sunny areas, there is some grass and herbaceous vegetation growth within the trail surface.

Trail 1 is one of the major trails in the Open Space and also serves as a primary emergency access route, but poor trail conditions and erosion has seriously degraded the overall quality and usability of this trail, particularly along the hillside portion. The quality of the trail does increase as the grade decreases along the top of the hill. Secondary Trails A, B, and C provide an alternate route to Trail 1 for access to top of the Eastern Woods hillside. Without a major trail reroute, Trail 1 will not be able to meet trail accessibility standards.

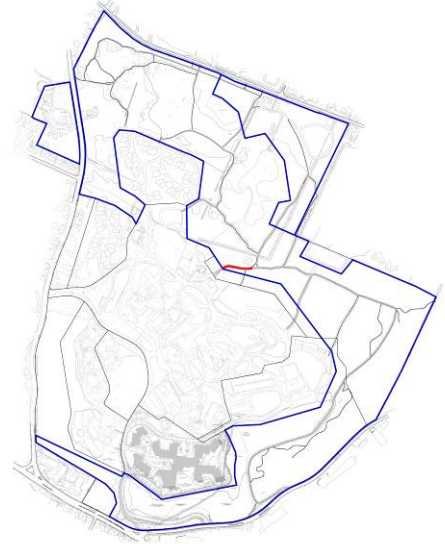
Analysis: Trail is in relatively good condition and provides a nice trail experience through the woods. The fact that half of this trail passes through private property restricts its inclusion as an official Open Space trail. Trail 6, which is about 160 feet to the west, runs parallel to Trail 5 and both connect to the same general areas of the Open Space and Cemetery. Measures could be taken to direct trail users away from Trail 5 and onto Trail 6.

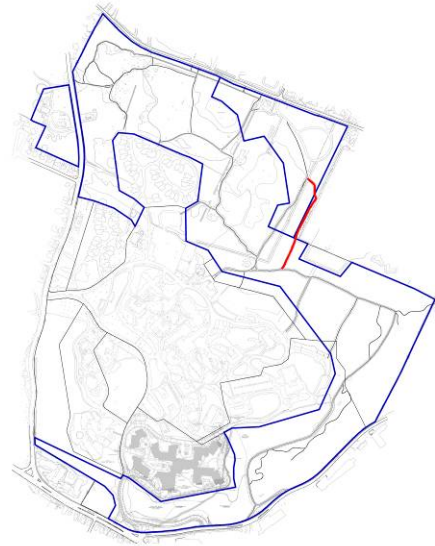
Analysis: Trail is in relatively good condition and provides a good, open trail experience through the woods. If accessibility is desired, some of the larger exposed rocks may need to be removed or allow for proper clearance. Trail 5, which is about 160 feet to the east, runs parallel to Trail 6 and both connect to the same general areas of the Open Space and Cemetery. The Cemetery is not expected to expand into this area for many years. Until then, this trail could be maintained on an as-needed basis for continued emergency access and allowed to continue its use as one of the connections between the main MOS, the Concord Avenue neighborhoods, and the Cemetery.

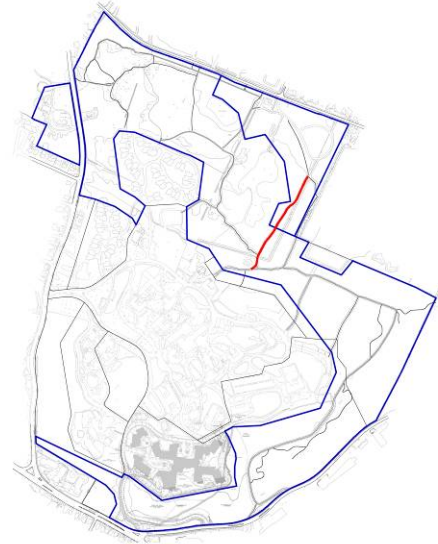
Analysis: Trail 7 provides a nice trail experience through the small Heart-Shaped Meadow. However, it may be desirable to move a portion of this trail away from the Cemetery and possibly closer to the edge of the woods to provide more of a meadow experience. Invasive plant issues are currently being addressed as part of the meadow management plan. Connections to the second, southern opening in the old stone wall on the west side of the meadow could be explored resulting in the possible installation a trail through the Red Maple Swamp. A more formal trail connection through the northern opening the stone wall will better connect the meadow to the cemetery roadway.

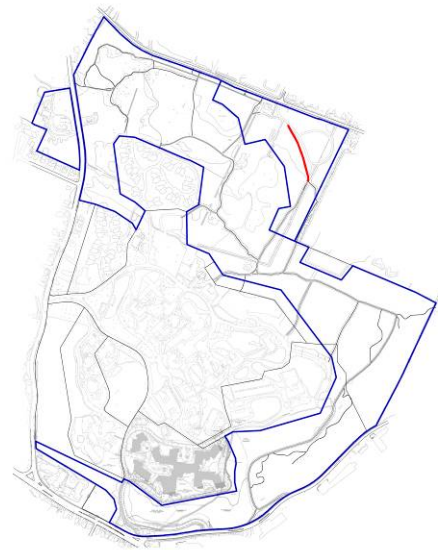
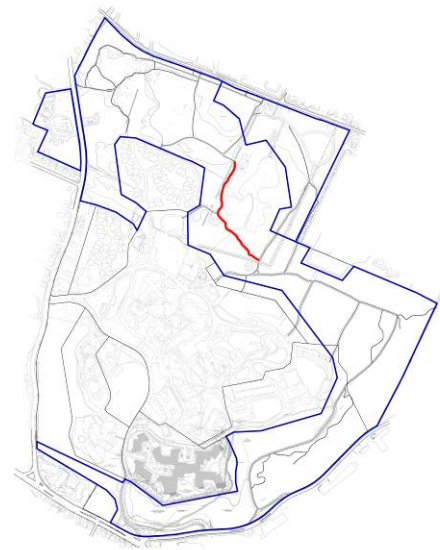
Trail 8

Trail Surface: Compacted soil with exposed rocks and roots throughout length of trail; some installed gravel at Trail 9 intersection. Along the steep area immediately east of the bridge, there is some significant trail erosion. There is also minor to moderate erosion at the stone wall. The seasonally wet area at point where trail is closest to wetland presents muddy conditions.

- Seasonally muddy area
- The bridge may be located too low, thus damming up the flow of the outlet stream. Debris typically collects on the upstream side of bridge.
- Bridge possibly too narrow; otherwise the bridge is in relatively good condition and appears to be stable.
- Most of trail is within the 25-foot and 100-foot wetlands buffers.
- Erosion problems due to steep trail east of bridge.
- The Belmont Fire Department desires to have this trail maintained for emergency access.

Analysis: This trail is a link between the wooded hillside of the Eastern Woodlands and Great Meadow while also being an enjoyable walk through the denser woods surrounding the Red Maple Swamp. If this trail is removed, the only other route to connect the east and west side of the property will be a combination of Trails 7 and 10. Options for replacement of the bridge should be considered to prevent debris buildup pending conservation requirements. A potential reroute along the steep area of the trail should be considered; otherwise the trail should be regraded to improve drainage of water off of the trail. Options should be evaluated to deal with seasonally muddy area adjacent to the wetland areas; area can possibly be fixed by raising the grade of the trail.

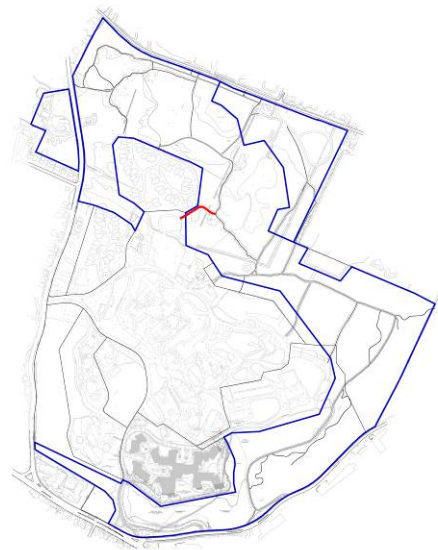
Trail 10

- Some minor seasonally wet areas with visible truck tire ruts.
- Some poison ivy immediately adjacent to trail
- There is potential for future erosion problems caused by the newly-constructed emergency tower paved access drive. The existing grading on drive funnels storm water flow directly onto trail.
- Portions of trail within the 100 foot wetland buffer area.
- The Belmont Fire Department desires to have this trail maintained for emergency access.

Analysis: This trail provides a direct connection between the Cemetery and the Great Meadow. A trail connection could be explored between this trail and Trail 7. Some water diversion measures may need to be taken to prevent any erosion issues resulting from the cell tower driveway.

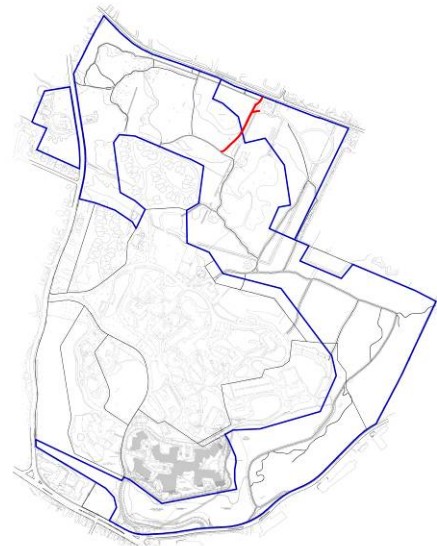
Trail 11

- Seasonally wet area allows for the creation of trail braiding in the springtime and presents muddy conditions.
- Some poison ivy immediately adjacent to trail.
- Portion of trail is within a delineated wetland buffer
- No areas of erosion problems visible.
- The Belmont Fire Department desires to have this trail maintained for emergency access.

Analysis: This trail can arguably be considered the most scenic of the trails in the Open Space. Further evaluation of the muddy area may call for possible trail rerouting or more permanent mitigation measure(s).

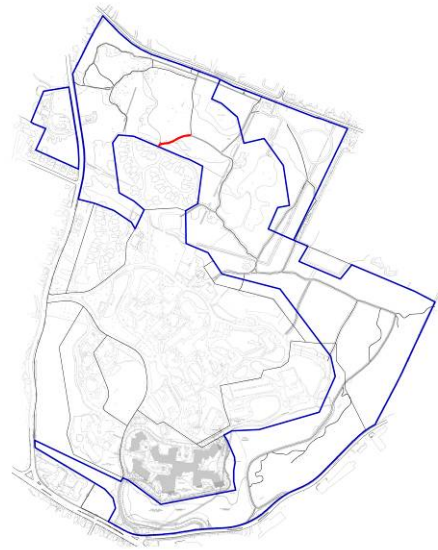
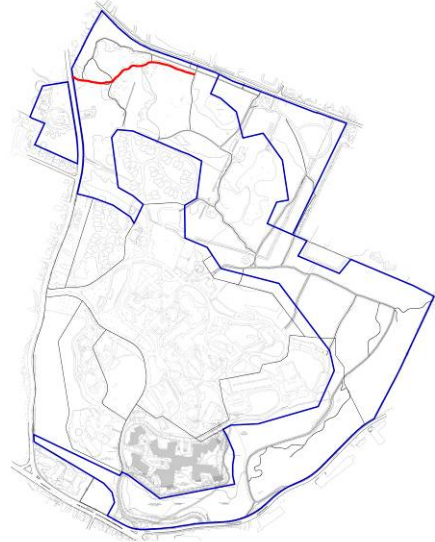
Trail 13

Trail Surface: The trail tread is relatively smooth compacted soil through the Great Meadow portion of trail. Within the Northwest Corner, the trail surface is a mix of looser, eroded soil with numerous exposed native stones and some larger rocks. Erosion is quite common as the trail typically follows the fall line of the hillside. Severe gullyng and u-shaped channeling of the trail is also occurring in some sections. .

- No regular mowing of the trail corridor through the Great Meadow means that tall grass covers the trail during spring and summer.
- Low hanging tree branches at western edge of the meadow.
- Tight woody and invasive vegetation along some sections of trail restricts sightlines.
- Highly eroded and gullied trail surfaces
- Loose soils
- Large rocks and steep trails restrict accessibility.
- Sections of trail follow fall line.
- Some poison ivy adjacently to trail.
- The trailhead at Mill Street presents a safety issue as the sightlines up and down Mill Street are restricted by vegetation and the overall alignment of the road. Automobiles travel at high rates of the speed on this road and the traffic levels are usually quite high, especially at rush hours, making crossing Mill Street very difficult.

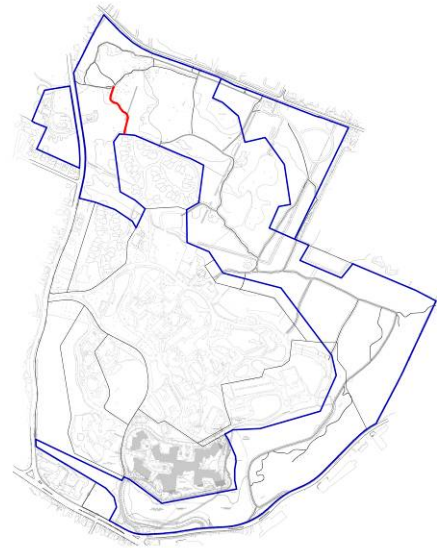
Trail 15

Trail Surface: Compacted soil with some rocks and minor roots. In the steeper sections, larger native rocks are exposed and gravel has been installed. Gravel tends to be quite loose when walked upon.

- Moderate erosion at steep portions of trail; trail often follows fall line
- Loose gravel presents some unsafe conditions

Analysis: Despite its erosion problems, this trail is arguably one of the best woodland trail experiences in the MOS even though there is the ever present traffic noise from busy Concord Avenue and Mill Street. The trail provides direct access to the Pine Allee and several pleasant small meadow areas. Options for eliminating the problems at the two steep areas of the trail should be explored.

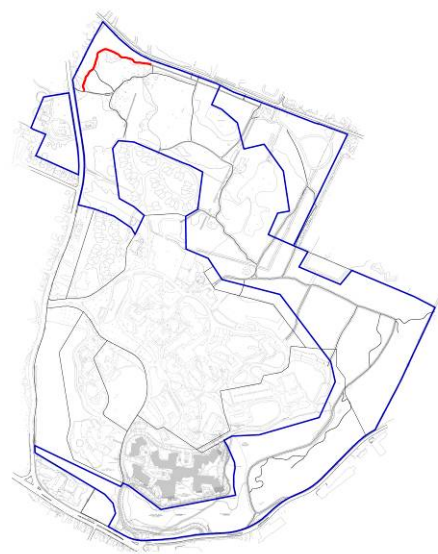
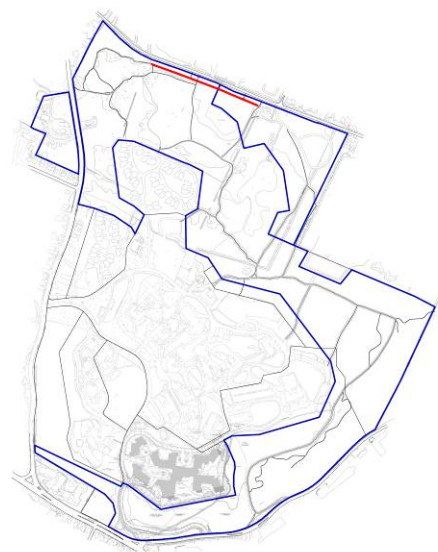
Trail 16

Trail Surface: Compacted soil with a layer of pine leaf and bark duff which acts to soften the surface of the trail. Some small roots break the trail surface.

- Several pine trees are missing.
- Broken branches from the pine trees fall on trail.
- Compacted trail may affect health of trees.

Analysis: This trail, as defined by the rows of pine trees, provides a unique experience. But some landscape maintenance will be required in order to retain the aesthetic and landscape quality. Vehicle traffic along this trail must be avoided to prevent damage to the trees by compacting and rutting the trail tread.

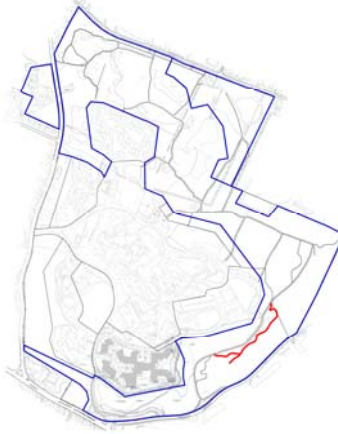
Trail B

- **Trails A, B, and C** are narrow (single-track) trails through the Eastern Woods and provide an alternate route to Trail 1. Some portions of these trails are very steep and in these areas there is potential for future erosion problems. There is a wet and muddy area along a section of Trail B.

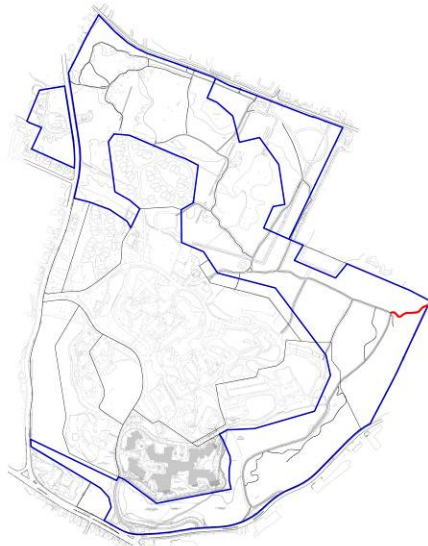
Trail D

- **Trail D** is a moderately well-used trail in the Eastern Woods that connects into the MOS from the dead-end of Snake Hill Road. It terminates at Trail 1. There are some areas of moderate erosion where the trail steepens.
