TOWN OF BELMONT

Presentation to BOARD OF SELECTMAN January 11, 2016

SEWER & STORM DRAIN SYSTEM REHABILITATION OVERVIEW

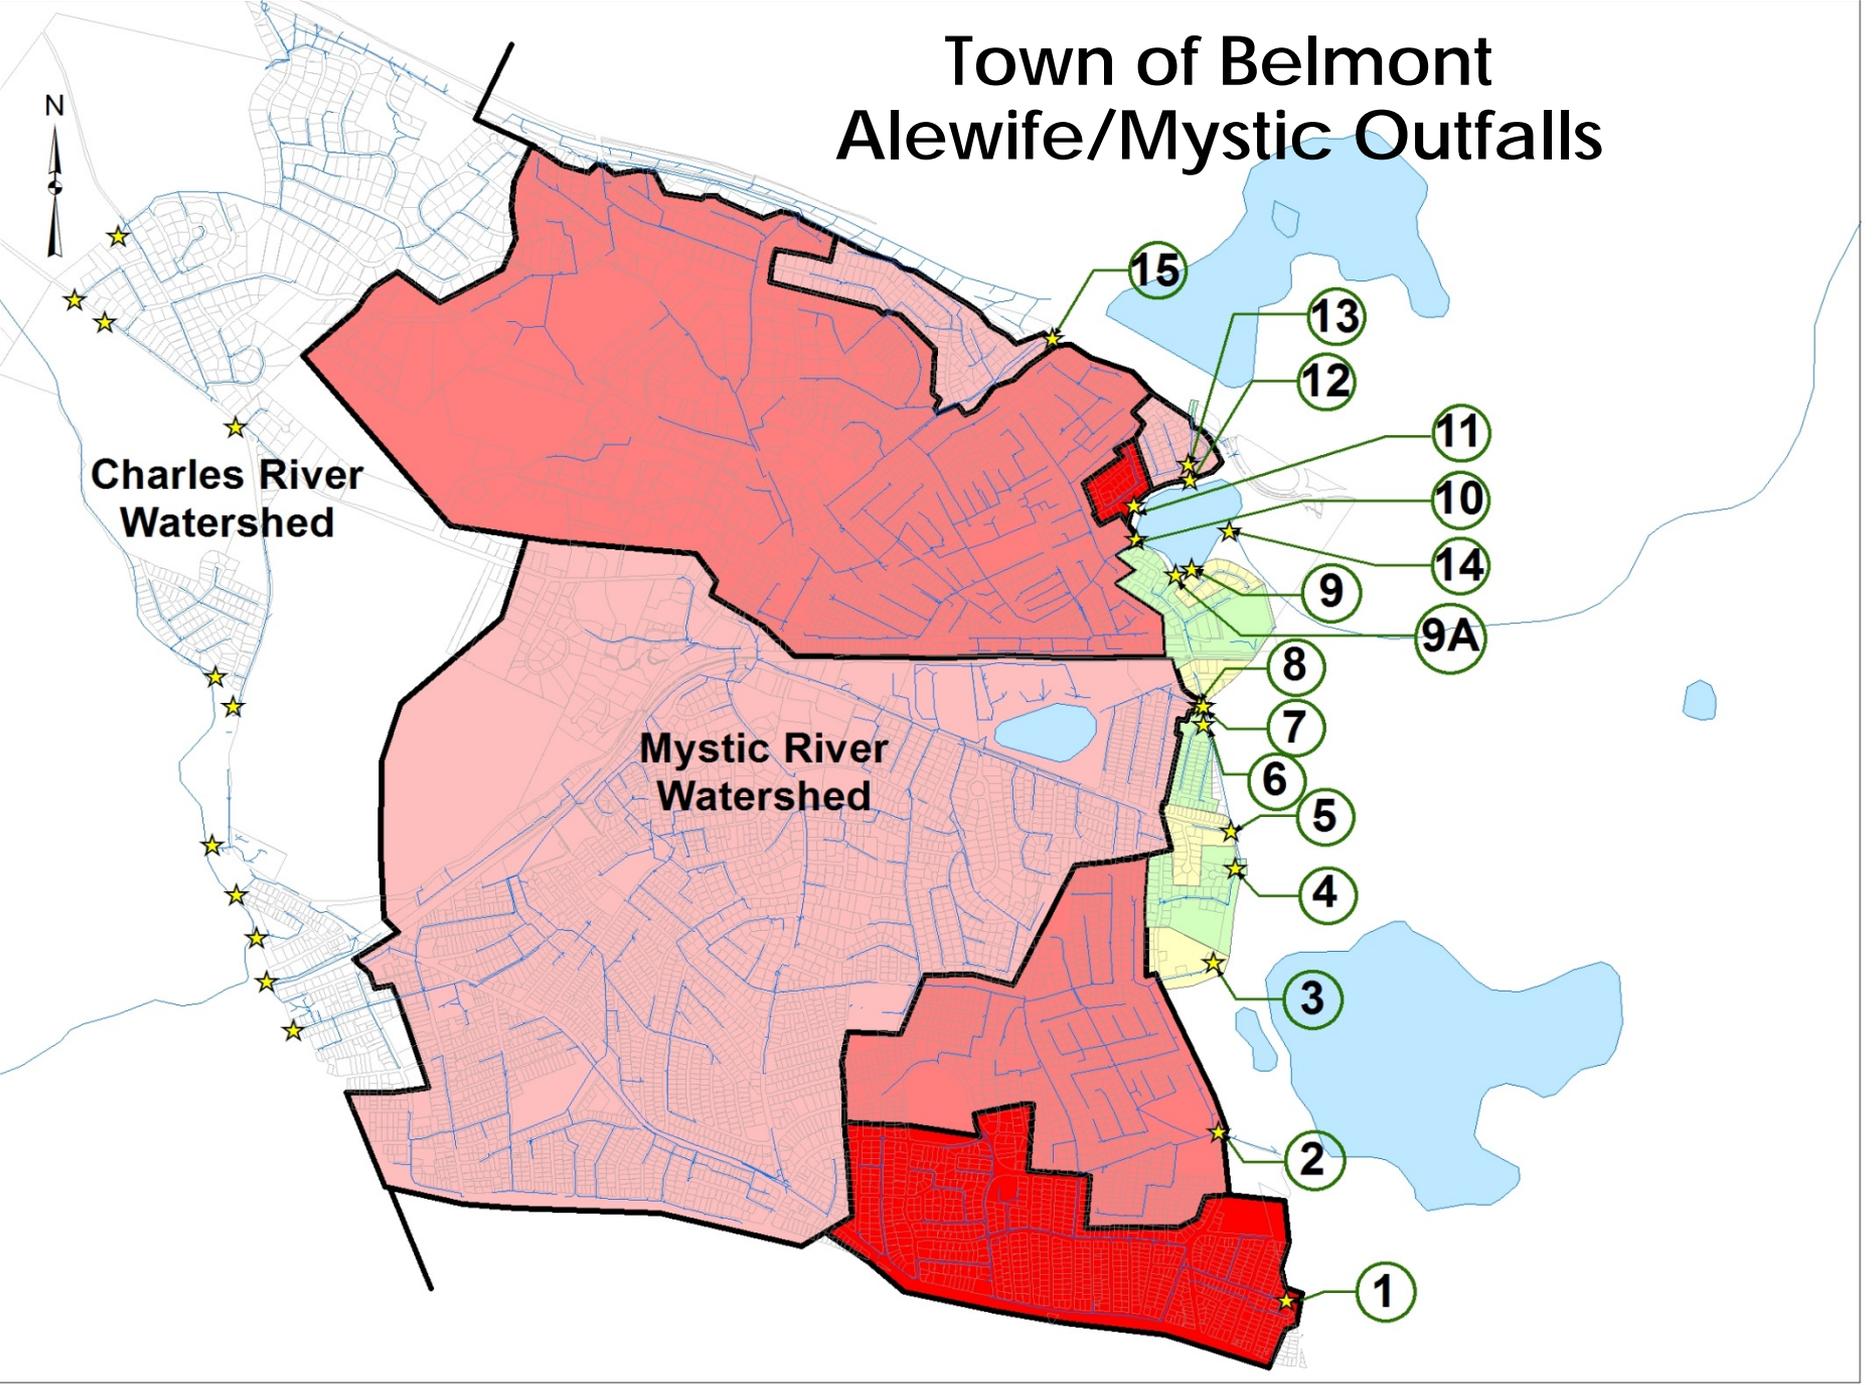
Town of Belmont Alewife/Mystic Outfalls

Belmont was required to investigate all outfalls directly discharging to Little Pond and Alewife Brook and their tributaries

- Identified 15 outfalls
- Performed baseline sampling at each location
- 7 outfalls found to exceed maximum standards

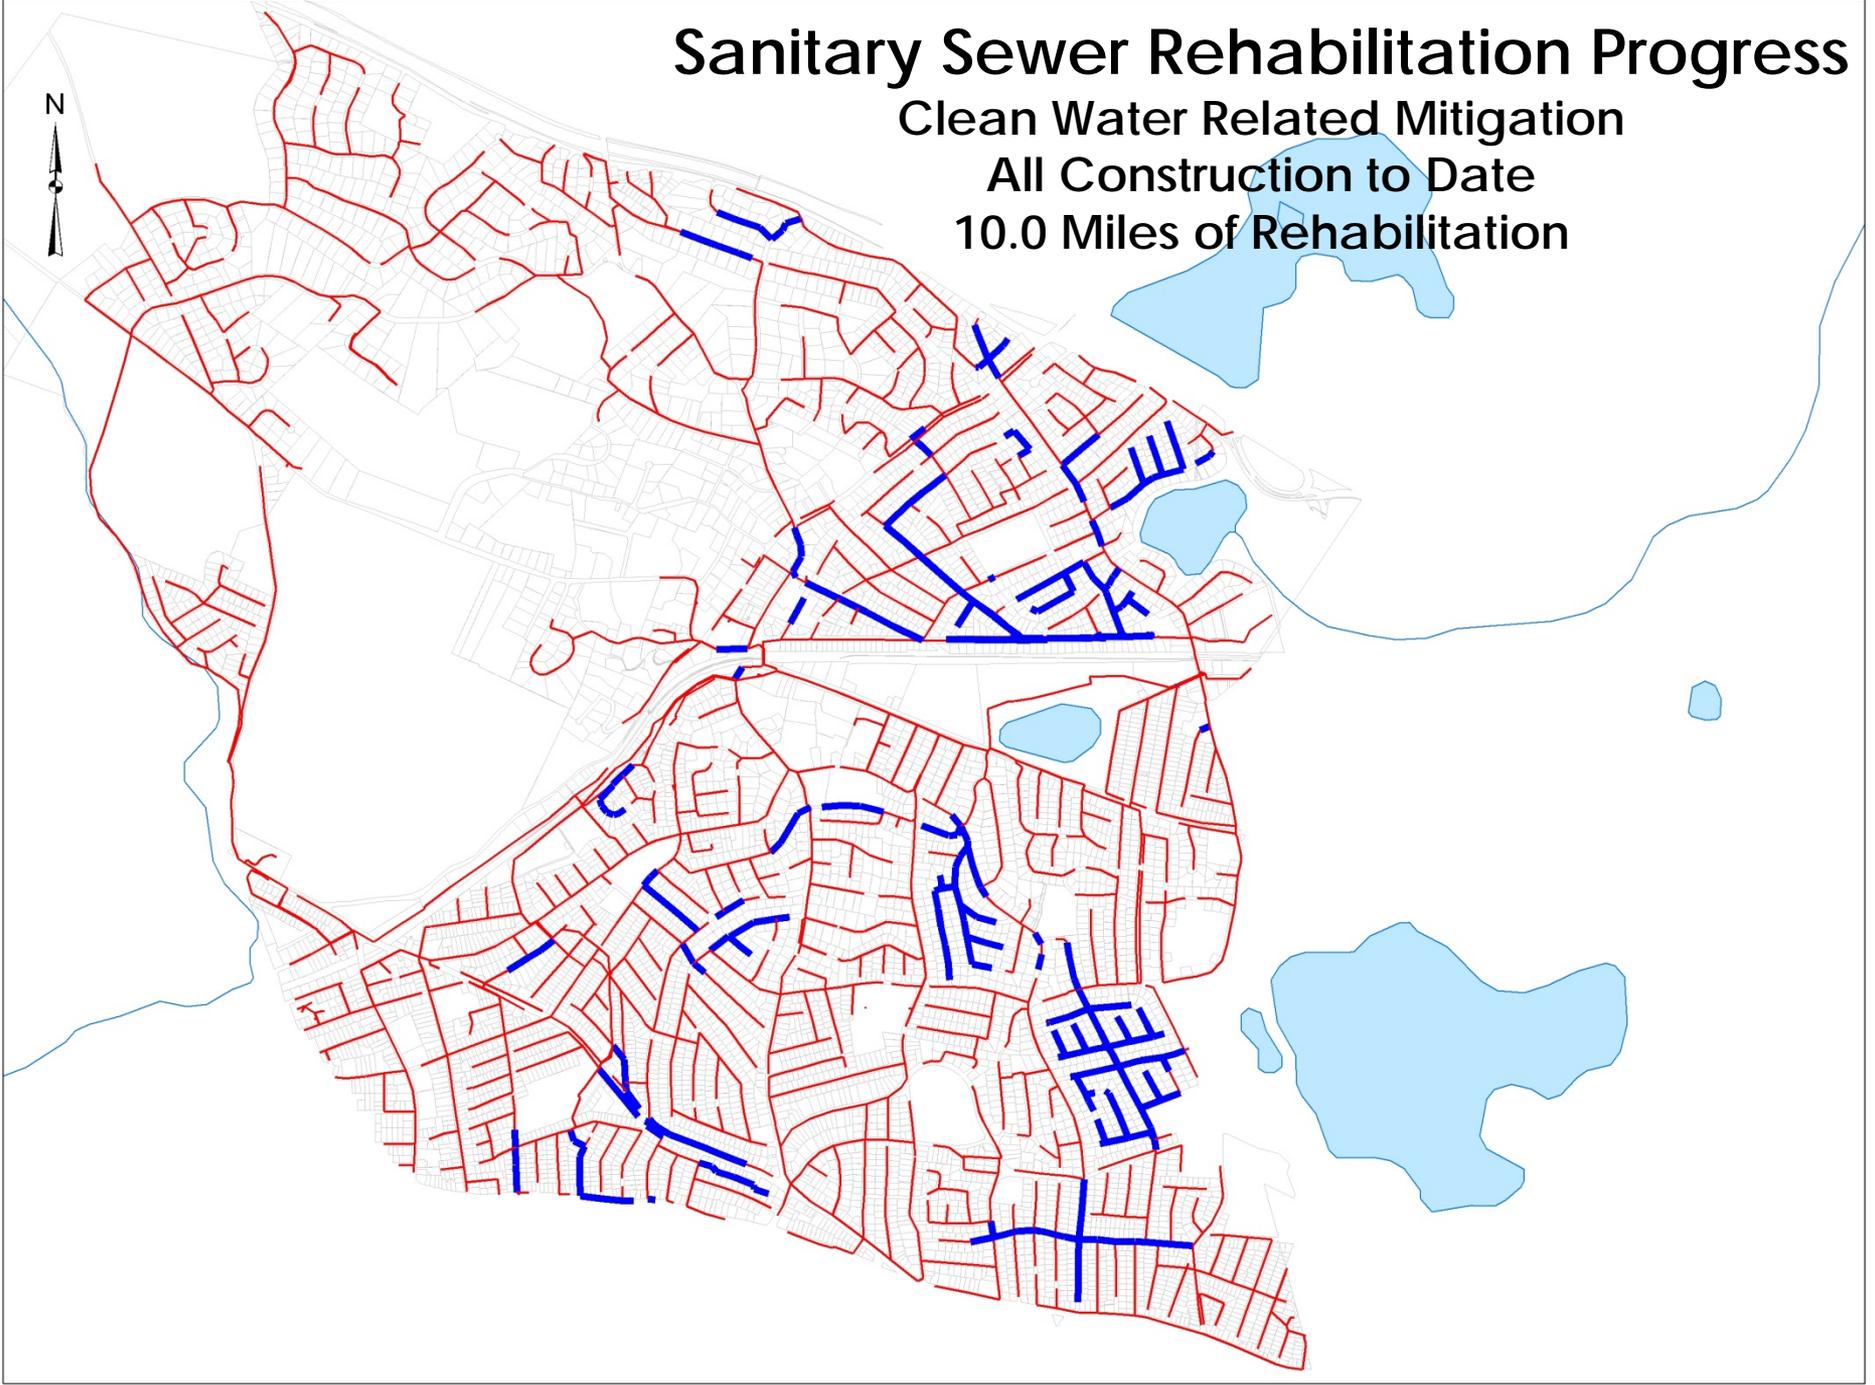
Sanitary Sewer Rehabilitation Progress

Clean Water Related Mitigation

All Construction to Date

10.0 Miles of Rehabilitation

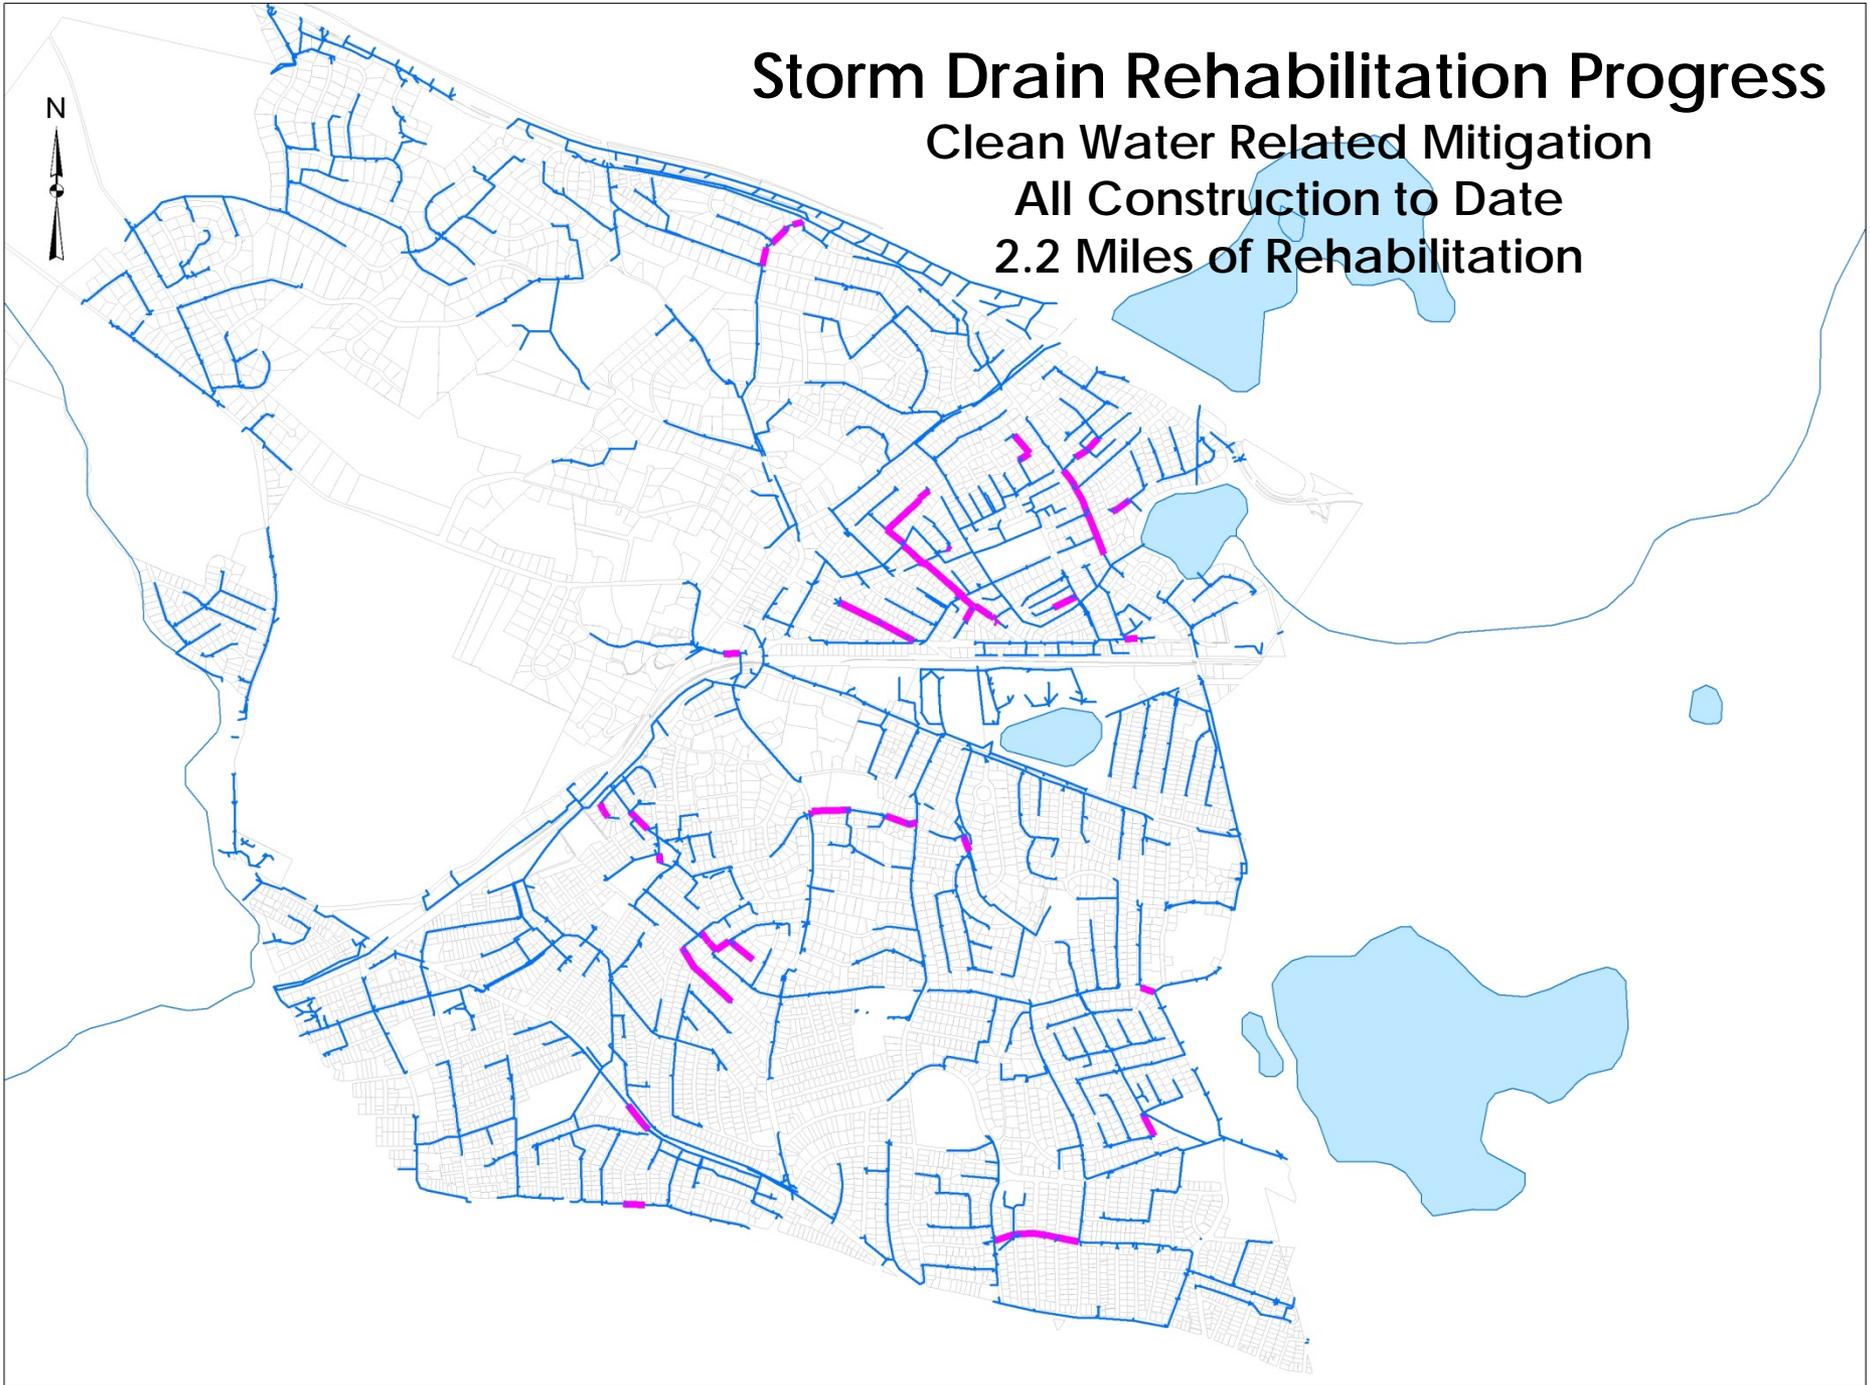
Storm Drain Rehabilitation Progress

Clean Water Related Mitigation

All Construction to Date

2.2 Miles of Rehabilitation

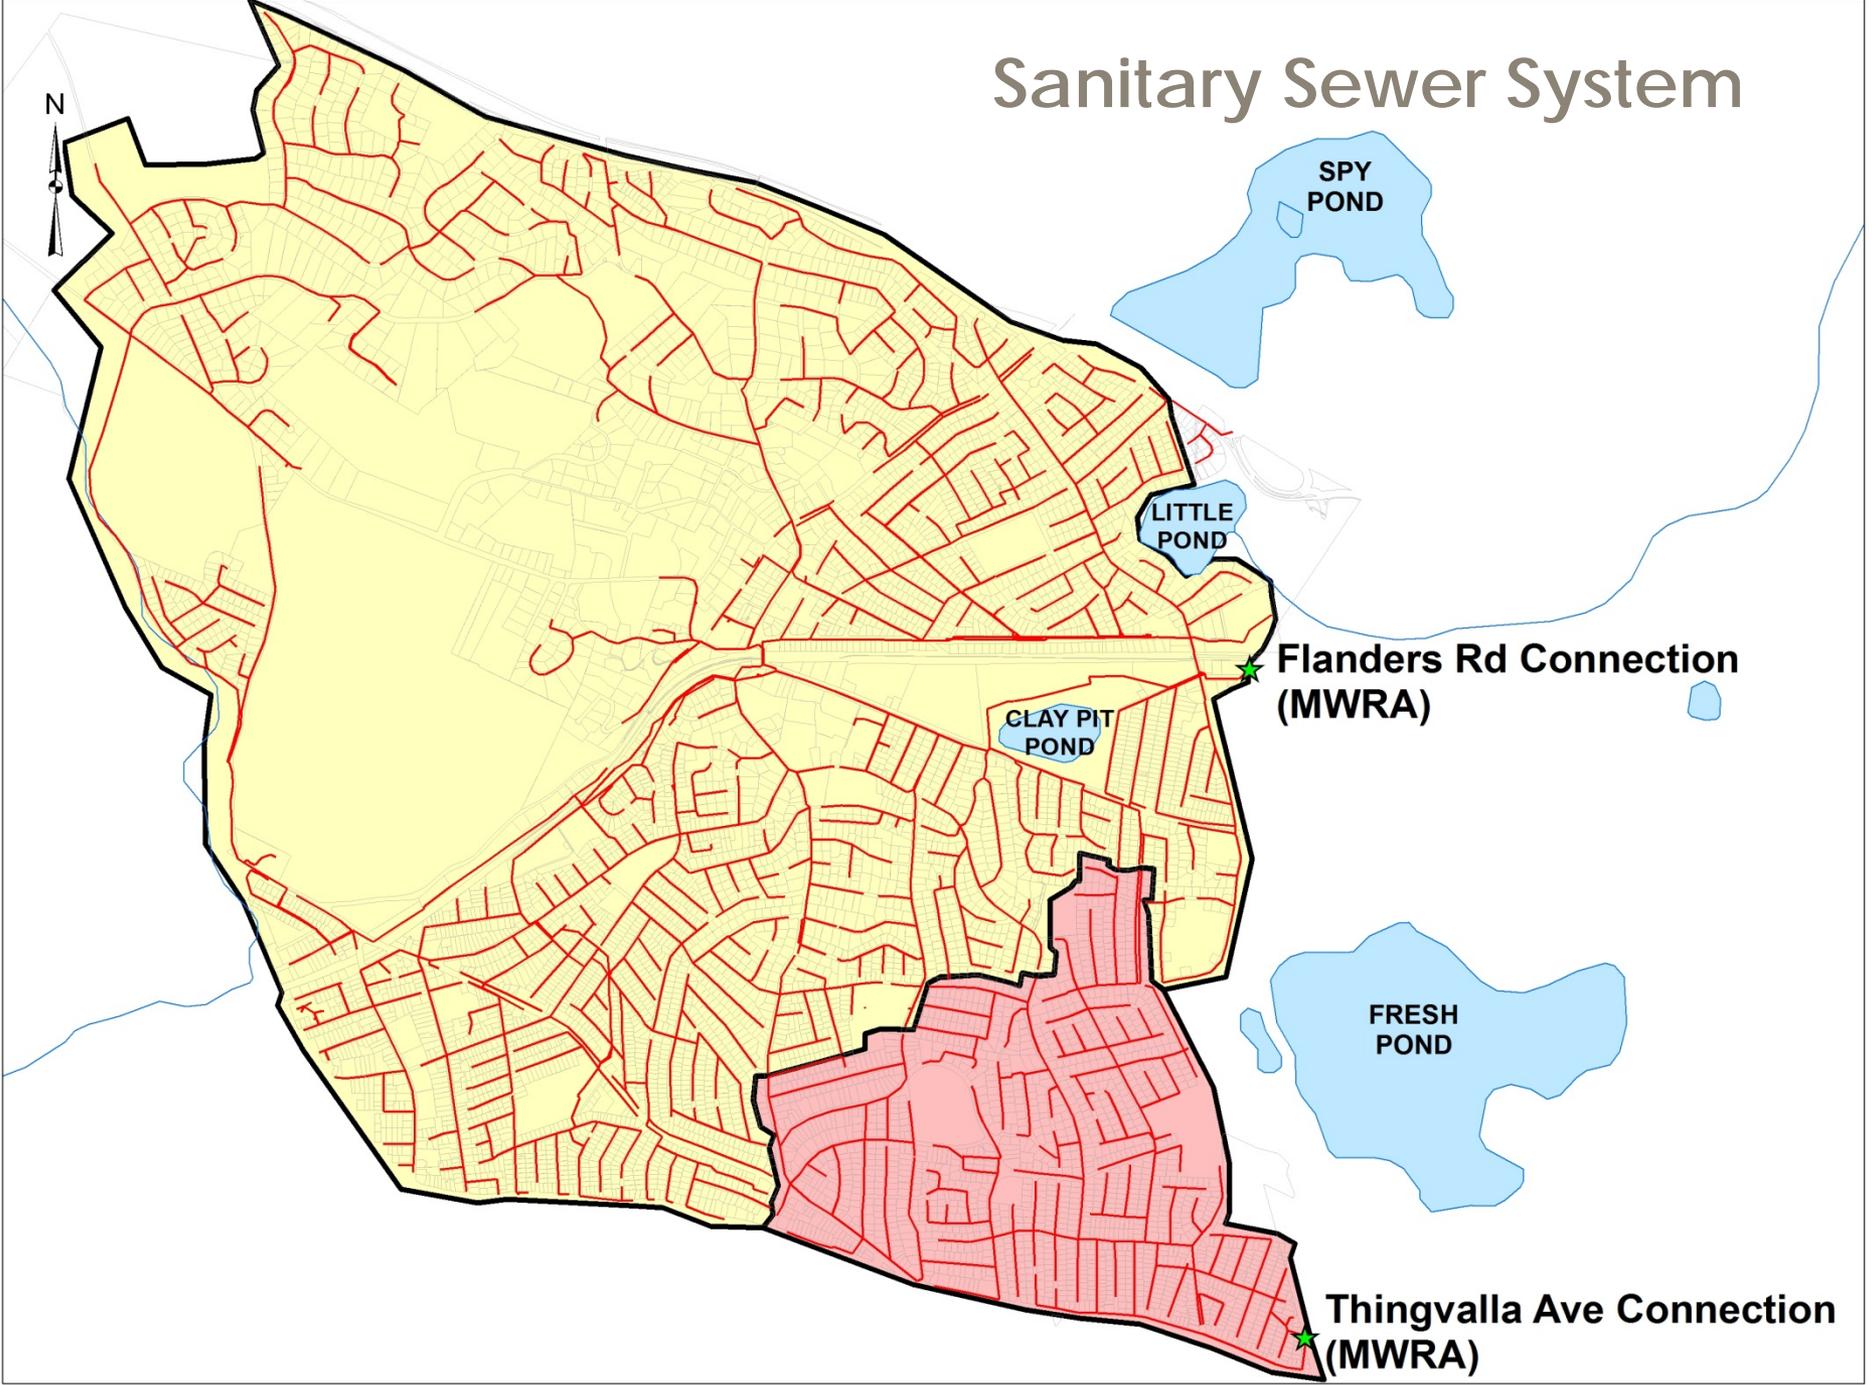
Sanitary Sewer System

**Flanders Rd Connection
(MWRA)**

**Thingvalla Ave Connection
(MWRA)**

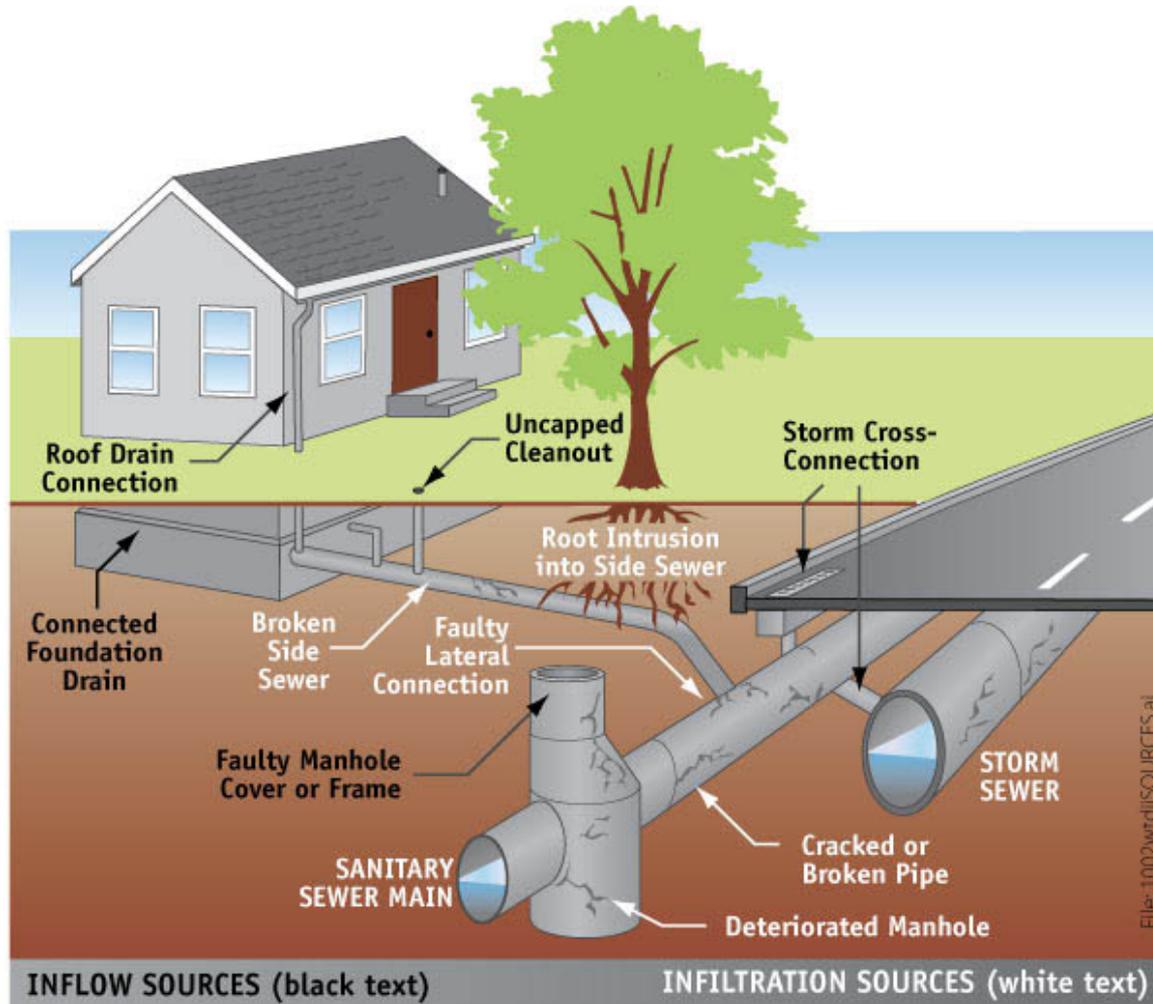
Sources of I/I

- **Infiltration** - groundwater seeping through defects into sanitary sewer pipes and manholes.
- **Inflow** - storm water connections such as roof leaders, sump pumps and catch basins that connect to sanitary sewer system.

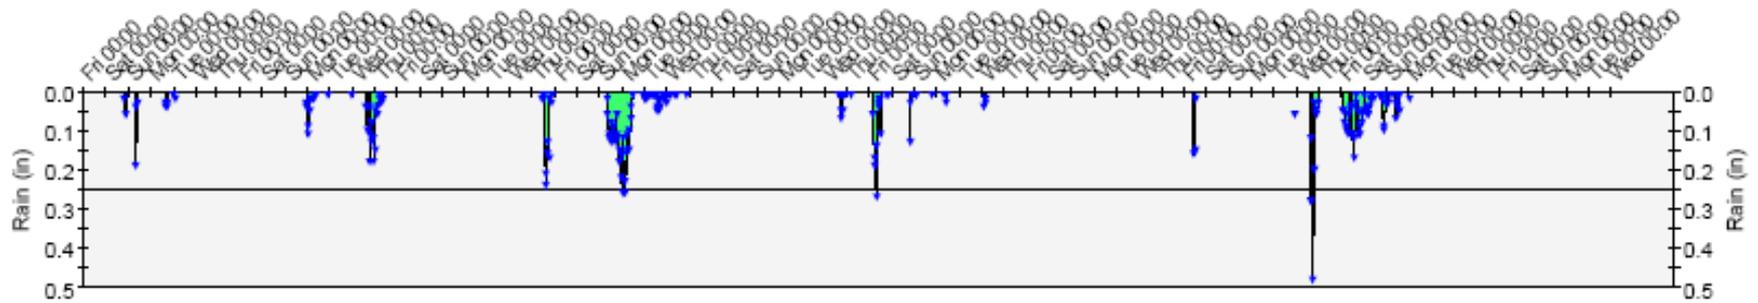
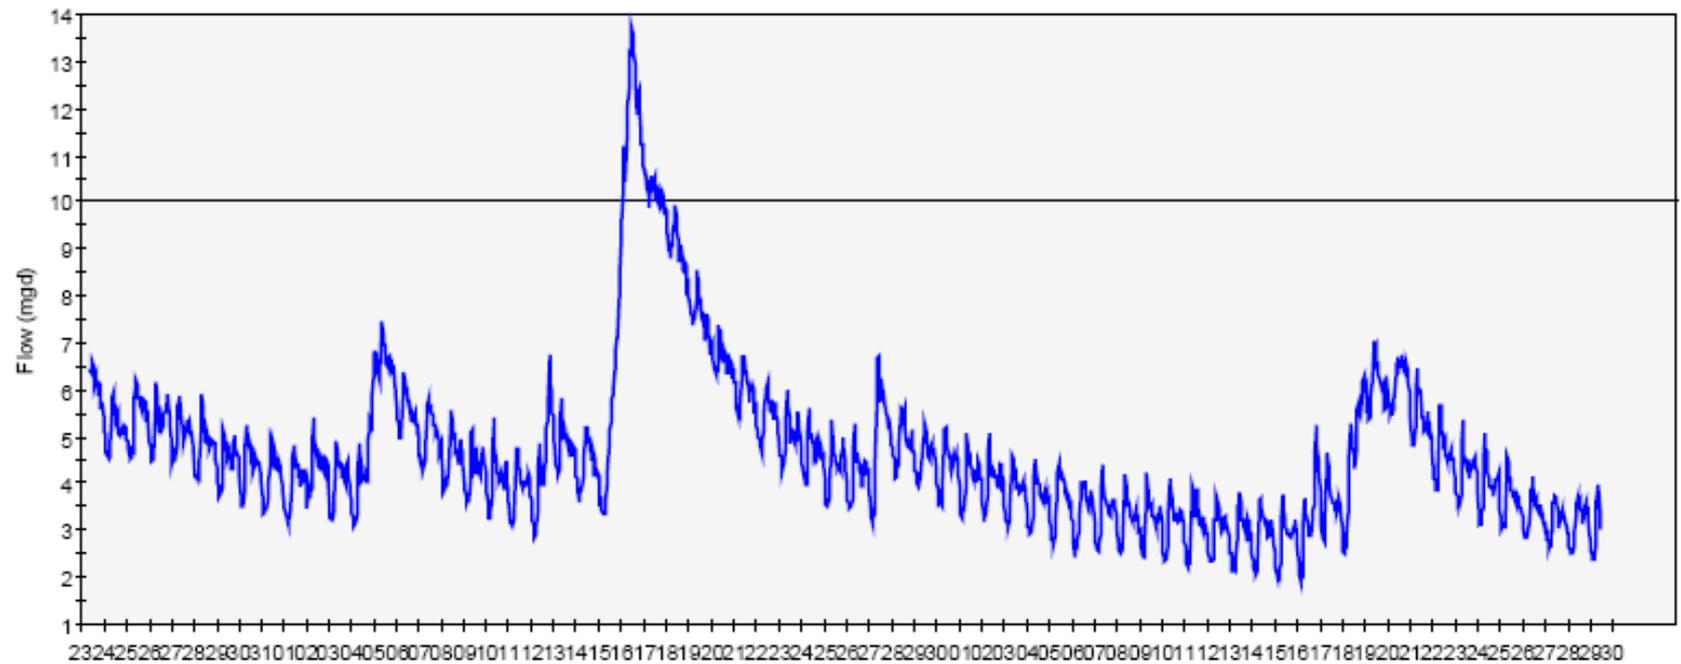
— Site 5

Site: 5 / Flanders Rd.

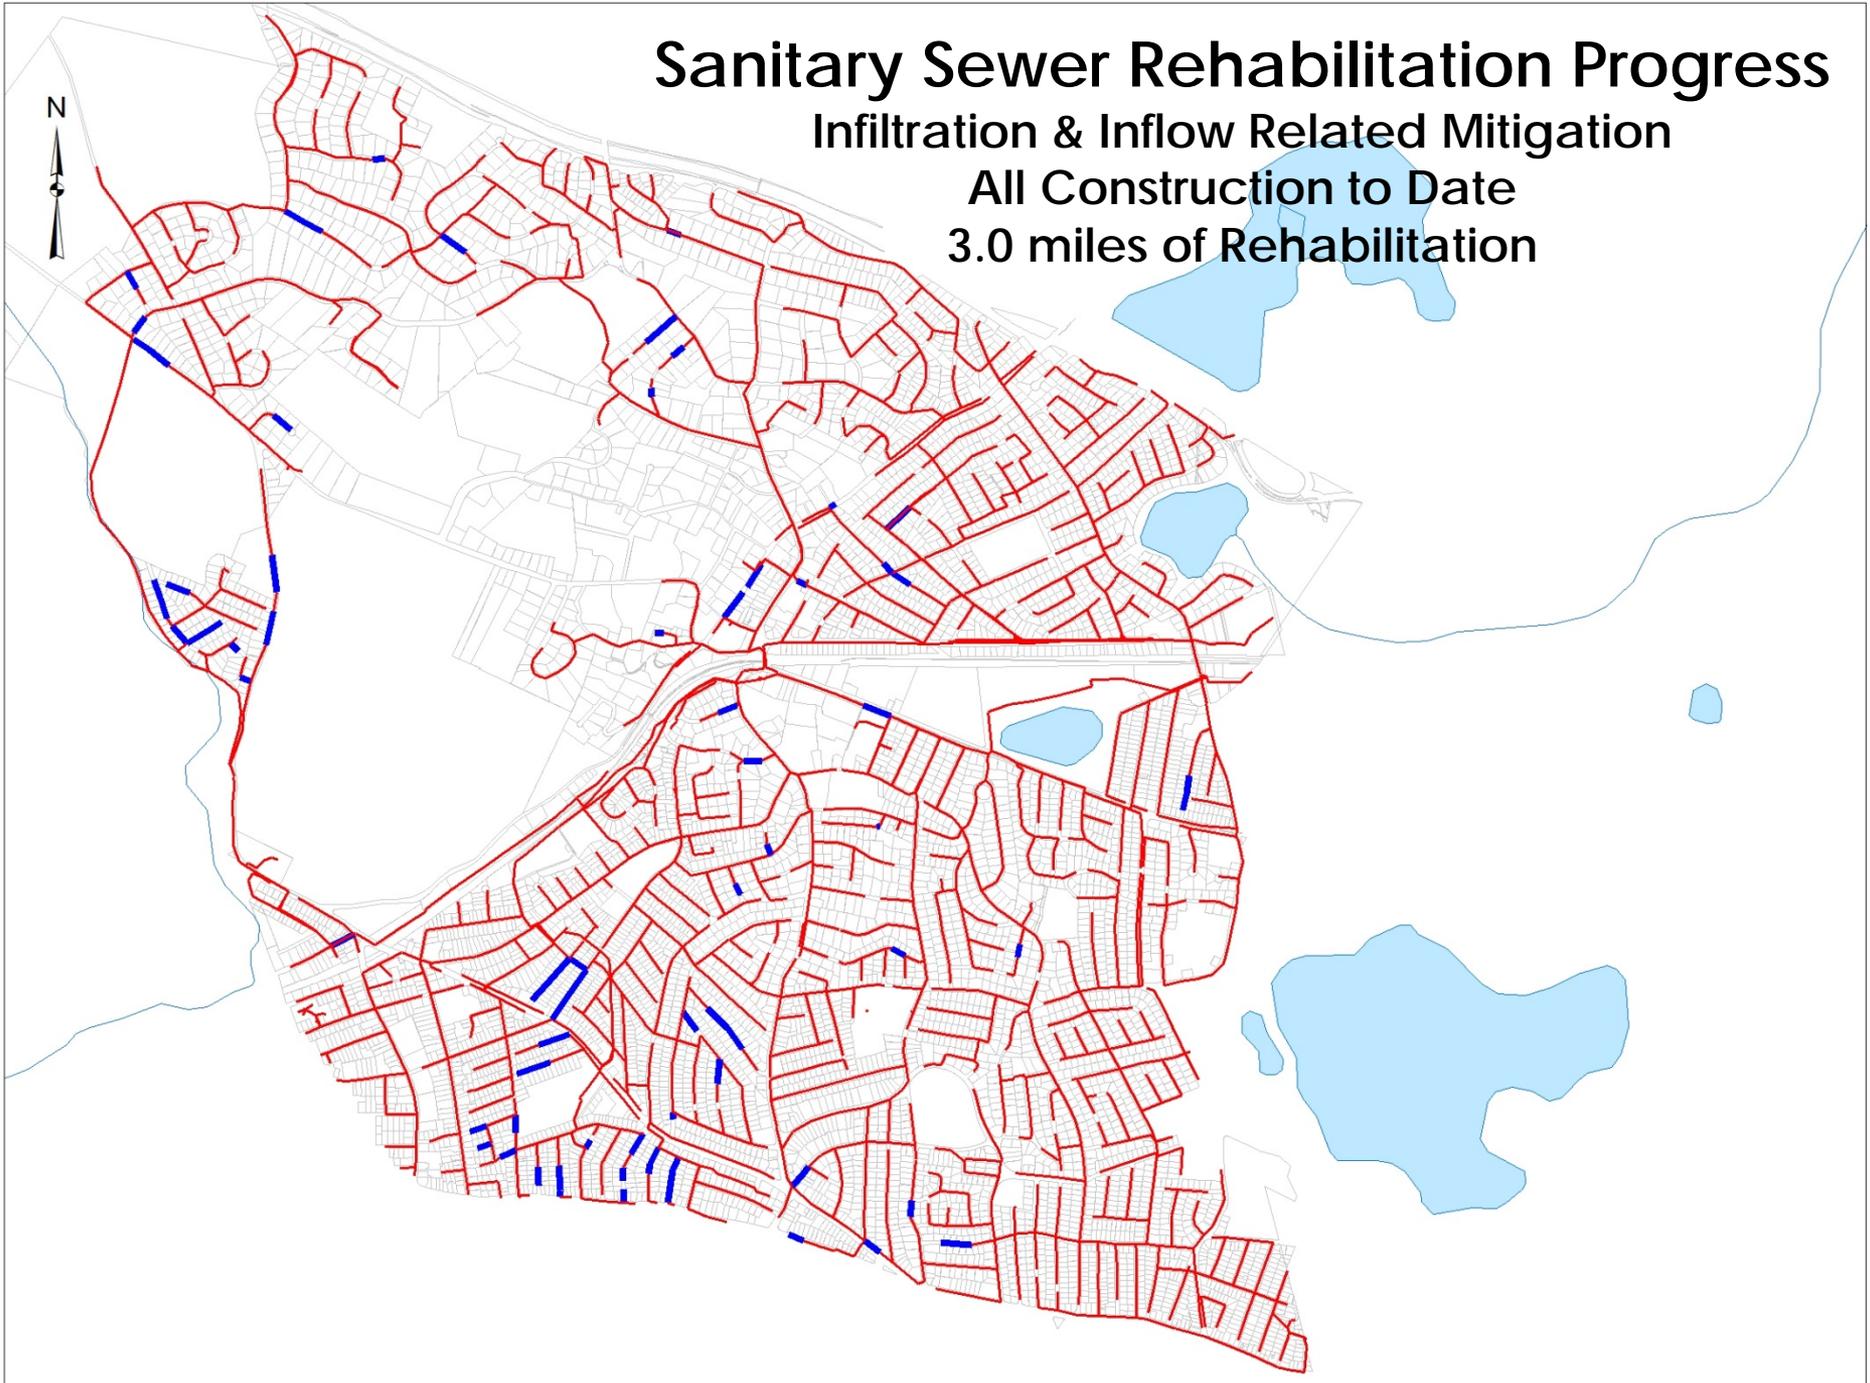
Sanitary Sewer Rehabilitation Progress

Infiltration & Inflow Related Mitigation

All Construction to Date

3.0 miles of Rehabilitation

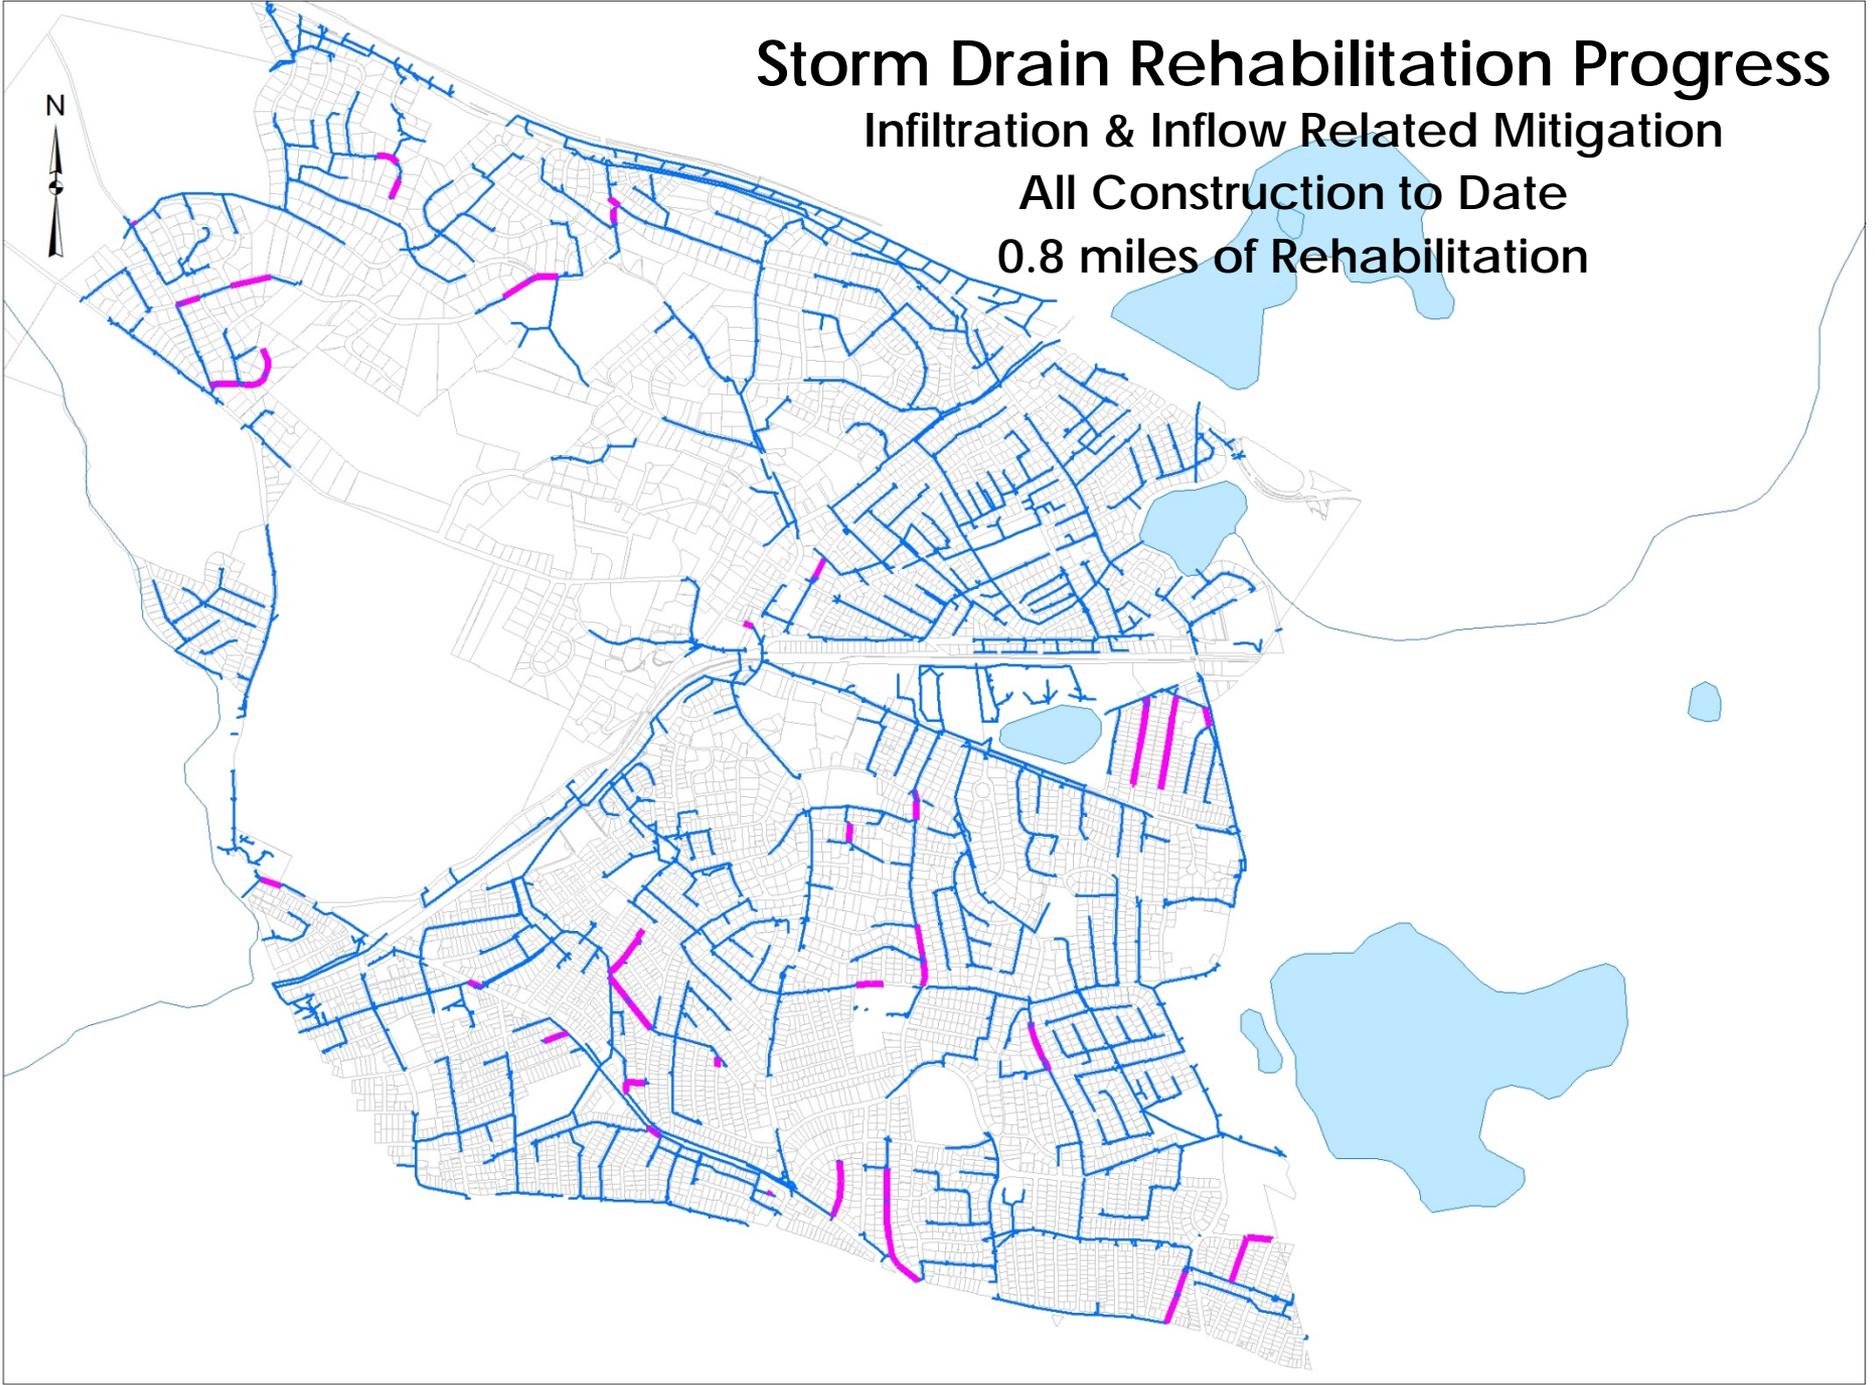
Storm Drain Rehabilitation Progress

Infiltration & Inflow Related Mitigation

All Construction to Date

0.8 miles of Rehabilitation

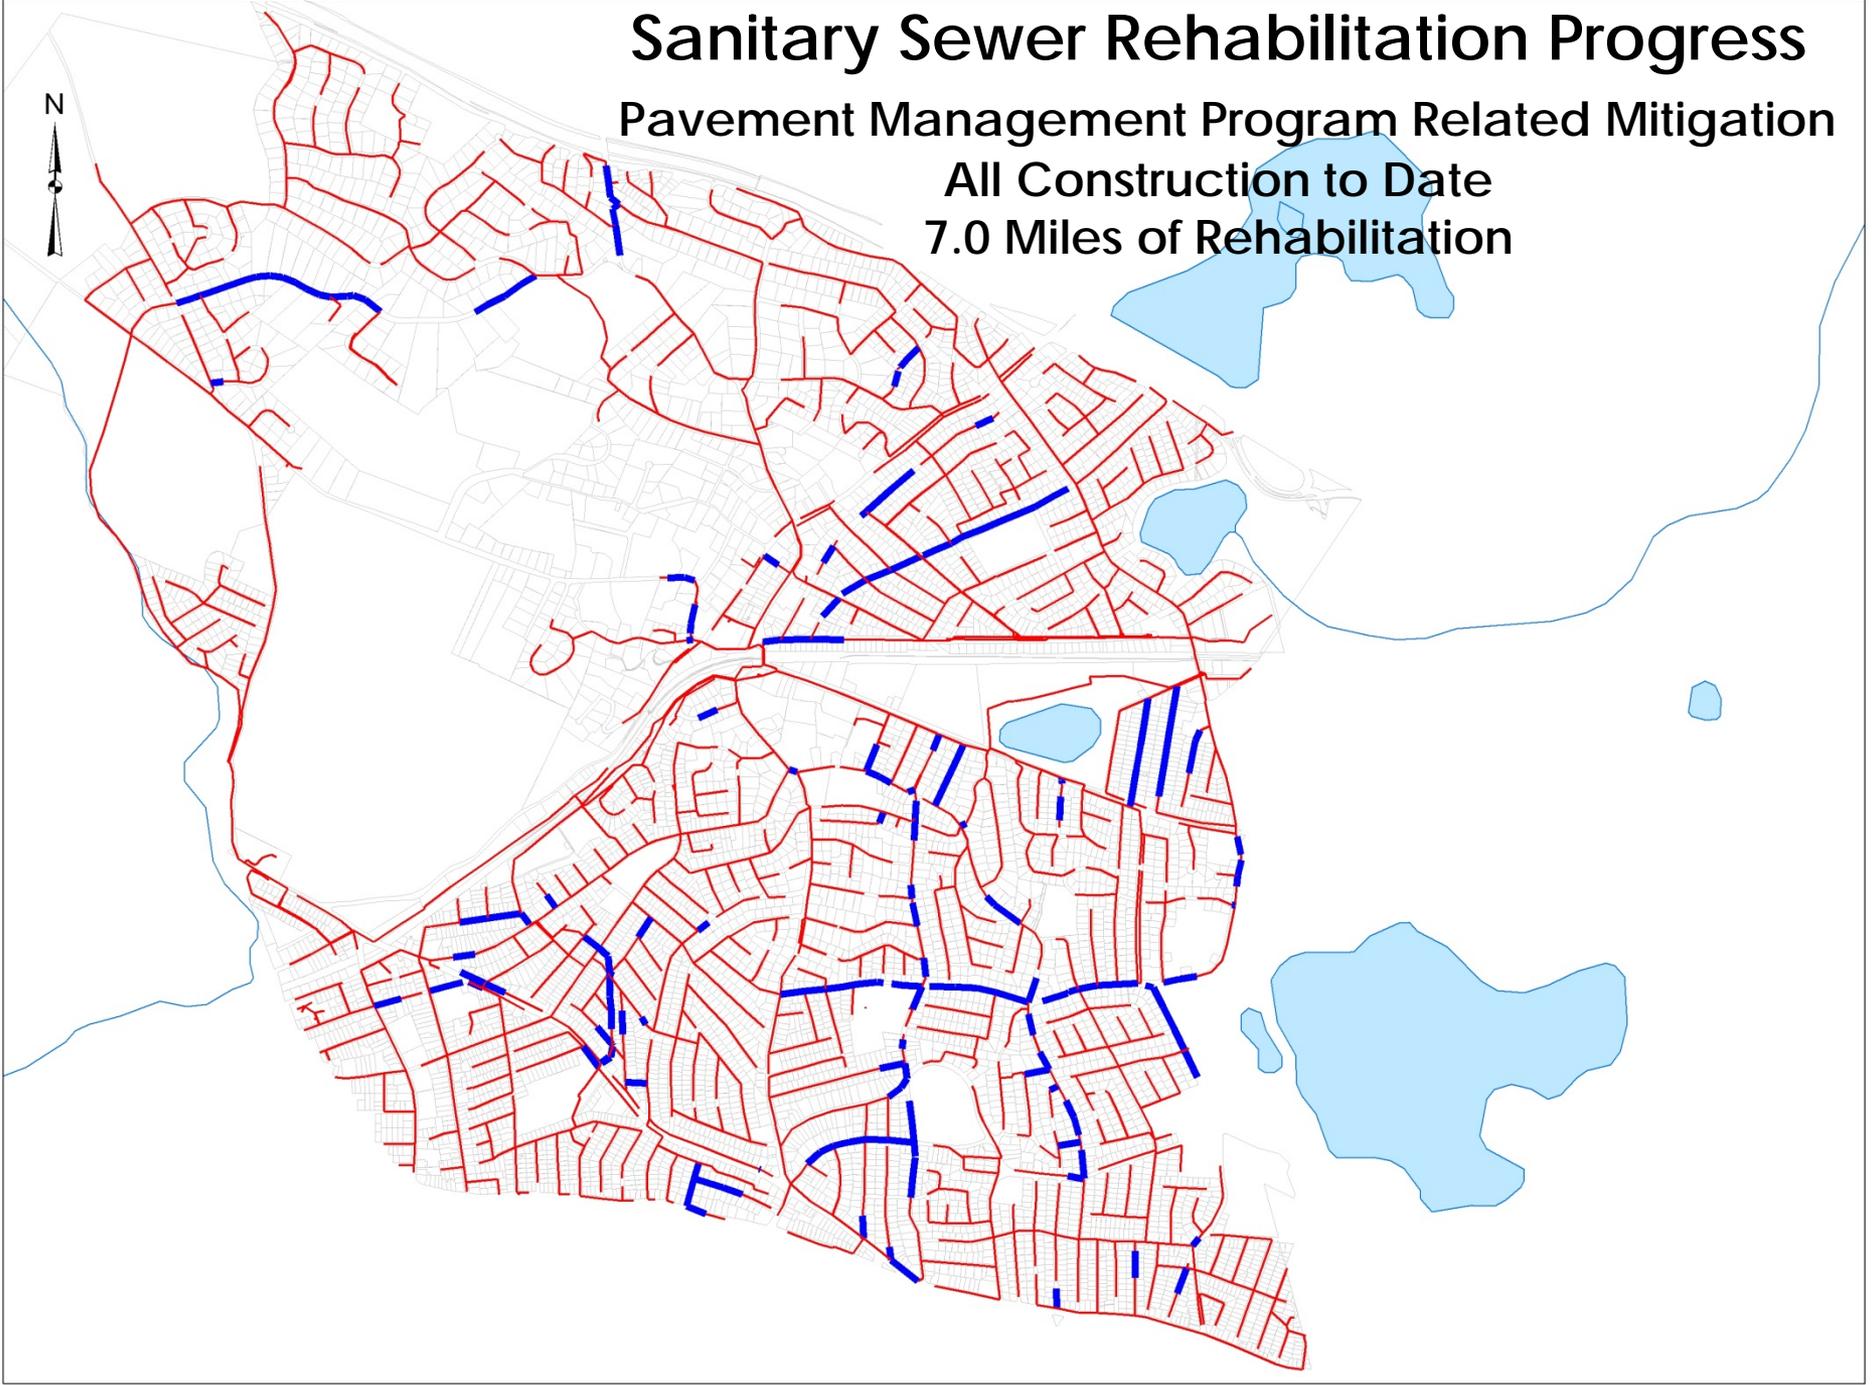
Sanitary Sewer Rehabilitation Progress

Pavement Management Program Related Mitigation

All Construction to Date
7.0 Miles of Rehabilitation
