TOWN OF BELMONT

Presentation to BOARD OF SELECTMAN January 11, 2016

SEWER & STORM DRAIN SYSTEM REHABILITATION OVERVIEW

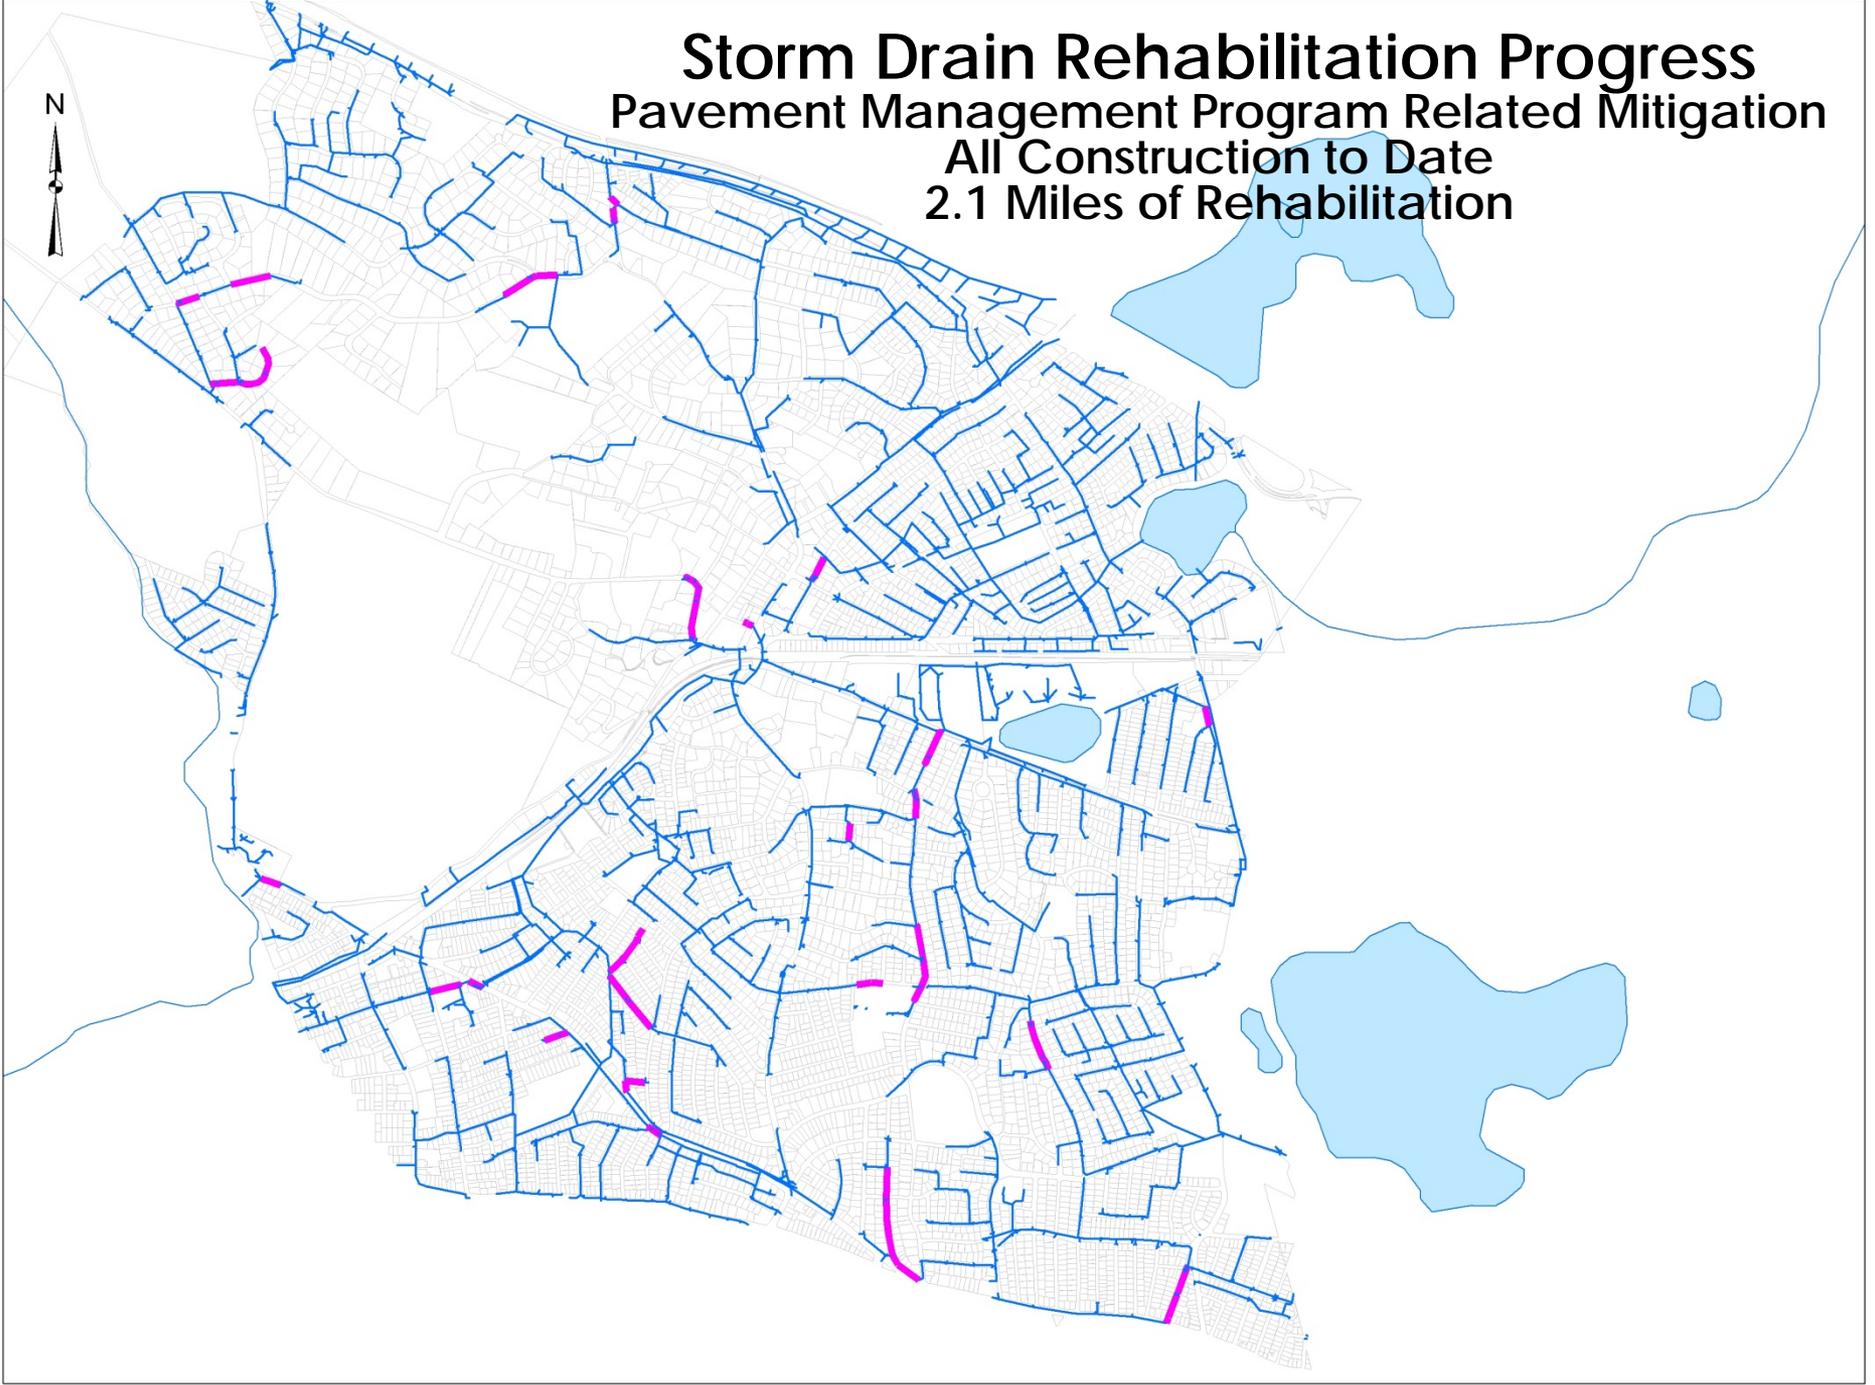
Storm Drain Rehabilitation Progress

Pavement Management Program Related Mitigation
All Construction to Date
2.1 Miles of Rehabilitation

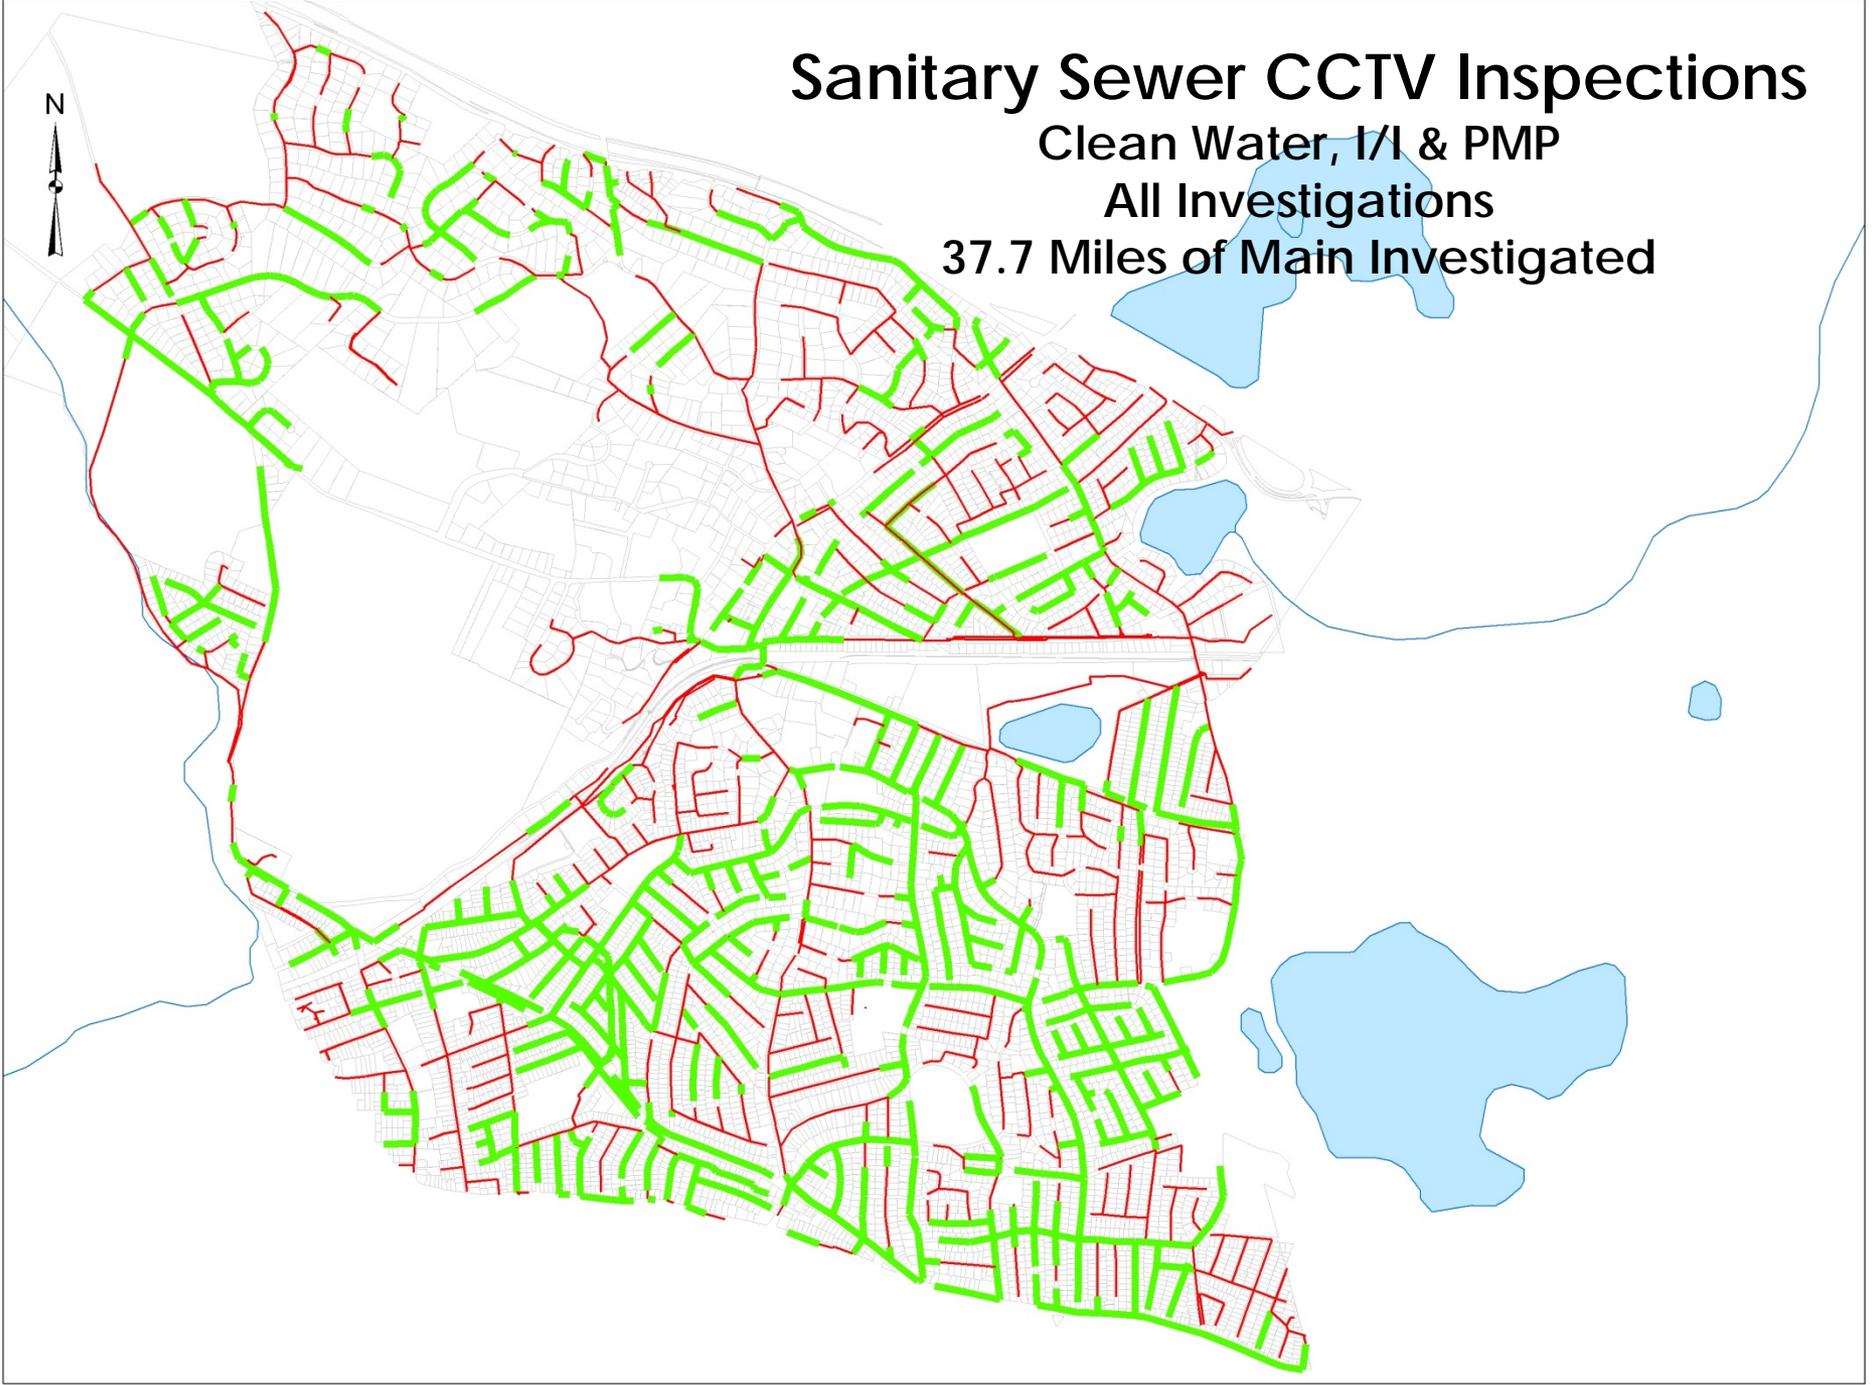
Sanitary Sewer CCTV Inspections

Clean Water, I/I & PMP

All Investigations

37.7 Miles of Main Investigated

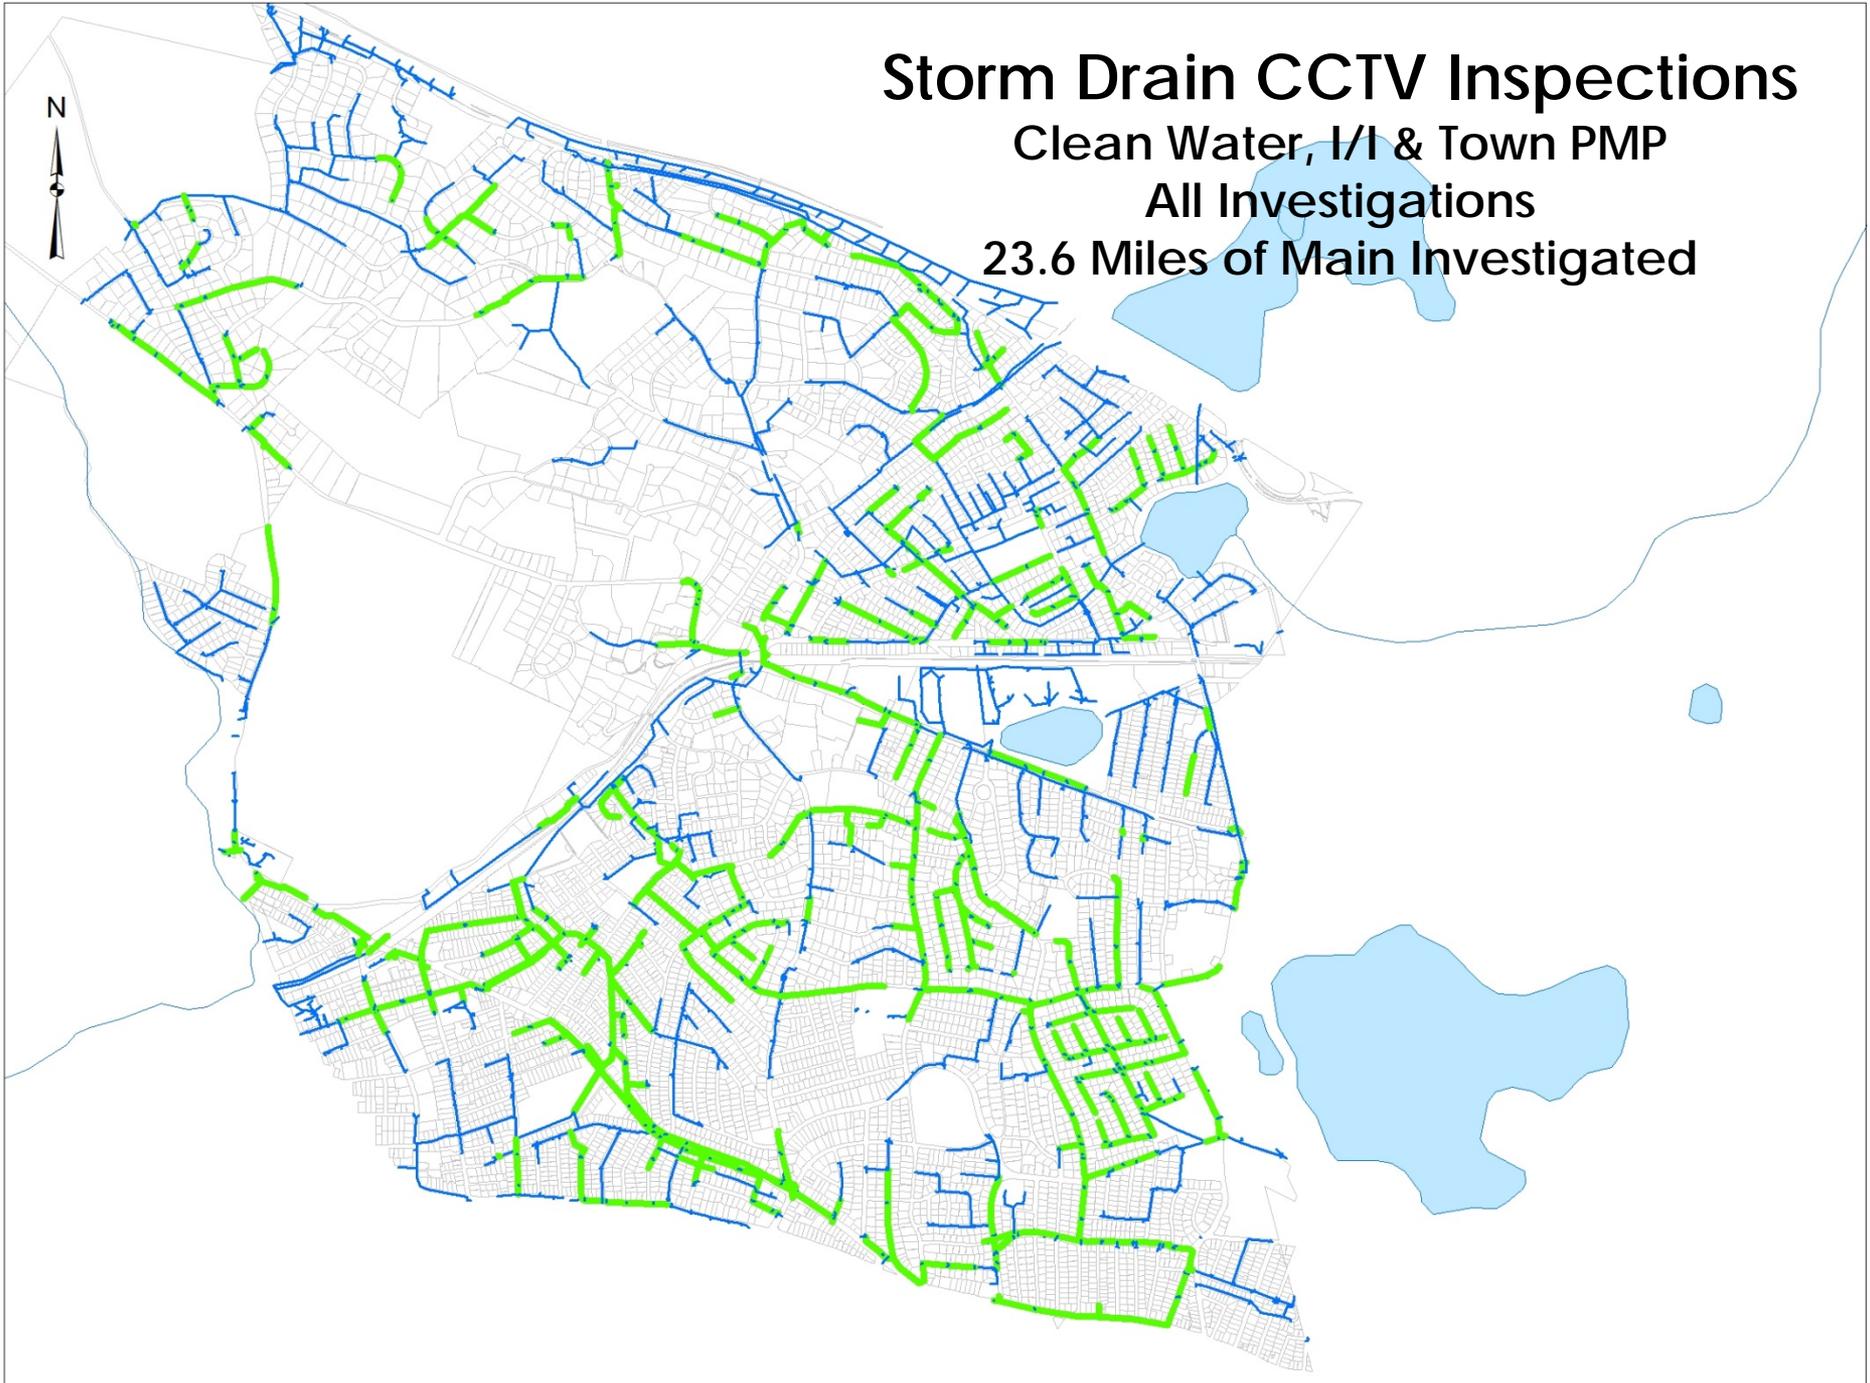
Storm Drain CCTV Inspections

Clean Water, I/I & Town PMP

All Investigations

23.6 Miles of Main Investigated

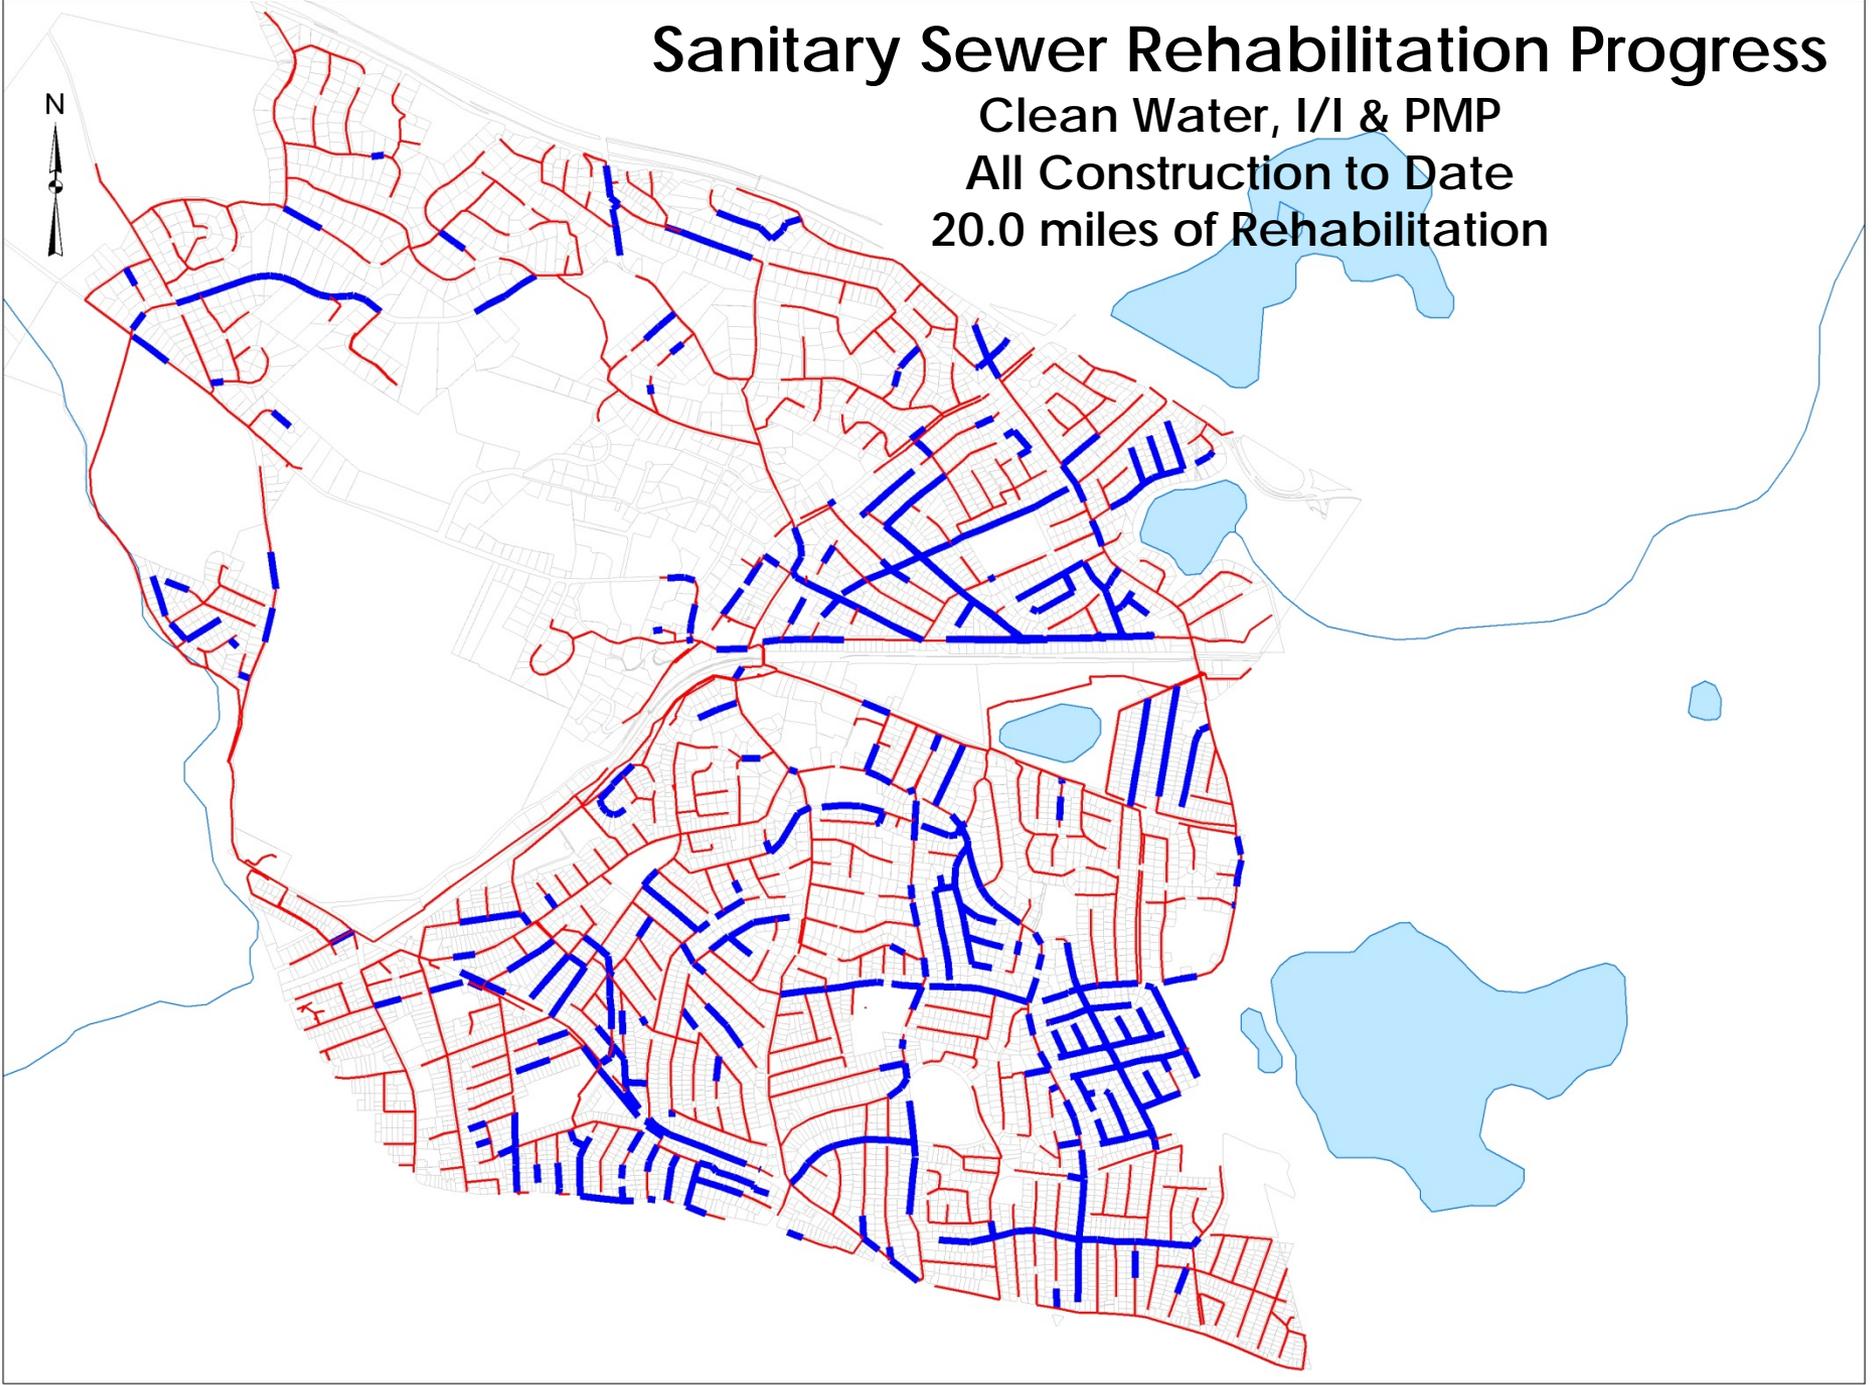
Sanitary Sewer Rehabilitation Progress

Clean Water, I/I & PMP
All Construction to Date
20.0 miles of Rehabilitation

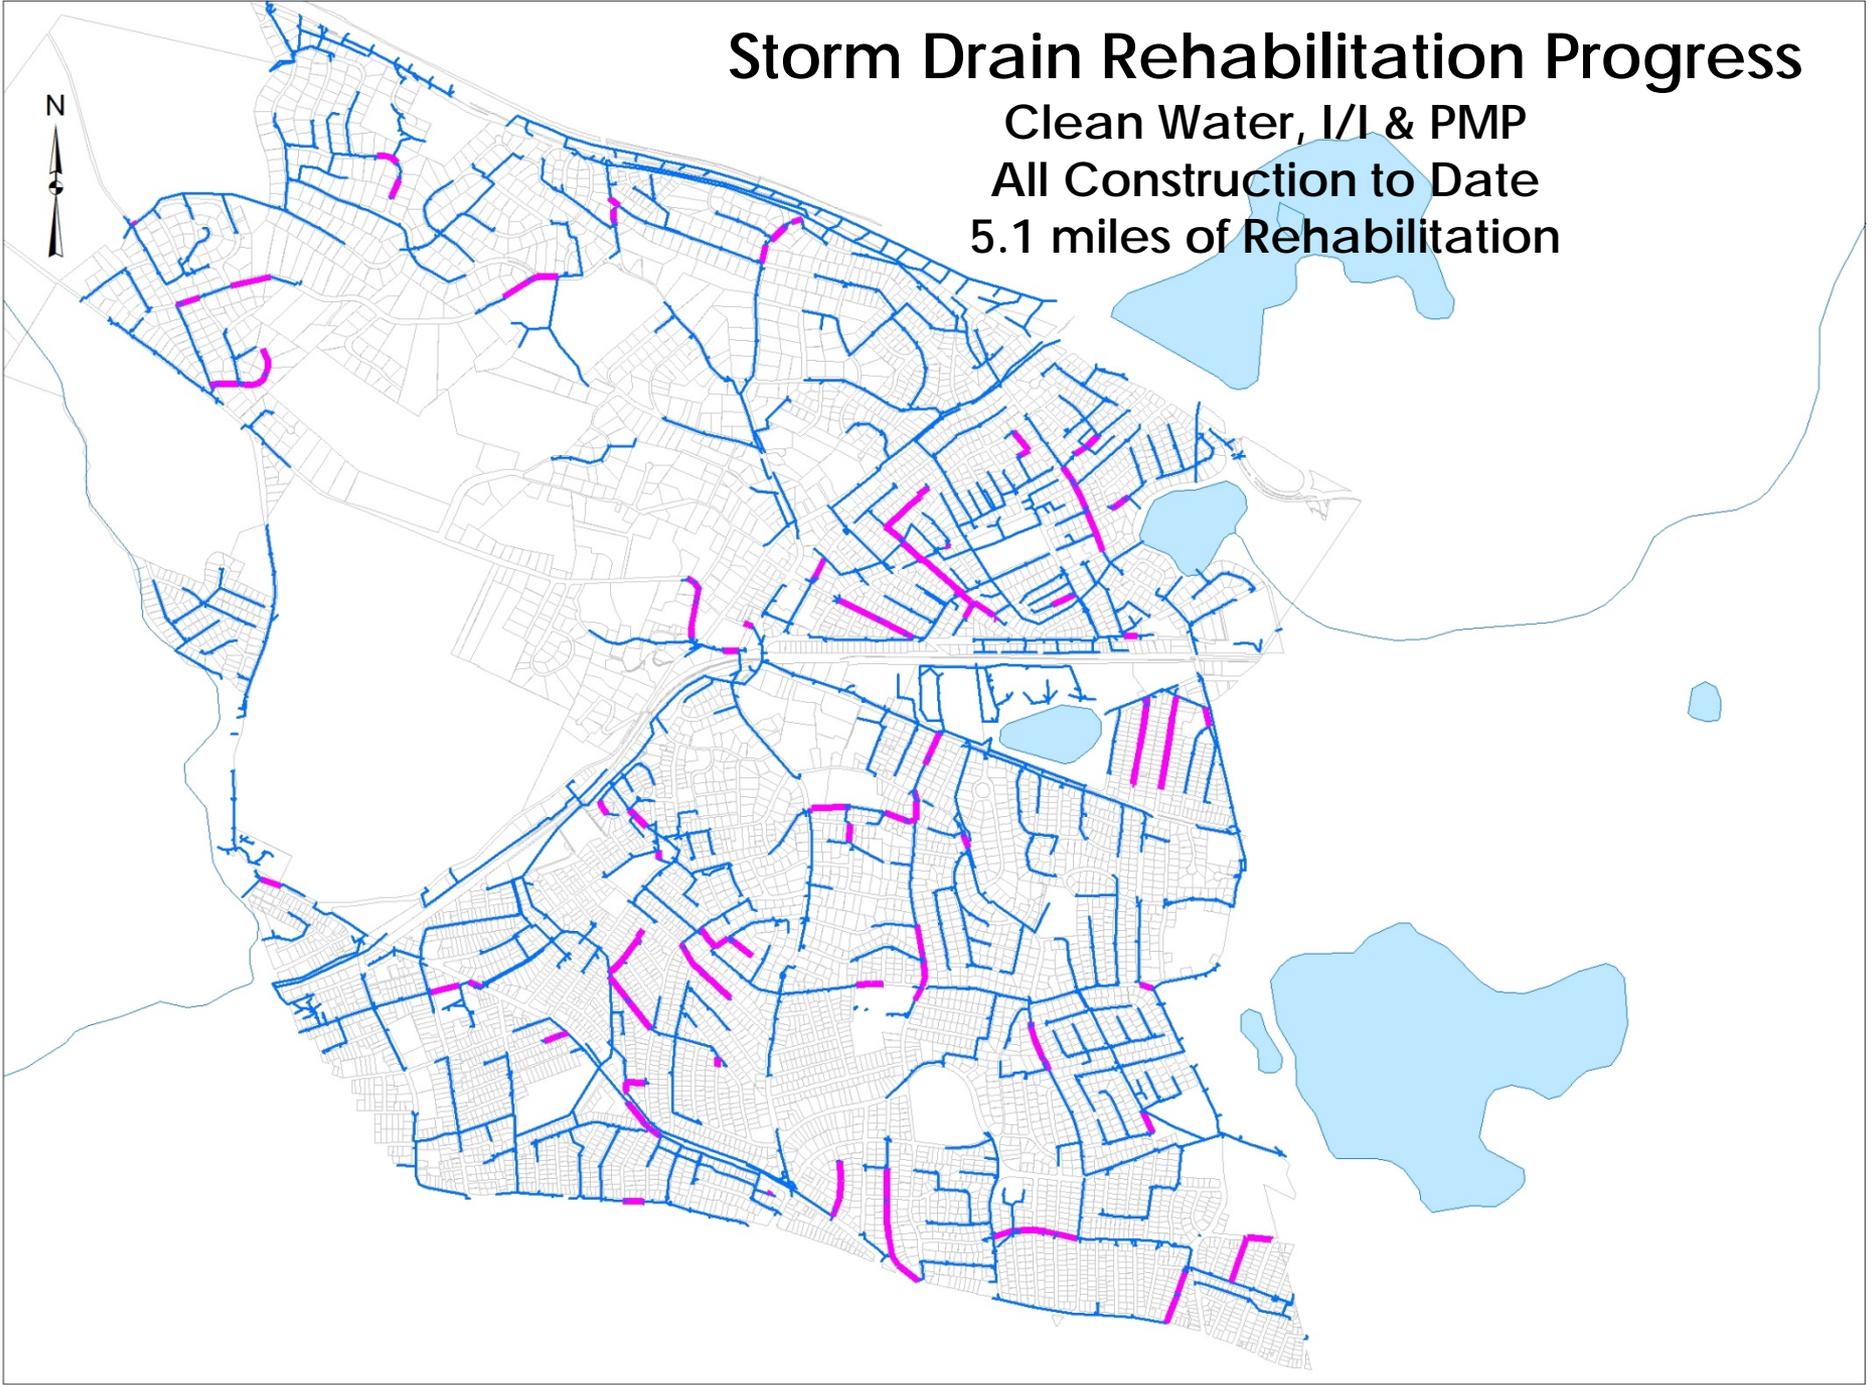
Storm Drain Rehabilitation Progress

Clean Water, I/I & PMP
All Construction to Date
5.1 miles of Rehabilitation

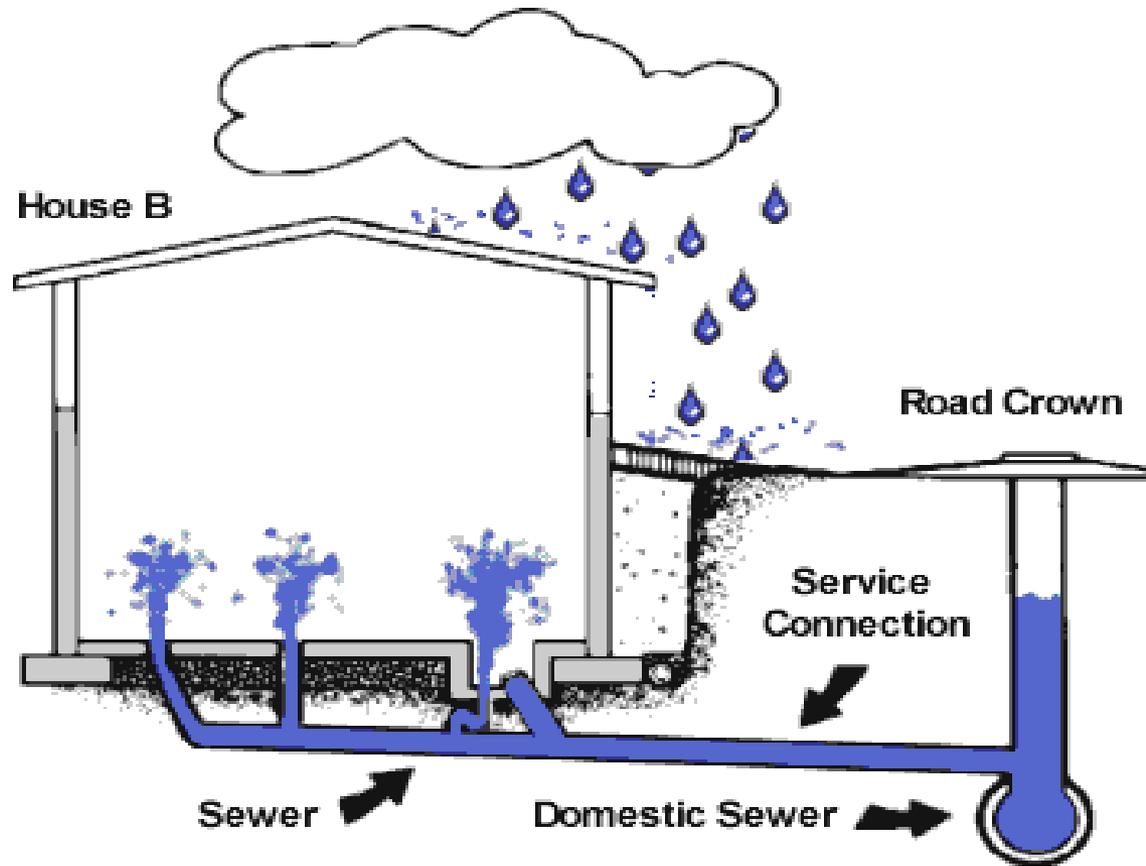
Elevated Hydraulic Grade Line

Increased Hydraulic Grade Line Creates Sewer Overflows

- System Capacity Constraints
- Infiltration/Inflow in Belmont
 - 2007 Flow Monitoring Program
- Elevated downstream hydraulic grade line

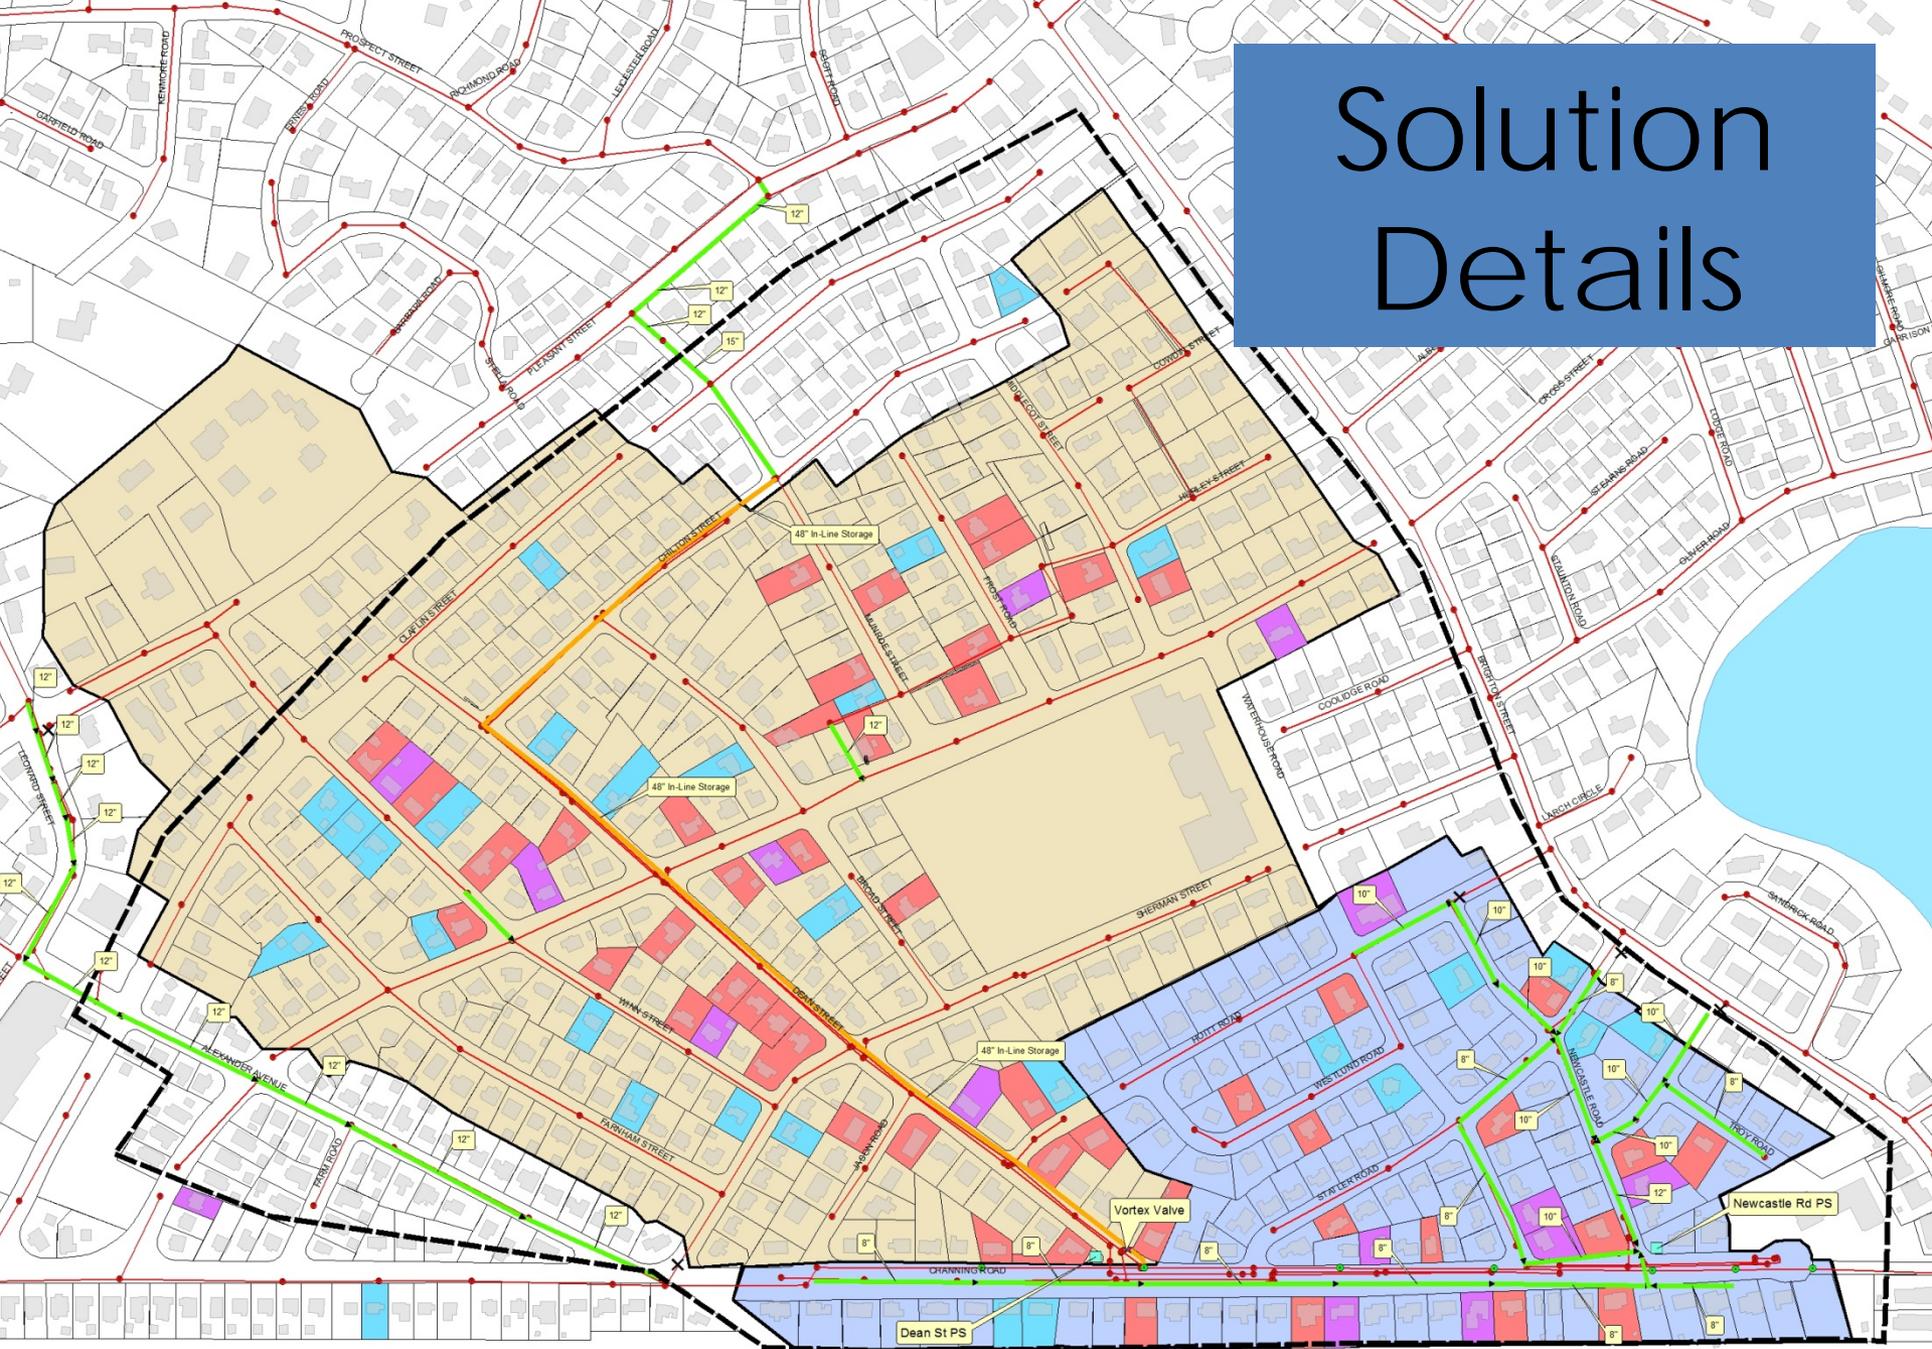
Solution Details

- Flow diversion(Alexander St. & Dean St.)
- Storage (Dean St. Box Culvert)
- Isolation and Pumping (3 Isolation chambers)
- I/I Removal
