LAND CONSERVATION & STEWARDSHIP

2024 Annual Monitoring Report

237.00--McLean-Open Space

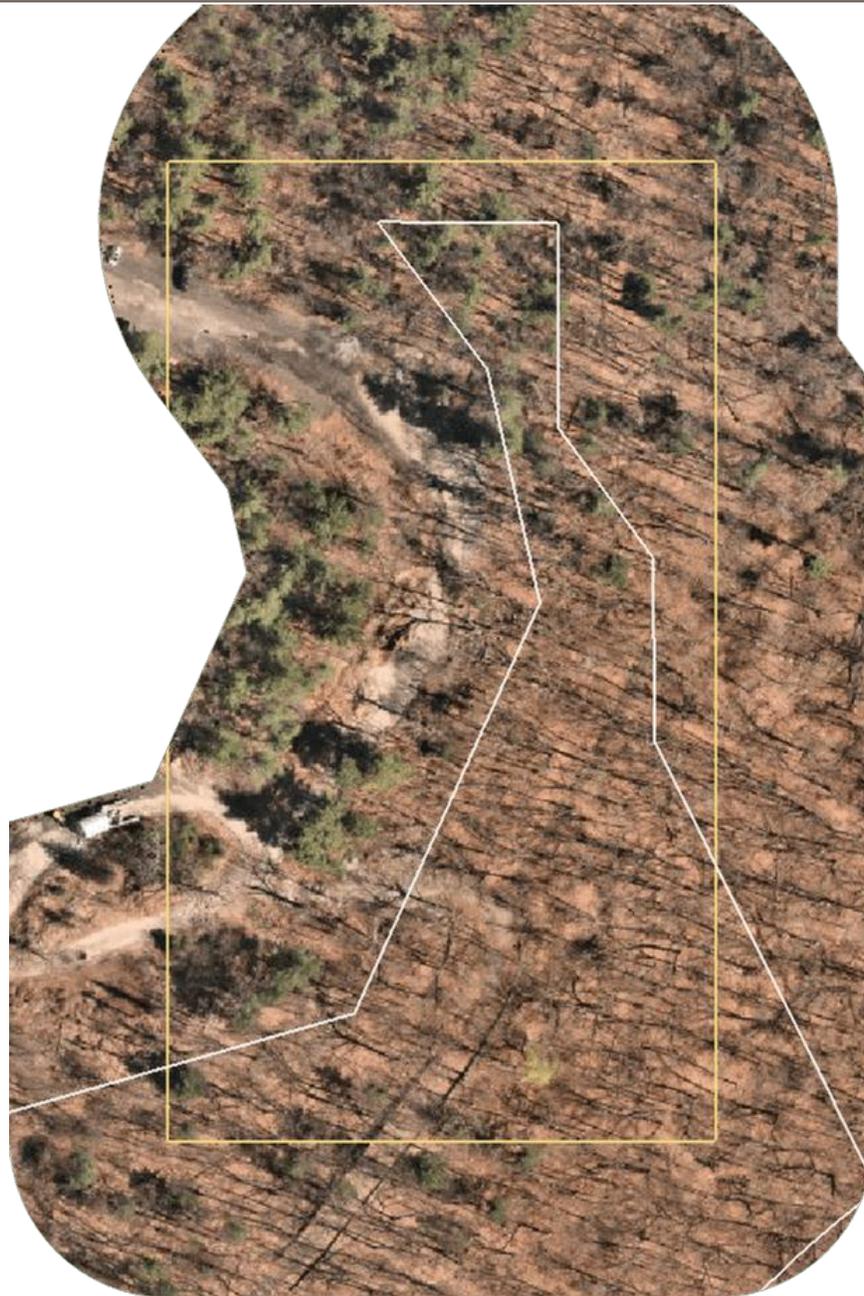
R1 -- North Section - No recent changes noted. -- (Imagery Date: 4/9/2024)
Nearmap (0.5m). Truecolor, high resolution. © Nearmap 2024.

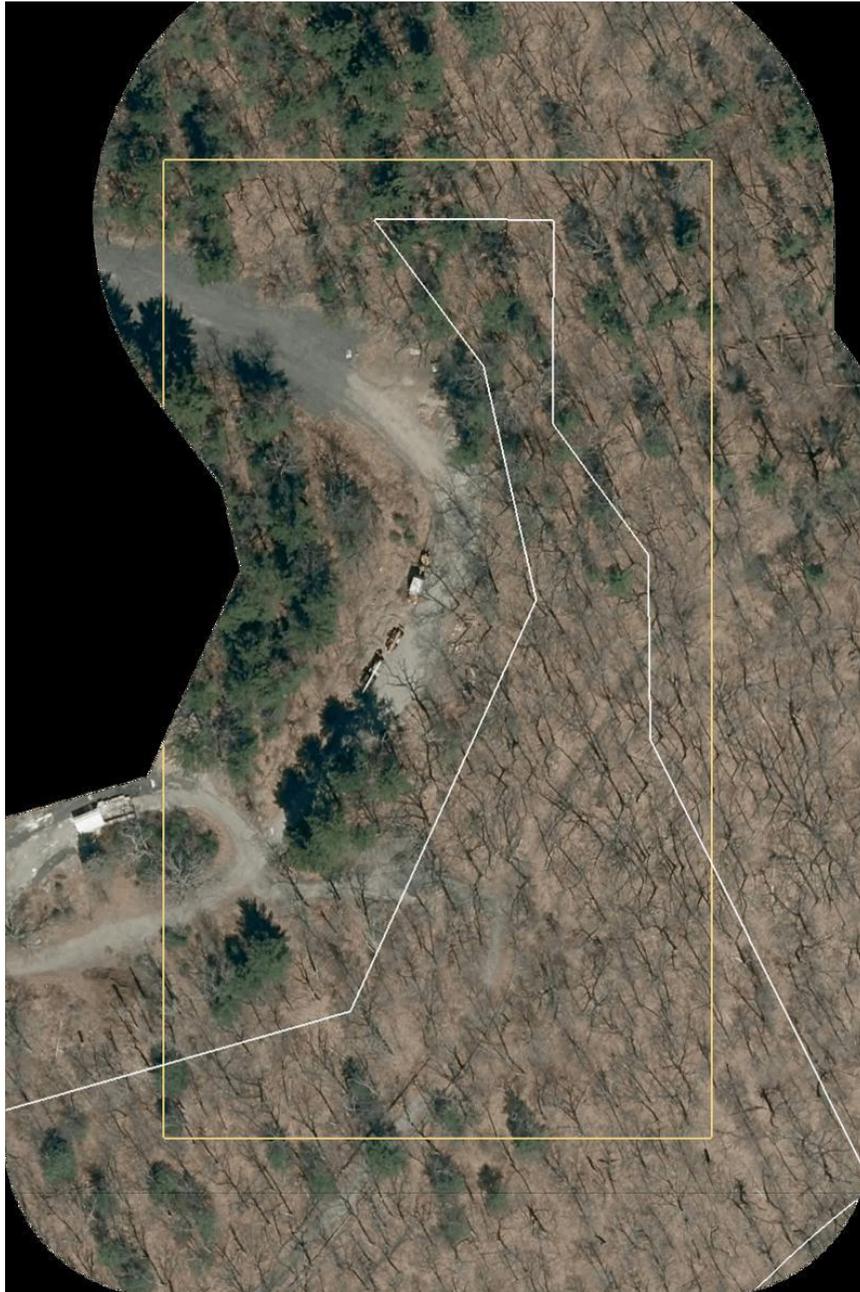
R1 -- North Section - No recent changes noted. -- (Imagery Date: 4/10/2023)
MassGIS Aerial Imagery. Truecolor, high resolution. 2023 Commonwealth of Massachusetts..

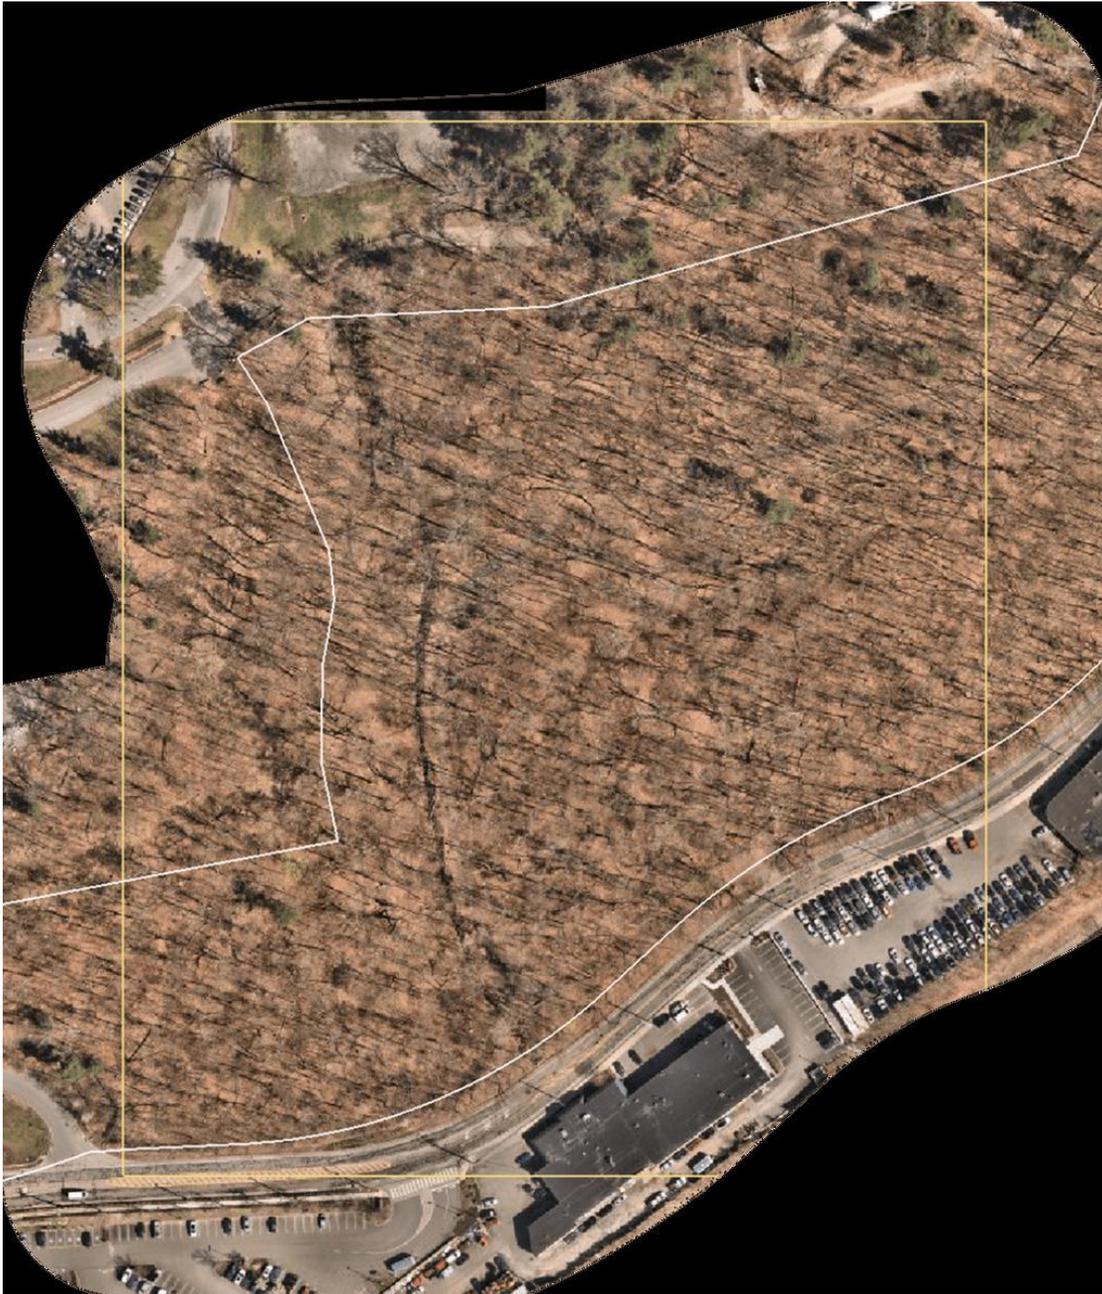
R2 -- Central area - No changes noted. -- (Imagery Date: 4/9/2024)
Nearmap (0.5m). Truecolor, high resolution. © Nearmap 2024.

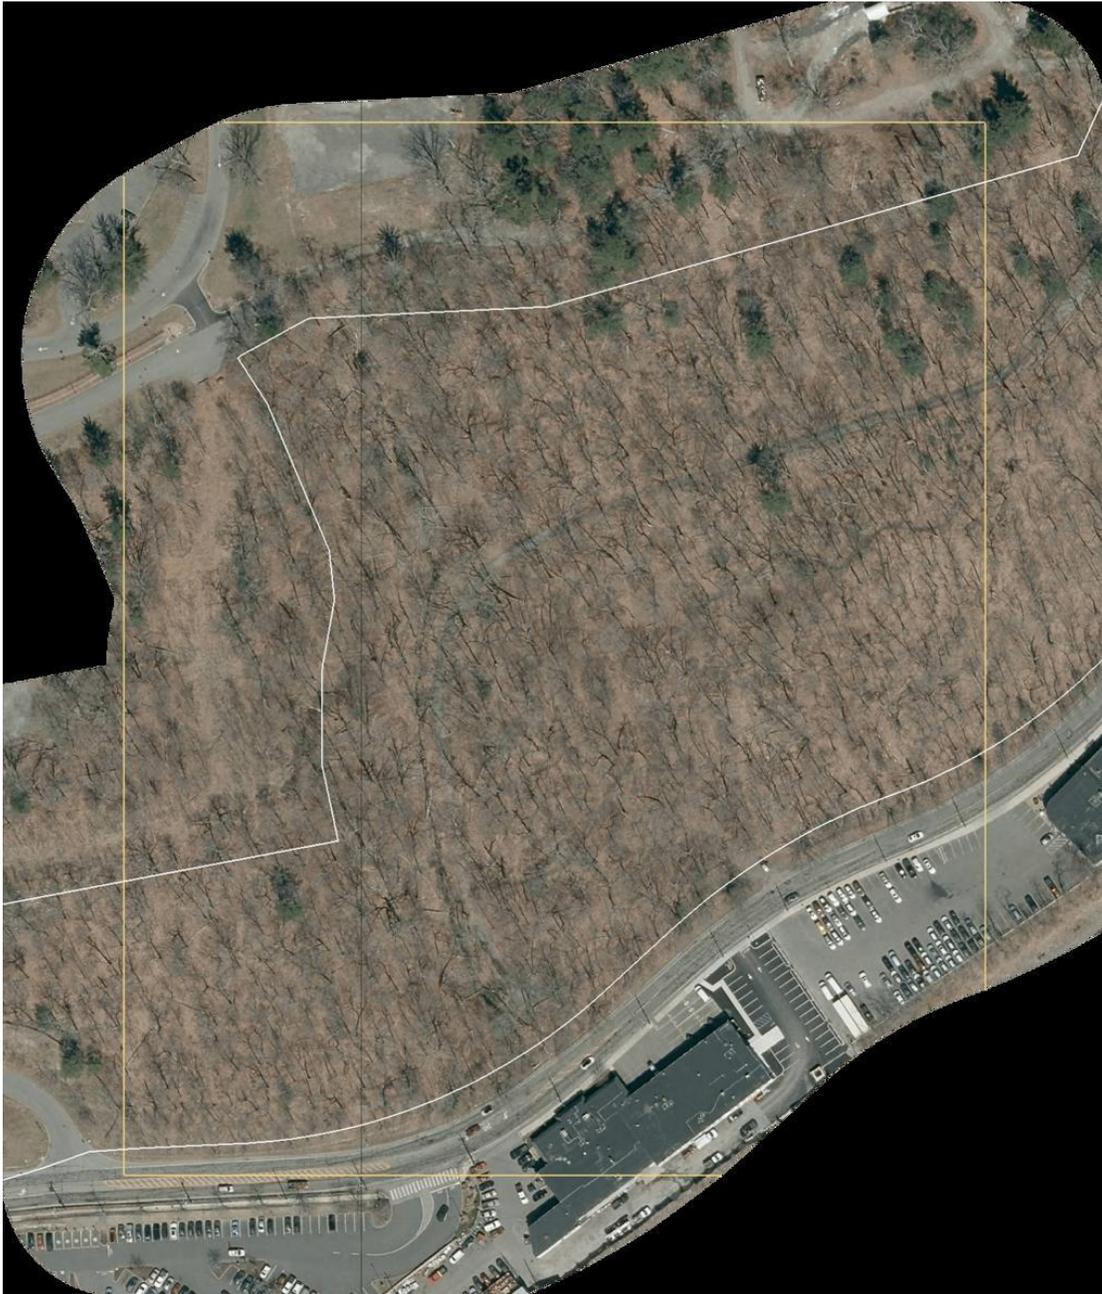
R2 -- Central area - No changes noted. -- (Imagery Date: 4/10/2023)
MassGIS Aerial Imagery. Truecolor, high resolution. 2023 Commonwealth of Massachusetts..

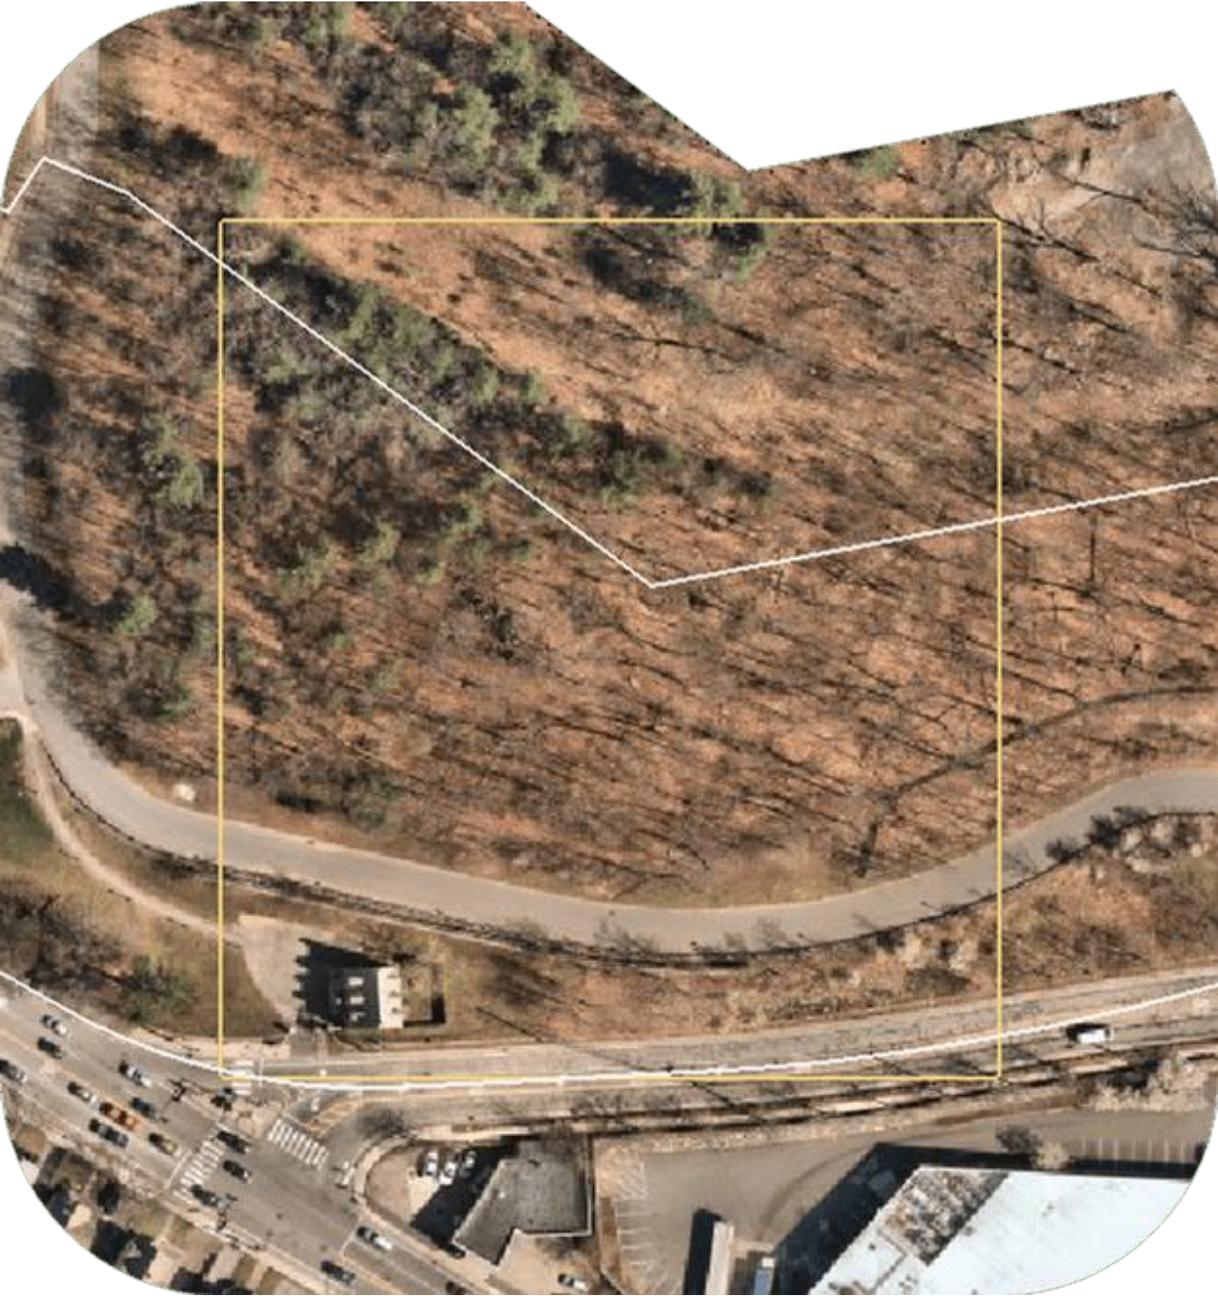
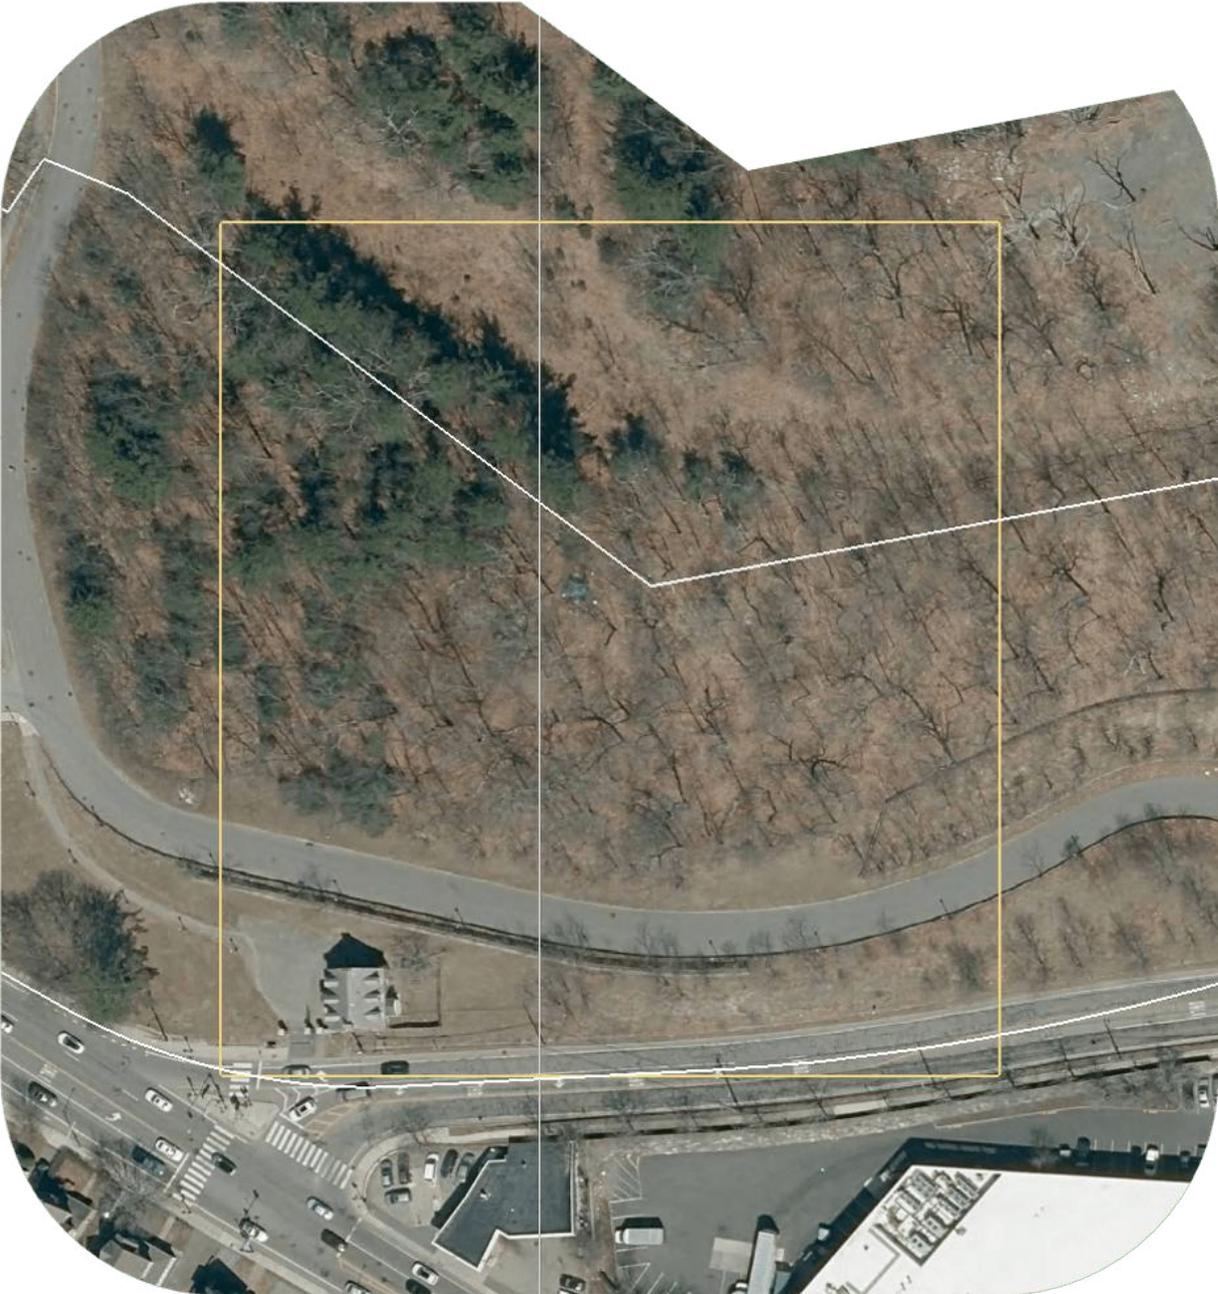
R3 -- Possible Structure - Maybe a tent was placed here sometime between Mar 2021 and Apr 2024, where it now appears to be removed. -- (Imagery Date: 4/9/2024)

R3 -- Possible Structure - Maybe a tent was placed here sometime between Mar 2021 and Apr 2024, where it now appears to be removed. -- (Imagery Date: 4/10/2023)

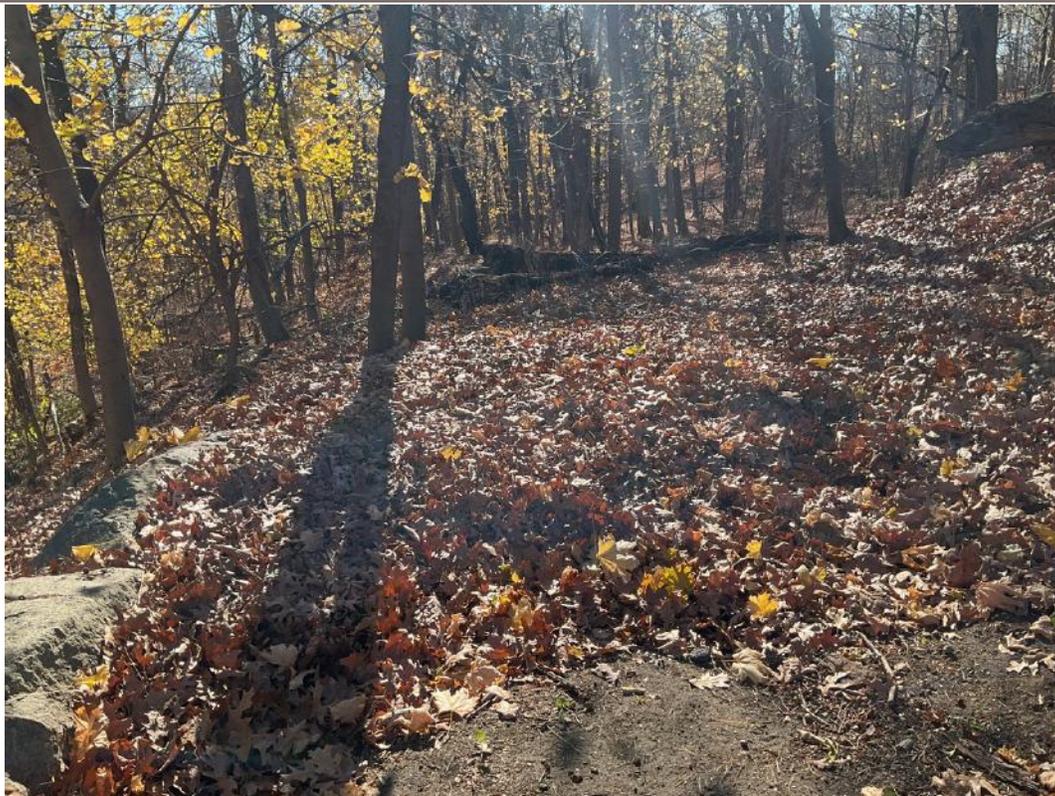
Photopoint 1--Leaves blown onto CR. 3' high piles

- a) Continued erosion of the coal road. This runoff is impacting the vegetation in that vicinity.
- b) Encroachment along the CR boundary line.
- c) Fill and leaves being dumped over the CR line. This destroys the native vegetation and allows for introduction of non-native invasive plants.

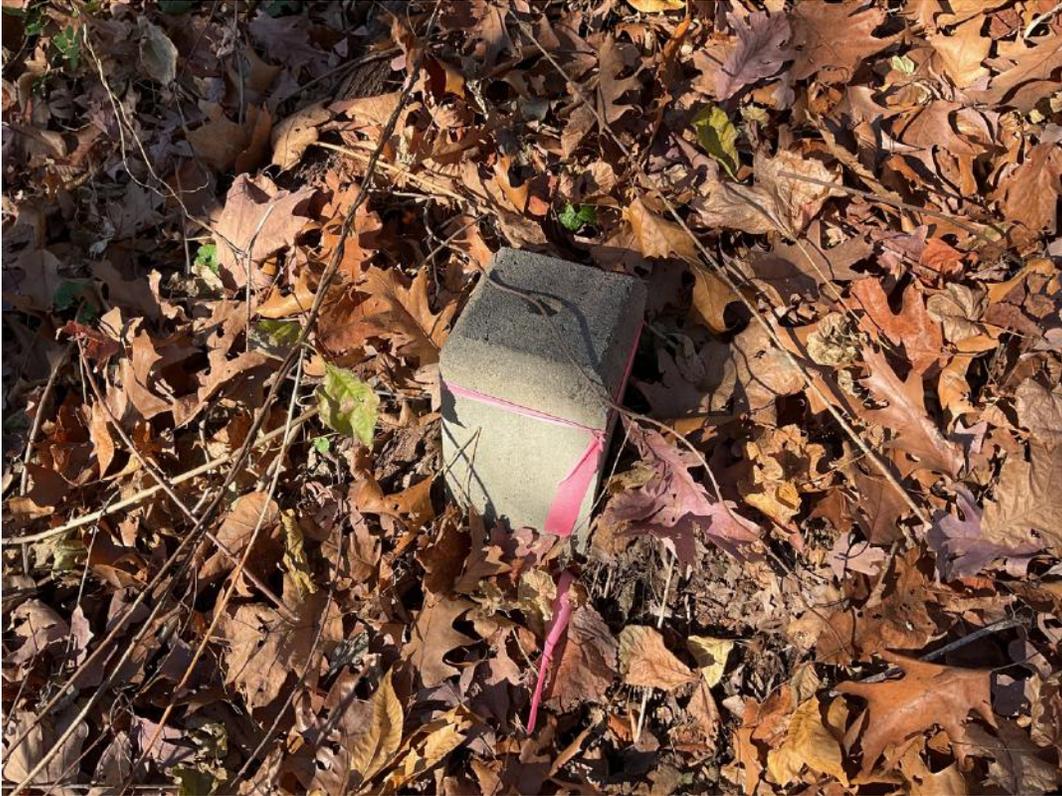
Photopoint 2--CR boundary monument

2) Boundary Monuments along CR boundary at Zone 3/4 and Vehicle Access Easement interface should be set prior to any development.

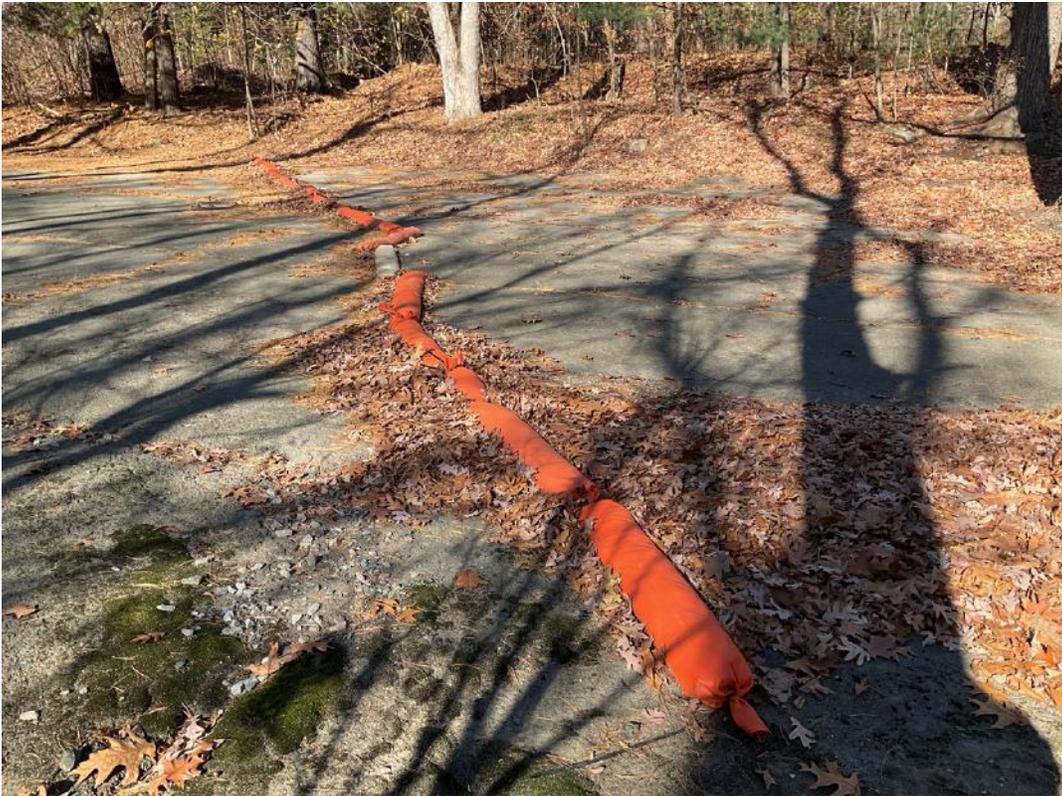
Photopoint 3--Attempting to direct water into trench and not down coal road

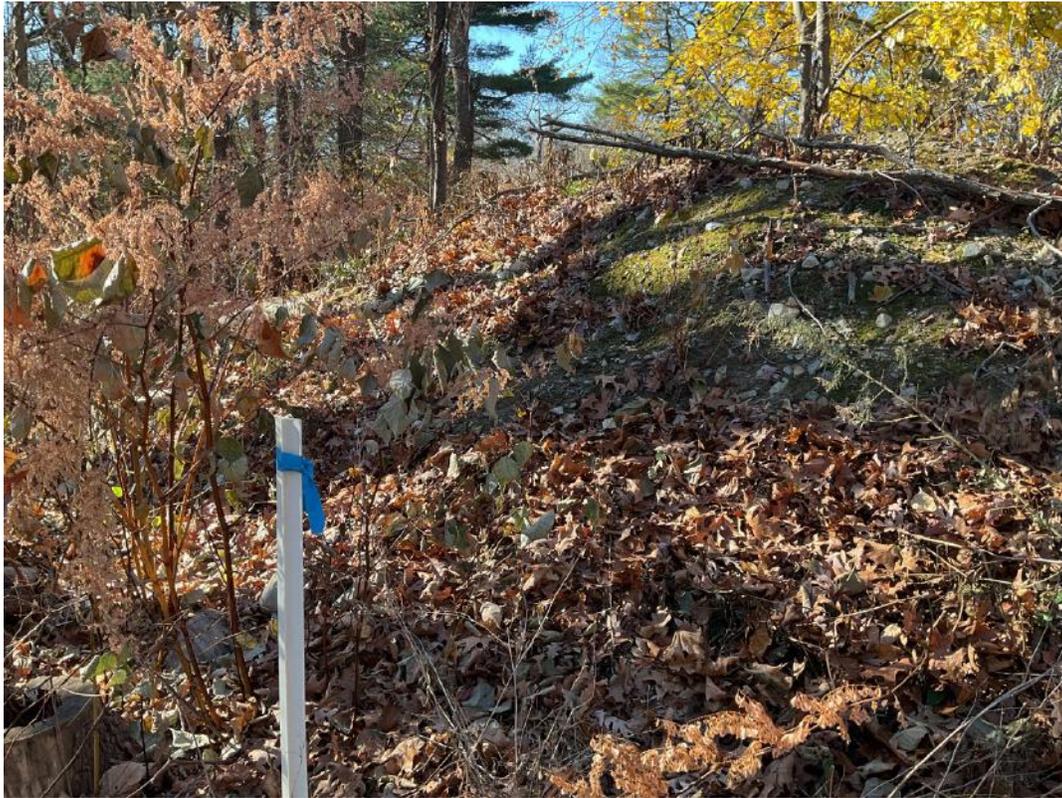
Did you observe any natural disturbances on the property?	Yes
...	Invasive Japanese Knotweed invading where fill was dumped over CR boundary line at Photopoint 4.
Did you observe or learn of any boundaries in need of posting or delineation?	Yes
...	Monuments should be found and/or installed along CR boundary and Zone 3 and Zone 4 to prevent any future. CR signs and posts should be placed along this line as well. If these Zones are being developed, then this should be required as an initial part of the project.
Did you observe (or see sign of) any notable flora or fauna?	No

Photopoint 4--8' high pile of loam up to CR line - CR sign post seemed to work.
(42.39265, -71.18625--Taken by:Tom Dodd--Facing:WSW--File:McLean-Open Space (#237.00) 2024-11-19 04.jpg)

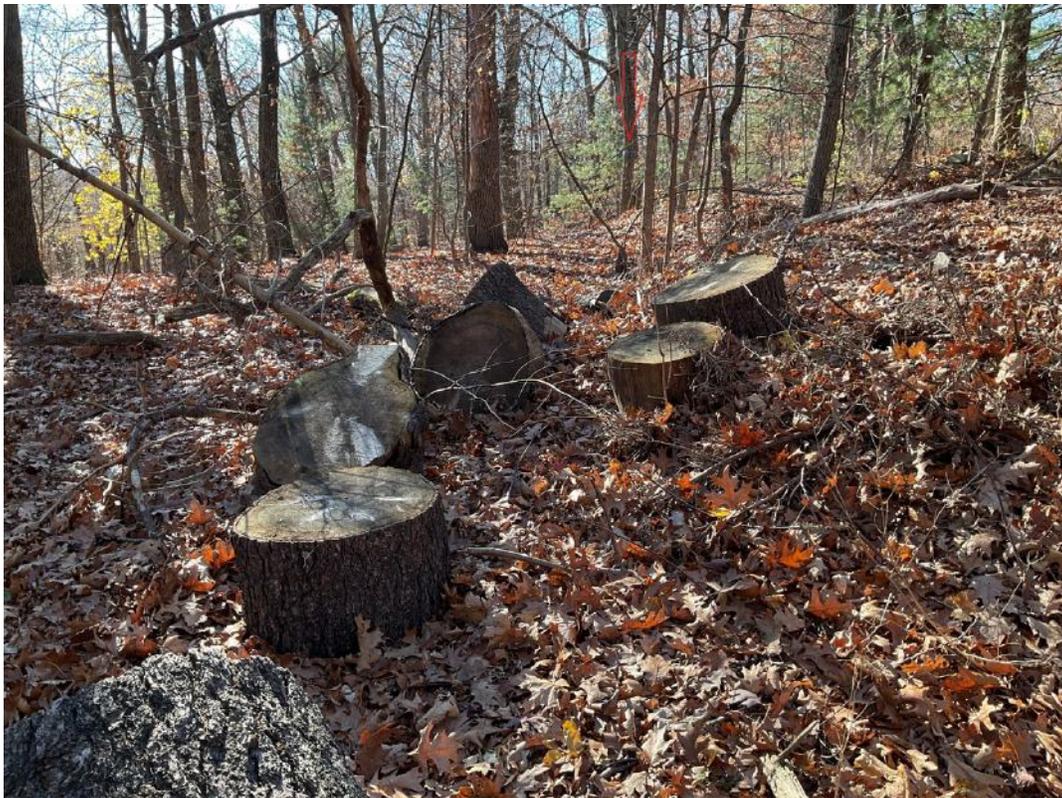
Photopoint 5--Cut tree trunks just over line. Standing on CR line. Blue flagging on CR line in distance
(42.39254, -71.18631--Taken by:Tom Dodd--Facing:SW--File:McLean-Open Space (#237.00) 2024-11-19 05.jpg.jpg)

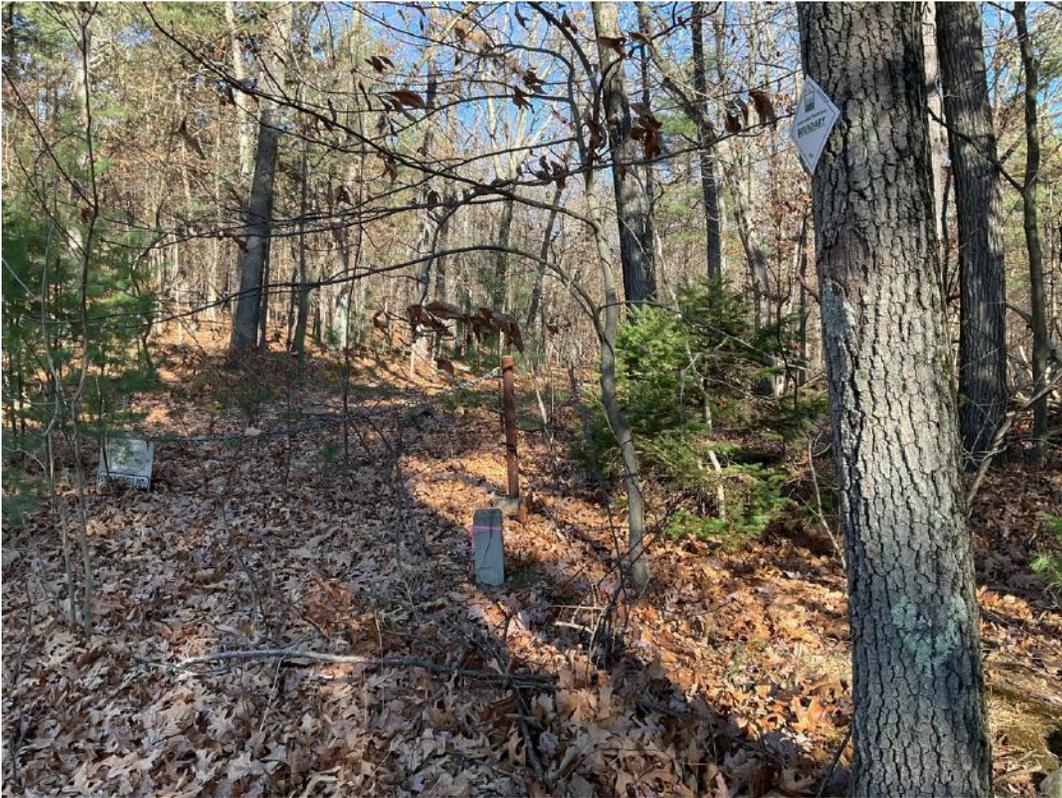
Photopoint 6--CR Boundary monument

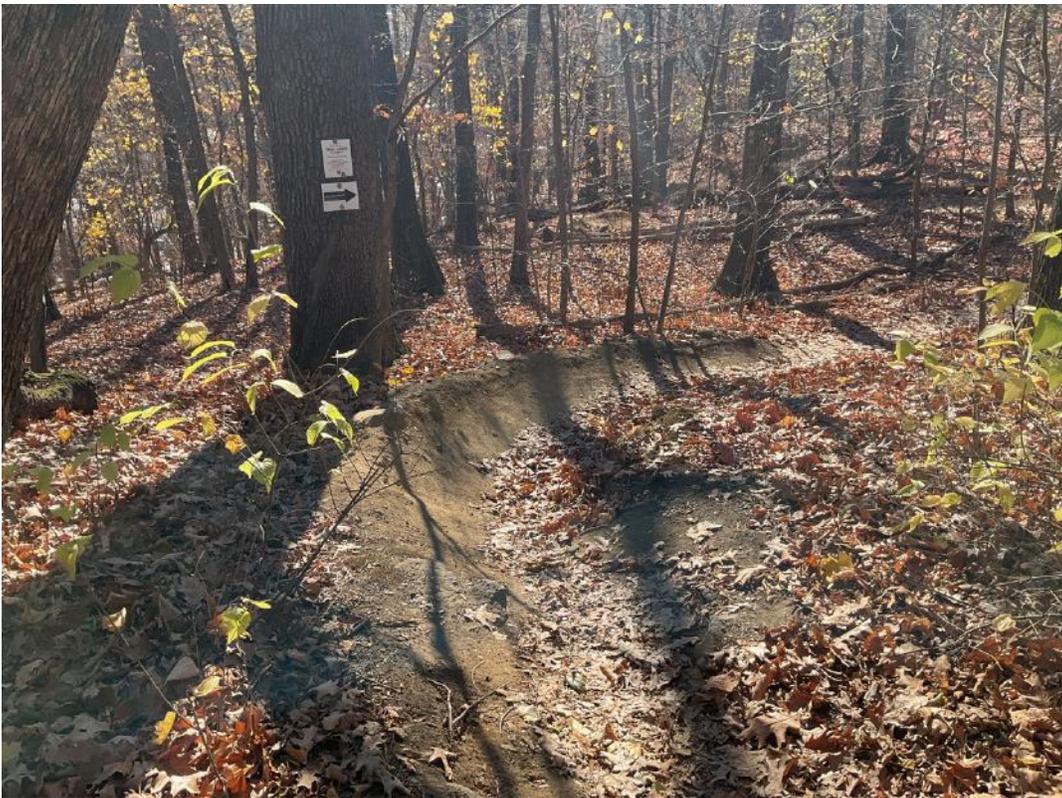
Photopoint 7--Mountain bikers built banked curve without permission

1) Non-permitted mountain bike changes along Hillside Trail should be restored - removal of banked curves, and jumps. The TrailForks app has a September 13, 2024 Log entry for Hillside Trail that states " (Trail) closed right now for new features" that was posted by "SizeableSender". I want to state that I believe NEMBA has a good reputation and that this was not of their doing. Given that, it would be great to have something like the following:

- a) Lone Tree Hill / NEMBA schedule a trail work day to restore this trail.
- b) The event could be publicized on NEMBA, Trail Forks, and Lone Tree Hill web sites (with before/during restoration/after photos) as non-permitted unauthorized activity that was restored by NEMBA members and Lone Tree Hill volunteers.
- c) Adding an entry in Trail Forks App - Hillside Trail - that these unauthorized trail features have been removed by NEMBA and Lone Tree Hill volunteers.

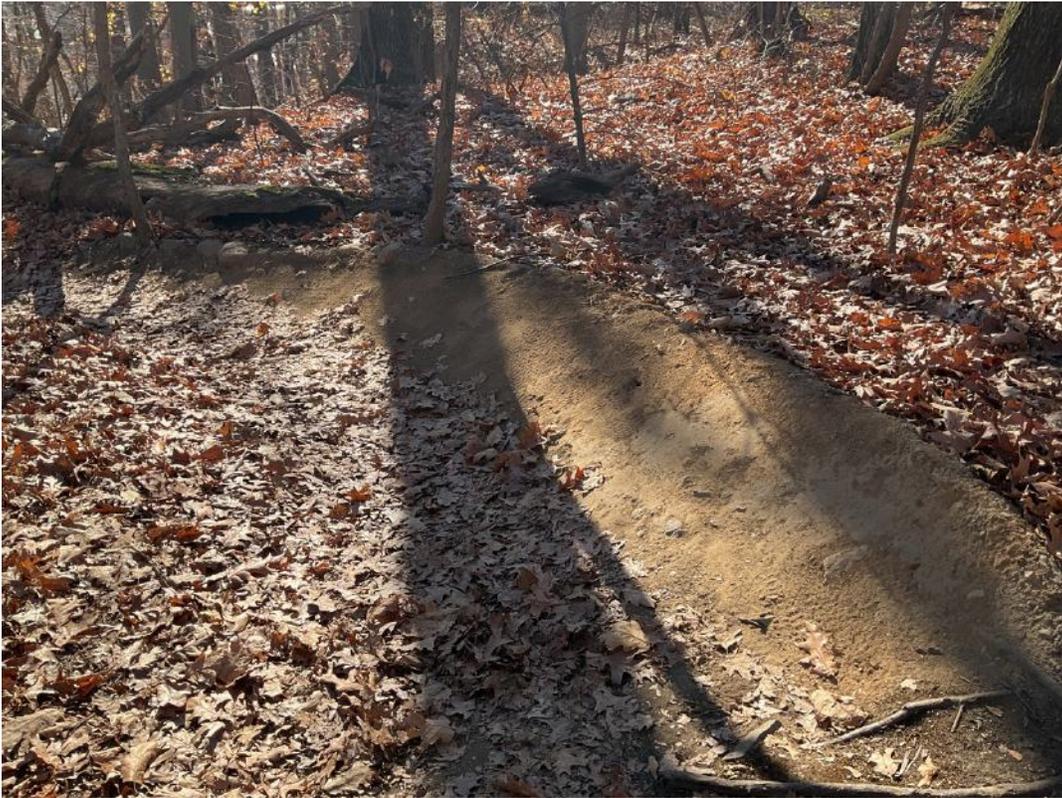
Photopoint 8--Banked curve

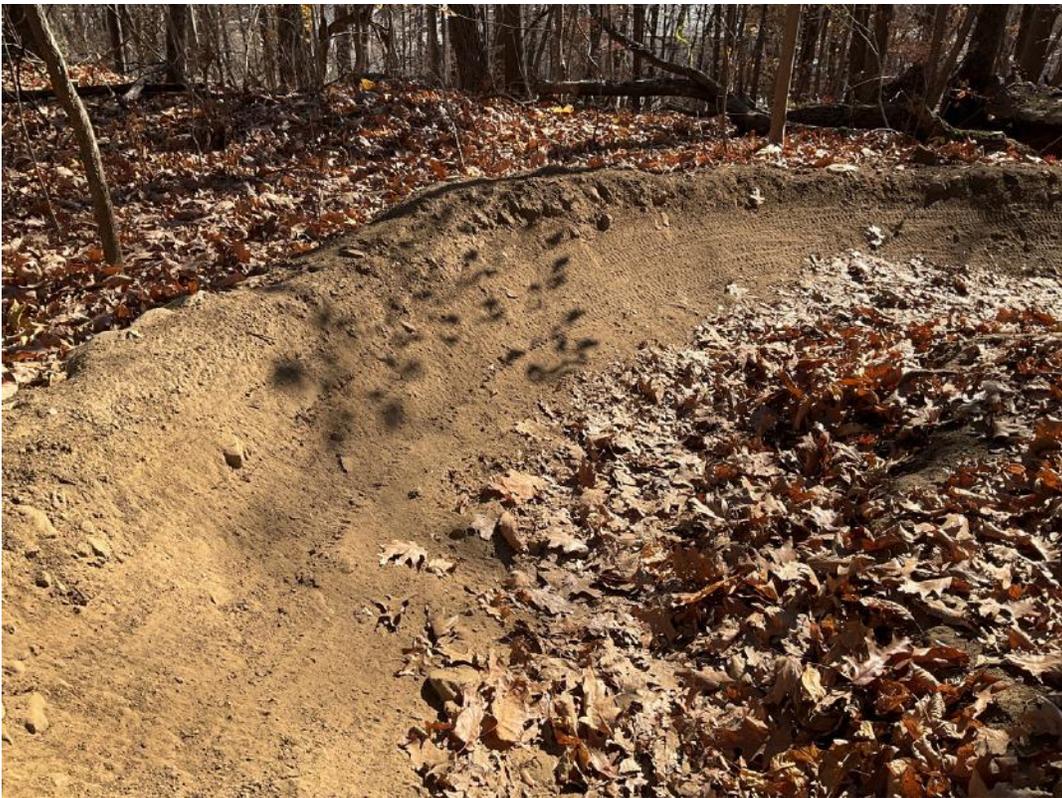
Photopoint 9--Banked curve

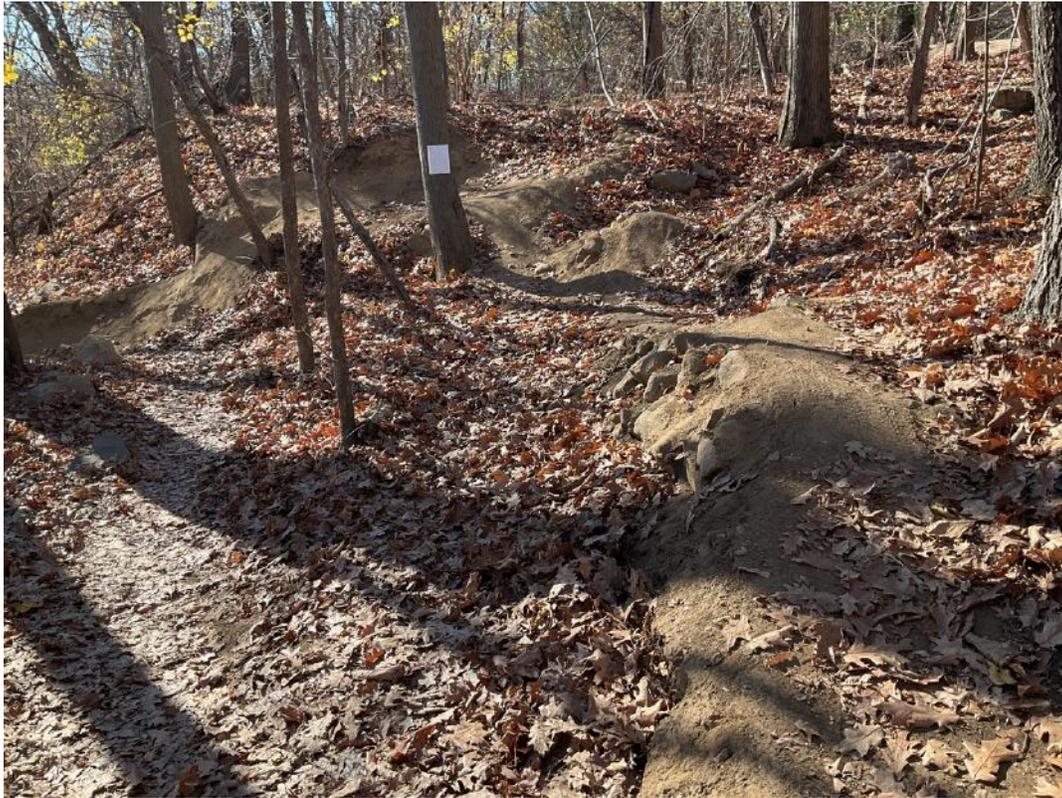
Photopoint 10--Built bike moguls and banked curves

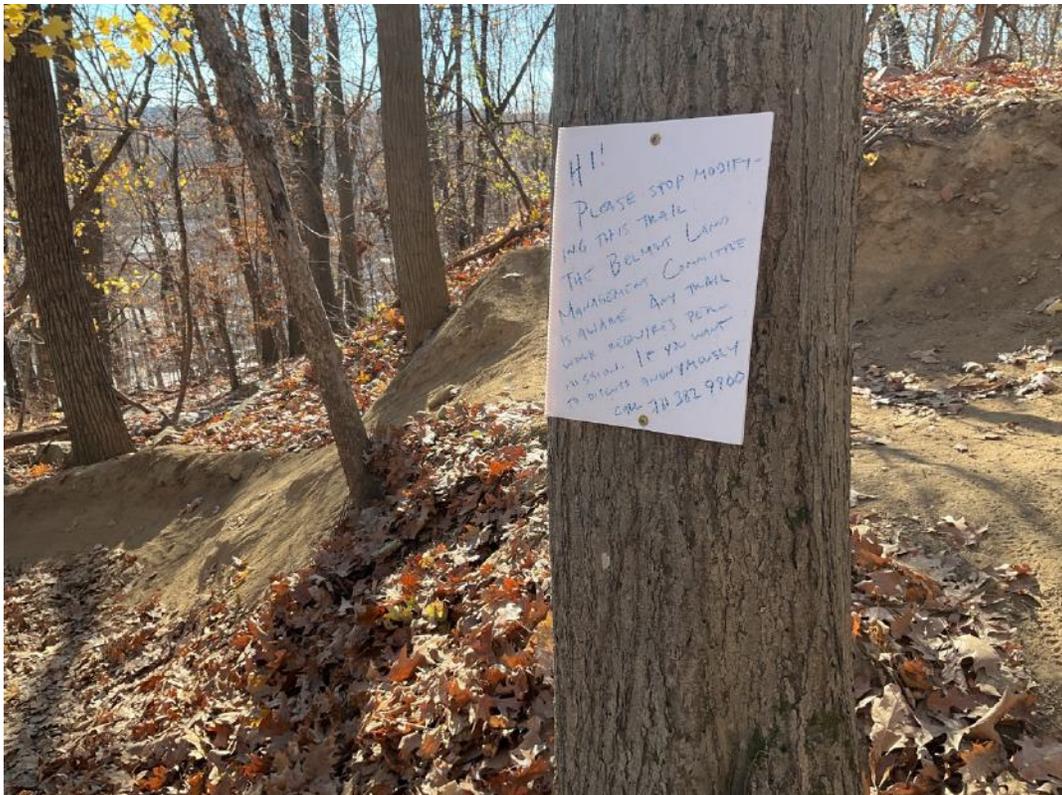
Photopoint 11--Sign indicates trail built without permission

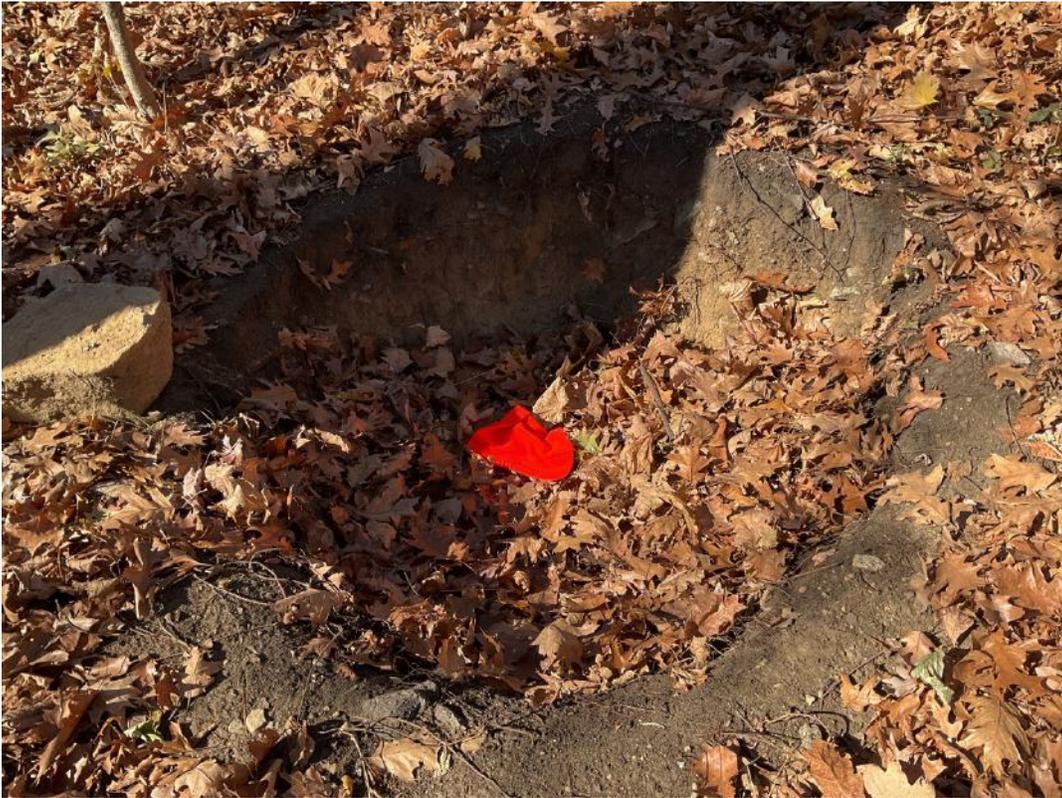
Photopoint 12--3' deep hole used for banked curve material

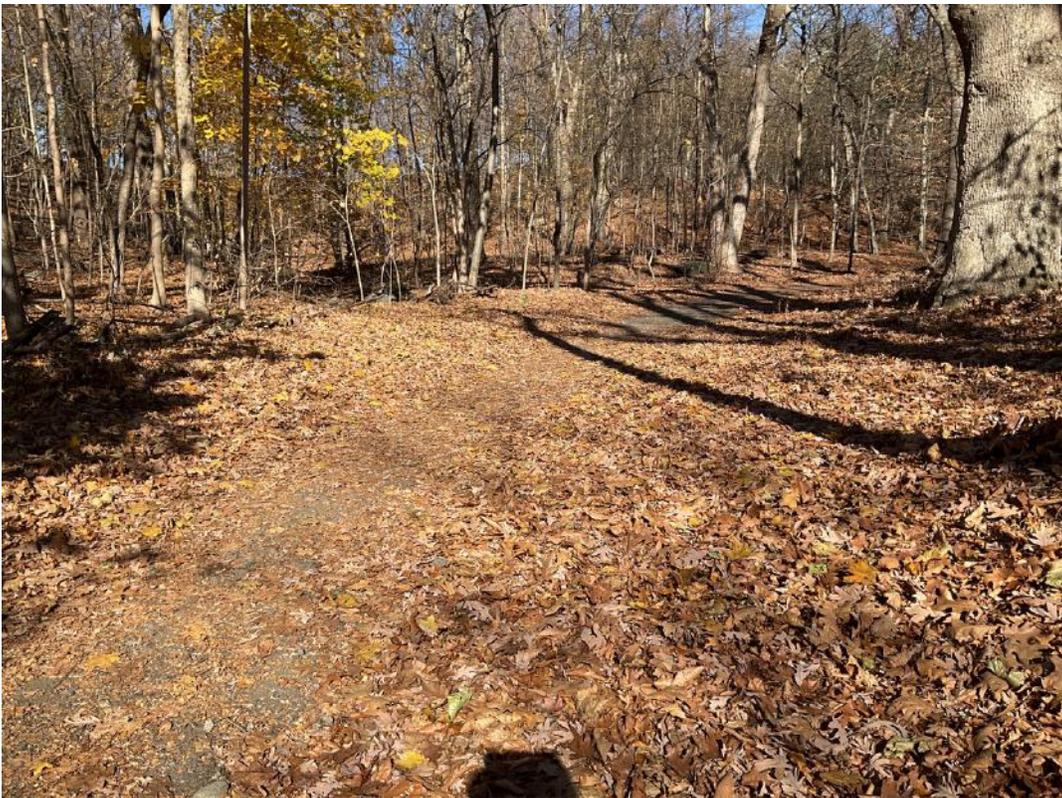
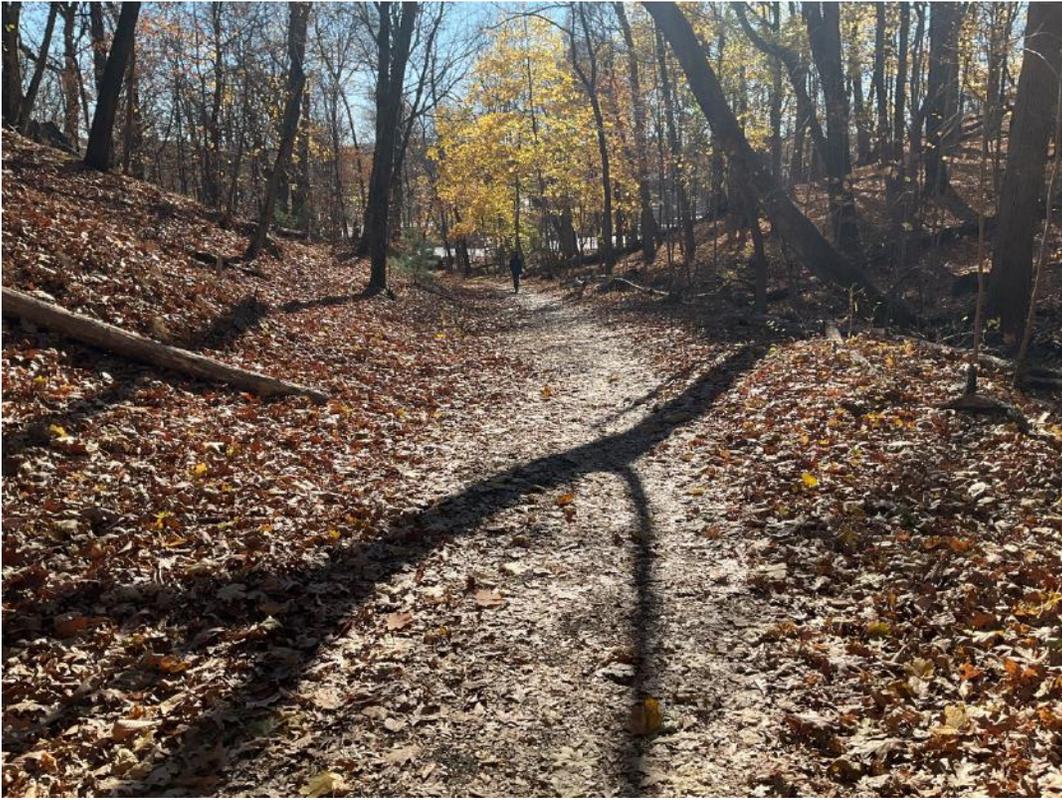
Photopoint 13--Coal road view

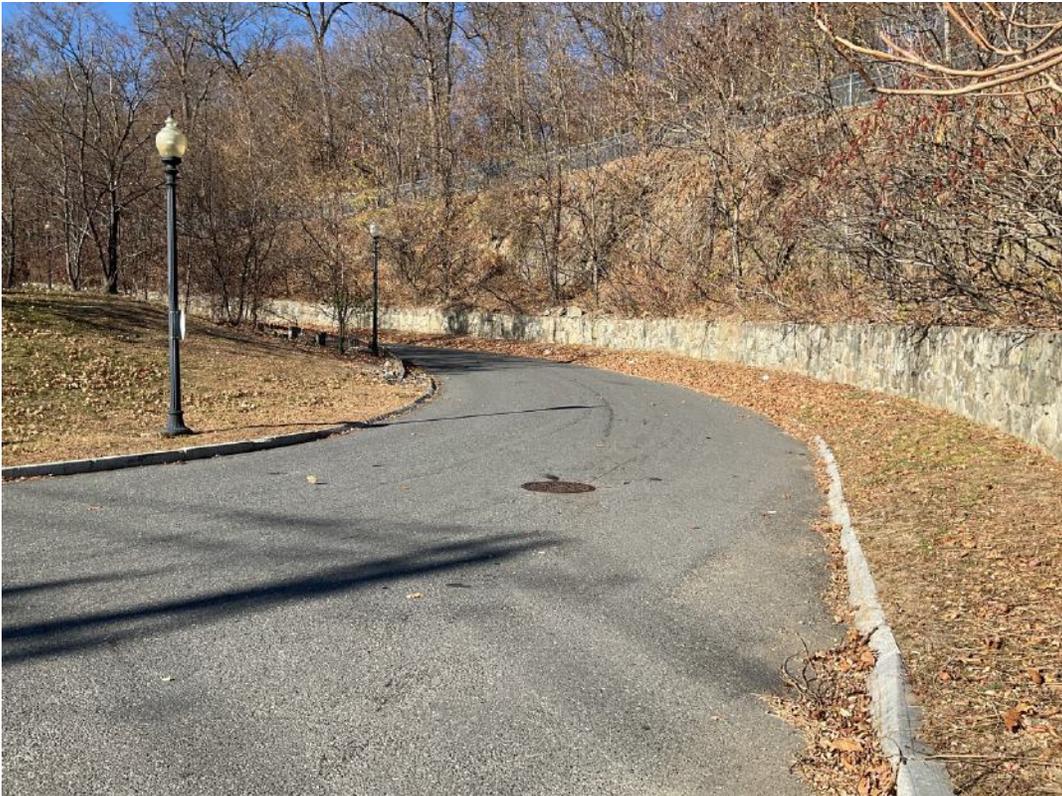
Photopoint 14--Olmsted Drive Entry (Vehicle Access Easement)

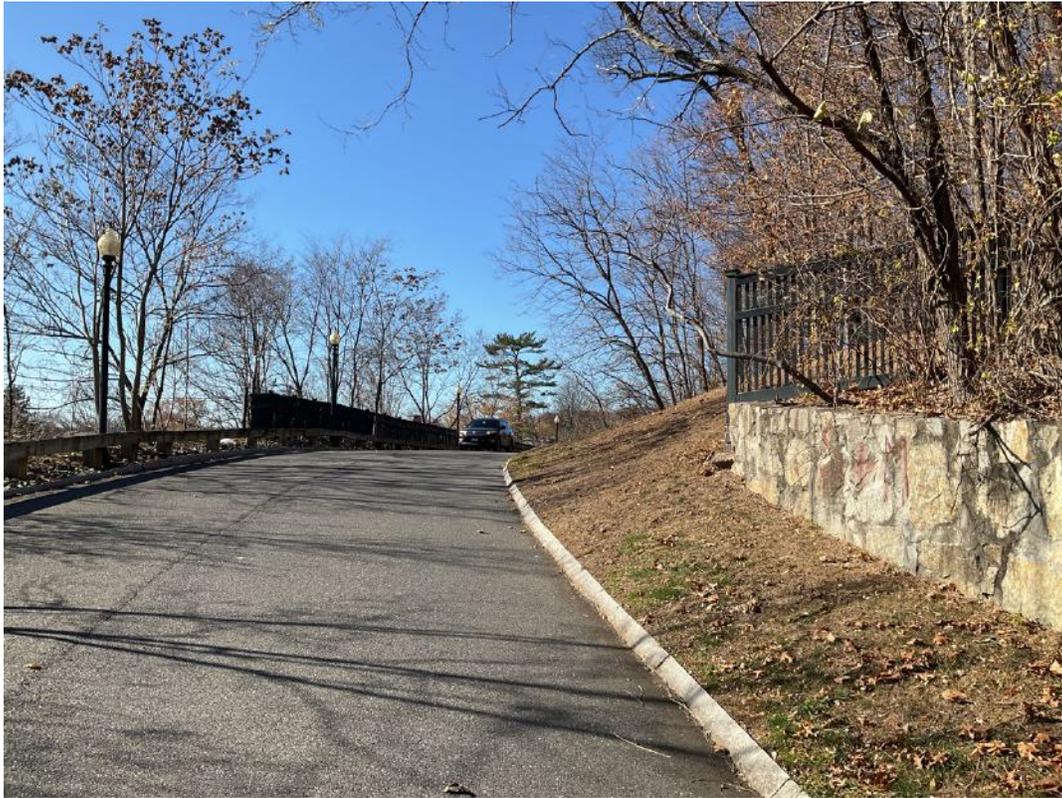
Photopoint 15--End of safety fence along Olmsted Drive (Vehicle Access Easement)
(42.38923, -71.19132--Taken by:Tom Dodd--Facing:W--File:McLean-Open Space (#237.00) 2024-11-19 16.jpg)
