LAND CONSERVATION & STEWARDSHIP

2024 Annual Monitoring Report

237.00--McLean-Open Space

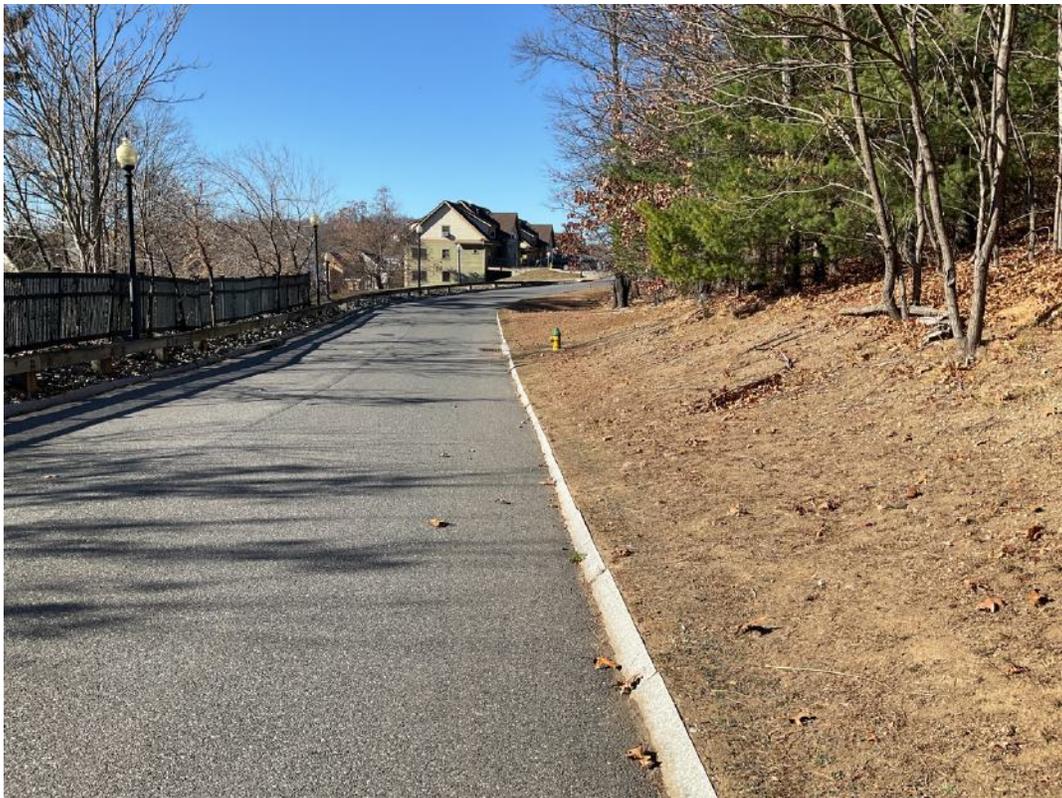
Photopoint 16--View along Olmsted Drive (Vehicle Access Easement)
(42.38923, -71.19222--Taken by:Tom Dodd--Facing:WNW--File:McLean-Open Space (#237.00) 2024-11-19 17.jpg)

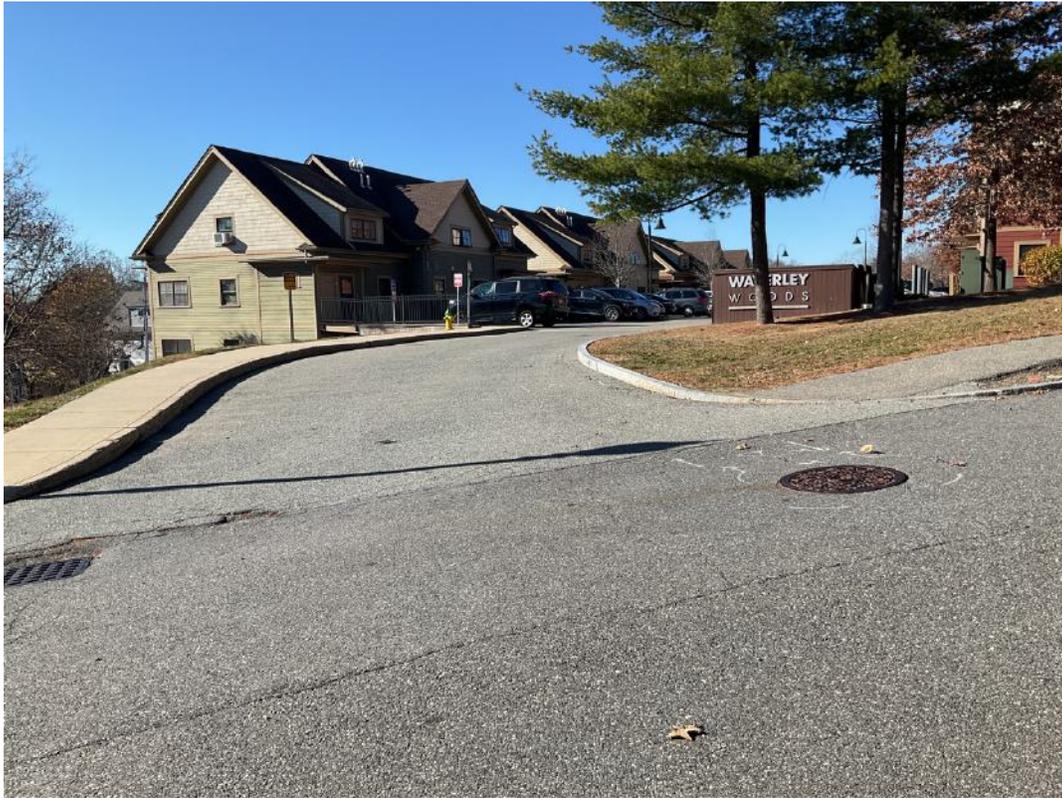
Photopoint 17--Olmsted Drive - Housing access (Vehicle Access Easement)
(42.38954, -71.19307--Taken by:Tom Dodd--Facing:WNW--File:McLean-Open Space (#237.00) 2024-11-19 18.jpg)

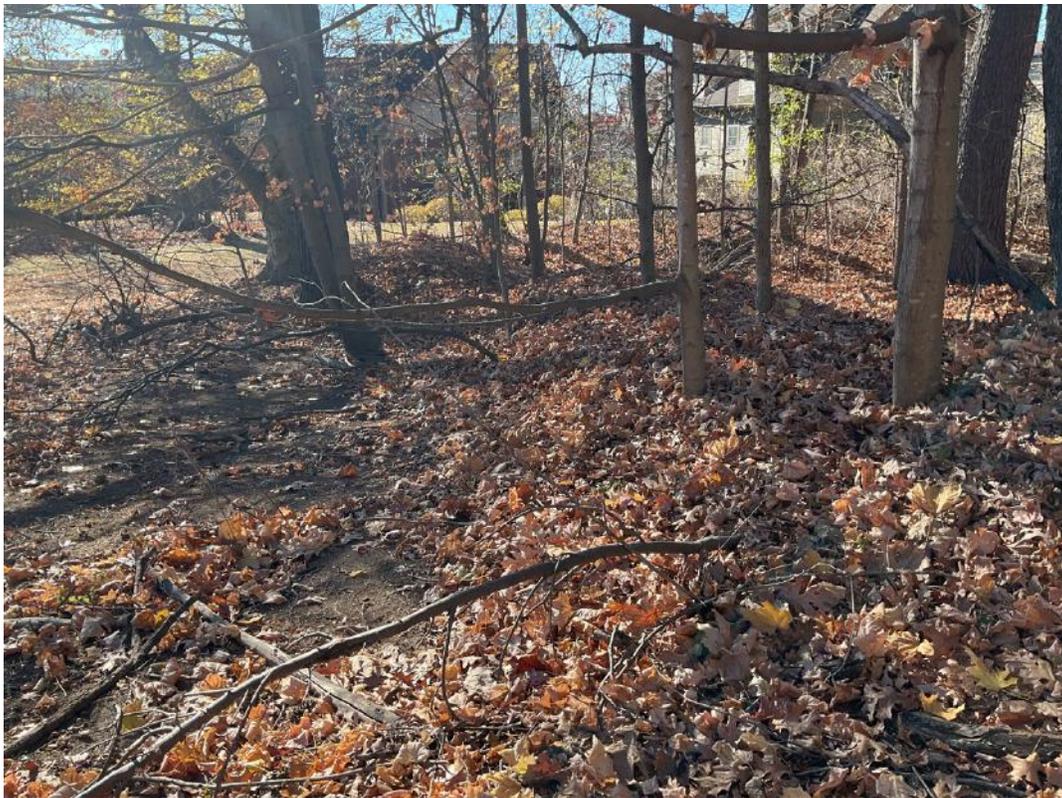
Photopoint 18--Leaves blown onto CR - 3' high, 40' long approximately
(42.39022, -71.19332--Taken by:Tom Dodd--Facing:WSW--File:McLean-Open Space (#237.00) 2024-11-19 19.jpg)

- a) Continued erosion of the coal road. This runoff is impacting the vegetation in that vicinity.
- b) Encroachment along the CR boundary line.
- c) Fill and leaves being dumped over the CR line. This destroys the native vegetation and allows for introduction of non-native invasive plants.

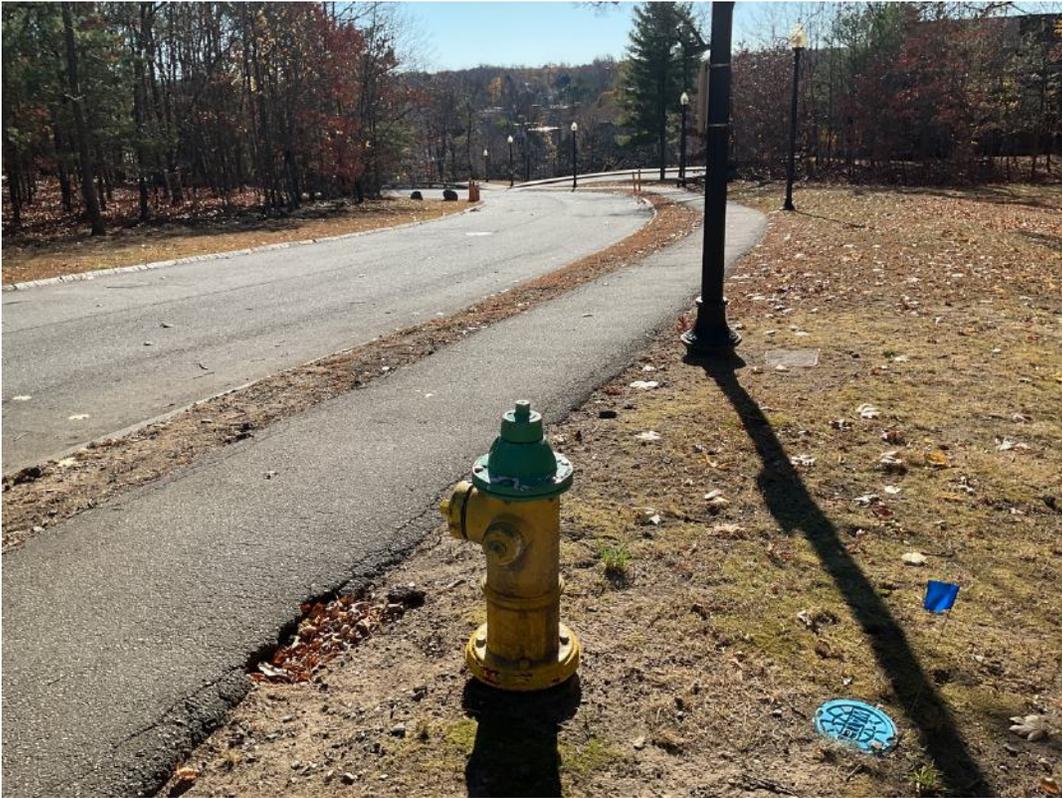
Photopoint 19--Olmsted Drive (Vehicle Access Easement)

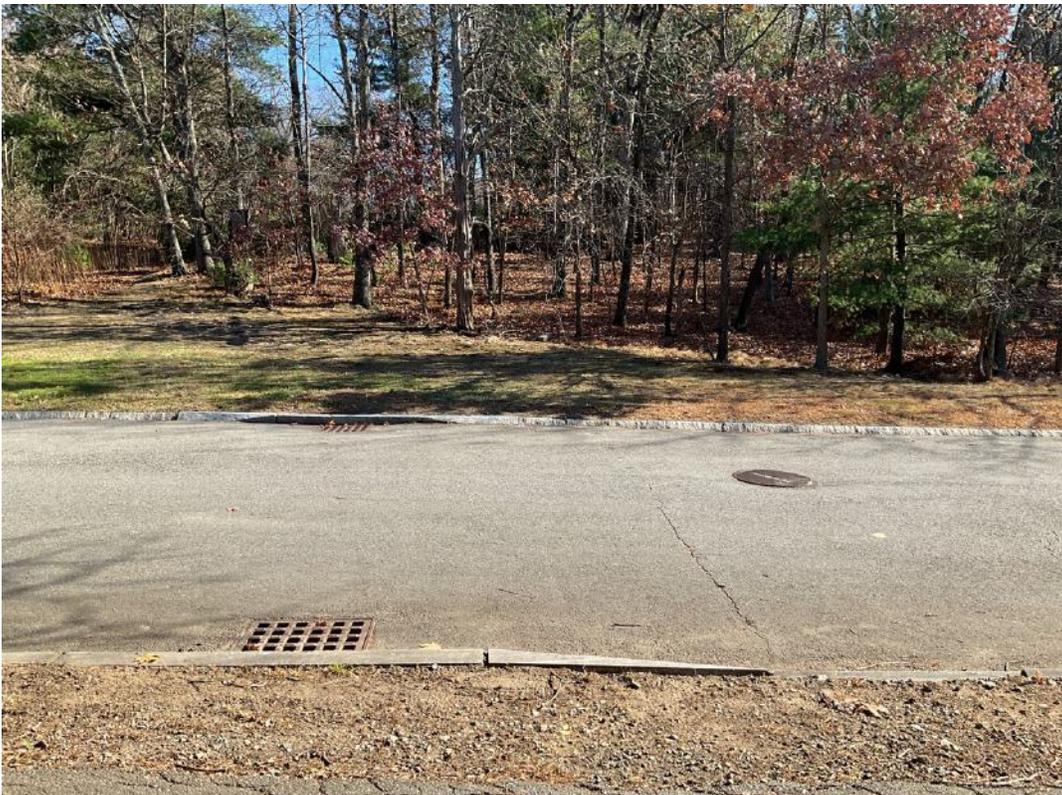
Photopoint 19--Olmsted Drive (Vehicle Access Easement)

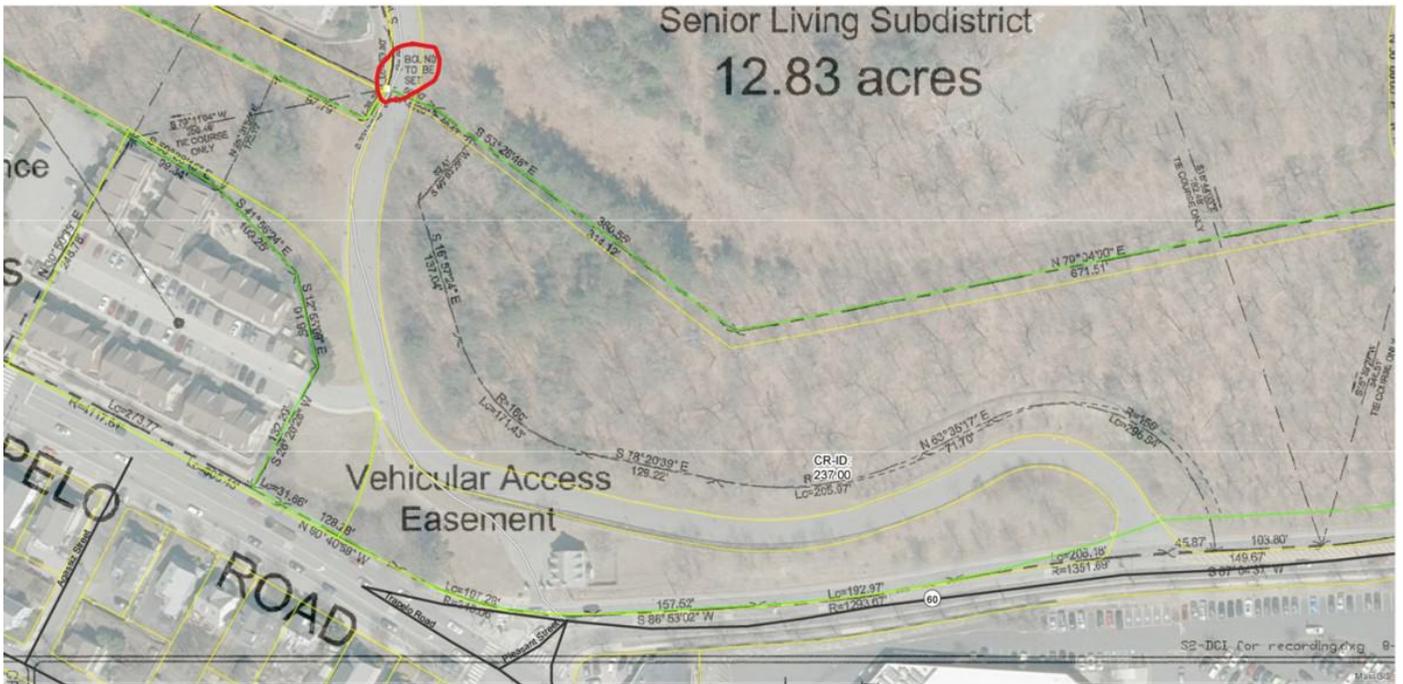
Photopoint 19--Vehicle Access Easement - Note that a bound was to be set (in red circle). This should be verified and if not set, then needs to be set. See Plan Book 2005, Plan 126.

2) Boundary Monuments along CR boundary at Zone 3/4 and Vehicle Access Easement interface should be set prior to any development.
