# FORM B – BUILDING

**Address:** 560 Concord Avenue

**Historic Name:** William E. Stowe House

**Recorded by:** Lisa Mausolf

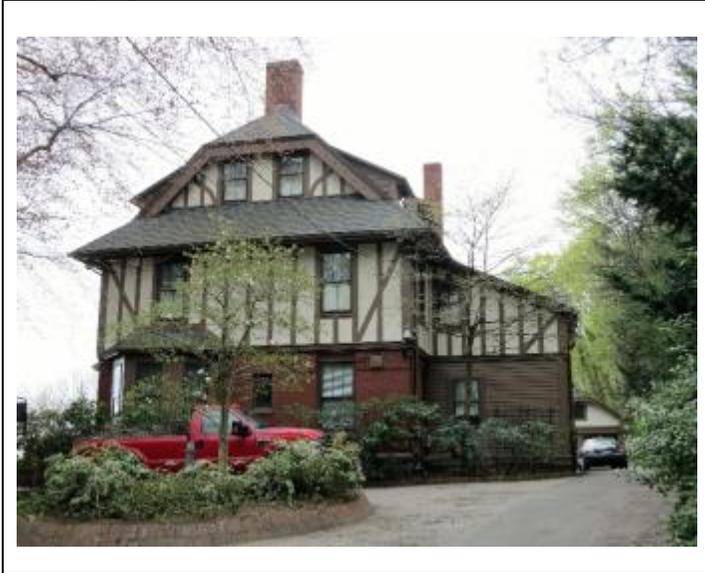
## Photograph

The Stowe House is significant as an excellent example of the Stick Style and the only example of the style that remains extant on Belmont Hill. The contrasting materials include a brick and clapboarded first floor and stuccoed second and third stories with an overlay of vertical, horizontal and diagonal stickwork. The steeply pitched roof is punctuated by brick chimneys, shingled shed dormers and gables – both conventional and clipped. Additional decorative elements include bay windows, porches, overstated brackets and a perforated bargeboard on the north façade. Windows contain double-hung 6/2 sash. The two-story ca. 1925 addition to the south of the original house includes half timbering with more of a Tudor style. The bay windows on the east elevation were added in the 1950s. Originally a single-story porch spanned the east elevation.
