EXISTING CONDITIONS SUMMARY

Belmont High School

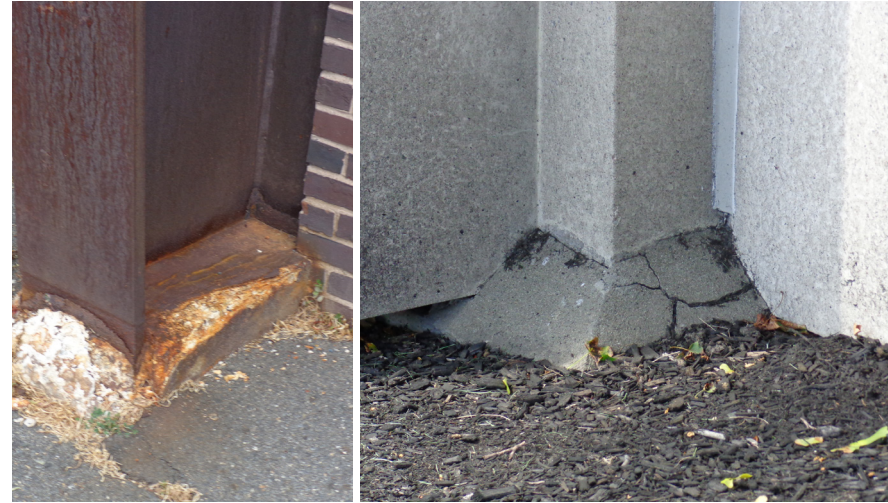
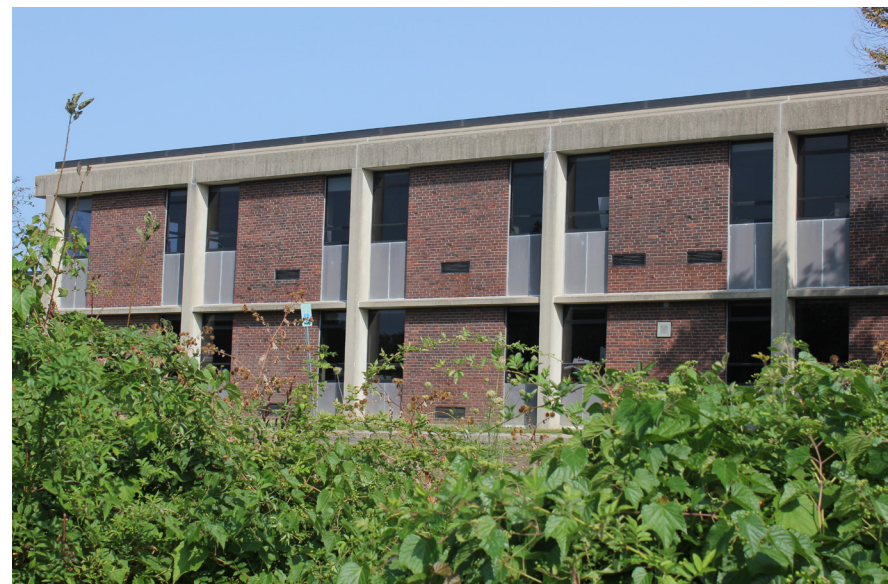
Vertical additions may not be feasible, due to limited capacity of foundations, columns, and roof structure.

- The existing structure is performing well - Minor cracks in the interior/exterior masonry walls were observed.
- No signs of foundation settlement and no undue vibration from footfall were observed
- Majority of walls do not appear to be structural in nature

- Compliance with International Existing Building Code
- Proposed renovations will trigger an analysis of the existing building and will require the addition of shear walls or braced frames - probably requiring additional piles within the building.
- Grade beams and piles will be required for phased and partial demolition to support the new exterior walls.
- Renovations will require trenching of existing slabs - not easy to trench under supported structural slabs
- Proposed additions should be horizontal, separated from the existing structure by expansion joints.

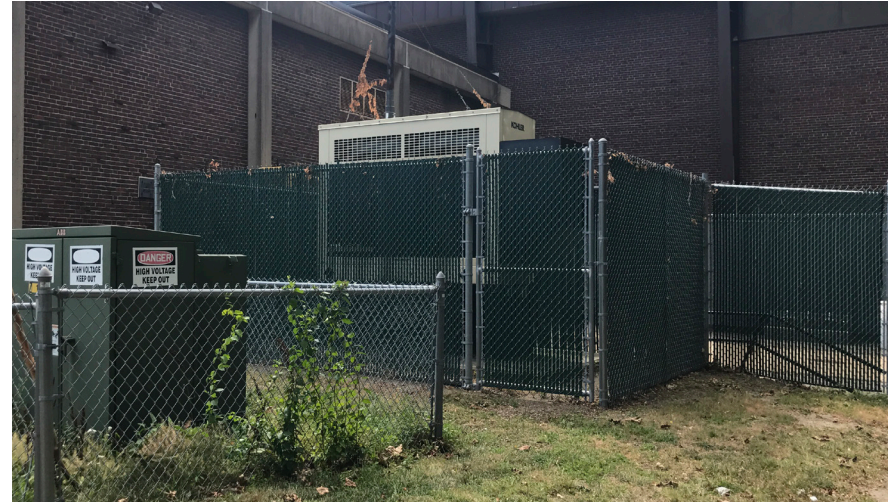
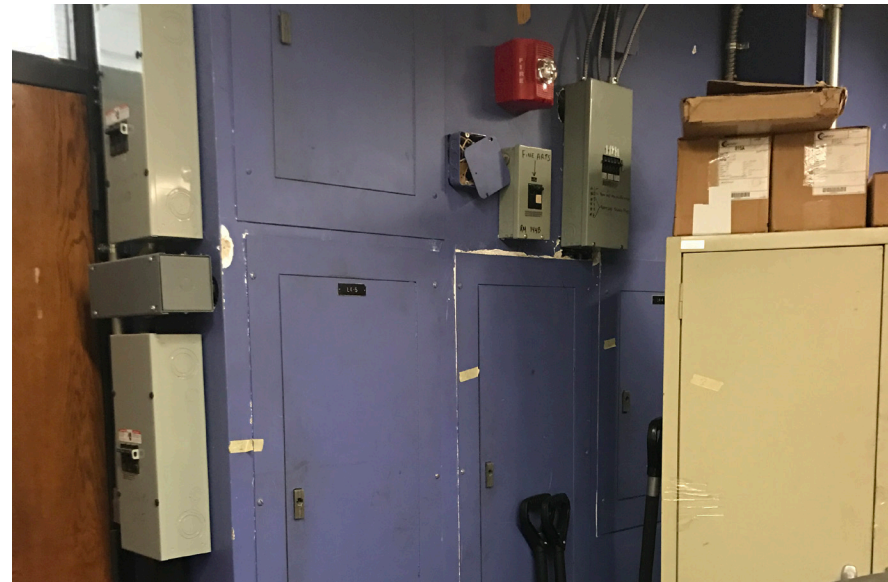
Lighting fixtures are inefficient, controls are antiquated, and space/storage is not adequate for current needs.

- **Original Fixtures:** Fixtures are original to the building in most of the spaces - utilizing fluorescent lamps (inefficient).
- **Controls:** Currently have local line voltage switches, but should have low voltage switches employing dimming, vacancy sensors and day lighting controls.

- **Transformer:** The transformer size and location will need to be addressed with any projected upgrades/additions.
- **Generator:** The generator size offers limited opportunity to add equipment. The existing distribution does not meet today's code required separation of systems.

- **Electrical Closets:** For new/renovated designs, all electrical equipment would be in dedicated electric closets. No equipment in storage closets or other non-dedicated areas.

- **Main Electric Room:** There are current space limitations.
- **Science Room Lighting/Controls:** Original fluorescent lighting and controls (local line voltage switching) are typical for most of the classrooms throughout the building.

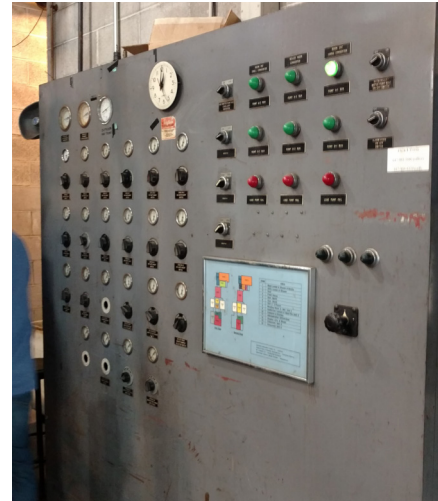
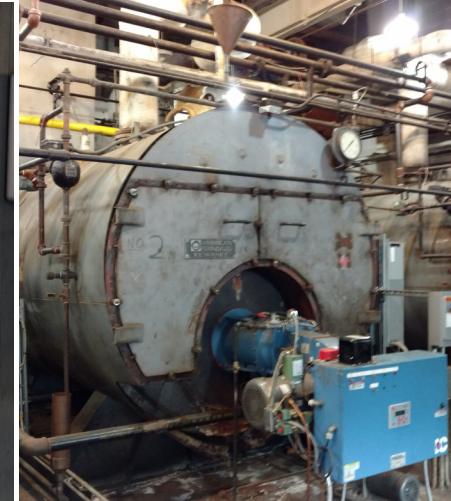
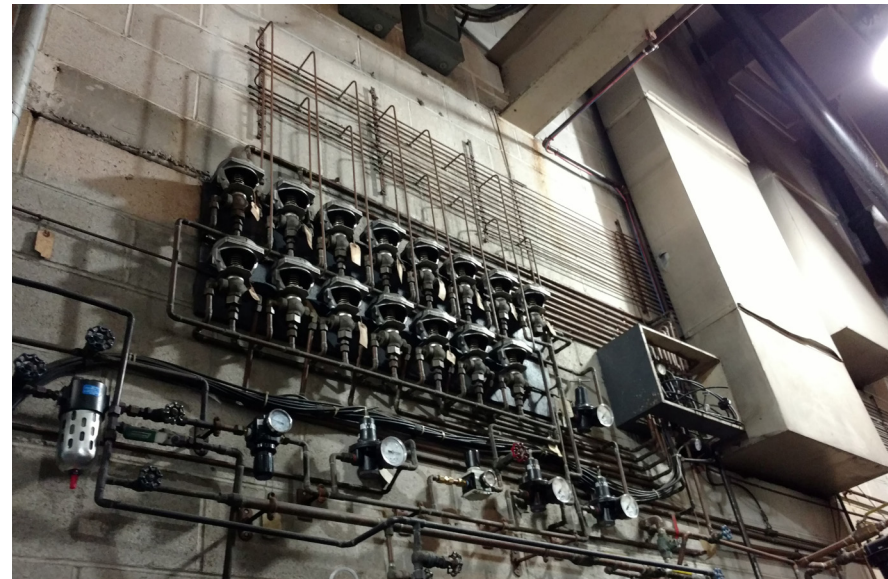
Current mechanical systems are reaching end of life, difficult to repair, and are not positioned to be energy efficient.

- **Steam Boilers:** 47+ year old steam boilers in building.
- **Duel Fuel:** The current burners can burn gas or fuel oil.
- **Boilers:** All boilers have been partially or completely re-tubed several times.

- **Steam System:** Requires maintenance of steam traps, condensate pumps, receiver tanks, control valves.
- **Roof Top Units:** Casings are in good condition, but corrosion around the unit base. There are two vintages of units (same manufacturer), but with differences in technology. Five units have web interfaces. All have steam heating coils.

- **Unit Ventilators:** Provides heating with hot water and outdoor air ventilation through exterior louvers. The casings are in good/fair condition (dented). Pneumatically controlled dampers and valves require a high level of maintenance.

- **Pneumatic Temperature Controls:** Has original copper tubing, some covered in fireproofing - repairing of leaks is difficult. Little to no monitoring capability.

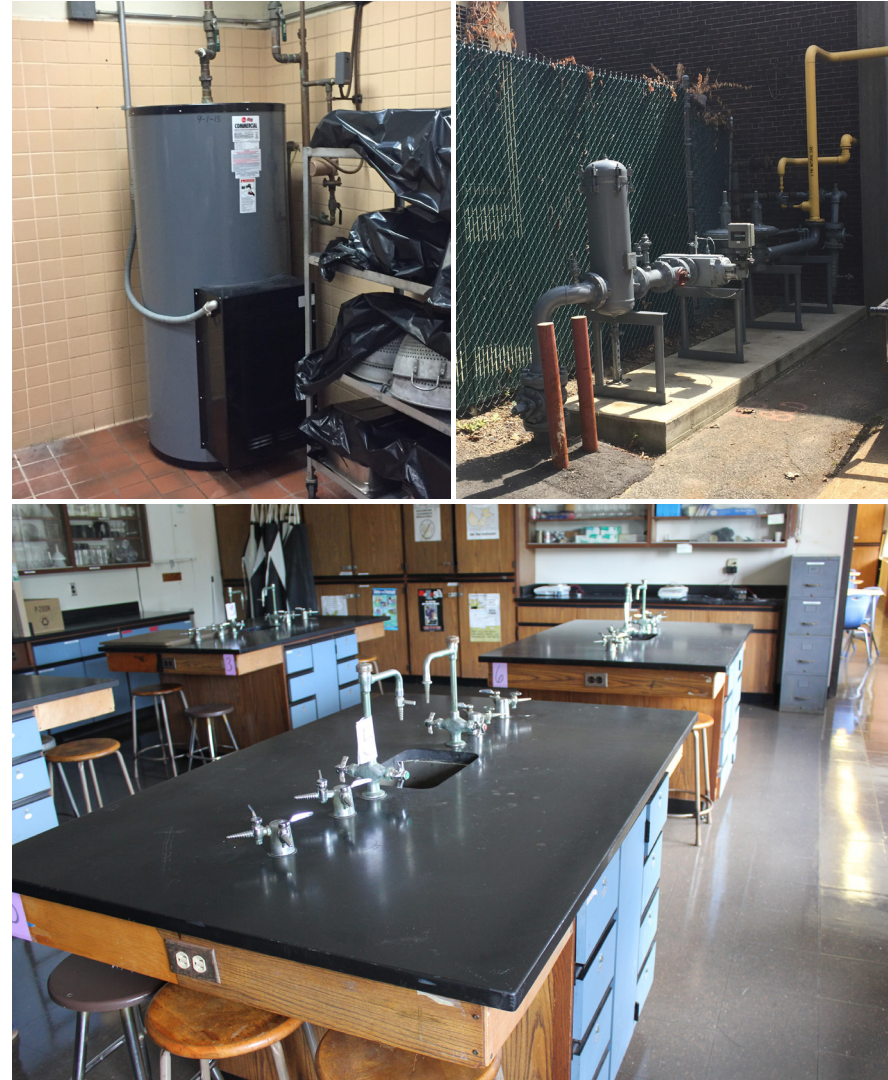
Current plumbing fixtures / systems are antiquated, do not meet current codes, and are not energy efficient.

- **Plumbing Fixtures:** Most fixtures are older models and are not compliant with current codes / does not meet ADA req.
- **Cold Water System:** More than adequate to meet existing / future demands.
- **Hot Water System:** Combination of steam-fired and electric water heaters. A more centralized approach should produce a more energy efficient solution.
- **Sanitary System:** Piping system is visibly in fair condition, but piping serving science labs is not acid-resistant per code. Lab water should be on its own protected system.
- **Storm System:** Existing roof drains and visible piping systems appear in good condition.
- **Natural Gas System:** Existing gas service is more than adequate to meet current needs of school and visible piping systems appear to be in good condition.
- **Kitchen:** Three-compartment sink / associated grease trap not used. No exterior grease trap on site.
