**Illicit Discharge Detection and
Elimination Program**

INVESTIGATION OF THE SPY POND
AND LITTLE POND TRIBUTARY
AREAS

Prepared for:
The Town of Belmont

Prepared by:
Stantec Consulting Services Inc.

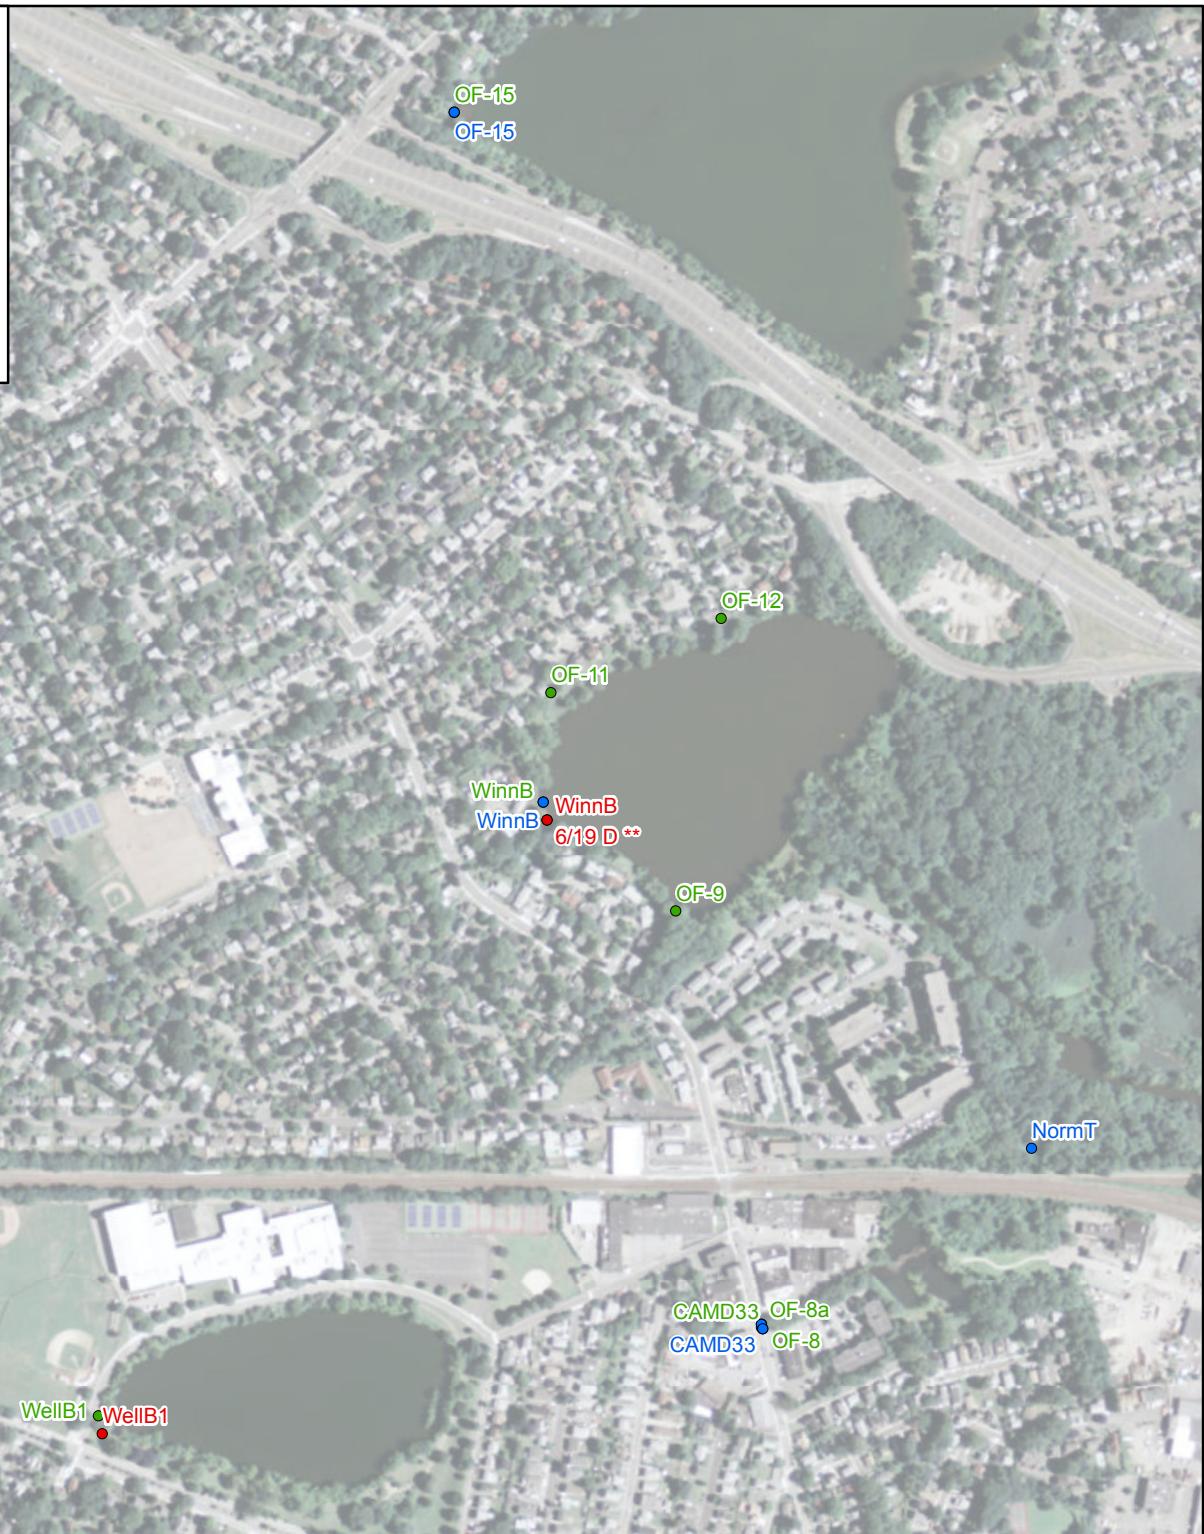
Water Quality Sample Locations

As presented in the Order, from 2012 – 2016 the EPA collected several water quality samples within the Spy Pond and remaining Little Pond tributary areas. The EPA sample results are included for reference in Appendix A.

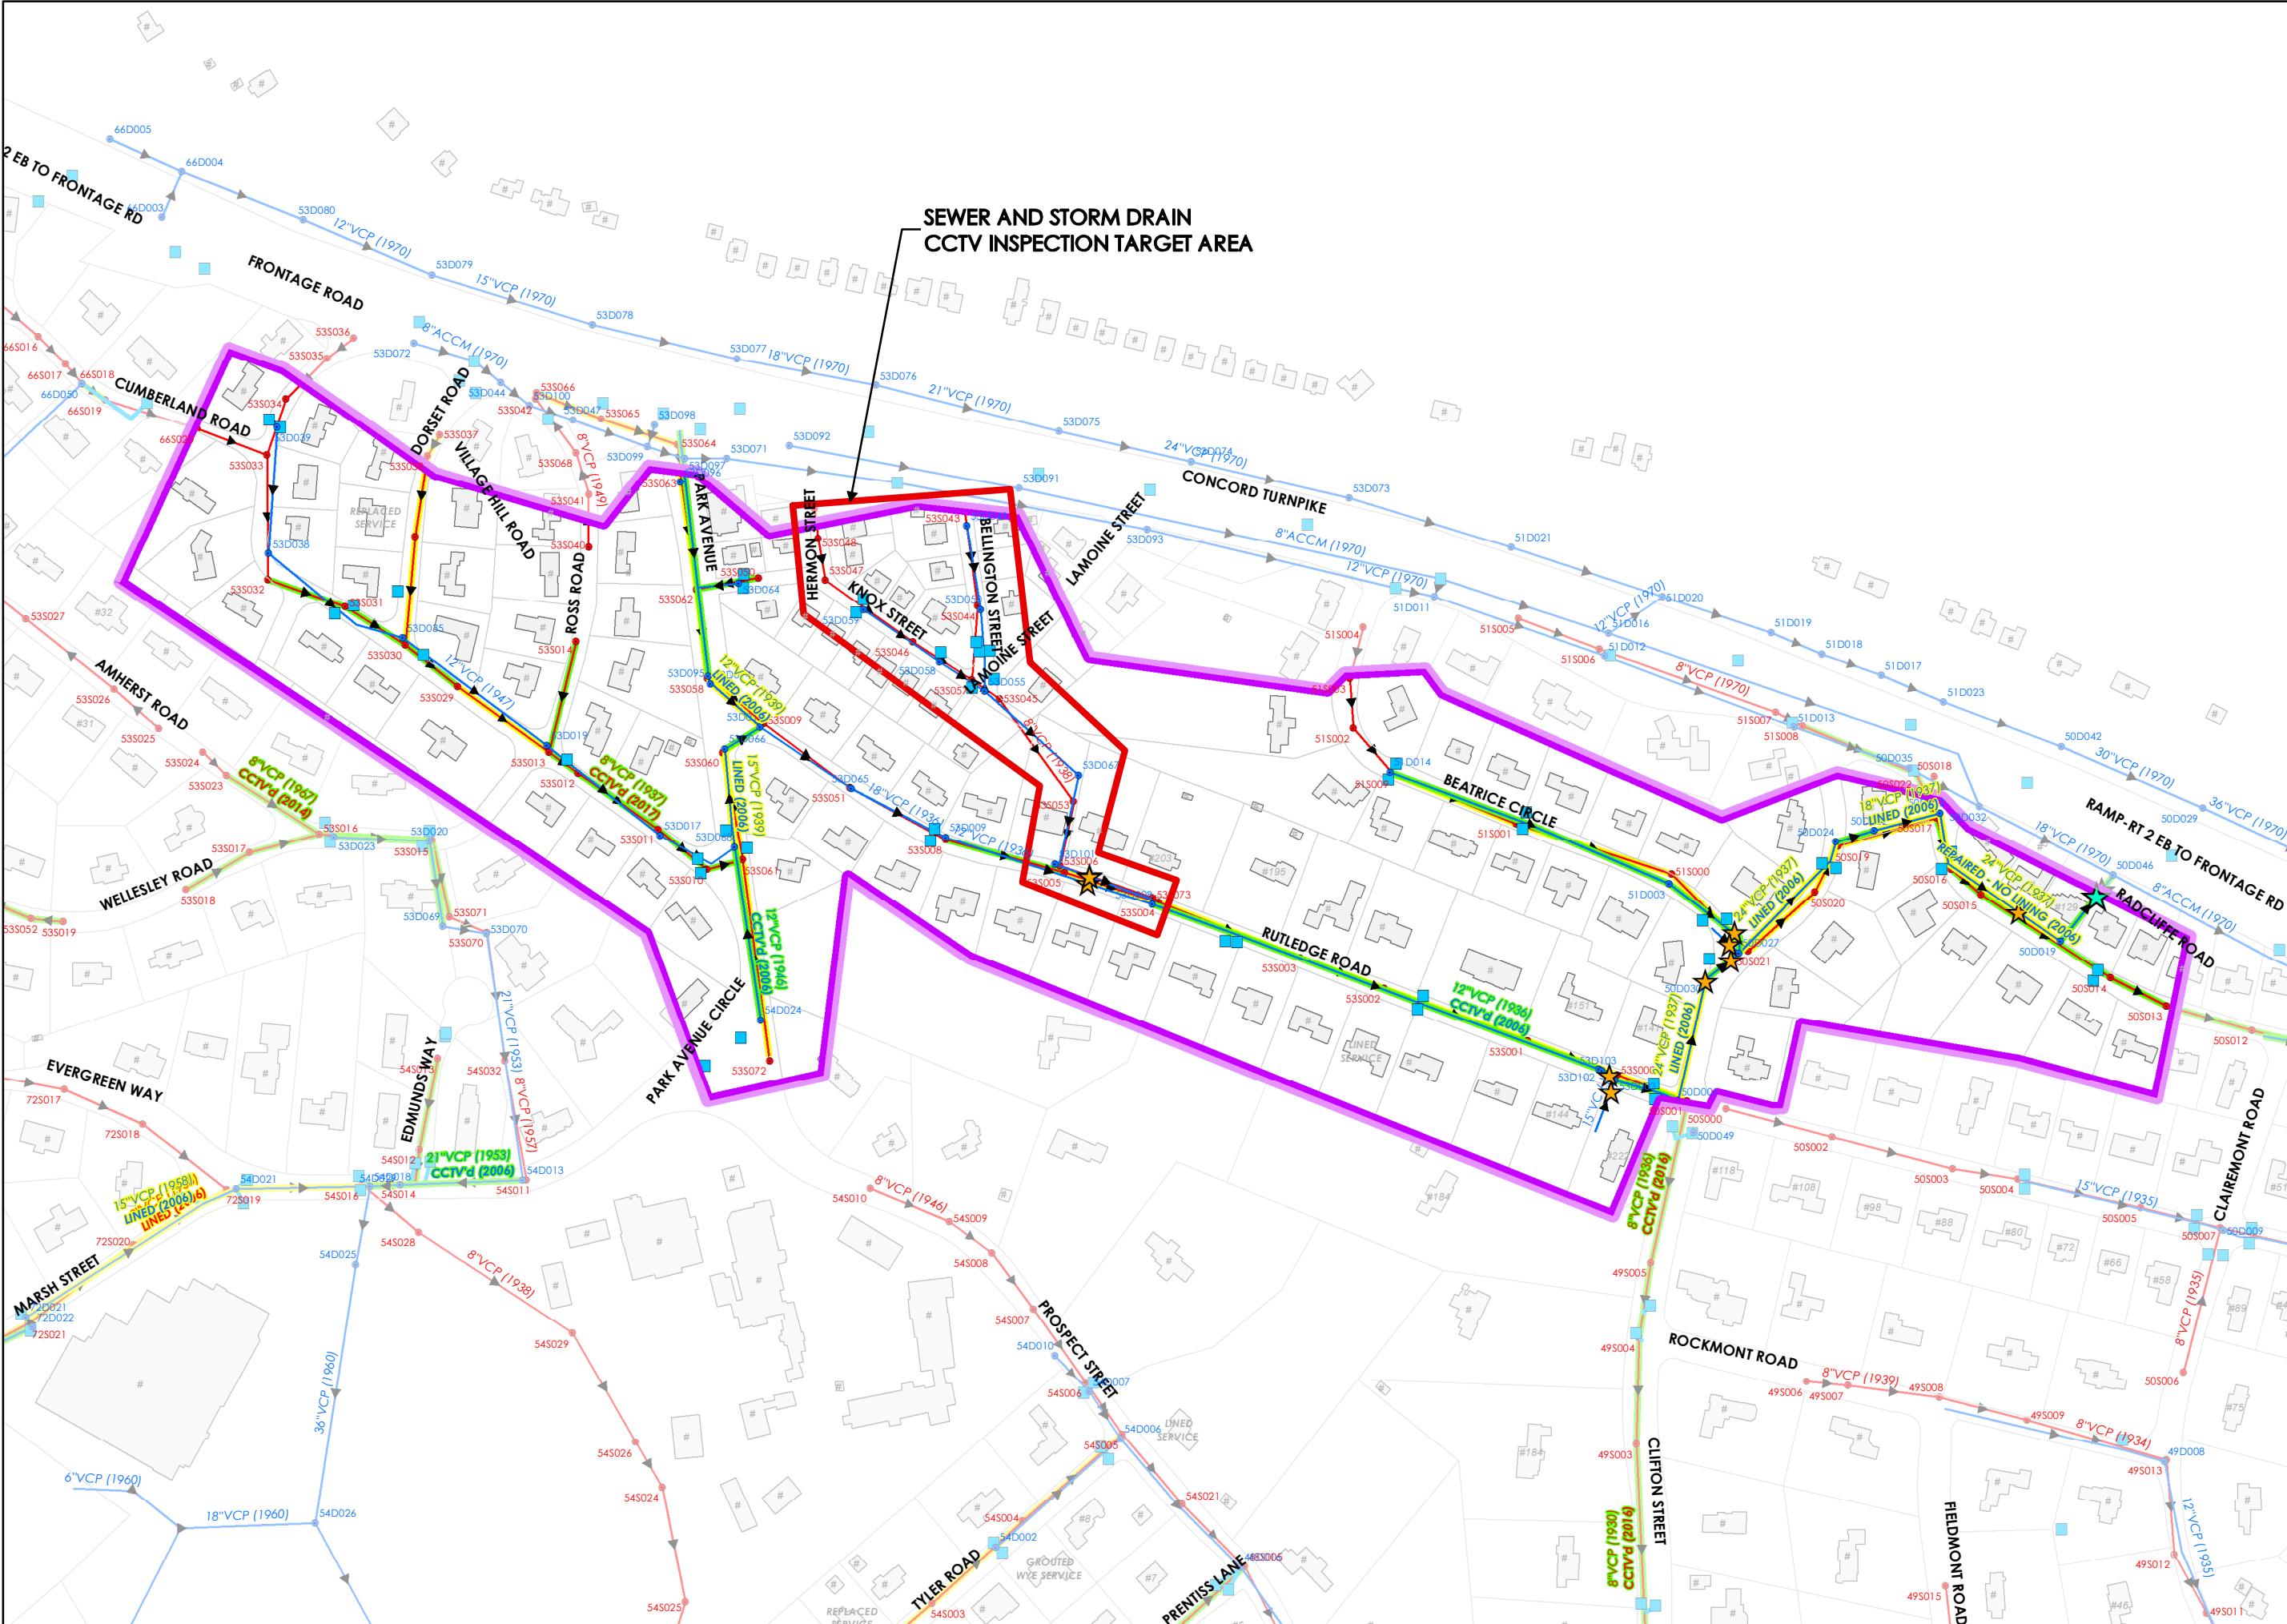
SEWER AND STORM DRAIN CCTV INSPECTION TARGET AREA

Outfall Area 15A - Knox Street Neighborhood – Scheduled to be CCTV inspected.

Complete CCTV inspection in Knox Street and conduct dyed-water testing as required based on CCTV results.

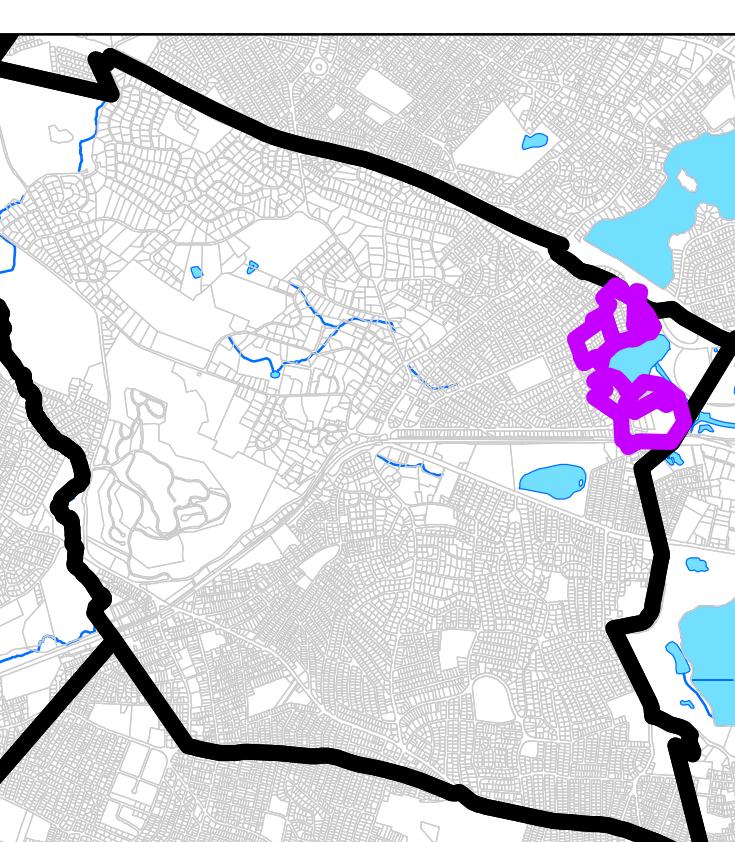
OUTFALLS 11, 11A & 12 TRIBUTARIES SEWER, DRAIN AND SERVICE CCTV INSPECTION TARGET AREA

Outfall Areas 11, 11A & 12 - Oliver Rd Area – The 235 LF of mainline sewer was in fair to poor condition with moderate to severe cracking, sags and offset joints. The 20 service laterals were also in fair to poor condition with defects including offset/separated joints, cracks, root intrusion and sags.

Evaluated for rehabilitation alternatives for the Oliver Rd Area.
