Subject: Belmont, Massachusetts
Illicit Connection Identification & Elimination Program
2008 Storm Water Sampling and Analysis Program

BELMONT, MASSACHUSETTS DRY WEATHER STORM WATER SAMPLING RESULTS

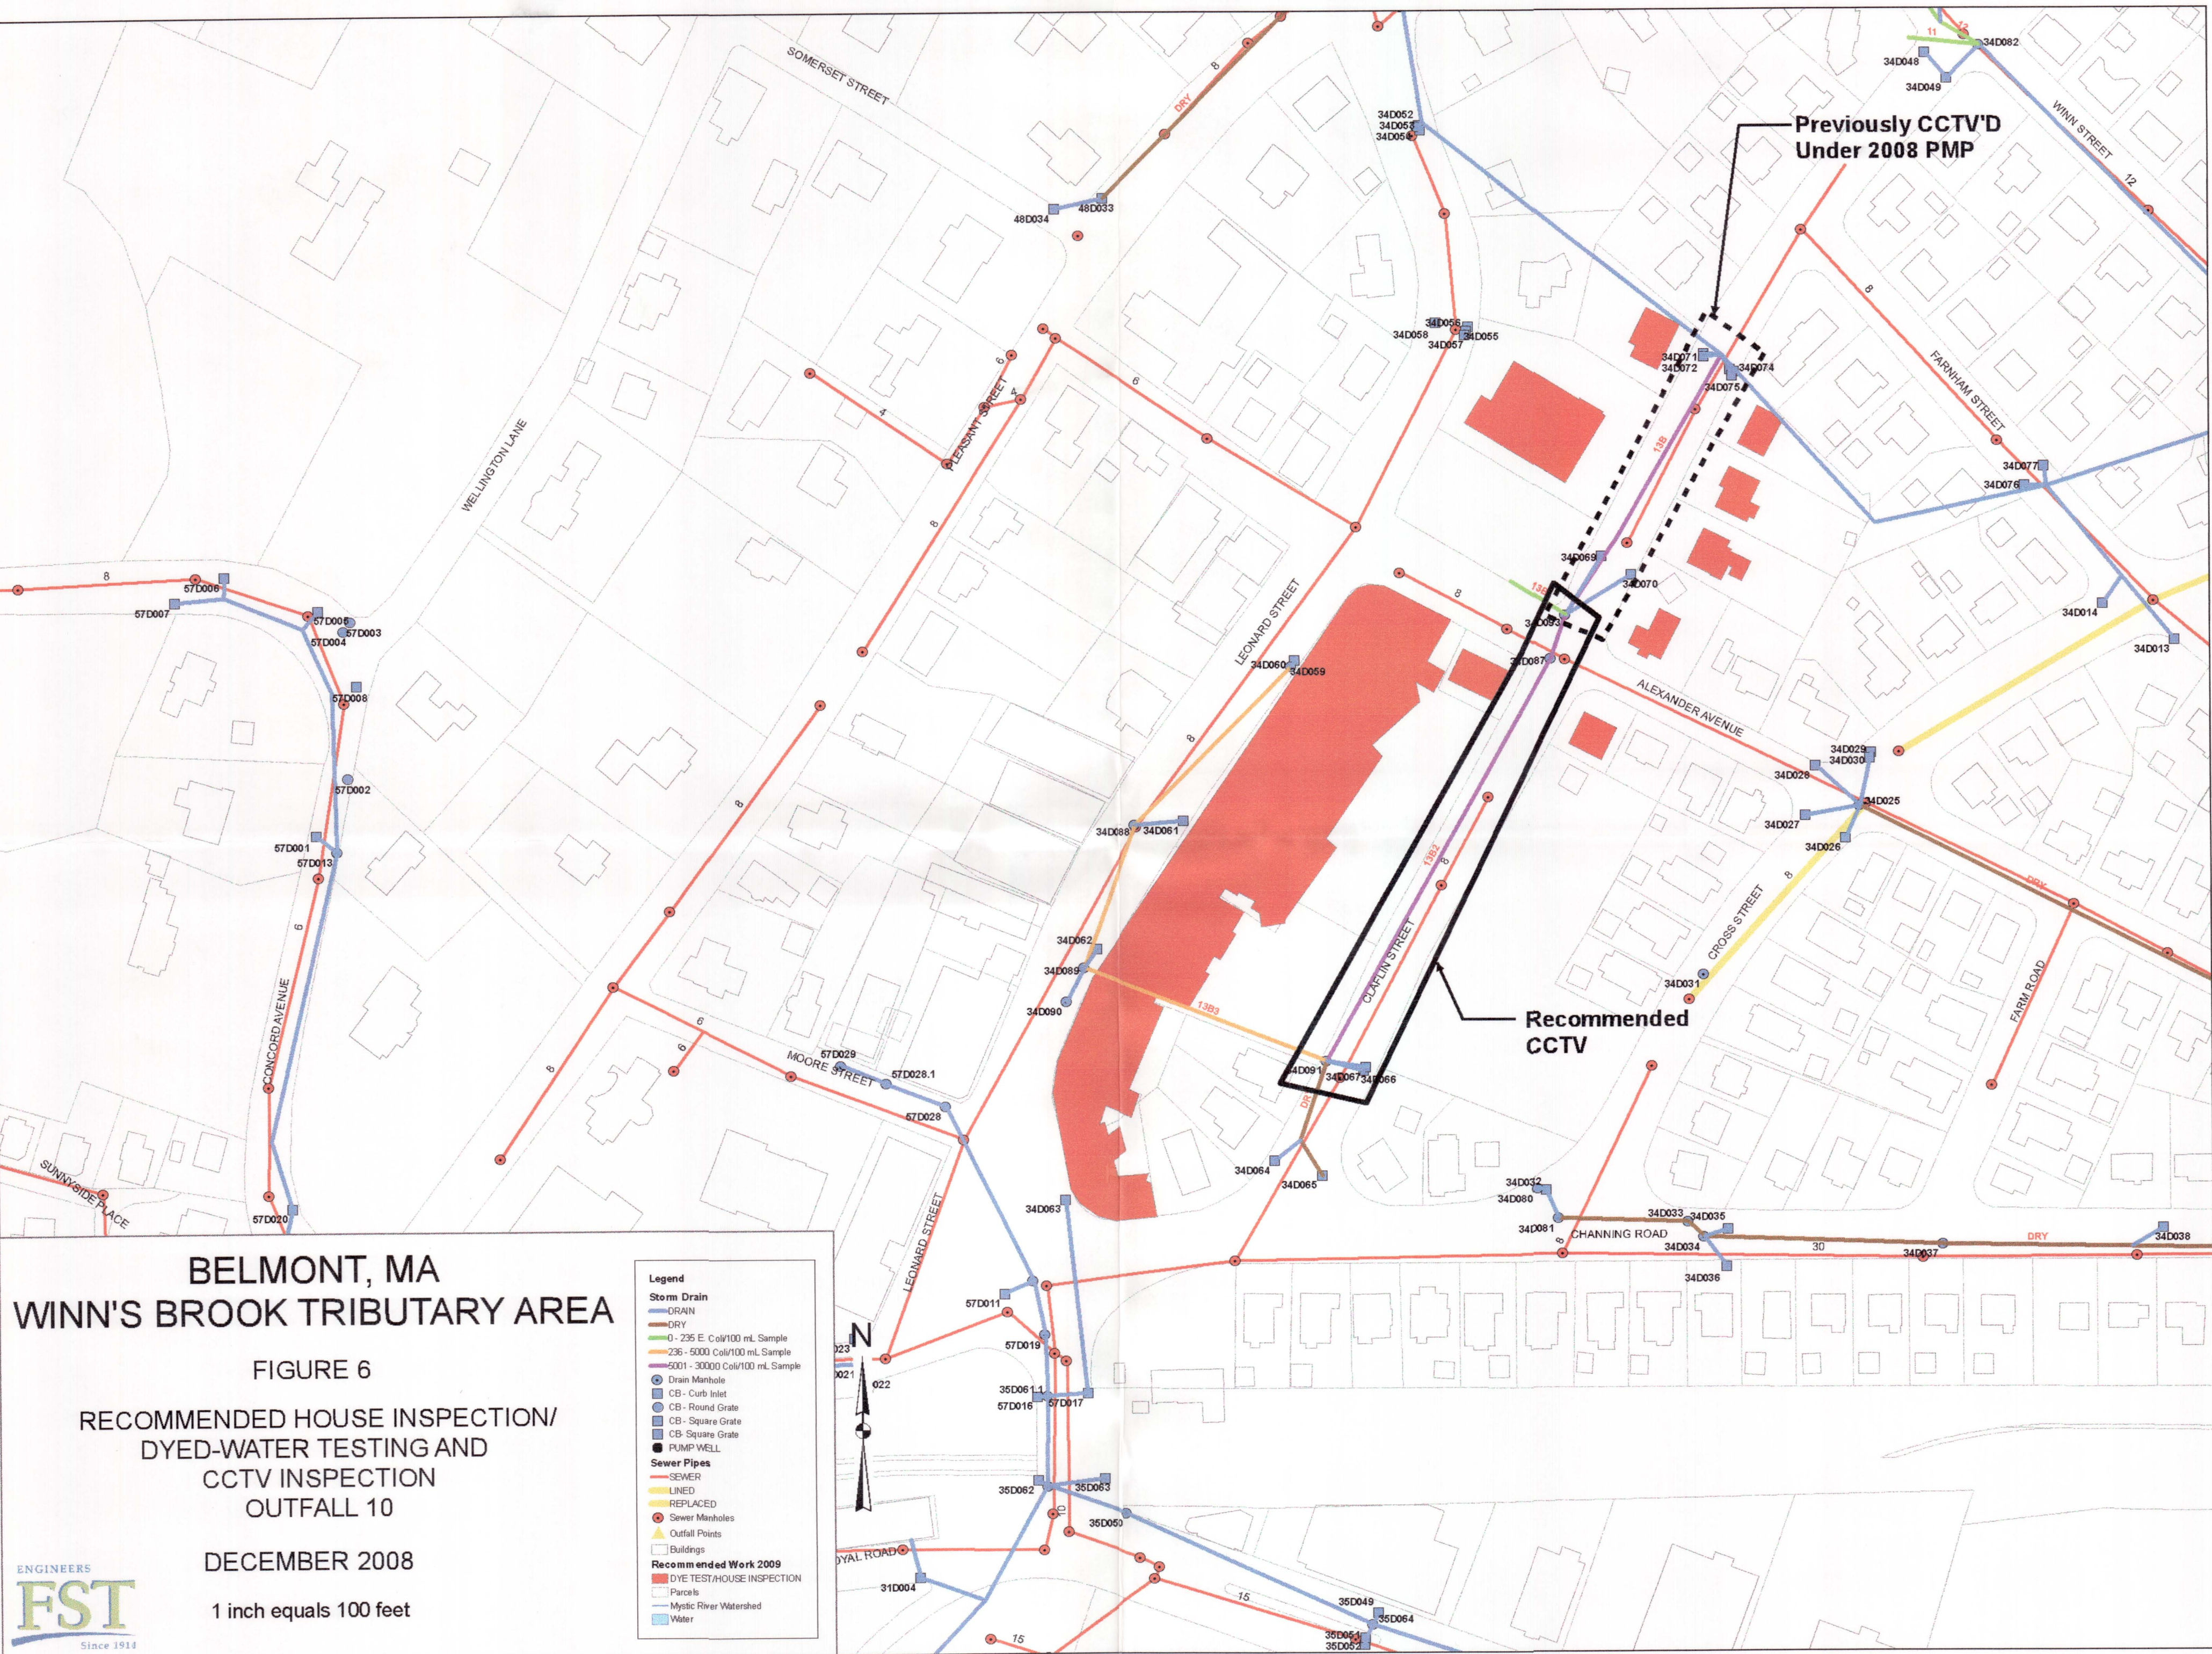
FIGURE 5

Outfall Area 10: The sampling successfully identified several smaller pockets of contamination in this very extensive outfall area. Similar to the Dalton Road area, the Westlund/Waterhouse/Hoitt Road area still has significant contamination despite extensive rehabilitation previously completed. Other areas showing contamination are Sherman Street by the Winn's Brook School, Claflin Street by the Macy's Parking Lot, Monroe Street between Claflin and Pleasant Streets, and the easement between Cowdin and Chilton Streets. Notably, animal feces were observed in the drain manhole where the sample was collected once on Sherman Street (34D009) and twice at the Cowdin Street location (44D015).

**RECOMMENDED HOUSE INSPECTION/
DYE-WATER TESTING AND
CCTV INSPECTION
OUTFALL 10**

Recommendations for illicit connection investigations are graphically shown in Figures 3 – 6 for each of the areas discussed above. The recommendations are tailored based on previous work conducted as discussed below. It is recommended that investigations focus on areas with a clear indication of an illicit connection(s); in general, areas exhibiting sample results greater than 5,000 E. Coli colonies per 100 mL. In areas below this threshold, shown in orange on Figures 1 and 2, quarterly sampling is recommended to establish a more complete database for future evaluation.

Areas Previously Rehabilitated: In both the Dalton Road and Westlund Road areas, approximately 96% of the houses were dye tested in 2001-2002. As described in the January 2003 Preliminary Design Report, the dye testing identified 13 direct and 36 indirect illicit connections. However, subsequent CCTV inspection did not validate these findings and concluded mainline sewer breaks to be the primary source. Presently, 100% of the mainline sewers have been lined and are eliminated as an illicit connection source, indicating that service laterals are likely the contributing factor. FST recommends that houses previously determined to have direct or indirect connections be retested and an internal inspection be conducted. The purpose of the inspection is to locate potential illicit basement connections isolated from the main plumbing stack that were not identified by the initial dye testing. Depending on those results, inspections and dye testing may need to be expanded to include houses previously cleared.

The recommended scope to work shown in Figures 3-6 includes approximately 6,300 feet of CCTV inspection and 170 house inspections/dye tests. The estimated cost to implement this work is \$80,000.
