FORM B – BUILDING

Town/City: Belmont

Address: 389 Common Street

Historic Name: Cushing Gate House

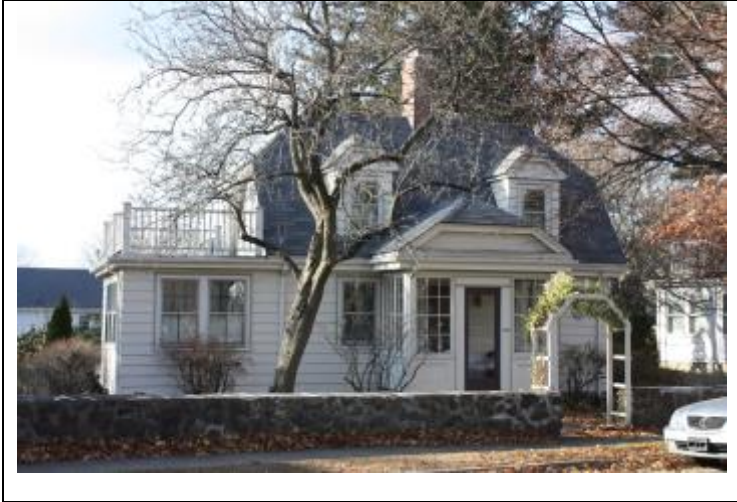
Photograph

This modest 1 ½-story cottage with jerkinhead roof was originally located on the Cushing-Payson Estate and served as housing for a servant or hired help. It is clad in a wide aluminum siding. Historic photos show a simpler structure, clad in clapboards, with 6/6 windows with shutters on either side of a central entrance capped by a flat door hood on brackets. The present front porch with its matching jerkinhead roof and glazed walls was added between 1915 and 1922 (Sanborn maps). A single-story, flat-roofed sunporch addition with roof balustrade is located to the south and was added in 1927 according to building permits. It is not known when the dormers were added to the front roof slope; a brick chimney rises from the ridge.

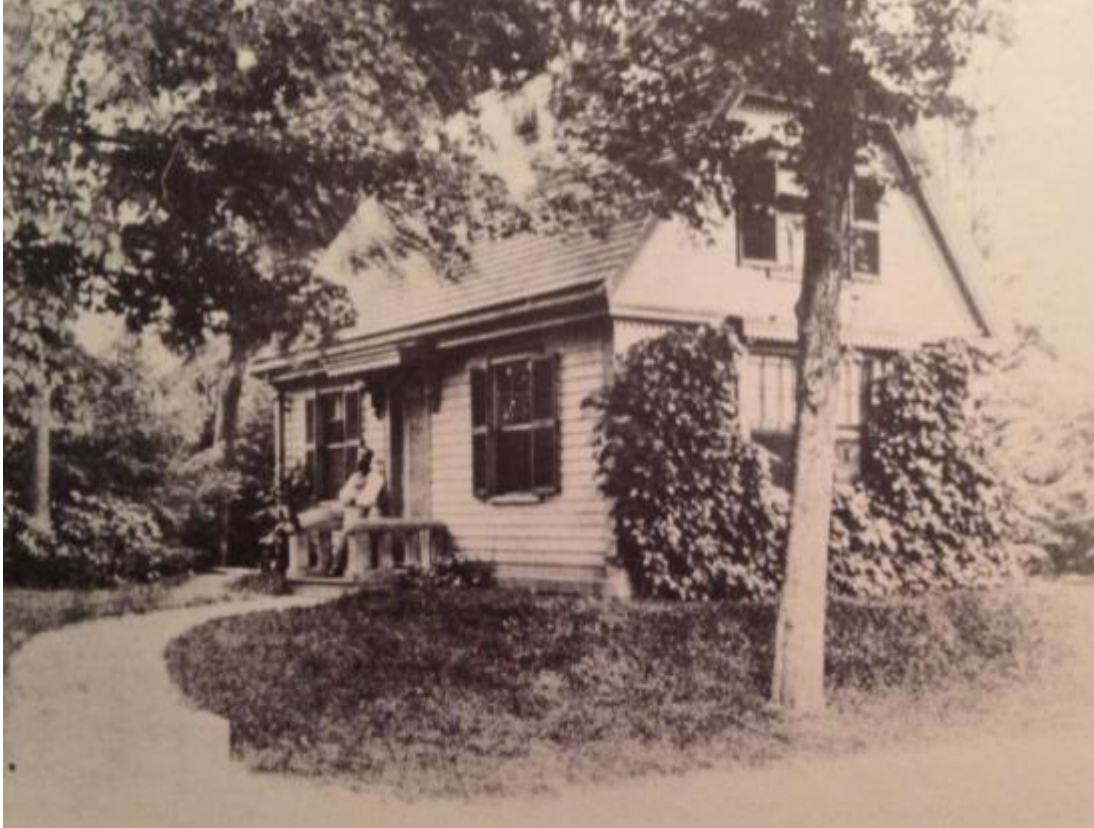
Undated photograph of house in original location
