# FORM B – BUILDING

BLM.134

**Address:** 96 Somerset Street

**Historic Name:** Holiday Farm Workers' Housing

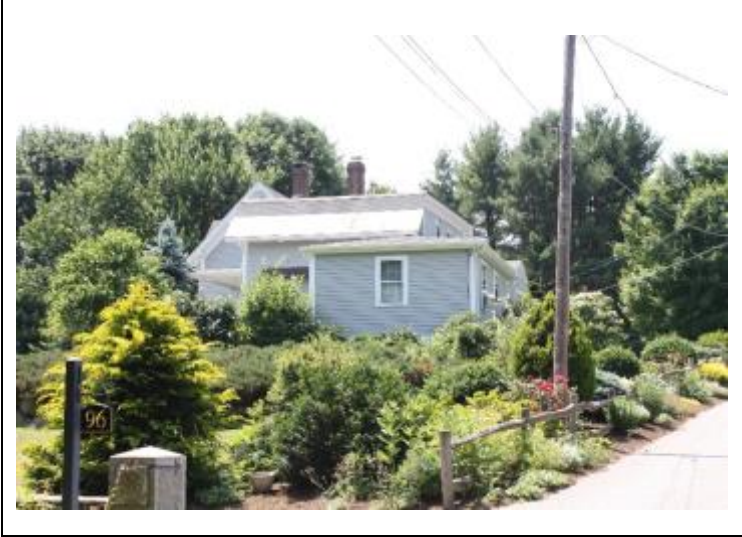
## Photograph

(view from Somerset Street)

**Style/Form:** Gothic Revival/Stick

**Condition:** good

This ca.1864 farmhouse is one of two extant outbuildings surviving from Holiday Farm (no longer standing). It is an unusual example of vernacular architecture that illustrates the support buildings of a mid-19<sup>th</sup> century working farm. While the main house was designed in the Italianate Style, this building blends the influence of the Gothic Revival and Stick Style. The 1 ½-story, 3 x 2-bay dwelling faces eastward. The building is clad in wood clapboards. The gable roof has overhanging eaves that display exposed rafters and purlins with a brick chimney centered on the ridge and twin gable wall dormers on the façade. The center entrance has a gable hood with incised ornament that rests on trusses. The flanking windows are capped by shed hoods resting on brackets (a detail which is also seen next door at 97 Somerset Street). A wing is offset to the north with a clipped gable roof. A series of additions were constructed to the rear in 1960, 1995 and 2000.

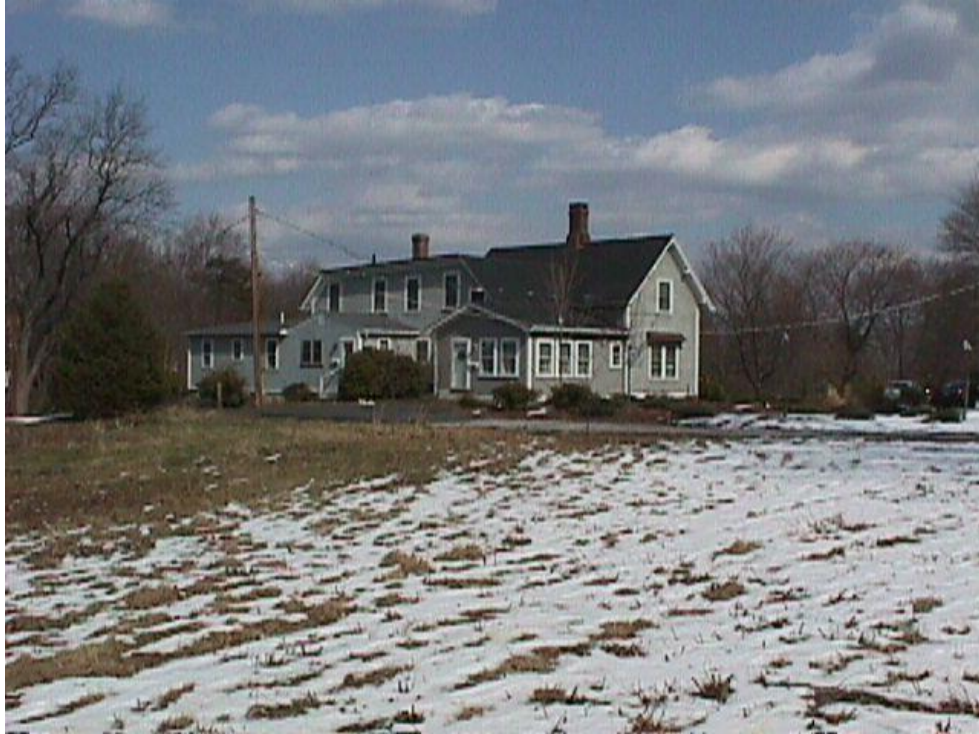
View of Rear elevation

1960 – 1 story addition at rear

1995 – 25' x 16' addition at northwest

2000 – 10' x 19' addition at southwest
