FORM B – BUILDING

BLM.133

Address: 97 Somerset Street

Historic Name: Holiday Farm Milkhouse

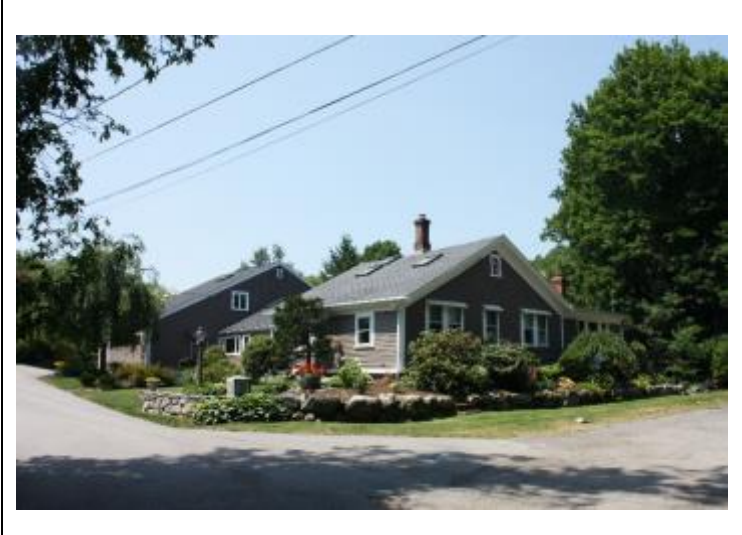
Photograph

Condition: good

The oldest portion of this house was originally a milkhouse for Holiday Farm. Rectangular in plan, the original milkhouse is a single-story structure measuring 32' x 24', set on a brick foundation and clad in wood clapboards with simple cornerboards. It is oriented with its broad gable end to Somerset Street with eaves that overhang slightly and are without returns. A brick chimney rises from the ridge of the asphalt-shingled roof. There are five windows – a single window flanked by two pairs on the north gable end façade. All of the windows are capped by shed hoods resting on simple brackets (a detail also seen on 96 Somerset Street). Two windows without the shed-like hoods are located on the east elevation with the top of the windows extending to the eaves. The location of the original entrance to the building is not clear.

In 1973 a large addition was constructed to the south (rear) of the original cottage consisting of a single-story wing which connects to a taller garage building. The new additions are more than double the size of the original cottage. The fenestration on the new sections consist of picture windows and casements. The area in front of the house is informally landscaped with low stone walls and granite posts.
