TOWN OF BELMONT, MA

Figure 5
Upper Tributary Sampling Results
Sub-Catchment Area 8-6 (Wellington Brook)

Illicit Discharge Investigations
November 2017

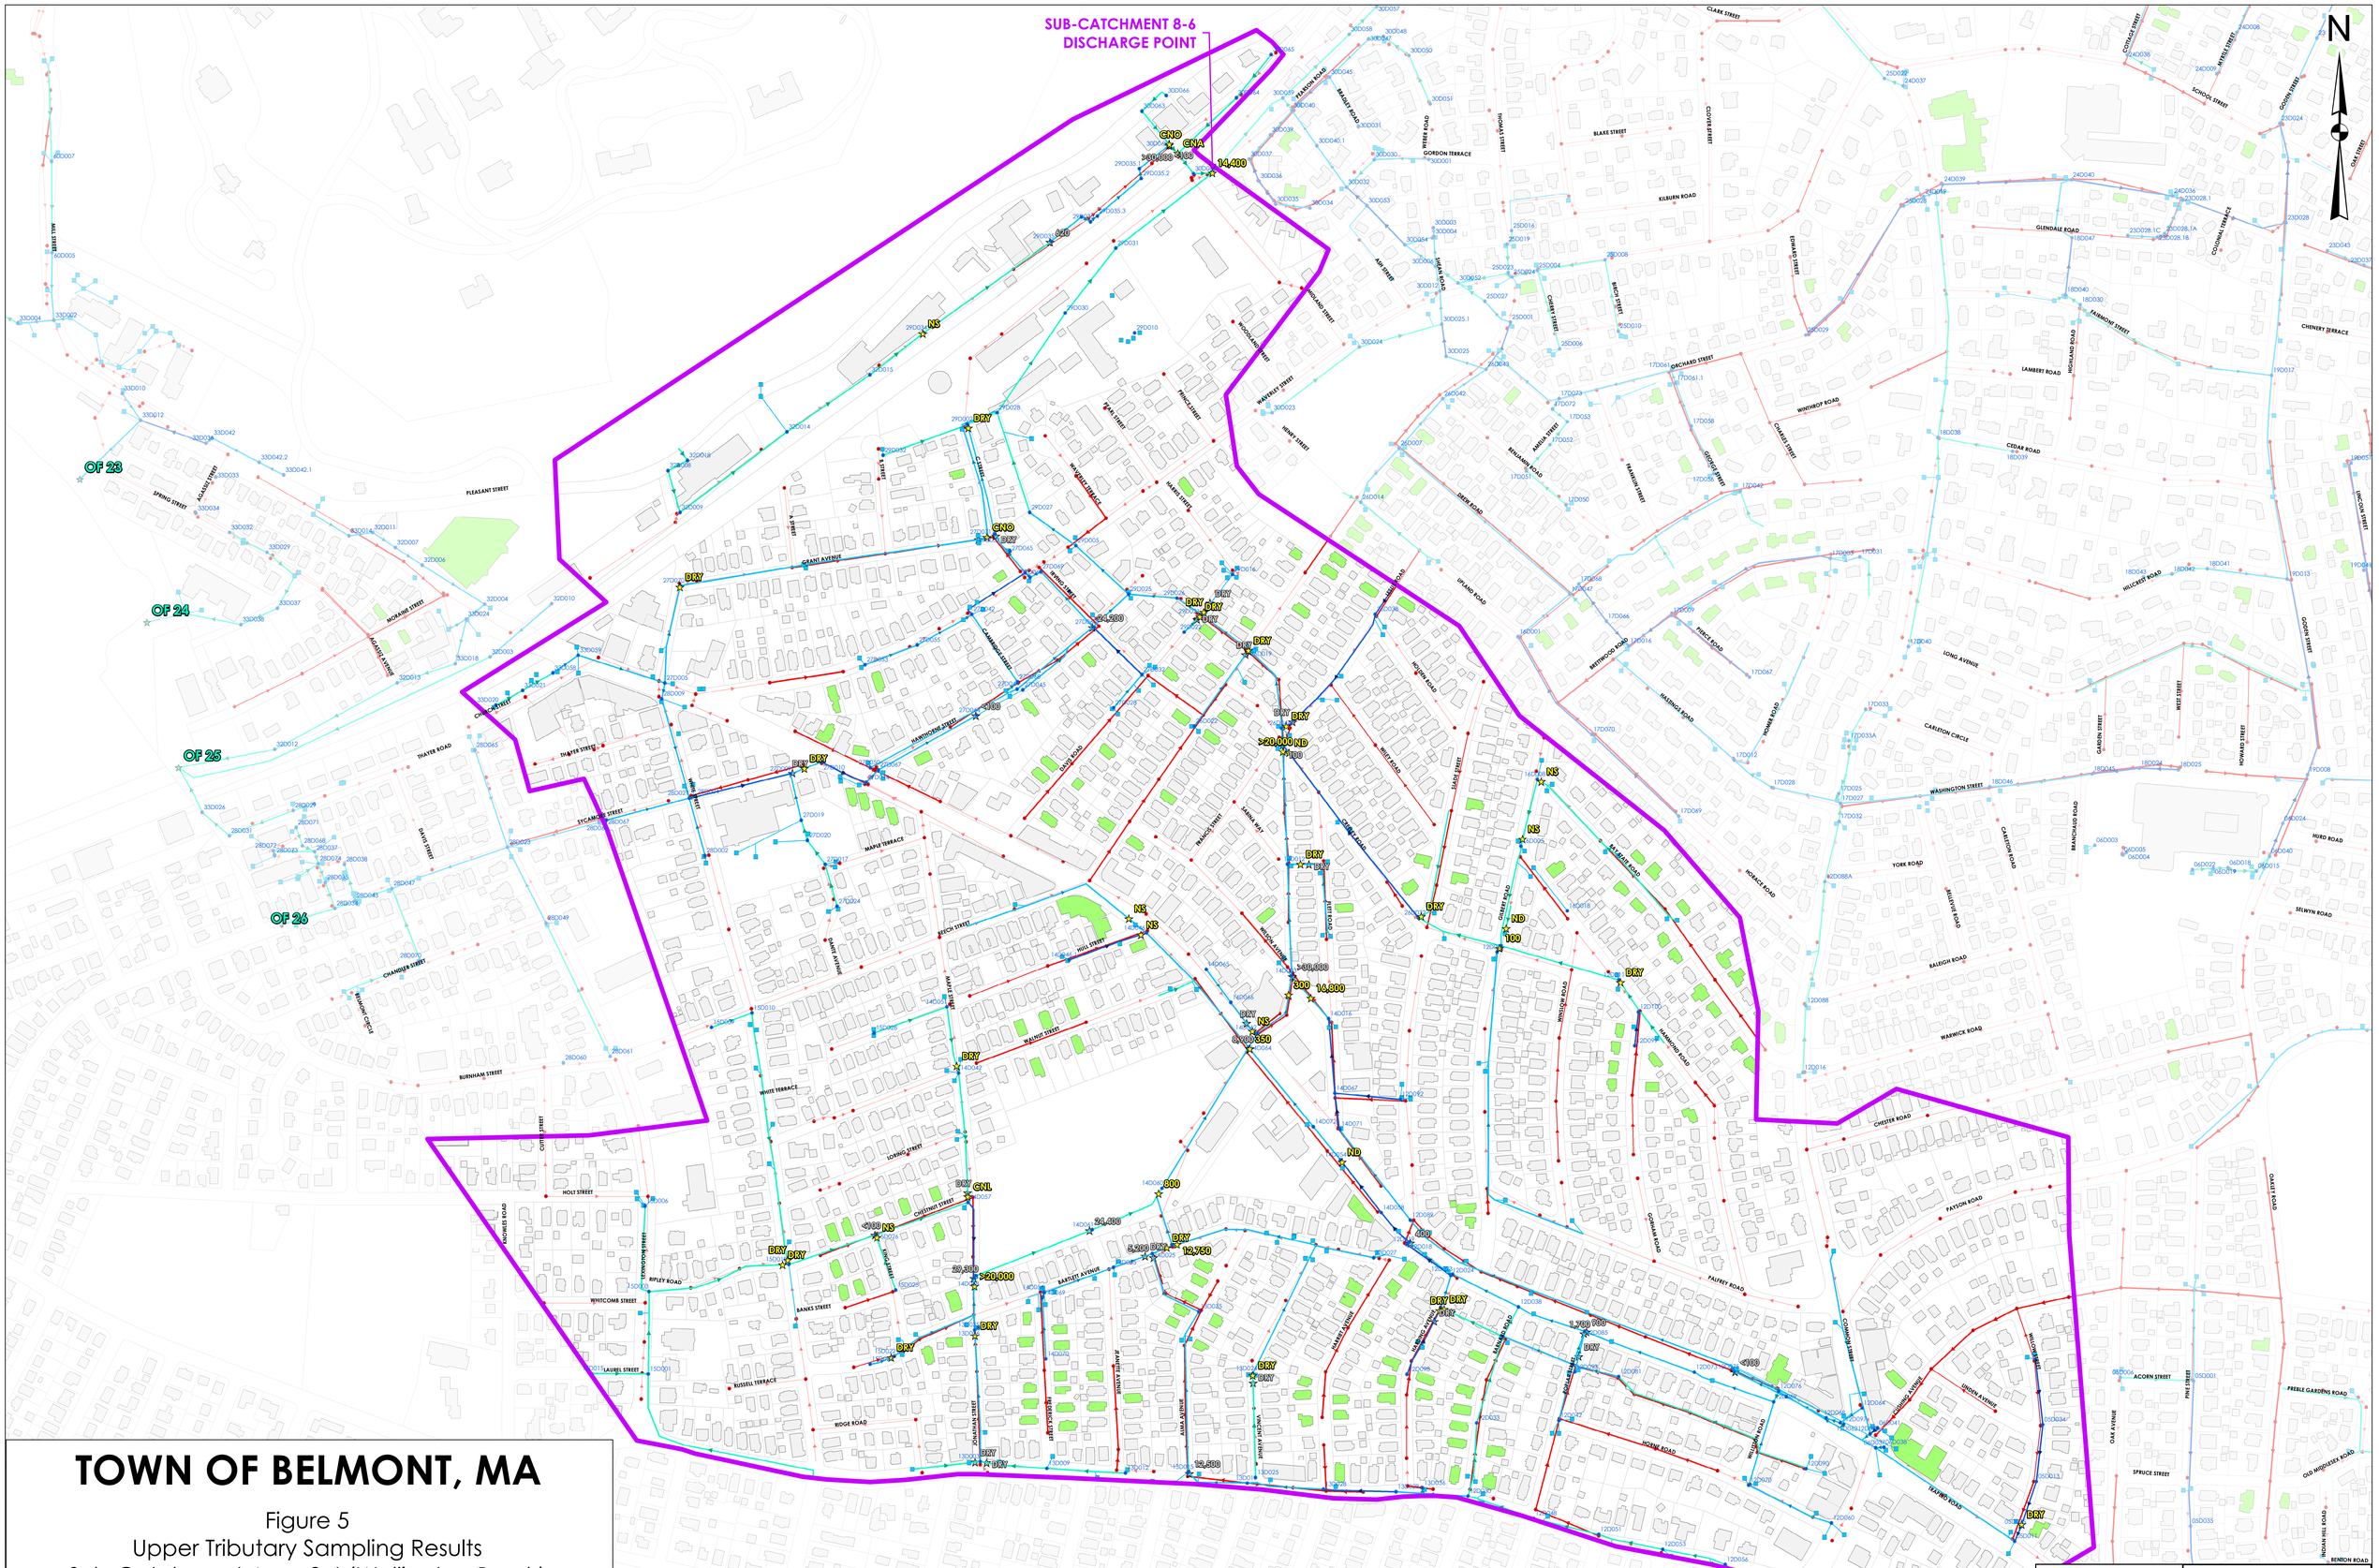
- Labels for "2016-2017 Sample Locations" are lab-analyzed values of the MPN (Most Probable Number) of E-Coli Colonies per 100 mL (milliliters) of sampled water. "ND" is abbreviated for "E.Coli Not Detected". Labels for "2007 Sample Locations" are lab-analyzed values of the MPN of Fecal Coliform per 100mL of sampled water.

- "DRY" locations within the storm drain network were observed without flowing water or moisture.

- "NS" locations within the storm drain network were not "DRY", but did not have sampleable flow. (For example, manholes having either "trickling" flows, sumps, or an invert coated with moisture.)
