TOWN OF BELMONT, MA

Figure 7
Upper Tributary Sampling Results
Sub-Catchment Area 10-2 (Winn's Brook)

Illicit Discharge Investigations
November 2017

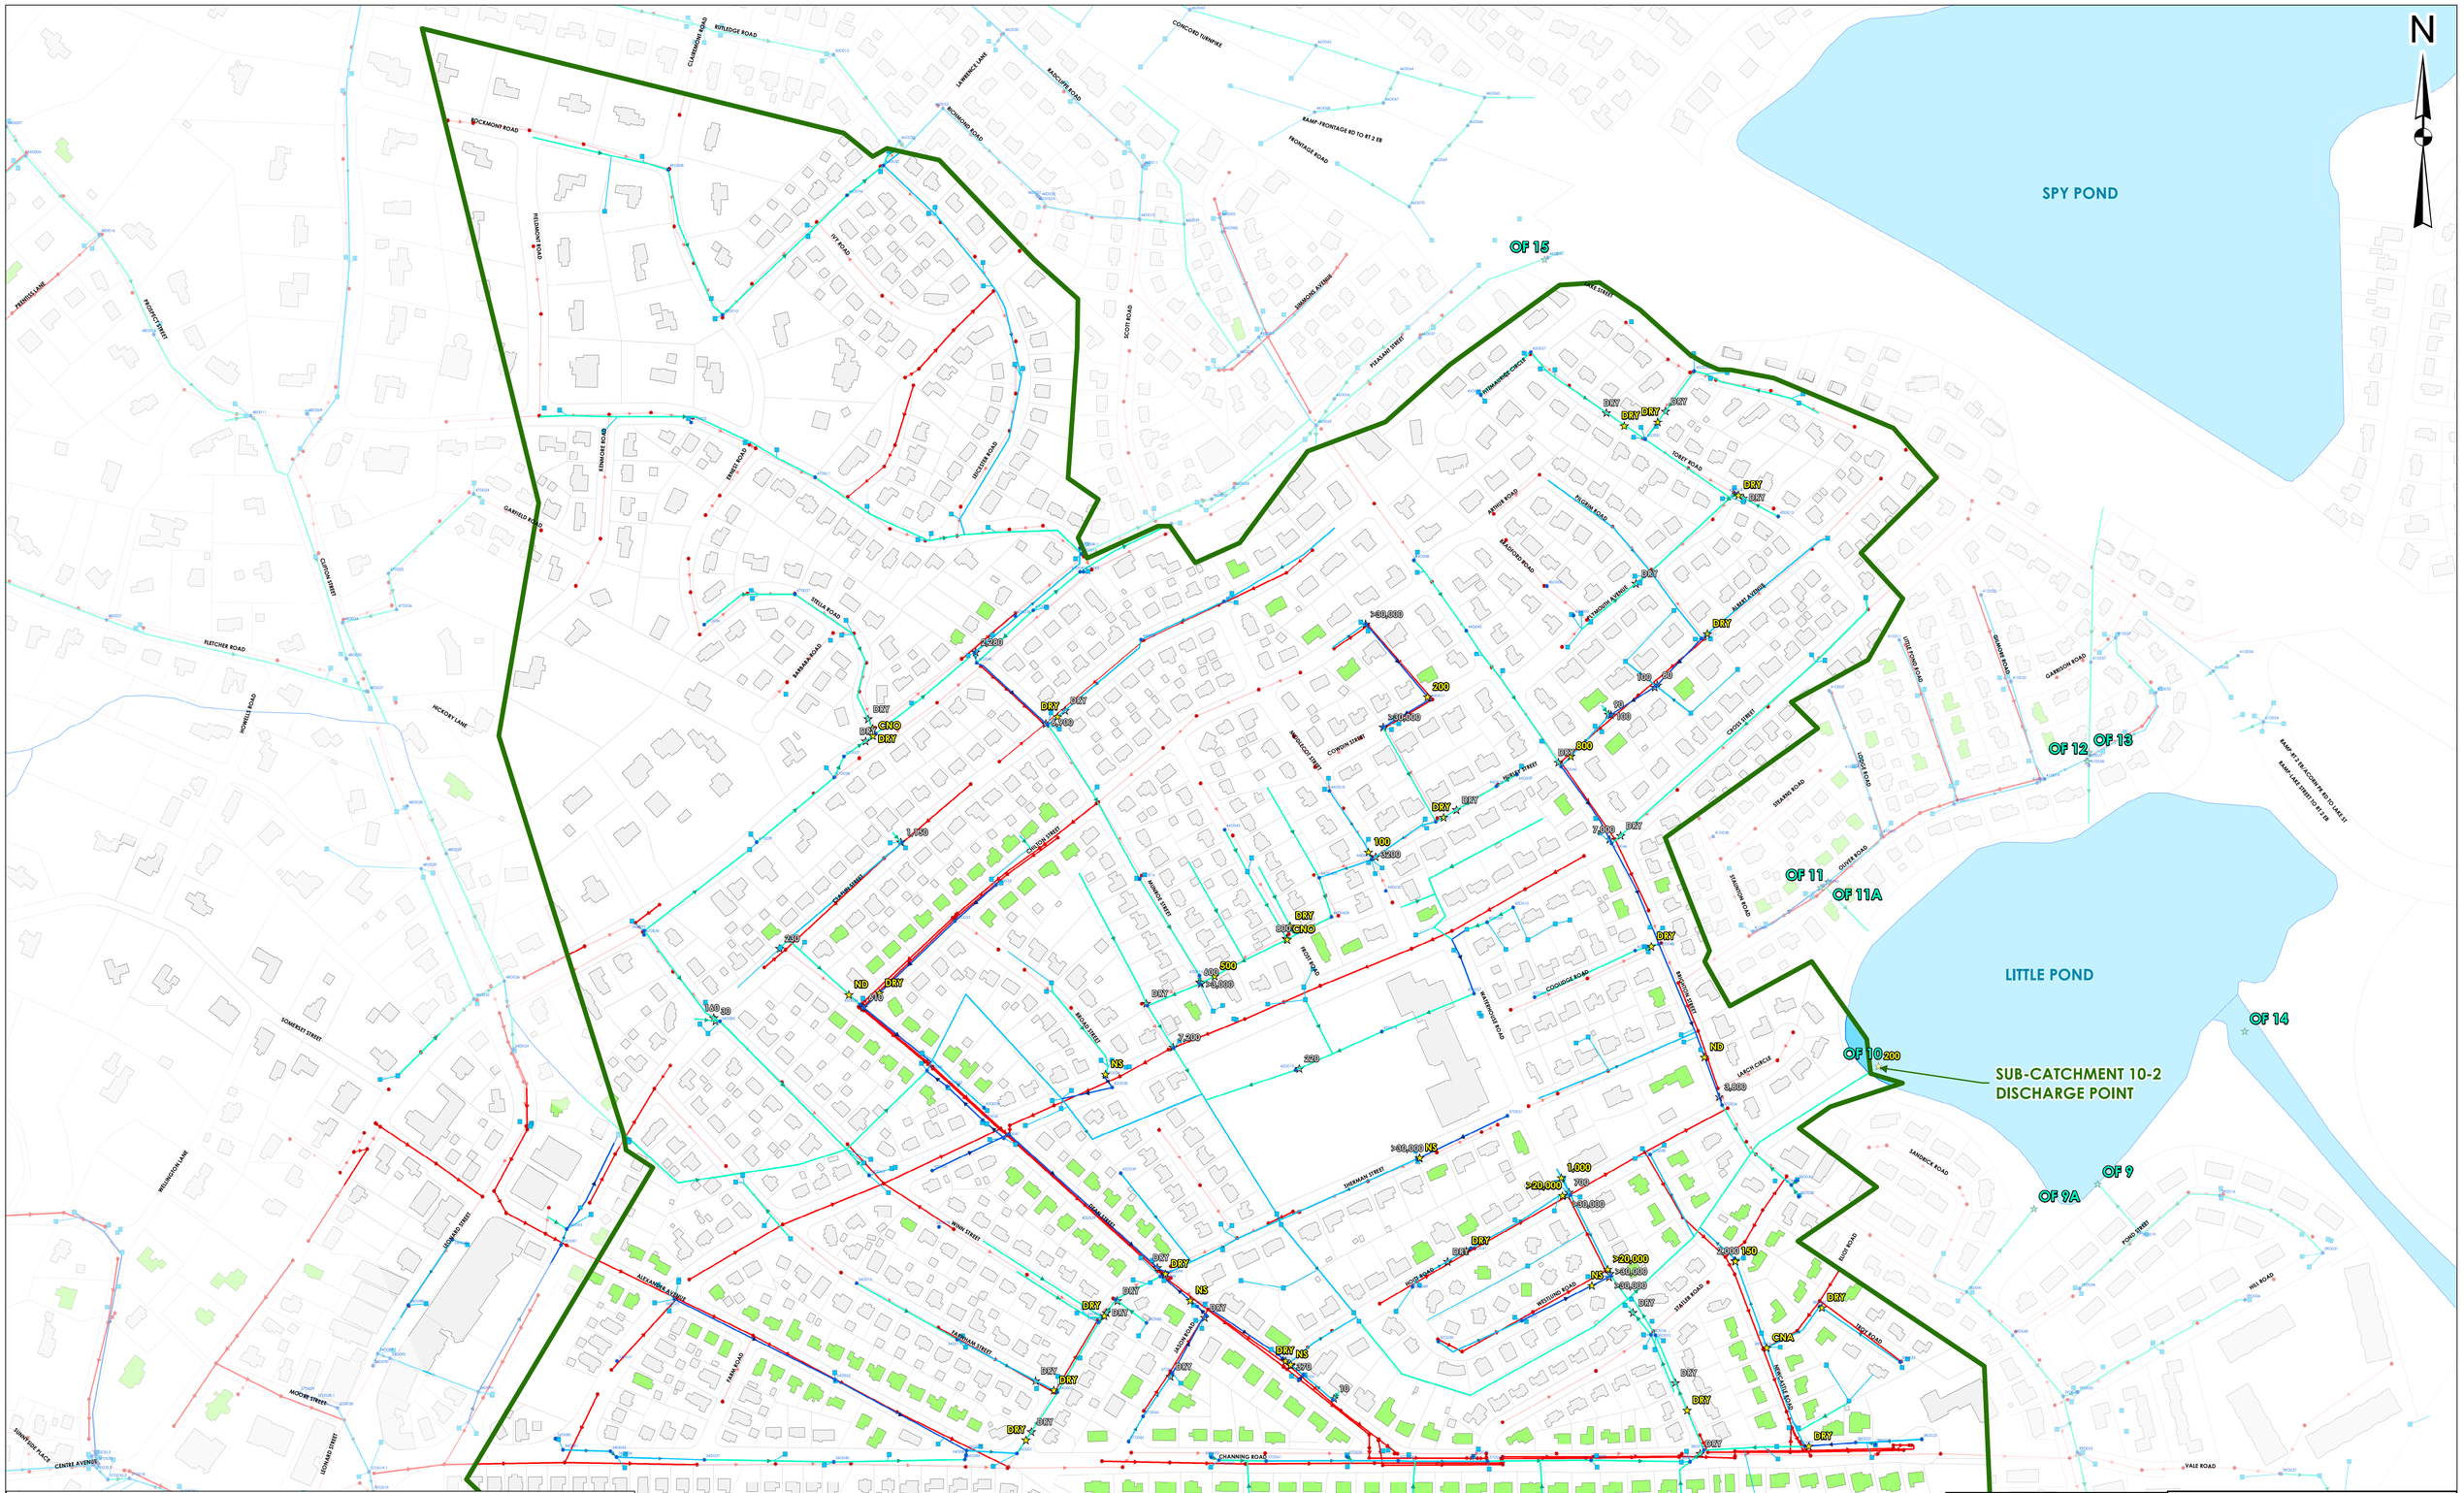
- Lablels for "2016-2017 Sample Locations" are lab-analyzed values of the MPN (Most Probable Number) of E-Coli Colonies per 100 mL (milliliters) of sampled water. "ND" is abbreviated for "E.Coli Not Detected". Labels for "2008 Sample Locations" are lab-analyzed values of the MPN of E.Coli per 100mL of sampled water.

- "DRY" locations within the storm drain network were observed without flowing water or moisture.

- "NS" locations within the storm drain network were not "DRY", but did not have sampleable flow. (For example, manholes having either "trickling" flows, sumps, or an invert coated with moisture.)
