## **Appendix A**

### **Trail Analysis Existing Conditions Photographs**

**McLean Open Space Land**  
**Comprehensive Trail System Plan**

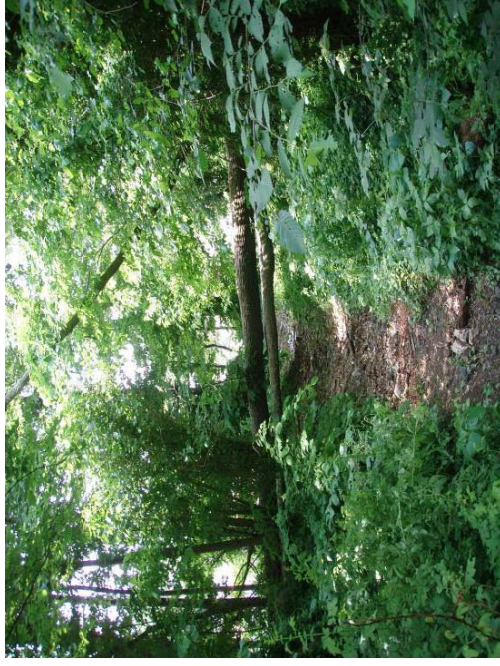
Figure 1d: Fallen trees blocking the trail near the bottom of Trail 1's southern, Pleasant Street trailhead (Trailhead I)

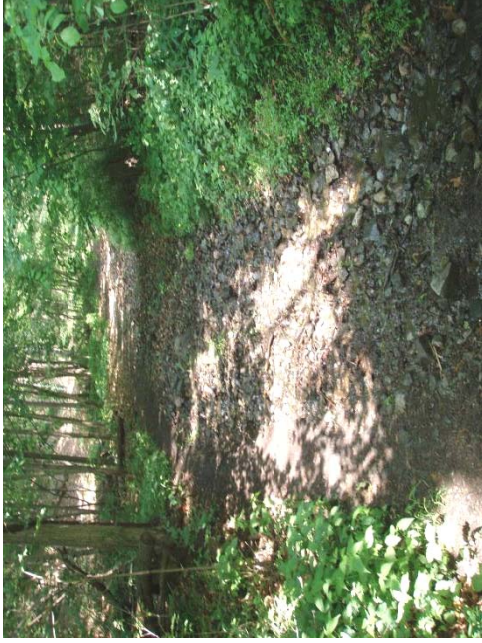
Figure 1e: Groundwater seepage near the base of Trail 1. This seepage is causing erosion and gullyng to the trail surface.

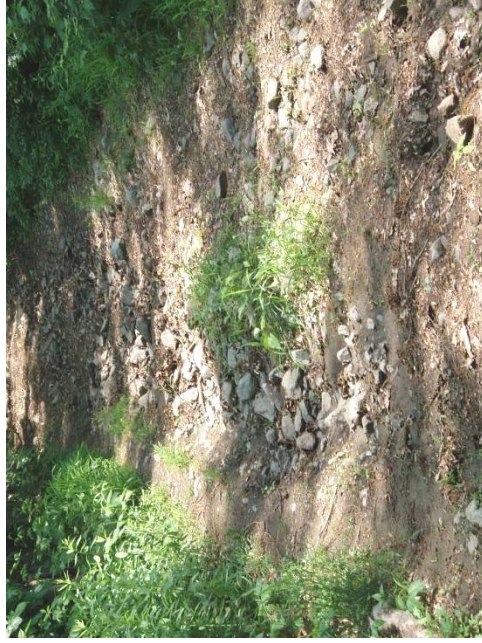
Figure 1g: Eroded trail surface below the McLean parking lot shown in Figure 1f. Water flow is channelized by the two stone walls (not shown) along the sides of the this section of Trail 1.

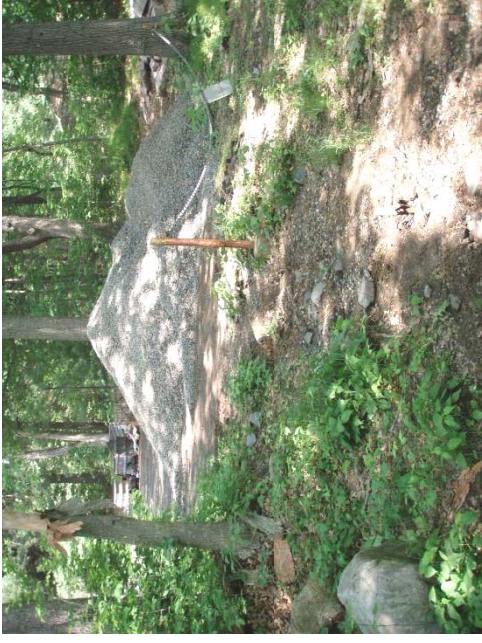
Figure 1f: The old McLean parking lot adjacent to Trail 1, currently a construction staging area, is a point source of surface water flow causing major erosion problems on Trail 1. Note half of this parking lot is within the Open Space Land.

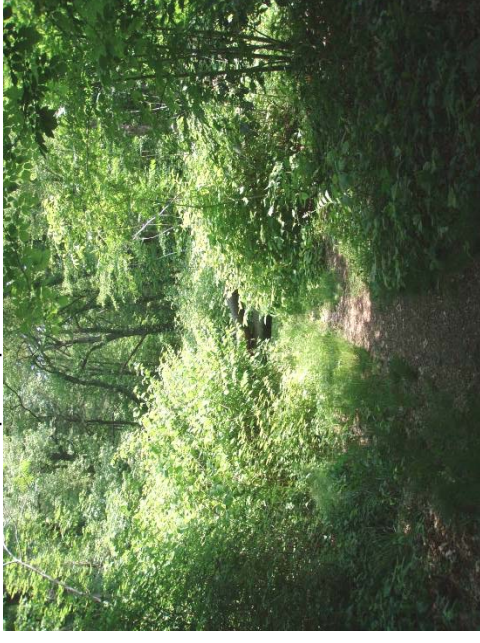
Figure 1h: Large fallen tree across Trail 1. A short path bypasses the tree on the east side of Trail 1. Also an area of Japanese knotweed growth is encroaching across the trail corridor on both sides of the fallen tree.

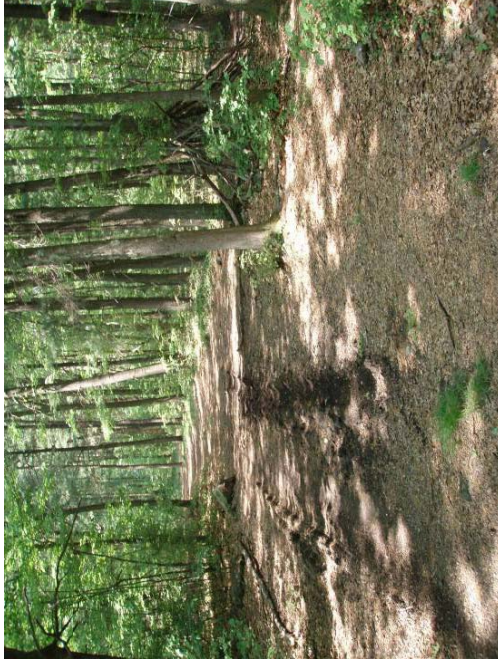
Figure 1k: Muddy trail tread near water tower area. This area in mostly only wet during the Spring months and dries out in the Summer. Notice truck tire marks.

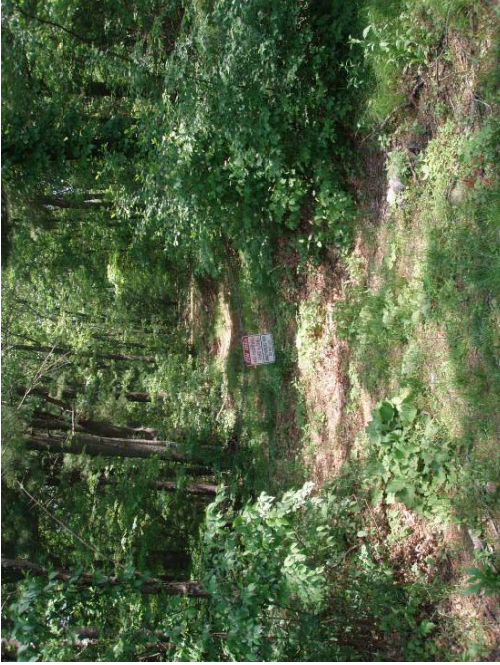
Figure 4a: Chained, vehicle access gateway for Trail 4 as seen from the McLean Hospital property (Trailhead VI)

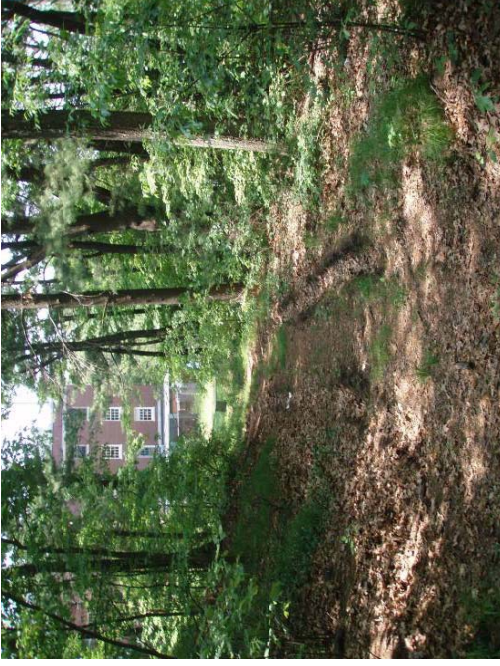
Figure 4b: Tire marks on Trail 4 within the 100' buffer zone.

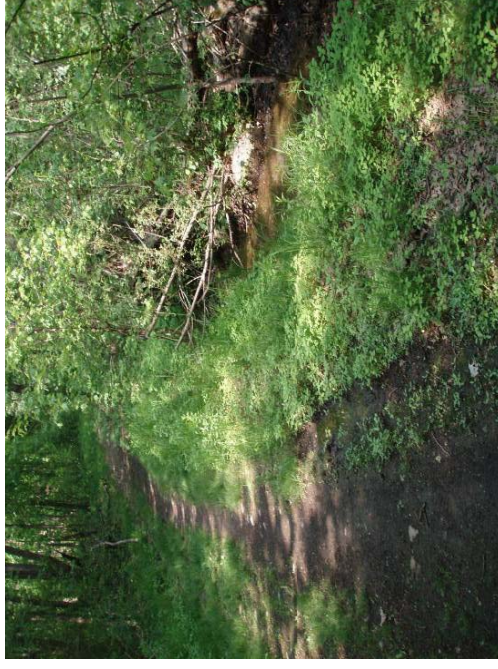
Figure 8d: Seasonally wet section of Trail 8 running immediately adjacent to the edge of the Red Maple Swamp. Notice the standing water and muddy tread..

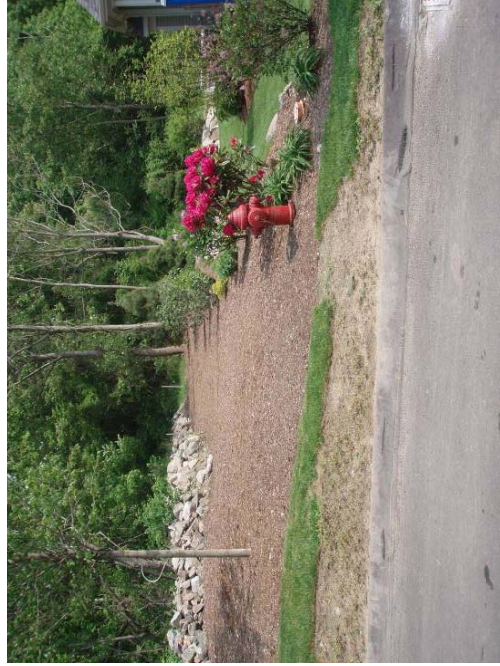
Figure 9c: Narrow mulched landscape area serving as a entry to Trail 9 from the Woodlands development.

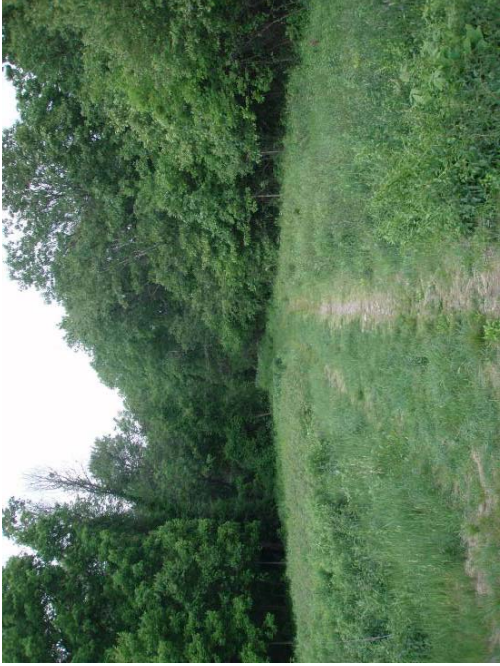
Figure 10a: Trail 10 running through the northeast corner of the Great Meadow. Tread is mostly composed of dual, compacted vehicular tracks. A good amount of grass grows within the trail tread.

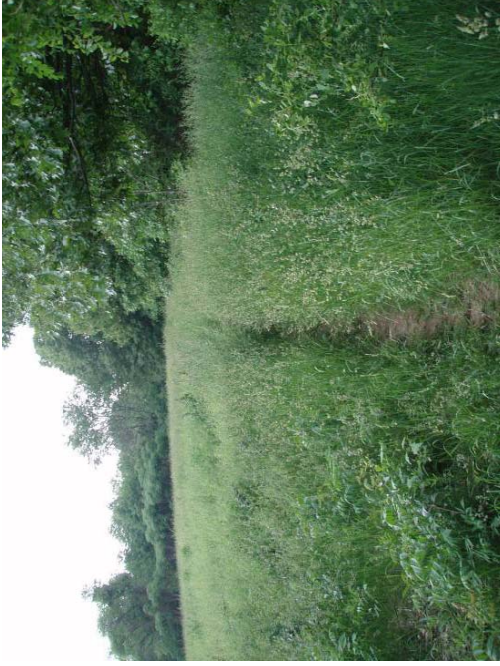
Figure 13a: Along the eastern section of Trail 13 through the northern part of the Great Meadow. This section has a narrow 1-foot tread. Notice uncut grass limits trail corridor width.

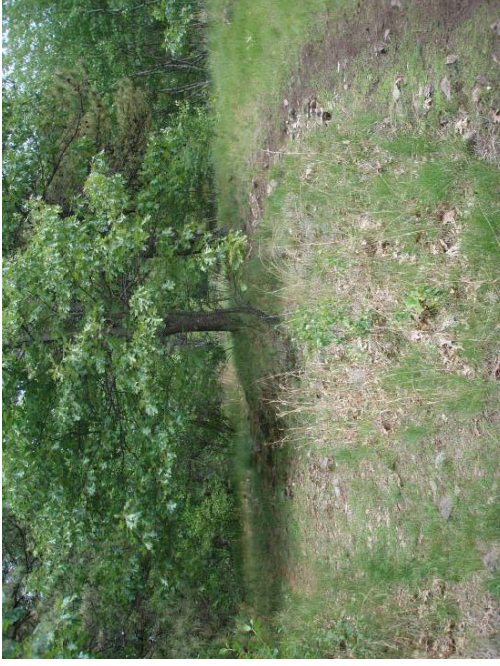
Figure 13e: At the top of the steepest section of Trail 13 and to the west of the area in Fig. 13d, the trail splits on either side of an oak and pine tree. Notice badly eroded areas of tread..

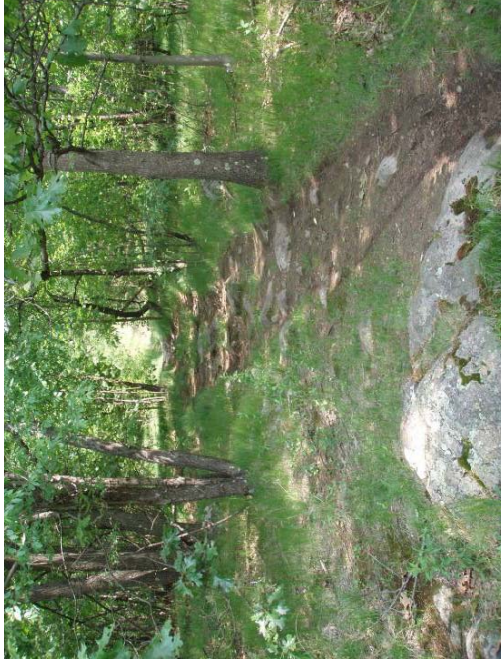
Figure 13f: View of the steepest and most eroded section of Trail 13 just east of the Mill Street intersection. Notice gullying of tread and exposed native stones due combination of water action and foot/bike traffic.

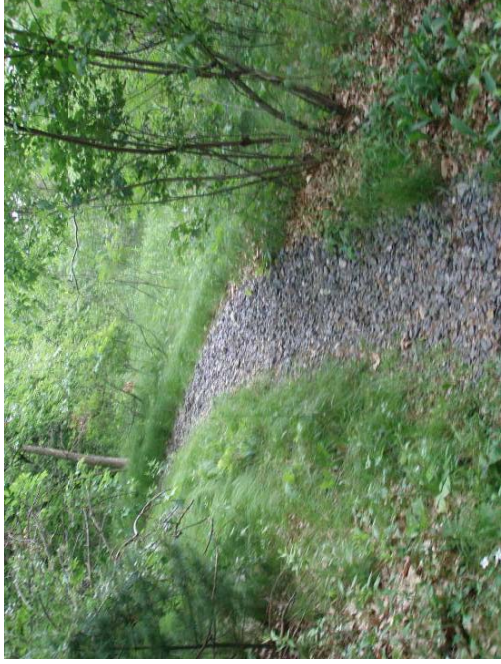
Figure 15c: Section of Trail 15 through a steep area of trail. The tread is wider in these steep areas. Gravel was installed in this section as a solution to the erosion occurring here. In addition, some minor grade dips were also installed at the base of these steep areas.

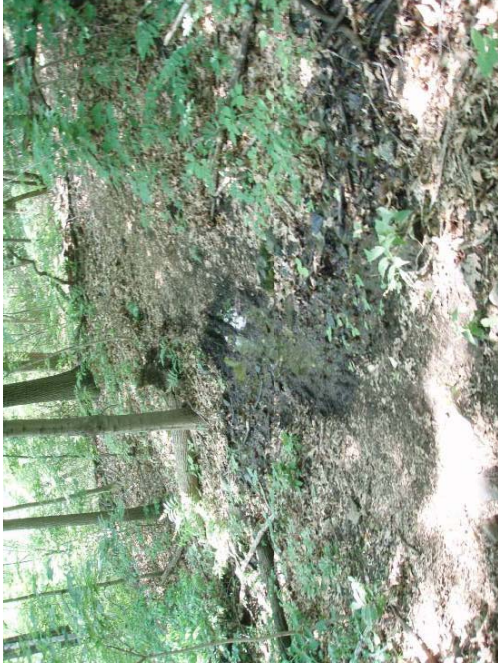
Figure B1: Wet area created by ground water seepage. Notice bike tire rutting in mud. This section of trail is typically wet year around.
