McLean Open Space Land

Comprehensive Trails System Plan

Prepared for the
Land Management Committee
Belmont, Massachusetts
FINAL - March 2008

Pressley Associates
Landscape Architects
Cambridge, Massachusetts

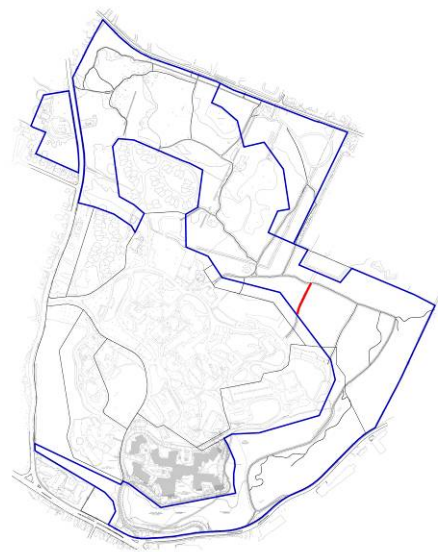
Description and Location: A moderate to well used short trail in the Eastern Woods connecting the water tower area to the McLean Hospital campus by passing through the 100' Buffer area. Trail terminates into a lawn area behind the Bowditch and Oaks buildings with a signed chain gate. Trail 4 connects to Trails 1 and 6 at the water tower area. The trail runs through an open forest area and the trail corridor is wide enough for vehicular access. The trail currently provides one of the three used connections from the McLean Hospital Campus into the Open Space Land.

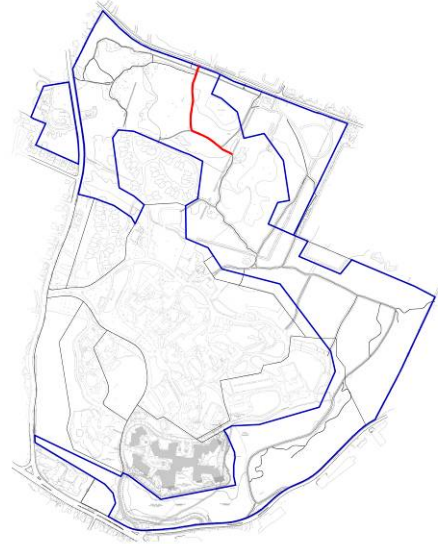
Description and Location: Within the southern part of the Great Meadow, this moderately used path provides a connection down the Lone True Hill from Trail 11 to the recently developed Residential subdistrict 1A. Although mostly within the mown grass of the Great Meadow, Trail 12 passes through an area of invasive plants and staghorn sumac. There is a moderate amount of erosion along the steeper part of the trail (trail goes directly down the fall line). The trail terminates at a newly gated trailhead located at an opening in the old stone wall defining the southern edge of the Great Meadow.

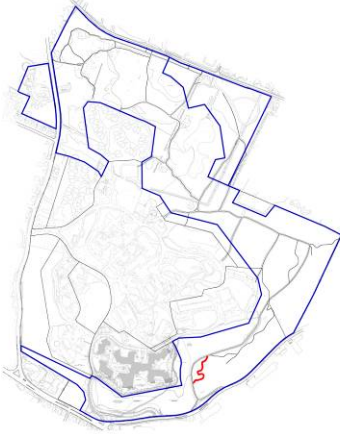
Trail A

- **Trails A, B, and C** are narrow (single-track) trails through the Eastern Woods and provide an alternate route to Trail 1. Some portions of these trails are very steep and in these areas there is potential for future erosion problems. There is a wet and muddy area along a section of Trail B.

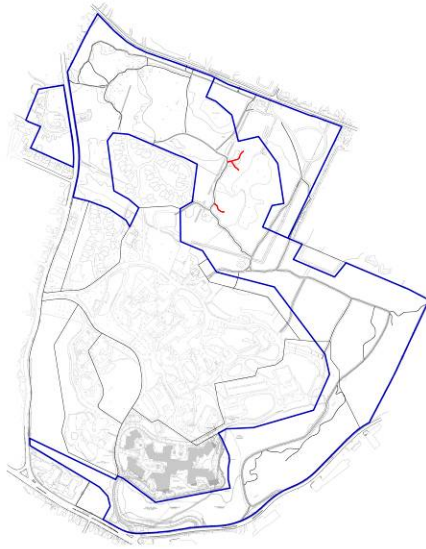
Trail E

- **Trails E** are a series of three trails emanating from Trail 8 and into the area surrounding Red Maple Swamp. All three trails seem to dead end at the edge of wetland.

Trails E: These trails serve as educational trails providing access to the wetlands and vernal pools of the Red Maple Swamp. There may be opportunity to extend one of these trails further into the swamp and connect to other areas of the MOS although there may be some wetland regulatory issues involved with such an extension. Extending these trails may lead to degradation due to increased use.

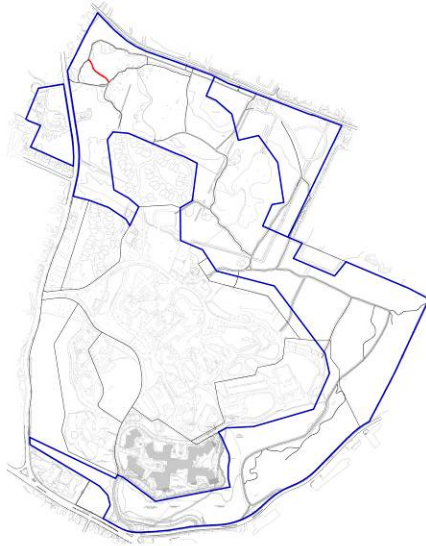
Trail F

- **Trail F** cuts across the side the hill in the Northwest Corner and connects Trails 13 and 15. It goes through the heart of the red pine forest.
