The Bradford (Former Cushing Village) Update

Presented Virtually
February 25, 2021

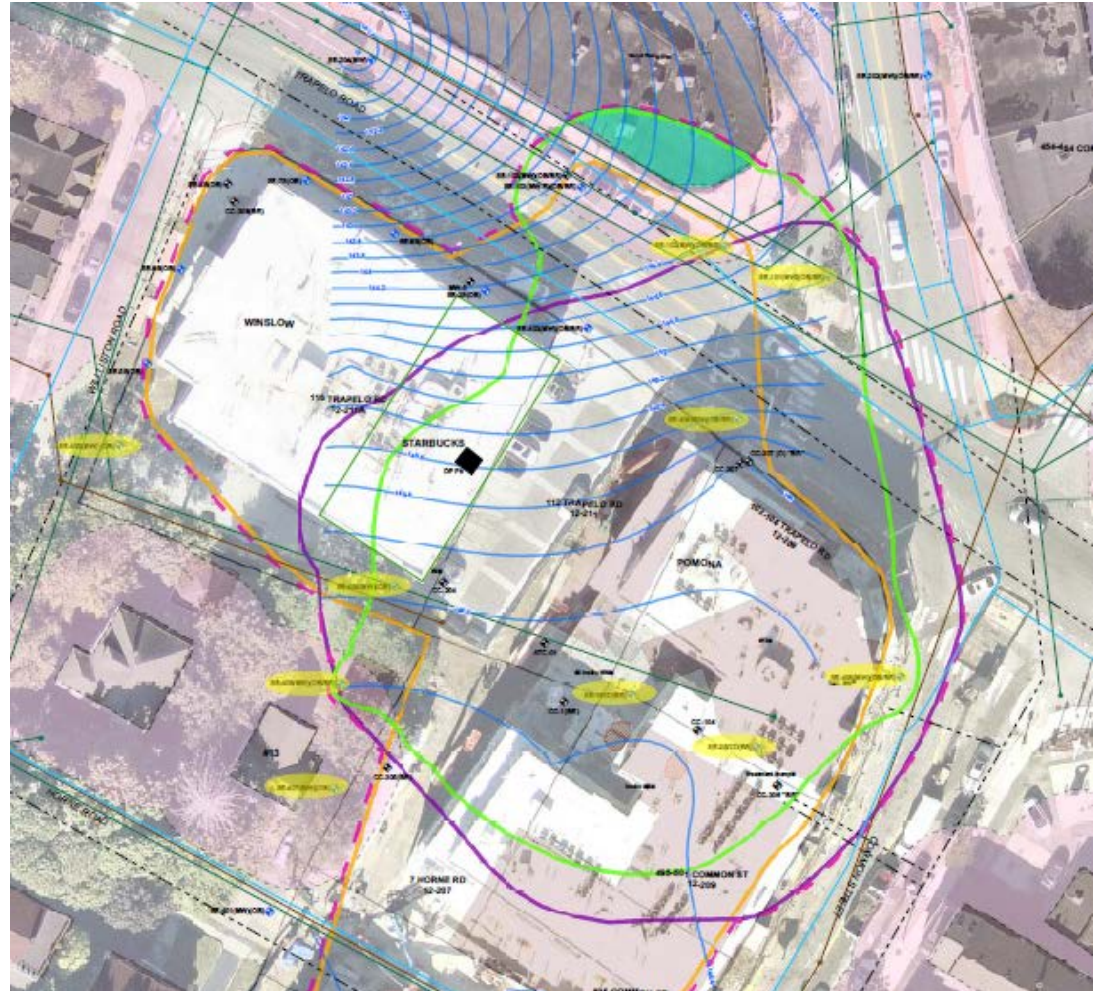
Sampled Monitoring Wells

General Location	Well ID	Sampling Zone
On-Property	SE-1S(MW)(BR)	Bedrock
	SE-1D(MW)(BR)	Bedrock
	SE-2S(MW)(BR)	Bedrock
	SE-2D(MW)(BR)	Bedrock
	SE-402(MW)	Overburden
	SE-409(MW)	Overburden
13 Home Road	SE-407(MW)	Overburden
	SE-408(MW)(OB)	Overburden
	SE-408(MW)(BR)	Bedrock
Common Street	SE-406(MW)(OB)	Overburden
	SE-406(MW)(BR)	Bedrock
Trapelo Road	SE-101(MW)(OB)	Overburden
	SE-101(MW)(BR)	Bedrock
	SE-102(MW)(OB)	Overburden
	SE-102(MW)(BR)	Bedrock
	SE-404(MW)(OB)	Overburden
	SE-404(MW)(BR)	Bedrock

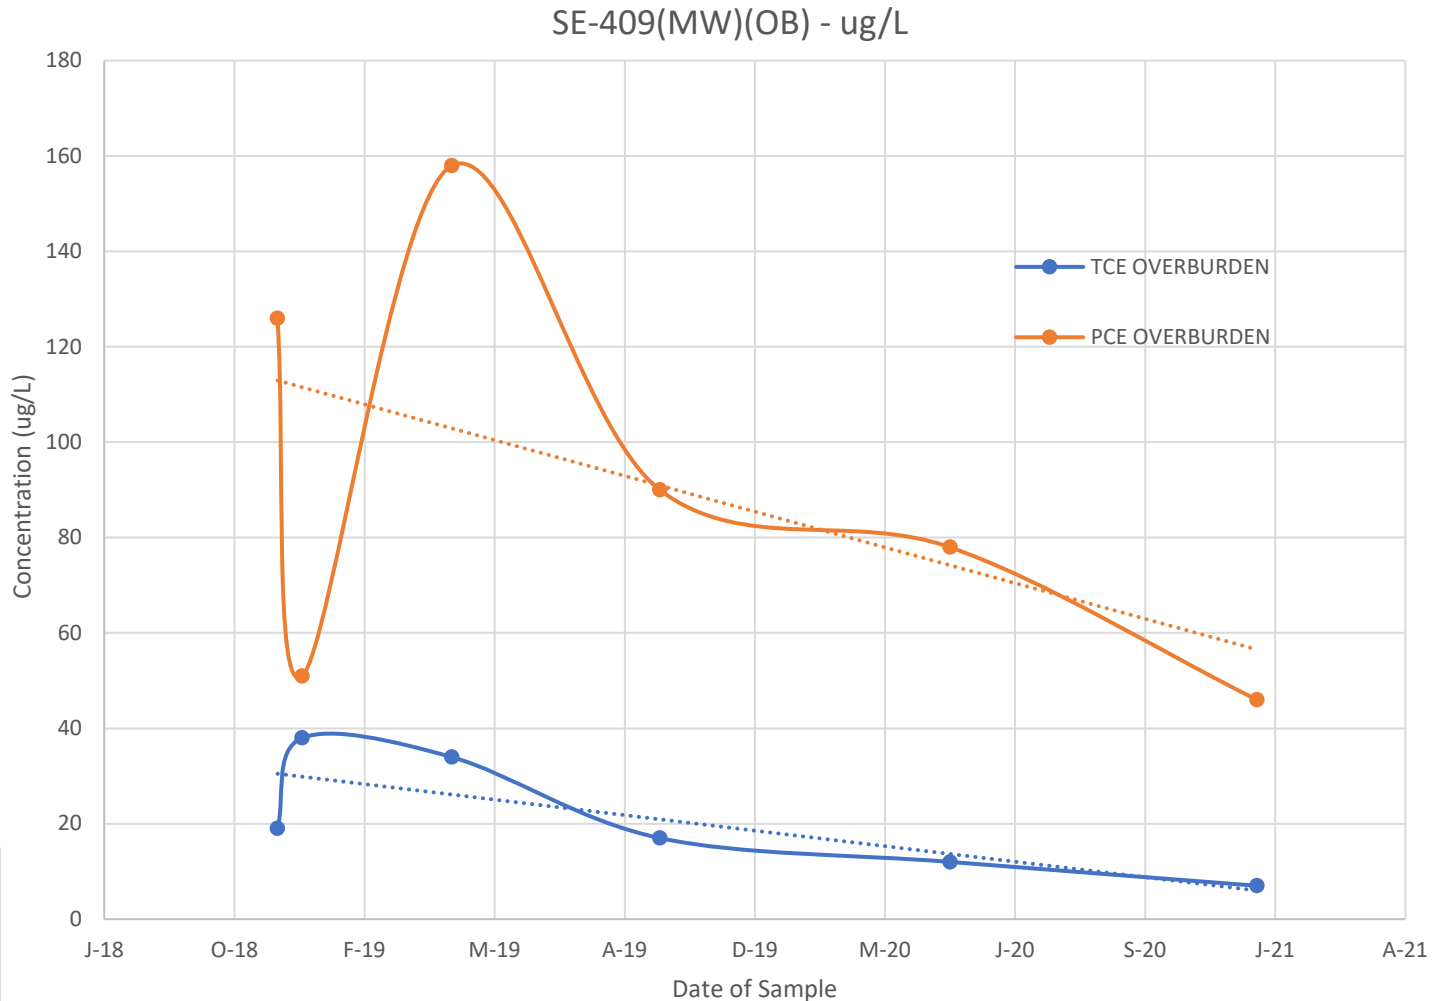
Groundwater Sampling Results Review Continued

➤ Overall results continue to show a stable to decreasing trend

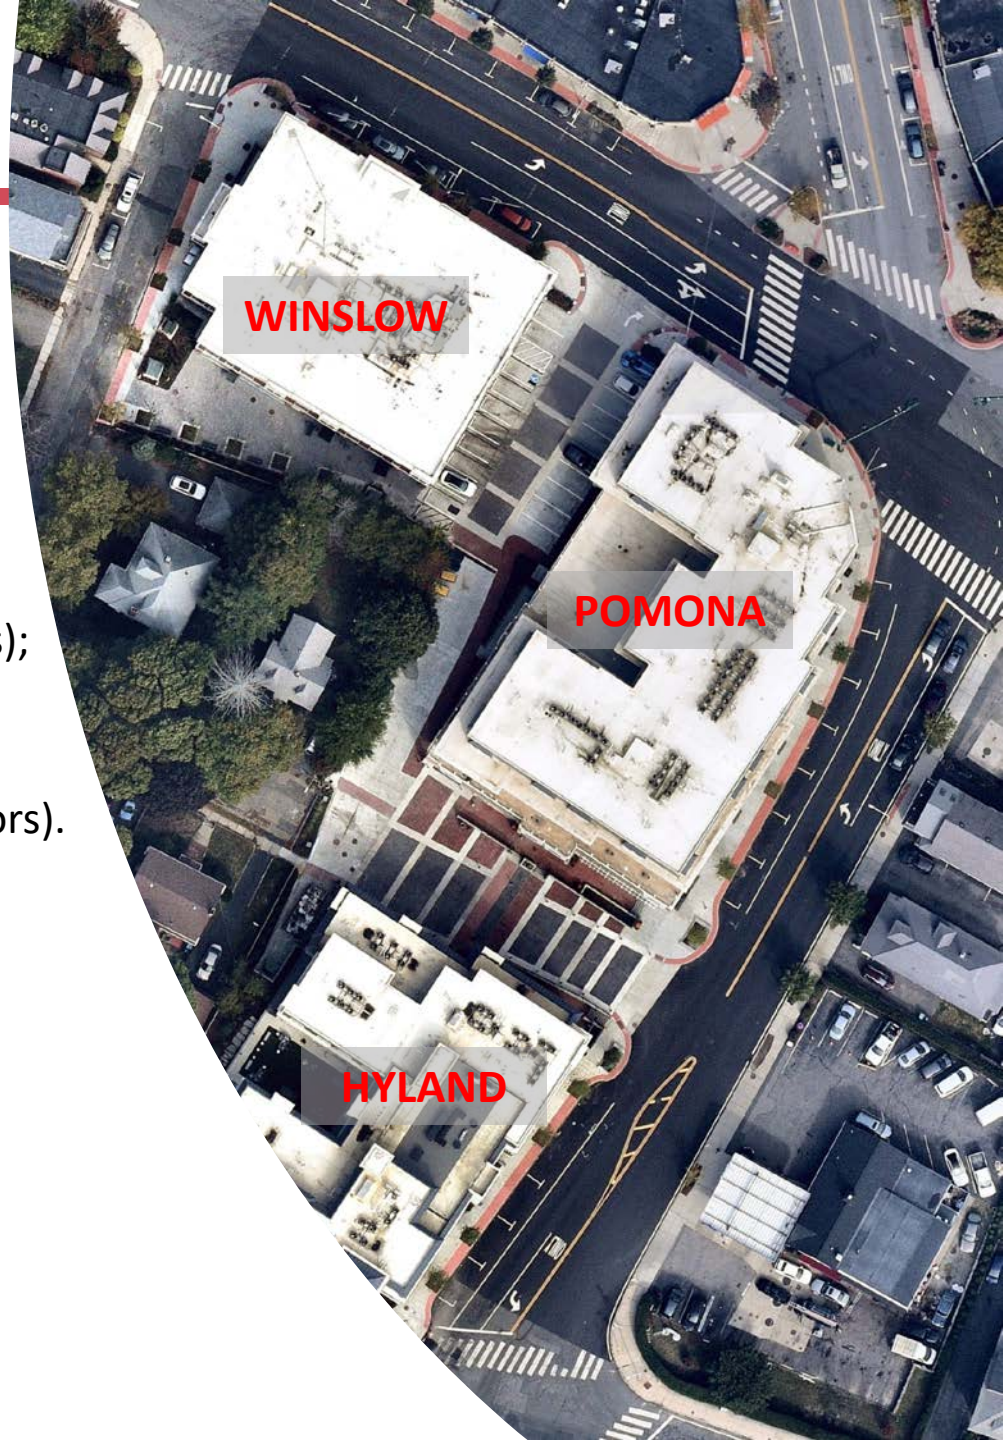
Indoor Air Sampling

- Comprehensive round of indoor air sampling conducted in December 2020
-
- Areas Sampled:
 - Parking Garage;
 - Winslow (ground, 2nd, and 3rd floors);
 - Pomona (ground, 2nd, 3rd, and 4th floors); and
 - Hyland (ground, 2nd, 3rd, and 4th floors).
 - No COCs detected in the Parking Garage, Winslow, or Hyland.
 - COCs detected in the Pomona above MassDEP Residential Threshold Values (RTVs).

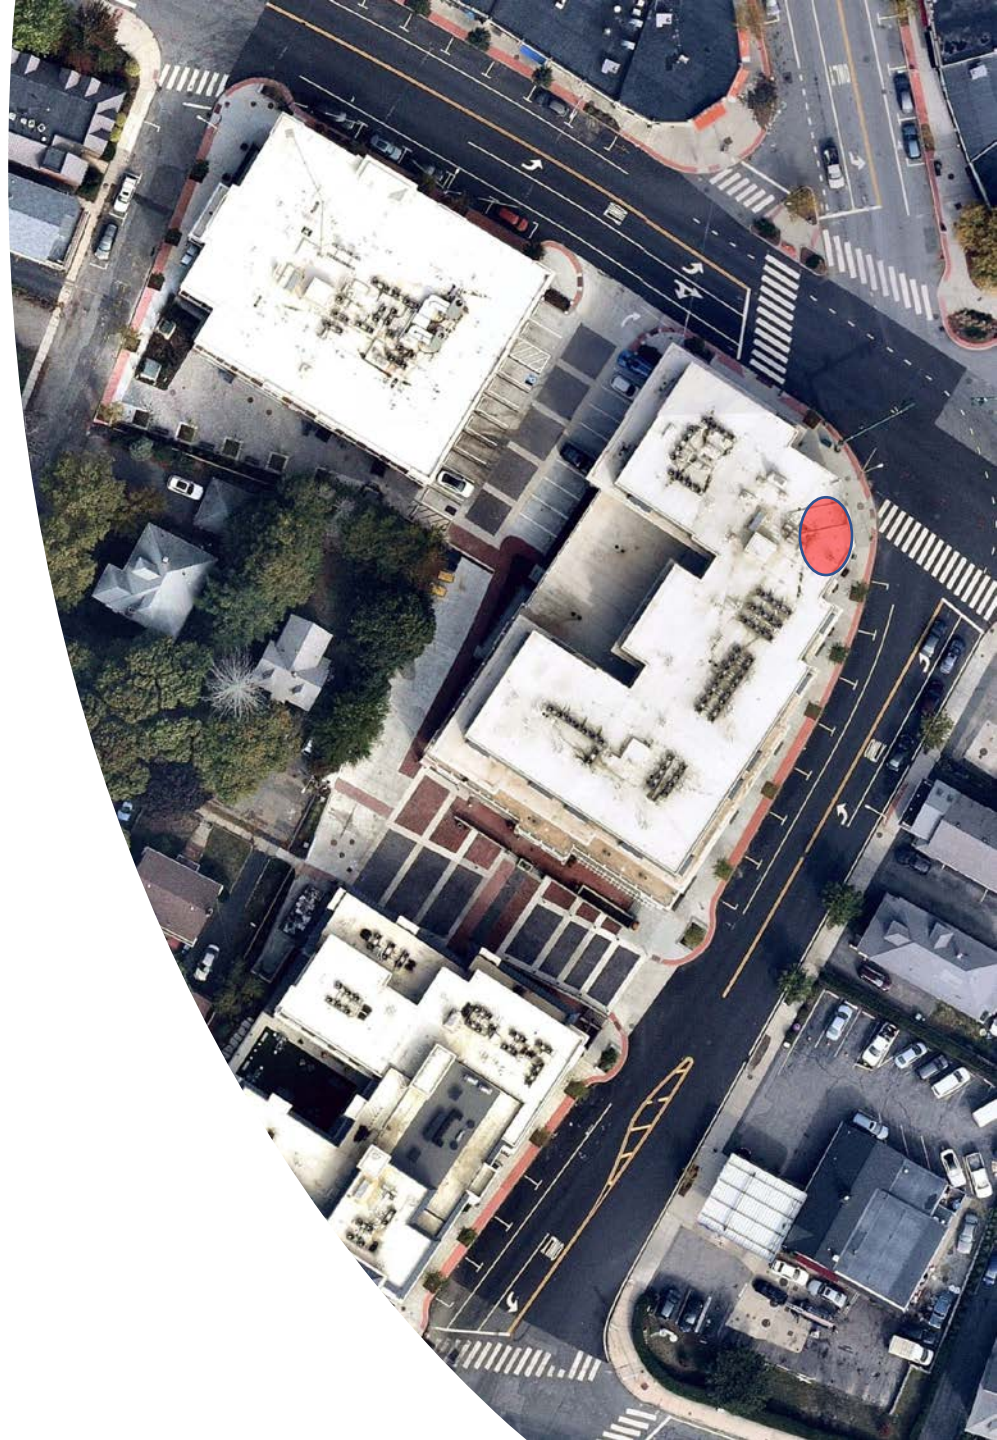
Assessment Activities and Conceptual Site Model for Pomona Condition

- SAGE has been conducting extensive investigation to identify and rectify the source.
- To date, we have collected over 350 HAPSITE samples and investigated multiple potential sources including:
 - Cleaning products;
 - Ventilation exhaust from the permanent sub-slab dewatering system;
 - Building products; and
 - Equipment.
- Additionally, extensive smoke testing has been performed to evaluate the flow of air throughout the building.
- Results of this testing and air flow evaluation have identified the source of vapors entering the building to be centered to a small mechanical room located within the garage.

- Source of VOCs found to be coming from a small room in the garage known as the mechanical room.
 - This was derived after an extensive investigation of possible other sources which lead to the room.
 - The room contains garage heating units and controls for floor drain collection pumping equipment.
 - VOCs found to be entering the room from a number of different sources:
 1. Floor drain;
 2. Electrical conduits from the floor drain collection sumps; and
 3. Floor seam between the foundation floor and wall.

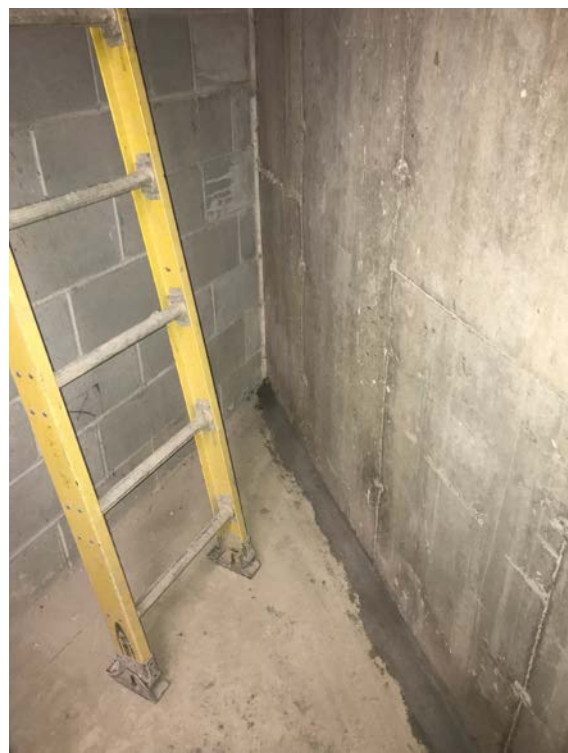
Summary & Conclusions Continued

- During its extensive investigation, SAGE was able to determine the source of vapors entering the Pomona to be centered from a small room (“Mechanical Room”) in the parking garage. Sources include:
 - Electrical conditions and floor drain from floor drain basins; and
 - Floor seam along the foundation wall
- Vapor migration from mechanical room through ceiling to upper floors (CSM).
- Corrective actions are underway and those taken to date have provided stability to indoor air. Neither PCE or TCE has been detected within the Lobby or upper residential floors for nearly 2-3 weeks.
- Once all actions have been made, suspension of air purifications units will take place and a round of indoor air sampling will take place using laboratory-provided Summa Canisters.
